# Mobile Harbor Crane Wheel Hub Fatigue Failure

J. Shirokoff

Failure analysis of a mobile harbor crane wheel hub demonstrated that the mechanism of failure was fatigue. The wheel hub was a ductile cast iron component that had been subjected to cyclic loading during a ten-year service period. The fracture surface of the fatigue failure also contained corrosion deposit, suggesting that cracking occurred over a period of time sufficient to allow corrosion of the cracked surfaces. Replacement and alignment of the failed wheel hub is recommended along with inspection of the nonfailed wheel hubs that remain on the crane.

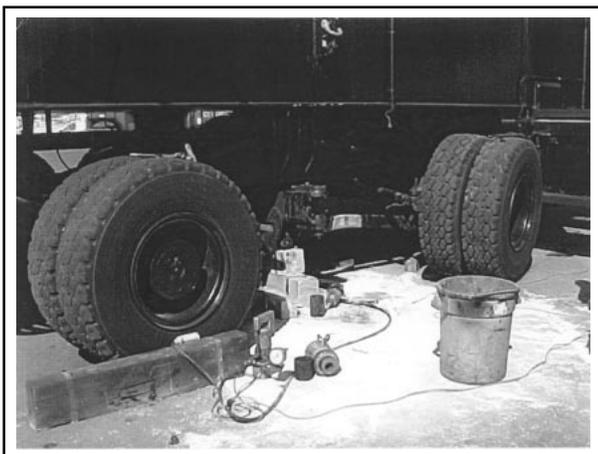
A general view of two of the six axles and their wheels along the side of the crane is shown in Fig. 1. In between the two axle/wheel assemblies is the failed axle with wheel assemblage removed. The photograph in Fig. 2 shows an axle, wheel hub, wheel, tire, and steering arm of an axle assemblage that is in good working order.

**Fig. 1** General view of two crane wheel sets and one failed axle (middle) with wheel and wheel hub removed. The wheels are turned at different angles.

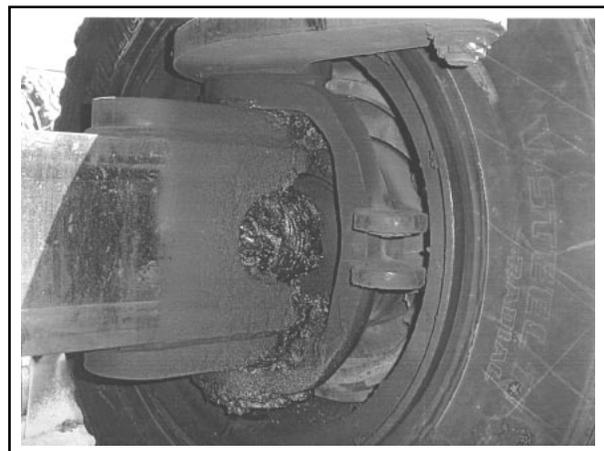
**Fig. 2** View of a nonfailed axle, wheel hub, and steering arm (top)

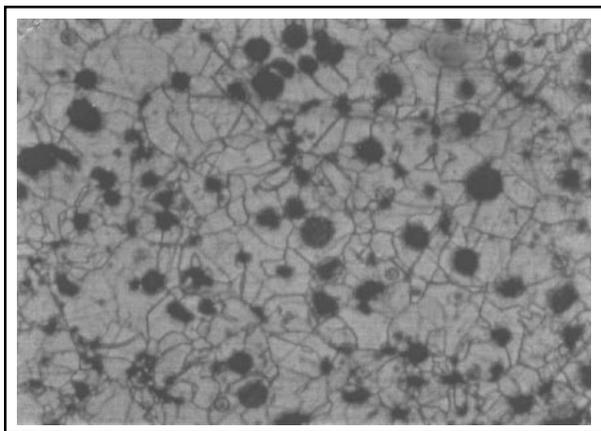
The microstructure of the wheel hub was spheroidal graphite dispersed in a ferrite metal matrix. This microstructure is typical of a ductile cast iron (also known as *nodular iron*).<sup>[1]</sup> A micrograph of the wheel hub microstructure near a fractured surface is shown in Fig. 3. This microstructure is representative of the entire component (near-fracture areas and bulk metal), thus suggesting the local variations in microstructure did not contribute to the failure process. Elemental analysis of the metal wheel hub using EDS on the SEM revealed that the primarily iron alloy contained 1.328 wt.% silicon (Fig. 4), and the carbon analysis (3.57 wt.%) was within the range of 3.5 to 3.8% reported for nodular iron.<sup>[1]</sup>

Fig. 3 Optical metallograph of ductile cast iron showing the spheroidal graphite phase in a ferrite matrix. 250x

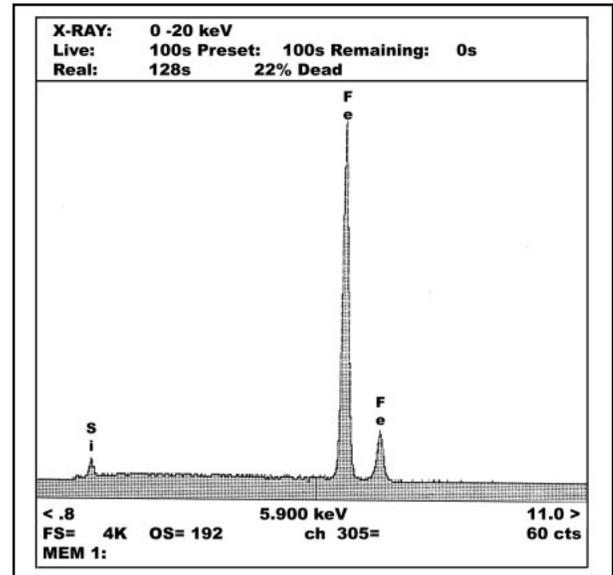
Fig. 4 Energy-dispersive spectroscopy of the ductile cast iron

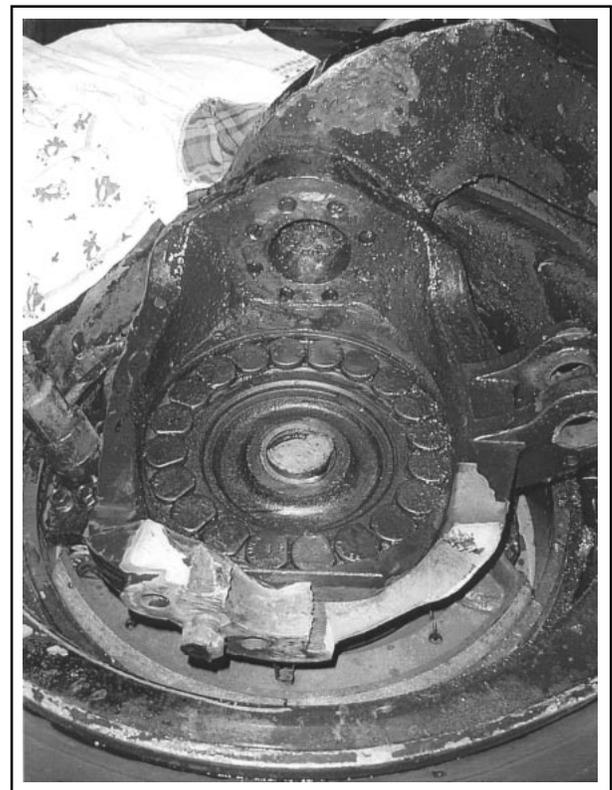
Fig. 5 Failed wheel hub (side view) showing fracture surface and area where material has broken away

The failed wheel hub and axle are shown in Fig. 5. Much of the fracture surface appears rough and granular, consistent with macroscopic appearance of overload fracture. Such fracture would occur after the load-carrying capabilities of the component had been reduced by the presence of fatigue cracks.<sup>[2]</sup> Additional examples of overload fracture are presented in Fig. 6, where a side view of the fractured wheel hub components are shown. Another smoother, flatter, and less shiny region of the fracture surface is shown in Fig. 7. Regions on this portion of the fracture appear as brown stains (arrow). The brown area was chemically analyzed by EDS on the

1. A new nodular cast iron wheel hub and axle should be used to replace the failed component.
2. The installation process should assure that the new wheel hub and axle are properly aligned.
3. The nonfailed wheel hubs should be examined for cracks using traditional inspection methods such as liquid dye penetrant.
4. A more detailed analysis of wheel hub stresses may be beneficial, especially if any additional cracks are found in the nonfailed assemblies. This analysis would require data and engineering drawings of the wheel hub assemblage from the crane manufacturer and could incorporate stress measurement of the wheel hub using strain gages.

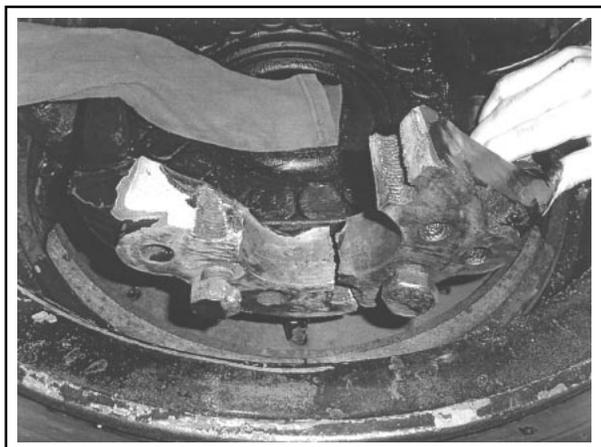
Fig. 6 Failed wheel hub (side view) incorporating the broken part held in place

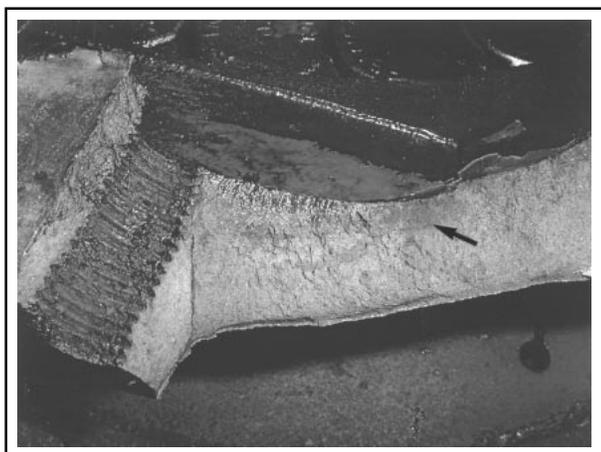
Fig. 7 Fracture surface of the failed wheel hub showing the brown discoloration or stain area (arrow)

SEM and found to be primarily iron with a minor presence of sodium, silicon, sulfur, chlorine, potassium, calcium, manganese, and zinc. The brown stain is assumed to be primarily iron oxide (the EDS system does not capture X-ray emissions from oxygen). Scanning electron microscopy fractograph and optical fractograph of the flat oxidized portions of the fracture surface (Fig. 9 and 10) are consistent with a ductile fatigue fracture failure without the presence of fatigue striations.<sup>[3,4]</sup> These fracture features are also consistent with the lack of embrittlement in the nodular cast iron.<sup>[5-7]</sup>

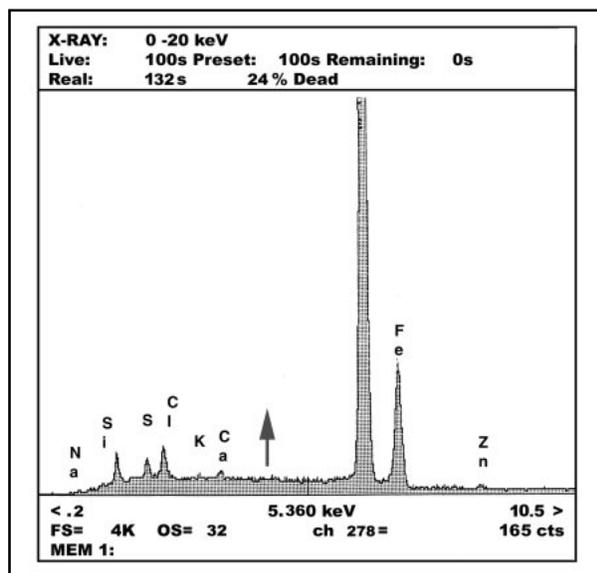
Fig. 8 Energy-dispersive spectroscopy of the discolored surface of Fig. 7

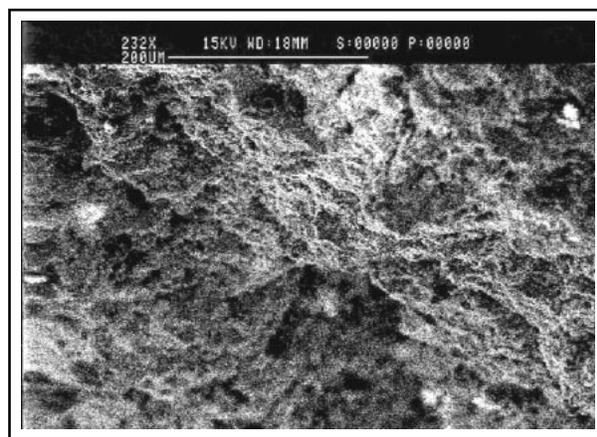
Fig. 9 Scanning electron microscopy micrograph of the fracture surface

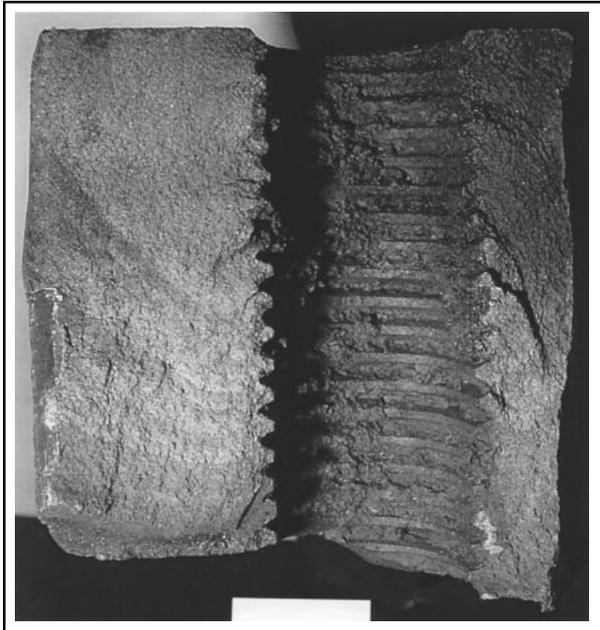
Fig. 10 Fractograph of the wheel hub fatigue failure

The wheel hub failure was due to the service-induced growth of a fatigue crack and stress-concentrating effects of that crack on motion-induced stresses. The cause(s) of fatigue crack initiation and growth was(were) not established, but misalignment of the hub is considered a likely candidate.
