Mobile Harbor Crane Wheel Hub Fatigue Failure

J. Shirokoff

Failure analysis of a mobile harbor crane wheel hub demonstrated that the mechanism of failure was fatigue. The wheel hub was a ductile cast iron component that had been subjected to cyclic loading during a ten-year service period. The fracture surface of the fatigue failure also contained corrosion deposit, suggesting that cracking occurred over a period of time sufficient to allow corrosion of the cracked surfaces. Replacement and alignment of the failed wheel hub is recommended along with inspection of the nonfailed wheel hubs that remain on the crane.

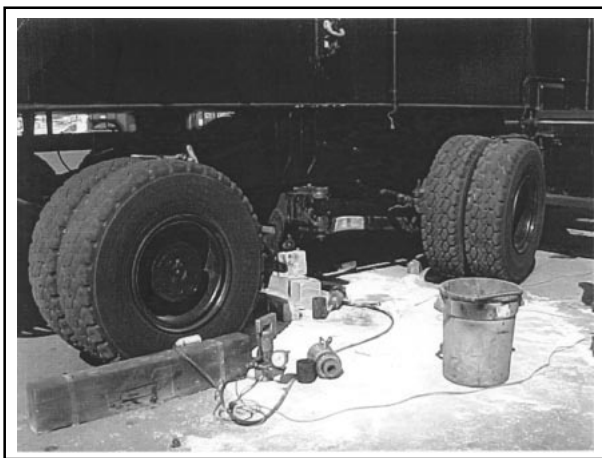
side of the crane, and one of the six wheel hubs on that side of the crane failed. The wheel failure led to an axle failure while the crane was still moving. The failed wheel was the second in line and the leading drive wheel for the crane (the drive wheels are the second and third wheels in line).

Fig. 1 General view of two crane wheel sets and one failed axle (middle) with wheel and wheel hub removed. The wheels are turned at different angles.

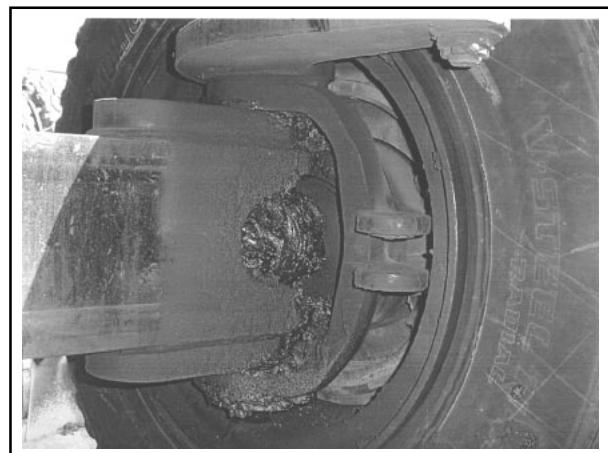
Fig. 2 View of a nonfailed axle, wheel hub, and steering arm (top)

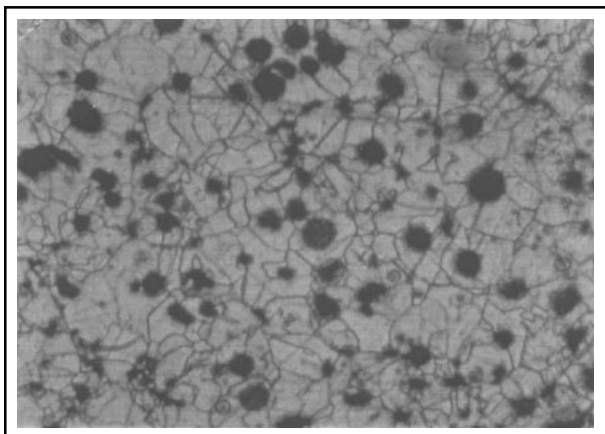
The microstructure of the wheel hub was spheroidal graphite dispersed in a ferrite metal matrix. This microstructure is typical of a ductile cast iron (also known as *nodular iron*).^[1] A micrograph of the wheel hub microstructure near a fractured surface is shown in Fig. 3. This microstructure is representative of the entire component (near-fracture areas and bulk metal), thus suggesting the local variations in microstructure did not contribute to the failure process. Elemental analysis of the metal wheel hub using EDS on the SEM revealed that the primarily iron alloy contained 1.328 wt.% silicon (Fig. 4), and the carbon analysis (3.57 wt.%) was within the range of 3.5 to 3.8% reported for nodular iron.^[1]

Fig. 3 Optical metallograph of ductile cast iron showing the spheroidal graphite phase in a ferrite matrix. 250x

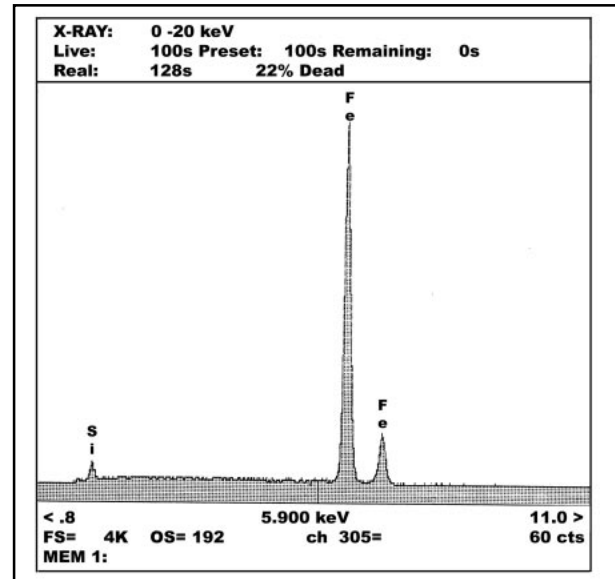
Fig. 4 Energy-dispersive spectroscopy of the ductile cast iron

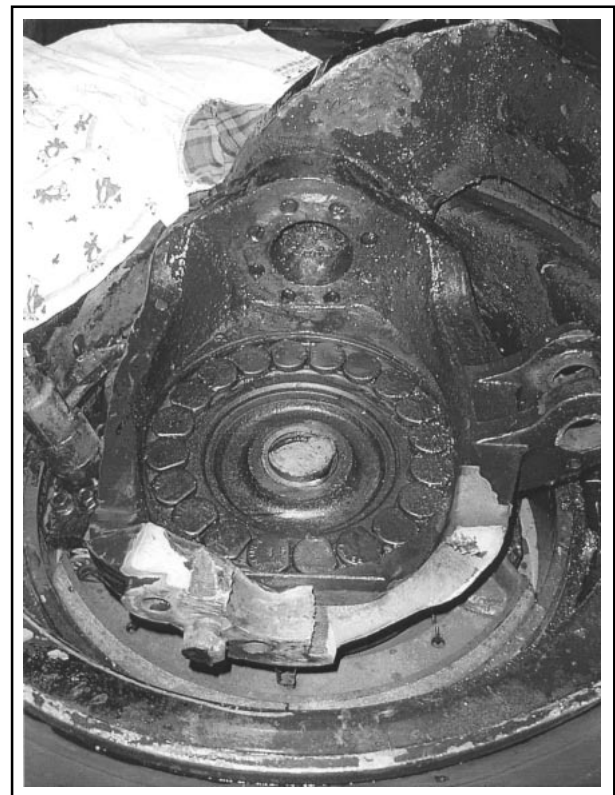
Fig. 5 Failed wheel hub (side view) showing fracture surface and area where material has broken away

The failed wheel hub and axle are shown in Fig. 5. Much of the fracture surface appears rough and granular, consistent with macroscopic appearance of overload fracture. Such fracture would occur after the load-carrying capabilities of the component had been reduced by the presence of fatigue cracks.^[2] Additional examples of overload fracture are presented in Fig. 6, where a side view of the fractured wheel hub components are shown. Another smoother, flatter, and less shiny region of the fracture surface is shown in Fig. 7. Regions on this portion of the fracture appear as brown stains (arrow). The brown area was chemically analyzed by EDS on the

1. A new nodular cast iron wheel hub and axle should be used to replace the failed component.
2. The installation process should assure that the new wheel hub and axle are properly aligned.
3. The nonfailed wheel hubs should be examined for cracks using traditional inspection methods such as liquid dye penetrant.
4. A more detailed analysis of wheel hub stresses may be beneficial, especially if any additional cracks are found in the nonfailed assemblies. This analysis would require data and engineering drawings of the wheel hub assemblage from the crane manufacturer and could incorporate stress measurement of the wheel hub using strain gages.

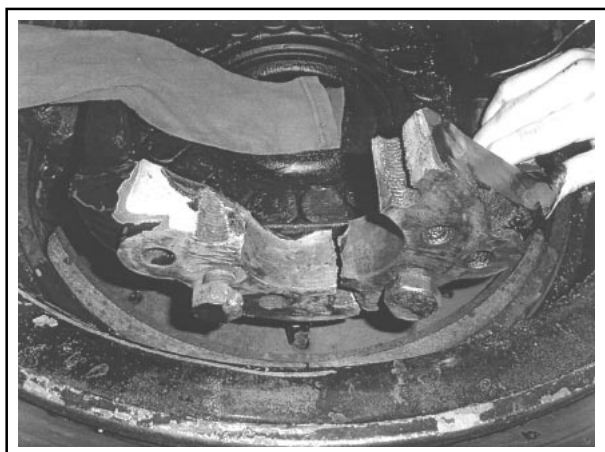
Fig. 6 Failed wheel hub (side view) incorporating the broken part held in place

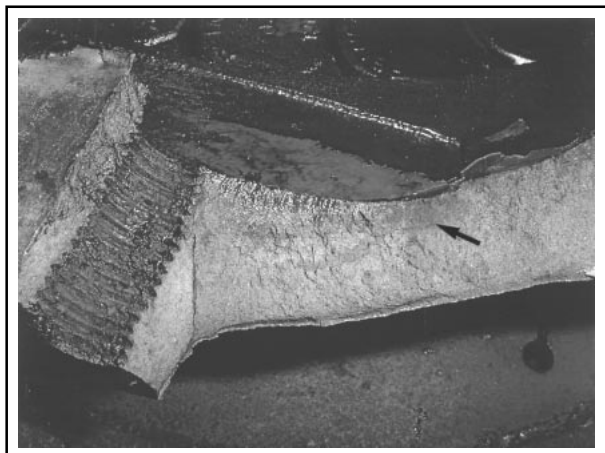
SEM and found to be primarily iron with a minor presence of sodium, silicon, sulfur, chlorine, potassium, calcium, manganese, and zinc. The brown stain is assumed to be primarily iron oxide (the EDS system does not capture X-ray emissions from oxygen). Scanning electron microscopy fractograph and optical fractograph of the flat oxidized portions of the fracture surface (Fig. 9 and 10) are consistent with a ductile fatigue fracture failure without the presence of fatigue striations.^[3,4] These fracture features are also consistent with the lack of embrittlement in the nodular cast iron.^[5-7]

Fig. 7 Fracture surface of the failed wheel hub showing the brown discoloration or stain area (arrow)

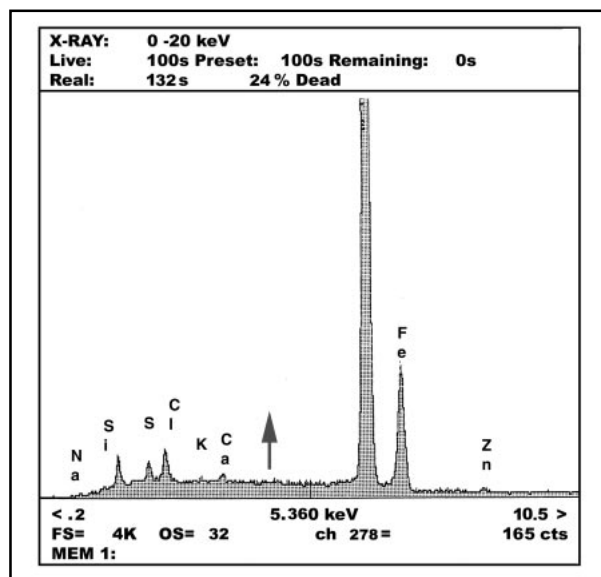
Fig. 8 Energy-dispersive spectroscopy of the discolored surface of Fig. 7

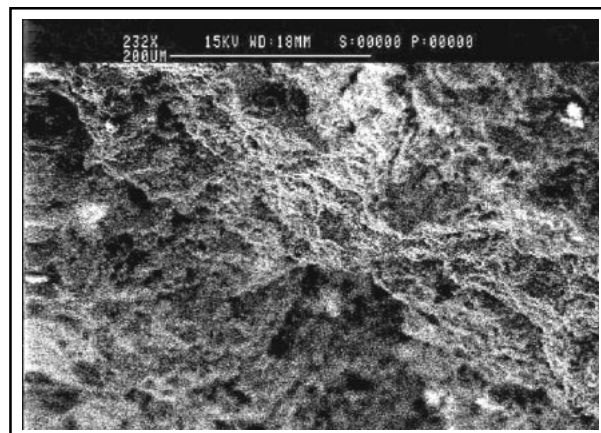
Fig. 9 Scanning electron microscopy micrograph of the fracture surface

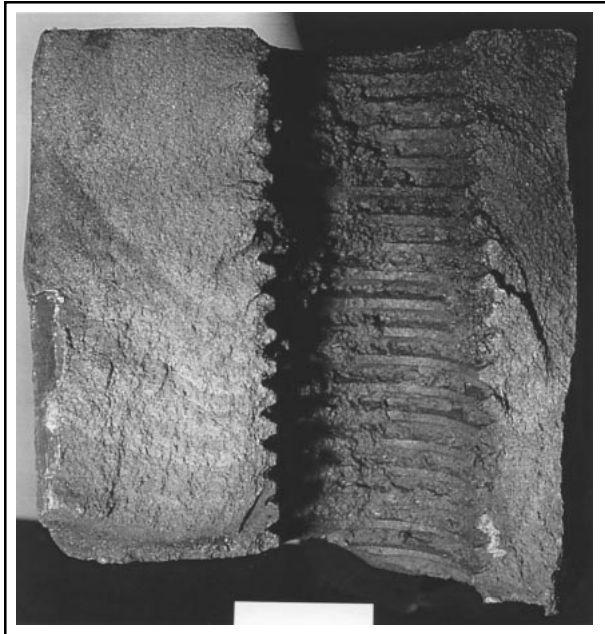
Fig. 10 Fractograph of the wheel hub fatigue failure

The wheel hub failure was due to the service-induced growth of a fatigue crack and stress-concentrating effects of that crack on motion-induced stresses. The cause(s) of fatigue crack initiation and growth was(were) not established, but misalignment of the hub is considered a likely candidate.
