# COASTAL GEOMORPHOLOGY, PROCESSES AND EROSION AT THE TOURIST DESTINATION OF FERRYLAND, NEWFOUNDLAND AND LABRADOR

A thesis submitted to the

**Master of Science**

April 2016

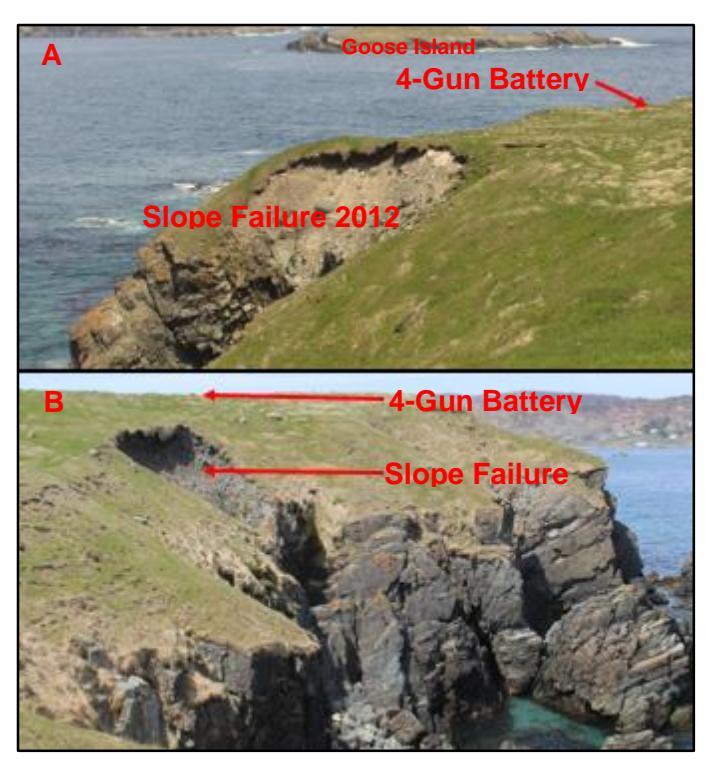
Figure 4.5. Slope Failures near 4-Gun Battery. A: Slope failure west of the 4-Gun Battery in 2012. B: Slope failure east of the 4 Gun Battery prior to 2012.

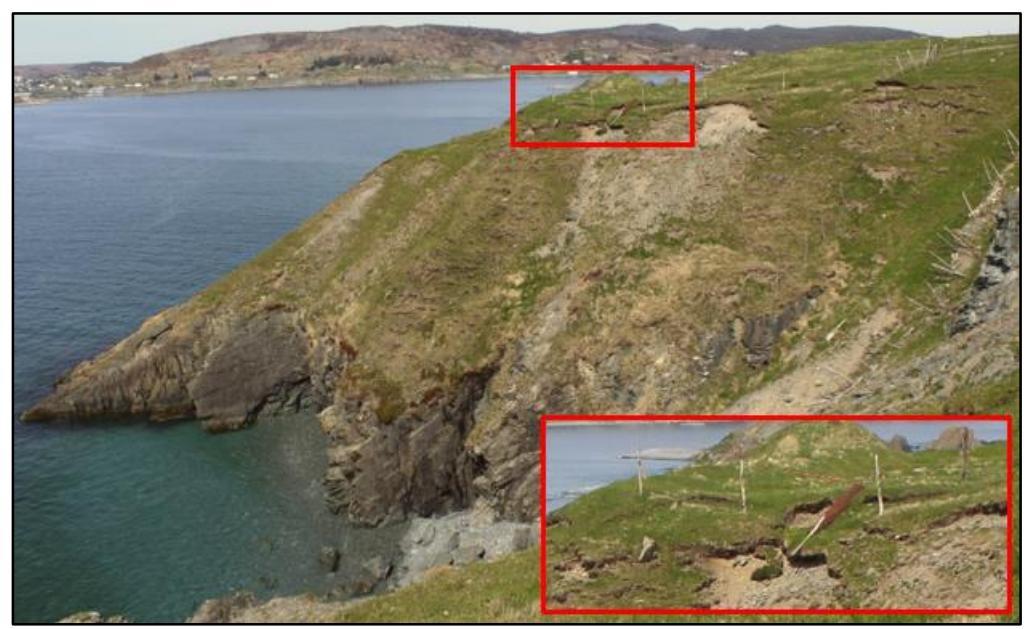
Figure 4.7. 6-Gun Battery. Erosion of ordnance due to slope processes. June 2015. 5 of 6 ordnance pieces were located with one ordnance piece at risk of erosion and one visually undetected piece. However, movement of a compass needle and light probing indicated a possible location and a GPS position was taken. The pocket beach and area to the left is the primary area subject to erosion from freeze-thaw cycles and easterly waves. Photo taken from N 47° 1.564', W52° 51.883' looking West.

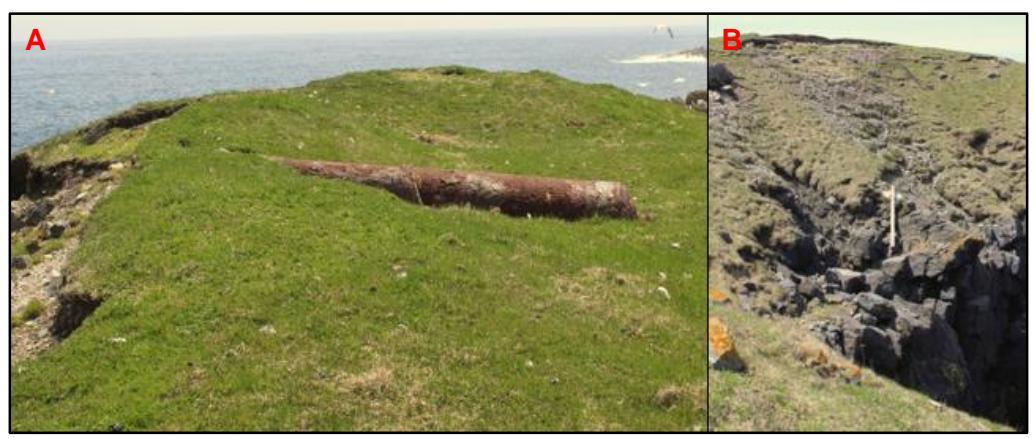
Figure 4.9. 2-Gun Battery. A: Ordnance with erosion left. B: Eroding till cliff with site sign directly below A.

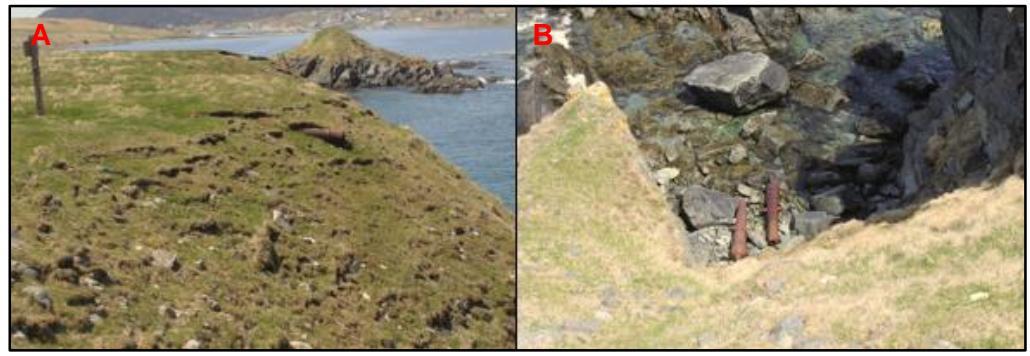
Figure 4.10. 4-Gun Battery. A: the only remaining ordnance. B: two pieces of ordnance that have been eroded from the till cliff. The fourth piece could not be located and is assumed to have been eroded and transported offshore to the west. A shoreline investigation was not completed although the piece could not be seen from a boat.

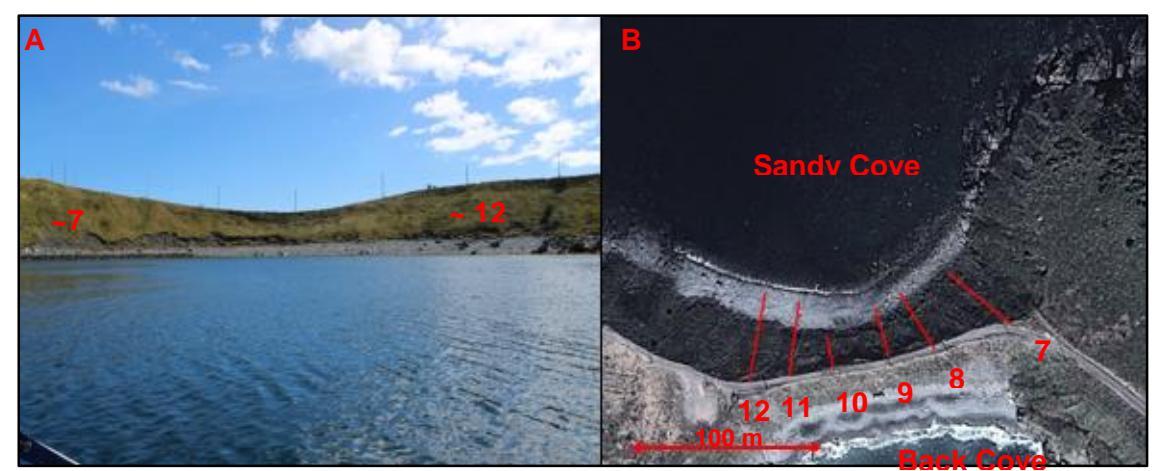
Figure 4.12. Sandy Cove. A: the northern aspect showing slope erosion due to water drainage, undercutting, and failing gabion/retaining wall. B: the planview of SBP 7-12. SBP-10 was cut off due to RTK receiver issues (Google Earth Image). Google Image is not georeferenced to MTM datum.

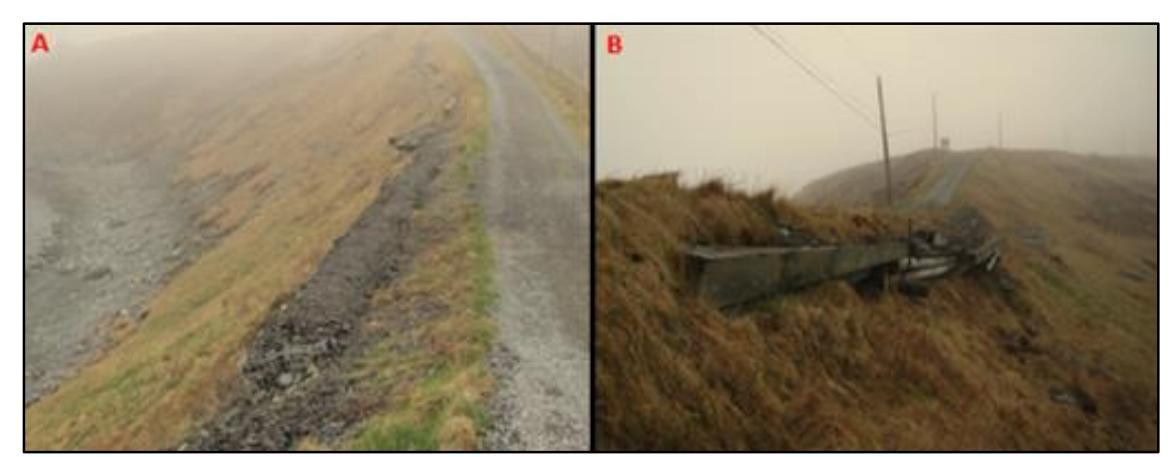
Figure 4.15. Looking east - gabion and retaining wall on north edge of road at Ferryland Head Isthmus in May 2013. A: looking west - gabion tipping downslope as creep continues. B: Retaining wall tipping downslope as creep continues.

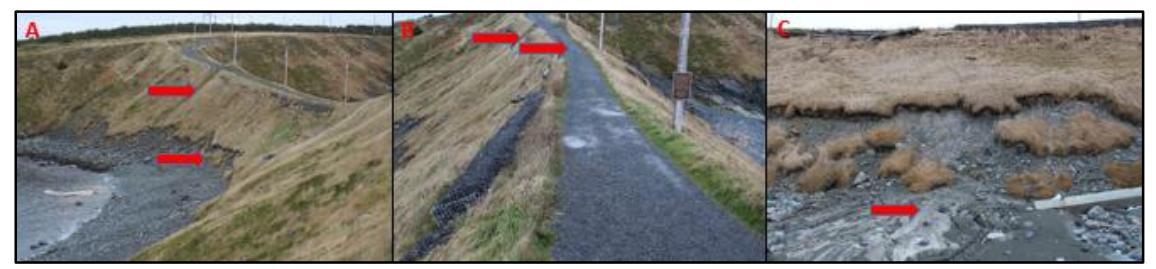
Figure 4.16. Sandy Cove Slope. A: shows former road runoff drainage channel (green linear vegetation) and slope failure/undercutting. B: shows failing gabion and residual water after rainfall drainage down the eastern road surface from Hurricane Gonzalo. C: shows slope drainage and debris flow with failed gabion and retaining wall above. Note: the square timber in C is from the failing retaining wall above.

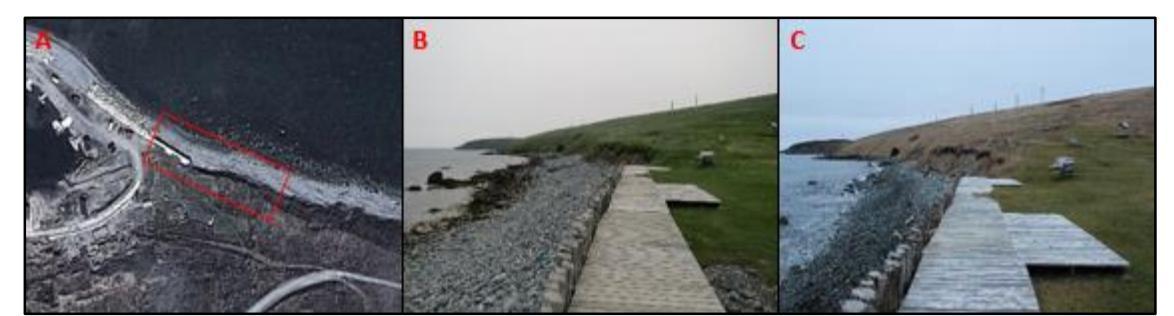
Figure 4.18. Colony of Avalon – Harbourside. A: is Harbourside area of concern (Google Earth Image), B: is July 2013, and C: is December 2014. Disregard water level and barrier exposure. Note cliff erosion at the end of the boardwalk.

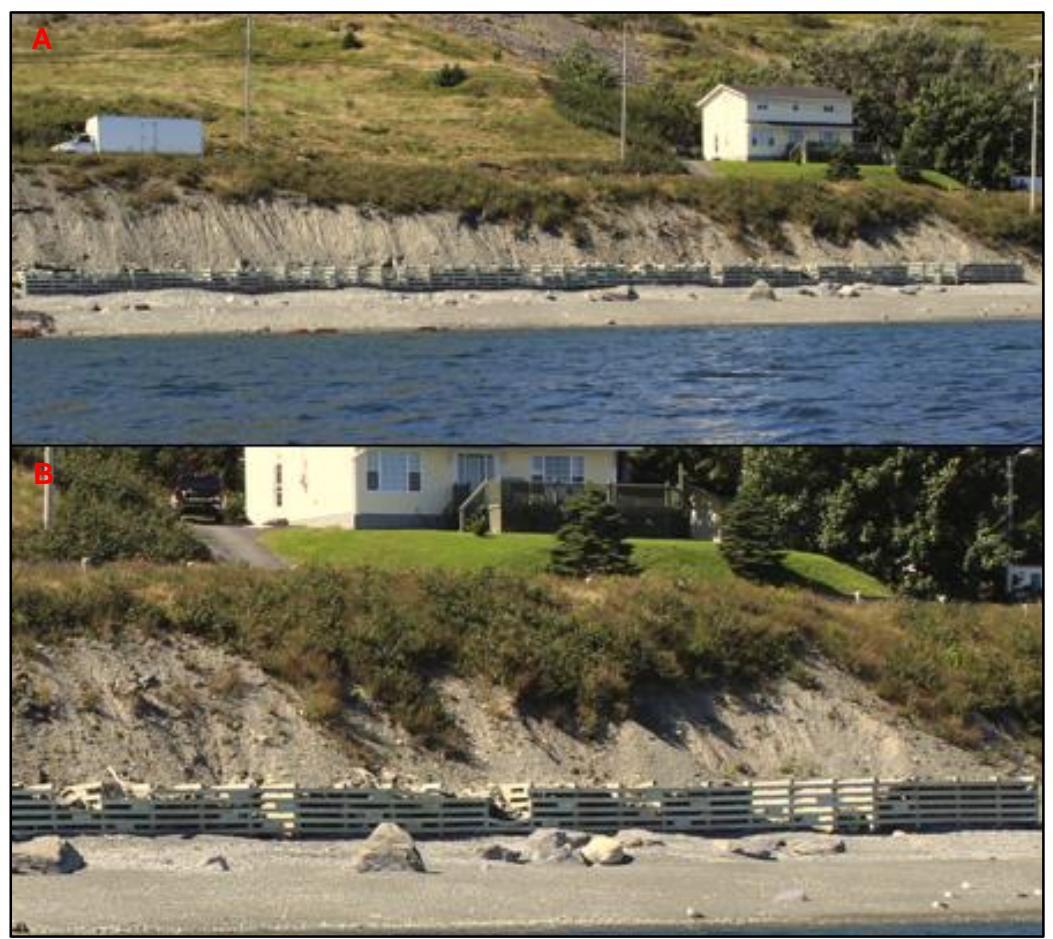
Figure 4.30. Cribbing installed along Route 10. A: White truck is traveling south on Route 10. B: Empty sections of cribbing and broken timbers. Surge, waves and currents erode undersized fill from inside the cribbing, causing further slope movement and destabilizing the road shoulder.

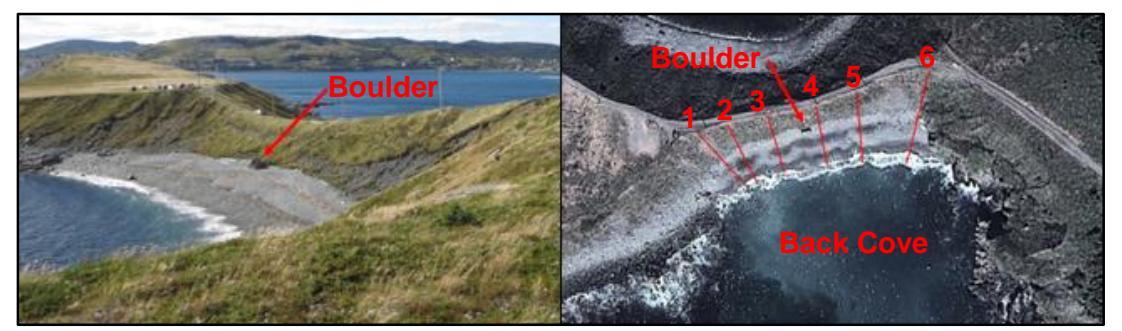
Figure 5.4. Back Cove barrier and till cliff. A: taken in September 2013. Barrier showing slope erosion due to debris flow, creep, undercutting. Sediment has been built up into berms after summer accretion. B: planview of SBP 1-6 (Google Earth). Google Image not georeferenced to MTM datum. Note the position of the large angular boulder on A and B.

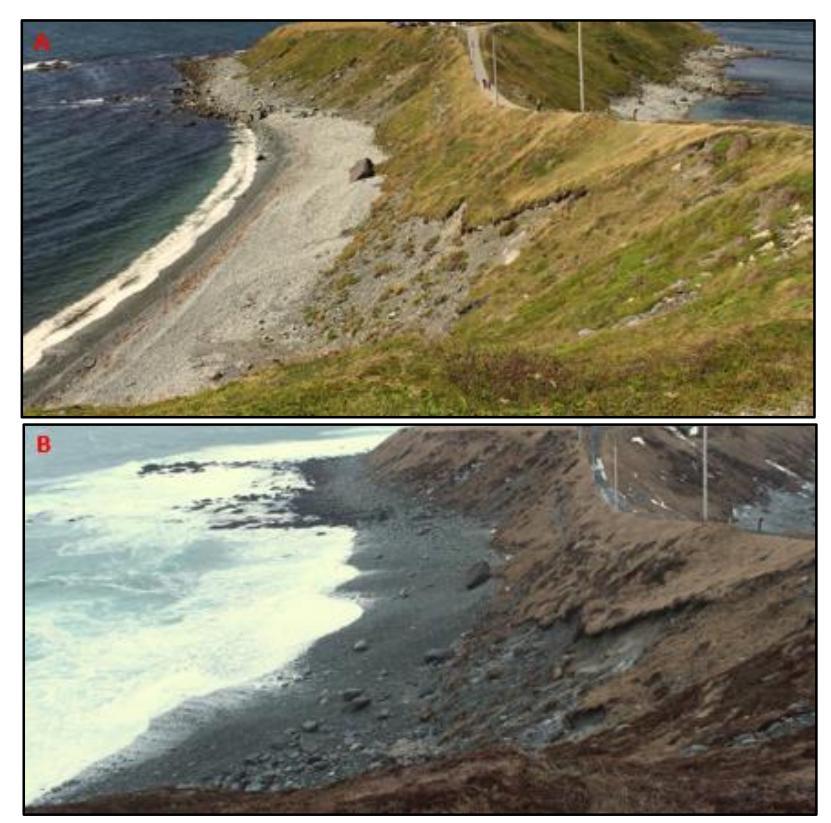
Figure 5.7. Back Cove Barrier looking west. A: August 2014 and B: January 2015. The multiple berms and convex profiles (A) have been eroded by higher water levels and large waves resulting in large shallow cusps and concave profiles (B). Also note the debris flow triggered by a recent rainfall in the bottom left of A. B shows more loose surface material above upslope of the same point than A.

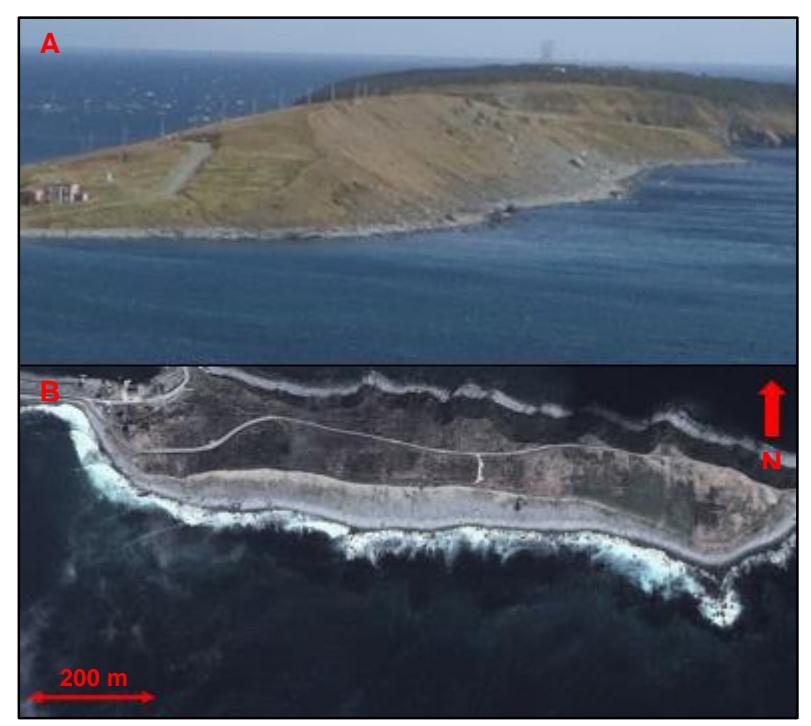
Figure 5.8. Eroding till slope on the south side of The Downs. A: the view from The Lookout. B: The dominant sediment transport is from east (right) to west (left) towards the breakwater (near the letter B in B) (Google Earth).

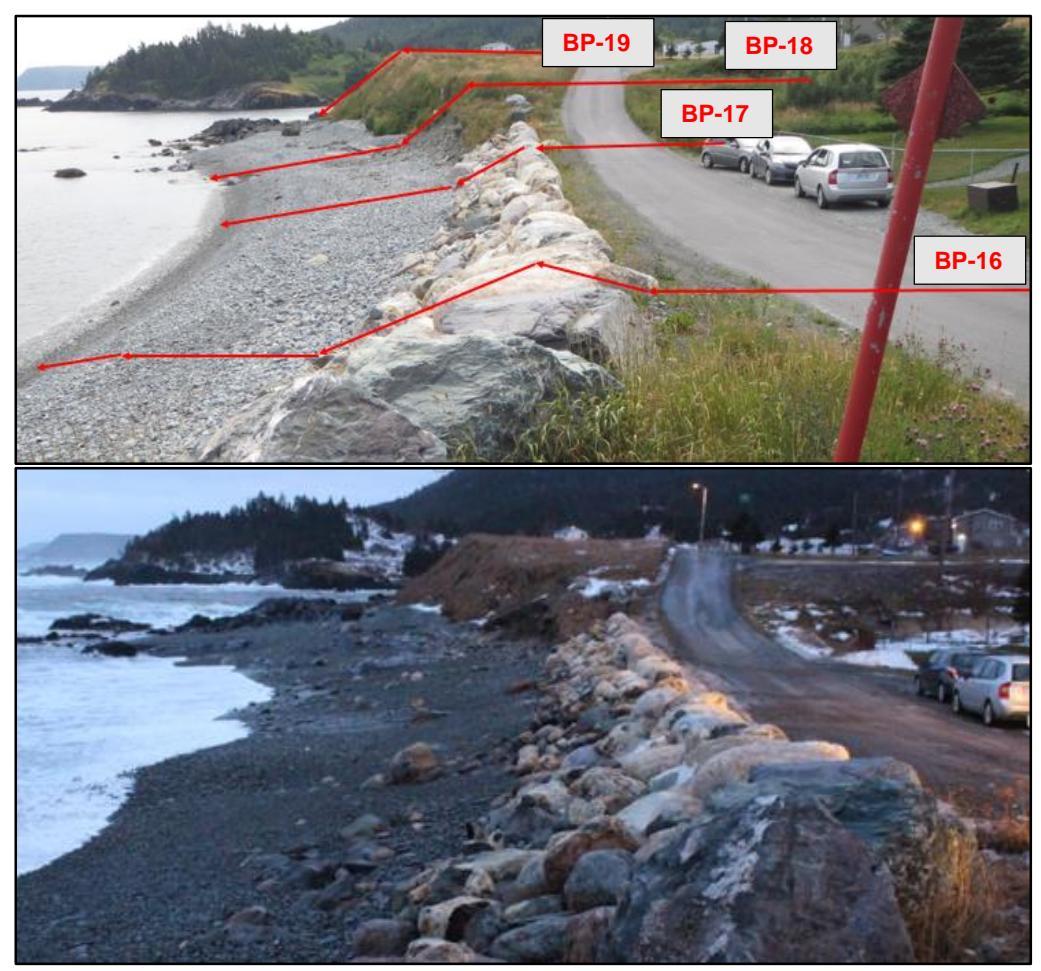
Figure 5.18. Approximate locations of BP-16 to BP19 and sediment changes. Top: BP-16 to BP-19 on August 3, 2014; bottom on January 25, 2015. Note that >0.5 m thickness of barrier cobbles have been removed. The bottom photo shows boulders from parent material and displaced armour stone. The top photo convex profile (calmer conditions) and the bottom profile is slightly concave (large waves normally associated with fall and winter storms).

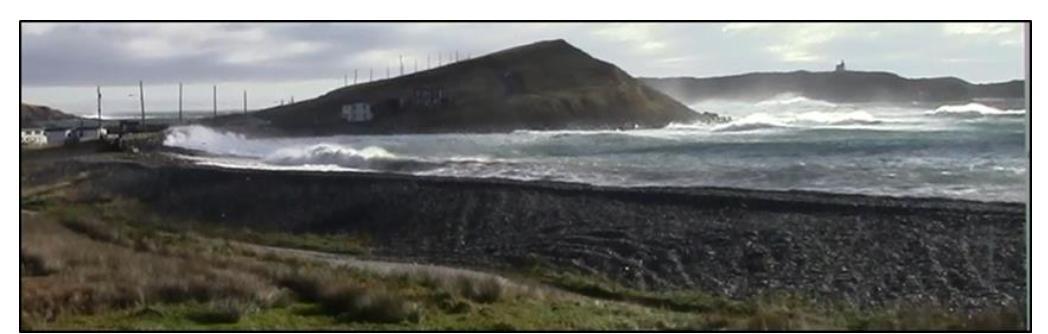
Figure 5.22 Wave breaking and overtopping the breakwater at falling tide during the passage of H. Gonzalo. Barrier sediment was deposited on the roadway with some erosion to north road edge was observed shortly after this moment.

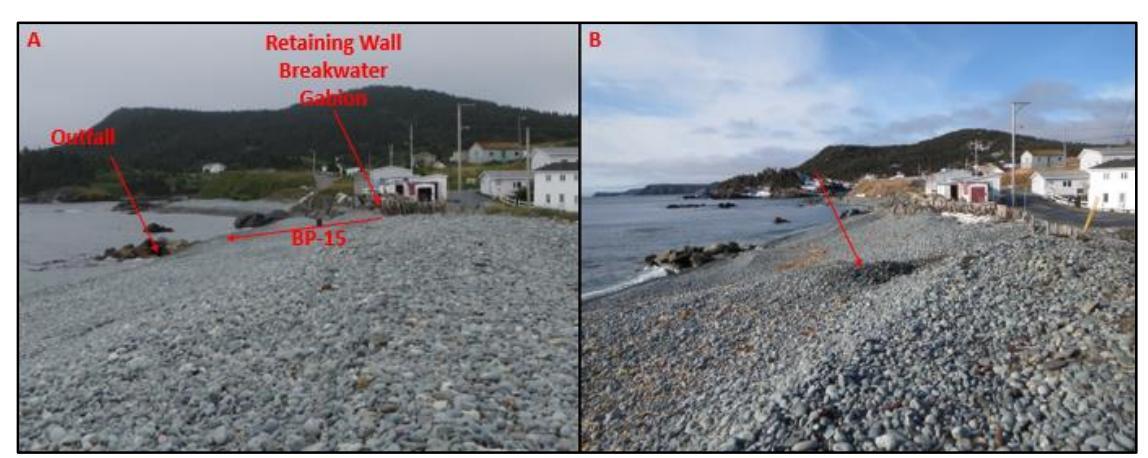
Figure 5.23. Storm berm changes at Freshwater – The Valley. A: shows southern Freshwater extent during August 2013. B: shows same during April 2014. The ridge of cobbles indicated by the red arrow in the middle of **B** is remnants of an excavated pile of cobbles to clear drainage for the culvert. Storm berm is moved landwards toward road from **A** to **B**.
