**House and Home:  
Scottish Domestic Architecture in Nova Scotia and  
the Rev. Norman McLeod Homestead**

A thesis submitted to the  
School of Graduate Studies  
in partial fulfillment of the  
requirements for the degree of  
Master of Arts  
Anthropology

Memorial University of Newfoundland  
St. John's, Newfoundland  
April 2005

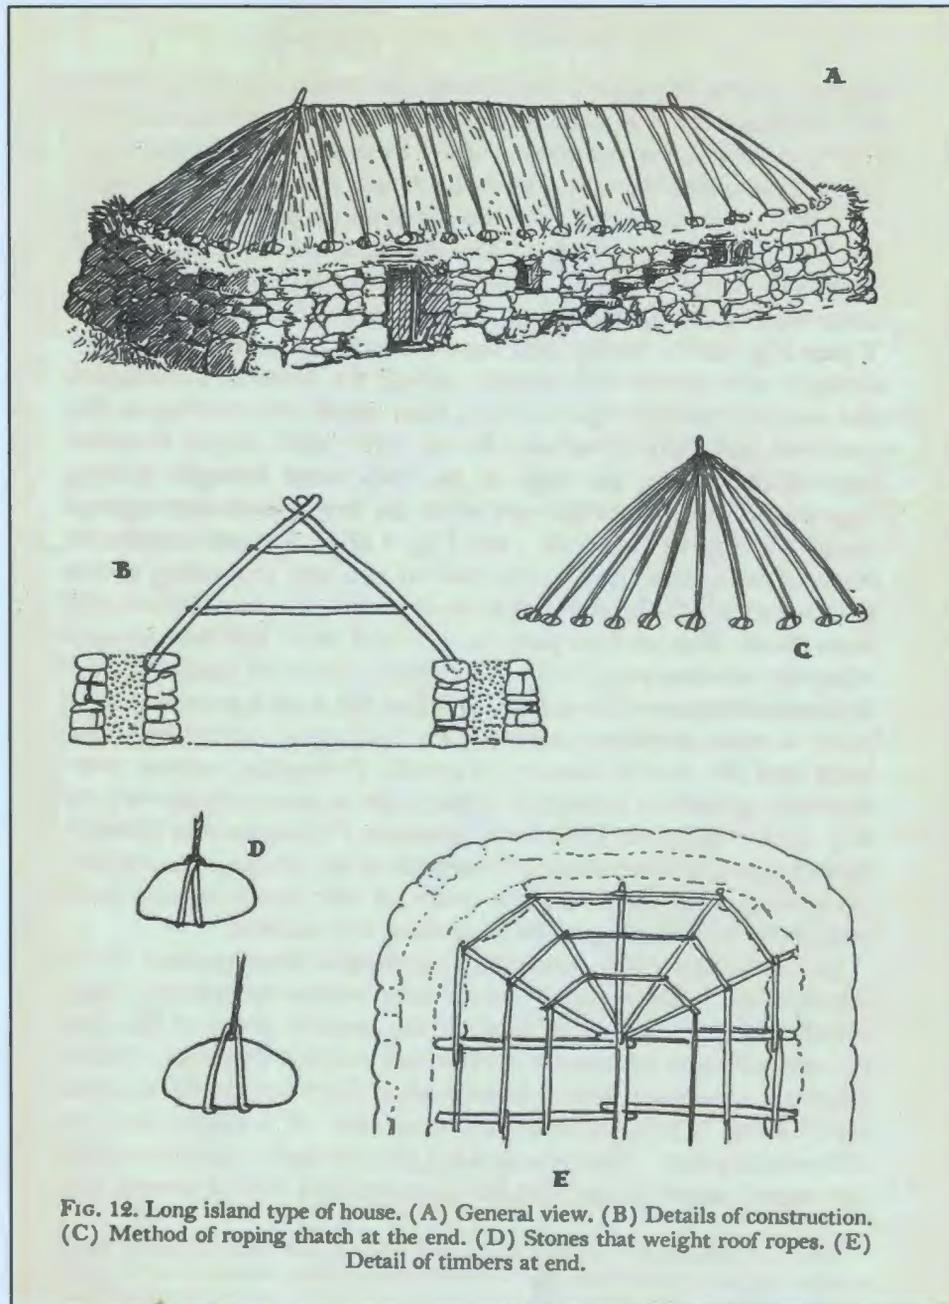
**Figure 2.1:** Typical Hebridean blackhouse construction of the eighteenth and nineteenth centuries (Grant 1961:143).

and hung along the base of the roof. The roof was most often hipped at the gable ends and, in many cases, the exterior corners of the walls were rounded to deflect the harsh winds of the North Sea (Figure 2.1). The absence of a hole in the roof to allow the smoke from the fire to escape meant that the smoke penetrated the thatching on the roof, which was stripped and spread on the fields as a source of fertilizer when the roof needed replacement. A stone ladder on the exterior of one gable end wall allowed access to the roof for repairs and replacement. The double-thick wall was filled with smaller rubble or, more efficiently, peat-mould and earth which allowed water shed from the roof to percolate down between the inner and outer skins of the wall insulating the house. The blackhouse had no windows. Instead, light was let in through a few small square openings in the walls (Grant 1961:142-143; Fenton 1978:5-15, 35; Symonds 1999:78). Inside the blackhouse, the floor was earthen and an open hearth burned in the center of the main room, usually the kitchen. The family congregated around the hearth to eat, do chores, sleep, and just about anything else that was done indoors. On one end of the house, the animals were kept in a byre that was accessed directly from inside the dwelling (Grant 1961:145-146). The smallest blackhouses had only one door which opened next to the byre and onto the kitchen. Larger blackhouses were an agglomeration of several units, each having a specialized function. These houses usually had box beds along one wall in a room designated for sleeping. Furniture throughout the house was arranged against the walls so as to maximize living and working space. Although the numbers of people occupying individual blackhouses varied, the size of the dwelling was not necessarily proportional to its number of occupants. Blackhouses ranged in size from

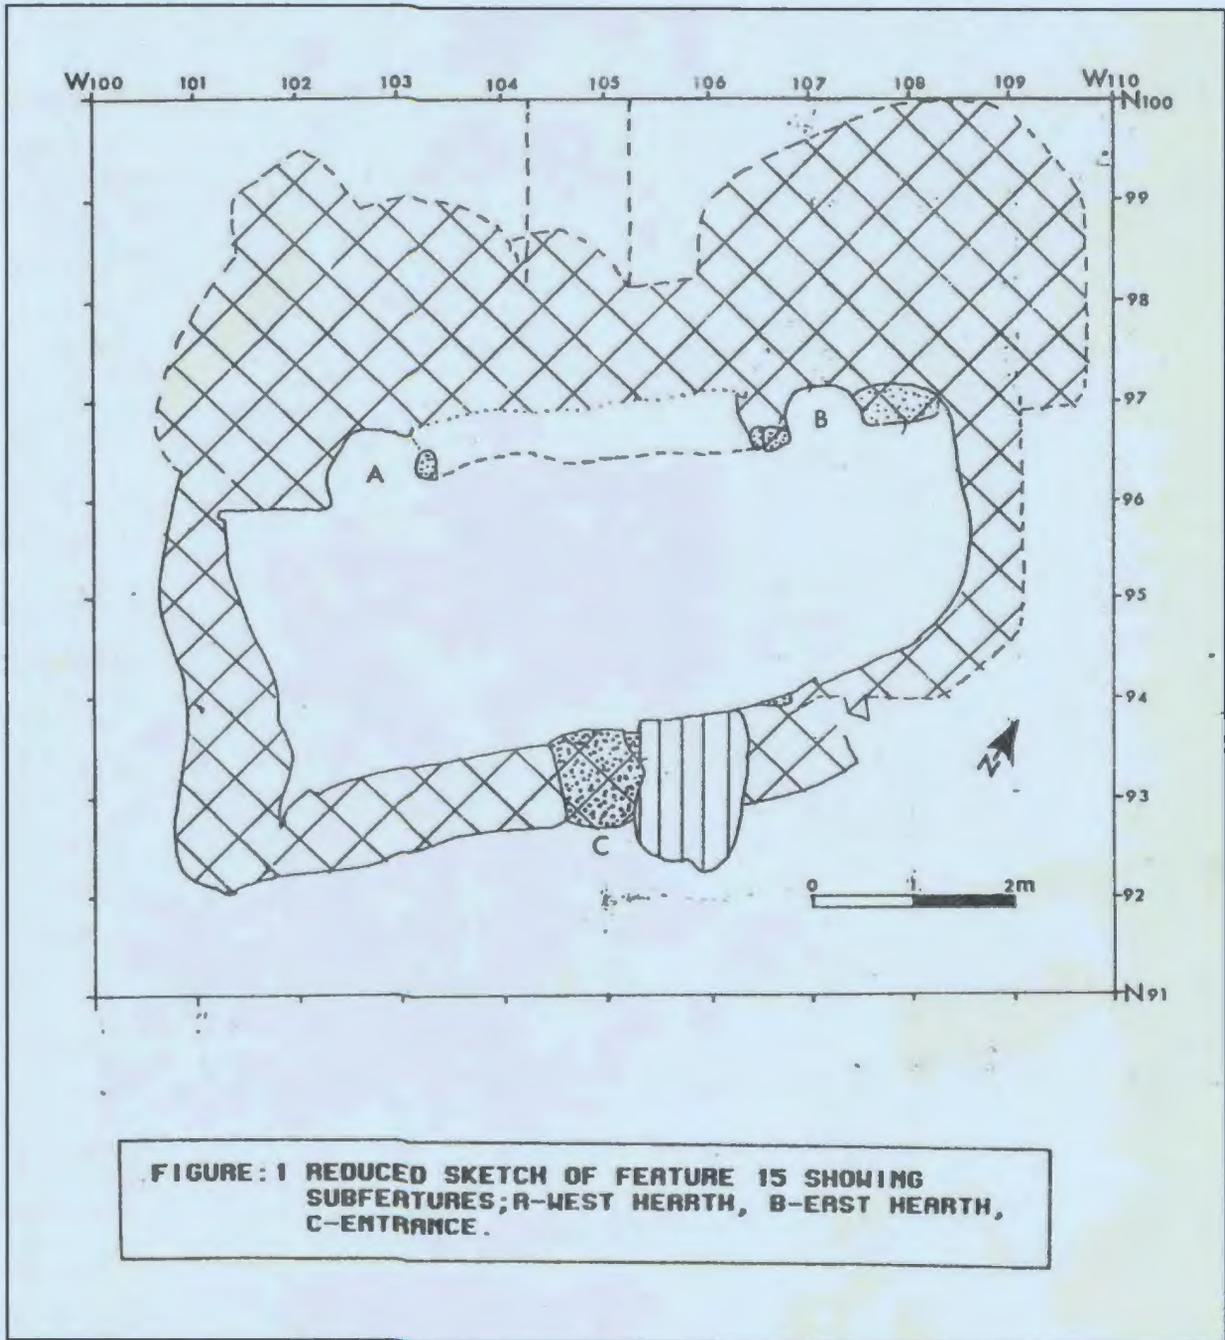
**Figure 2.2:** House excavated along the Shubenacadie Canal in Dartmouth. Many elements of the house are reminiscent of Celtic (Scottish and Irish) blackhouses of the eighteenth and nineteenth centuries (Davis 1985:96).

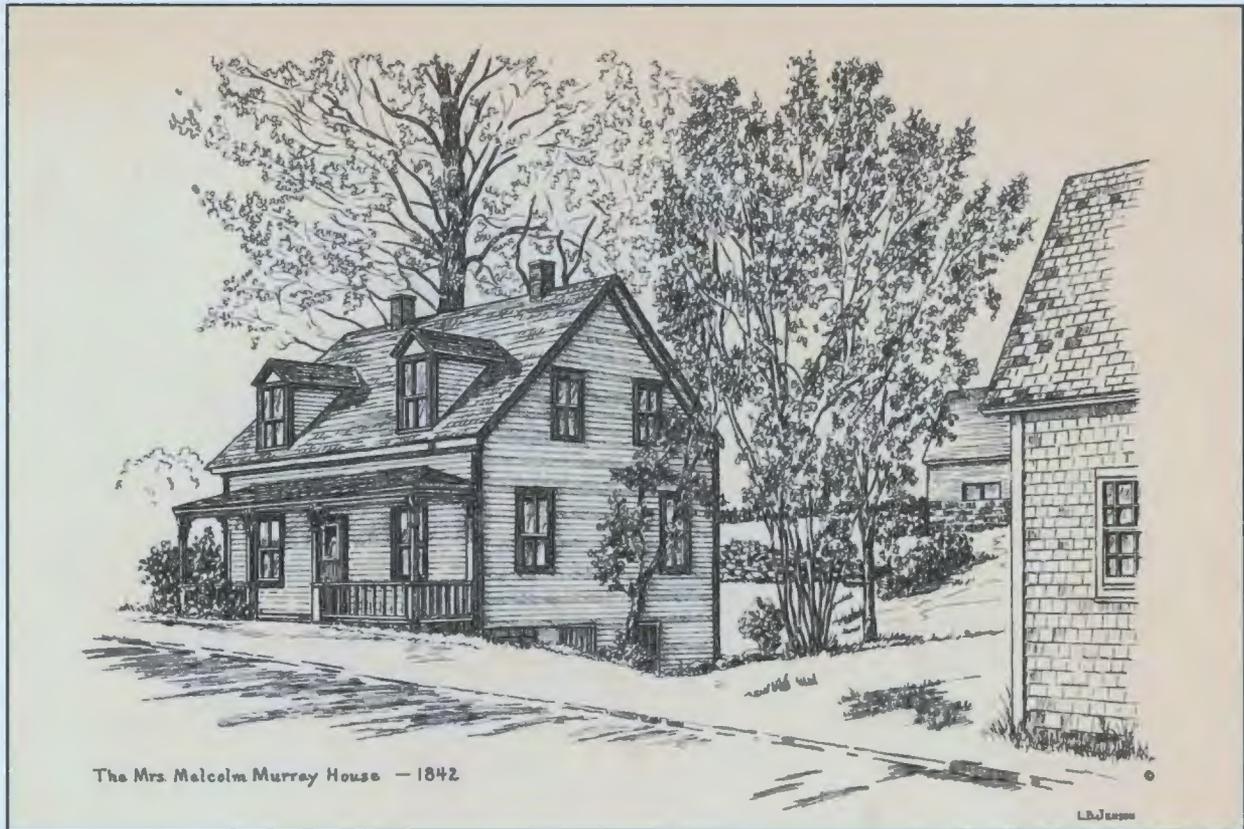
**Figure 2.4:** Typical Maritime vernacular house built in 1842 in Pictou, Nova Scotia (Pictou Heritage Society 1972:n.p.).

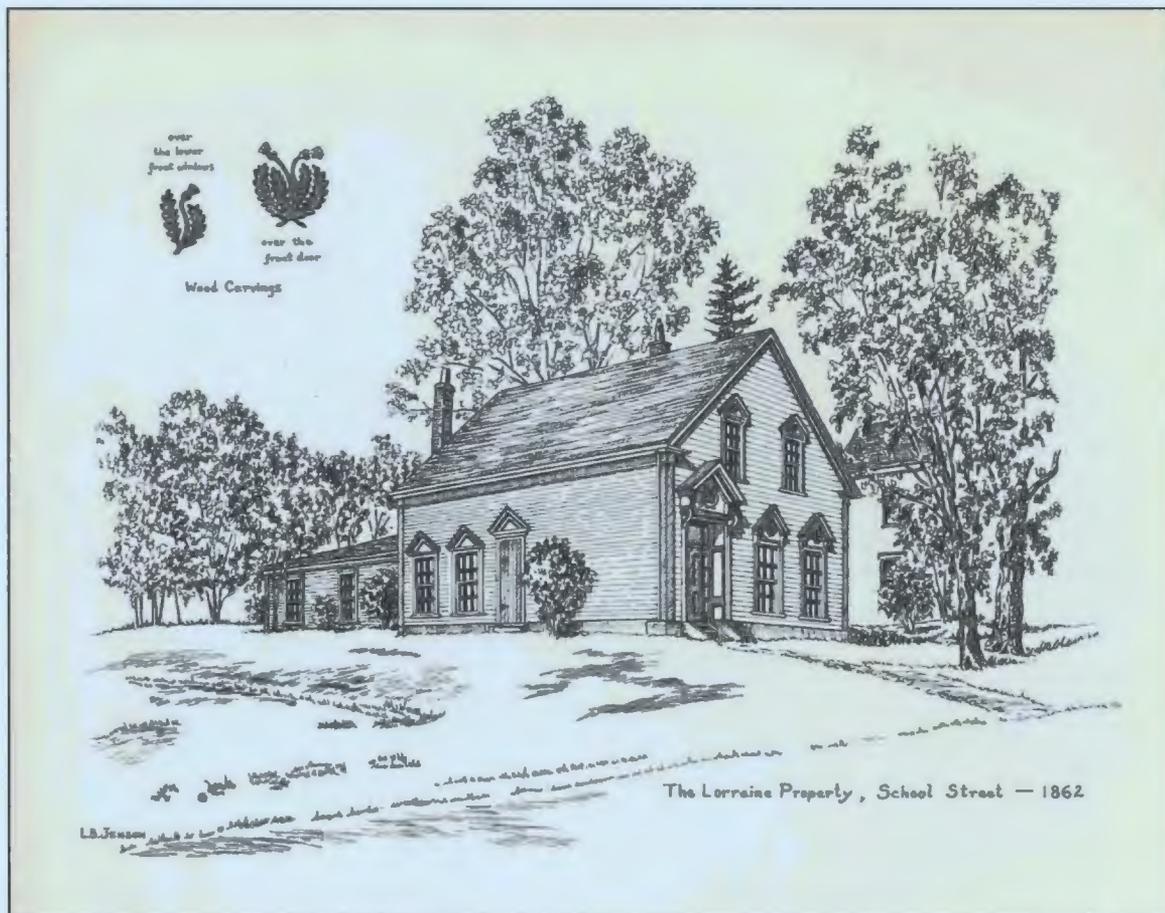
**Figure 2.5:** Greek Revival temple house in Pictou, Nova Scotia. Built in 1862, this style of house was likely brought to the Maritimes by New England Loyalists in the 1820s but it did not gain popularity until late 1830s (Pictou Heritage Society 1972:n.p.).

Another architectural style which emerged in Nova Scotia in the 1830s but did not become widespread until the second half of the century was the temple house (Figure 2.5). This style was believed to have been adopted from the northern New England states sometime after 1820 when the Greek Revival movement was in vogue in the United

States (Ennals and Holdsworth 1985: 343-349). The main façade of the temple house was at the gable end and the entrance was positioned here, usually off-set near the corner of the house. The temple house of the northern United States was complete with portico and columns. The modest Maritime version of the temple house was one-and-a-half to two-and-a-half stories high and void of high-style trimmings. The doorway on the front of the house opened onto a hallway that ran along one end wall on the long axis of the house. To the side of the passageway at the front of the house was the parlour. At the back of the house the hall opened into another room, usually the kitchen or dining room

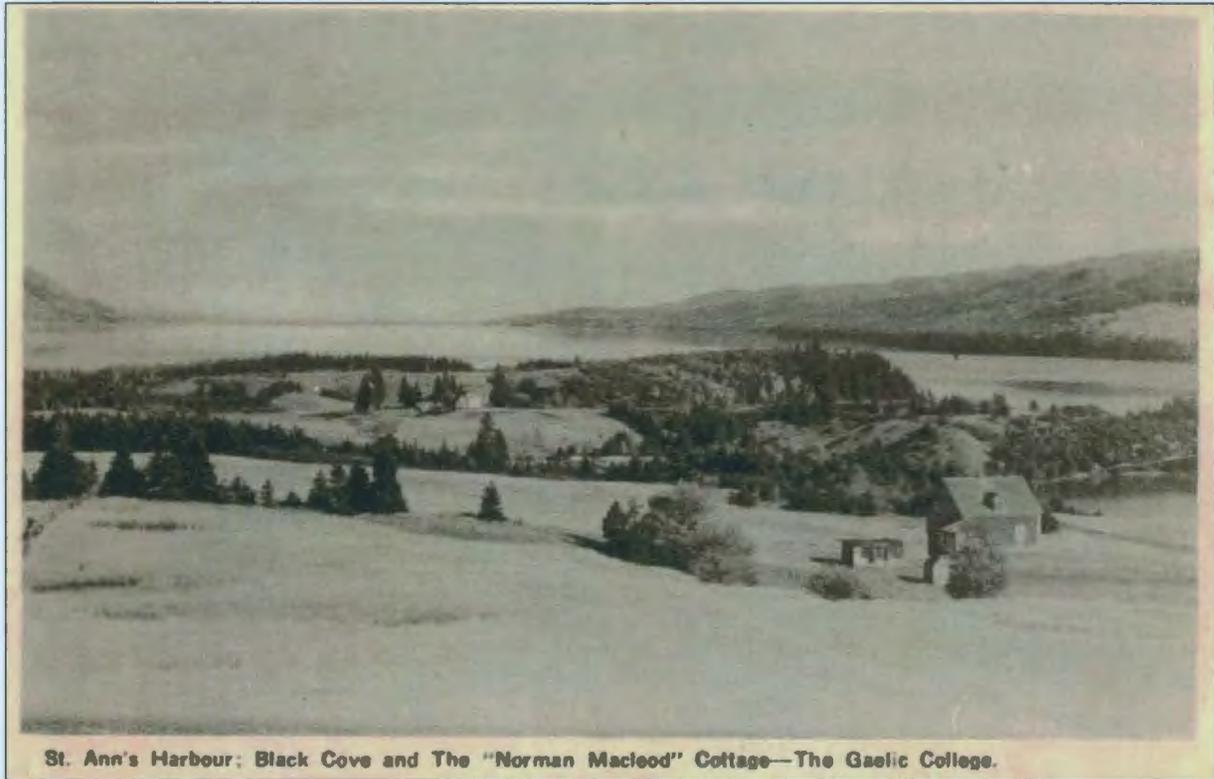
**Figure 3.4:** Mid-twentieth century post-card showing the John Robertson house, mislabelled the McLeod cottage (Photogelatine Engraving co. Limited).

Although the Big Red House stood until fairly recently, few photographs of it survive in public collections. I was, however, repeatedly shown the same photograph and a similar post-card of the Robertson house by local residents. The postcard reads “St. Ann’s Harbour; Black Cove and The ‘Norman MacLeod’ Cottage – The Gaelic College” (Figure 3.4). Many local residents also assume this to be the McLeod house. Residents claim that the photograph (and likely the picture postcard) were taken in the mid-twentieth century (around 1945-1950) (MacDonald, pers. comm.). The McLeod house was not standing at this time, for it was likely dismantled late in the nineteenth century. The photograph and post-card speak for themselves. The house in the post-card is much closer to the shore of Black Cove than McLeod’s house was and it is situated below the swamp on low ground. The photograph was likely taken from the northeast side of the McLeod house, tens of meters away from the subject.

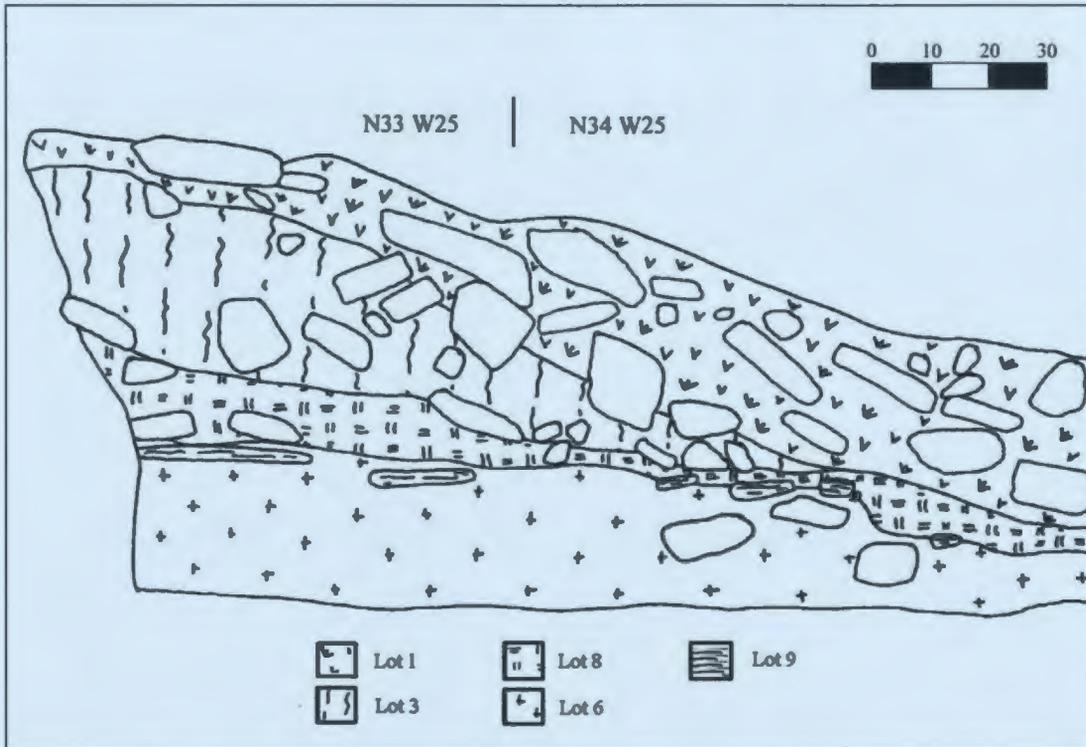
**Figure 4.2:** Units N32-34 W25 soil profile.

being dismantled. The chimney collapse was confined to lots 1 and 3, the latter of which is directly associated with the chimney collapse. The large granite field stones on the chimney mound descended into lot 3 and are likely from the chimney base. About half a dozen coarse bricks were found on the north and south sides of the chimney in lots 1, 2, and 3 but do not suggest anything structural and may be post-abandonment debris from another location, perhaps from the Robertson house which had a brick chimney. On the north and east sides of the chimney, directly below the collapse in lot 3, is a layer of beach sand (lot 8) which is likely associated with cleaning the hearth and/or the wooden floors of the ground level of the house (Figures 4.2 and 4.3).

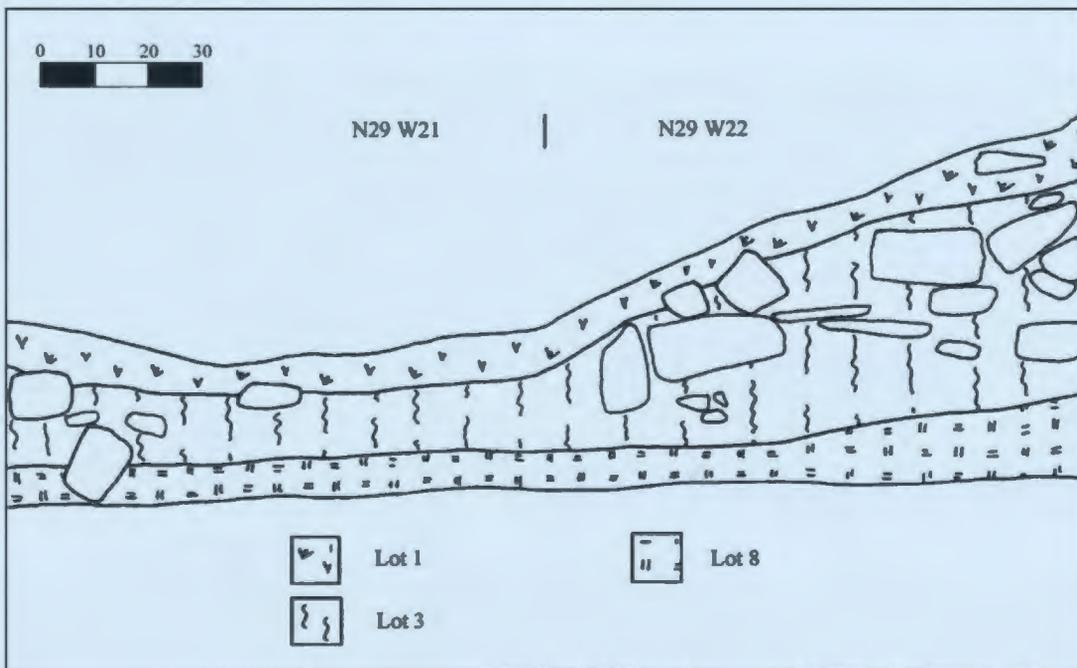
**Figure 4.3:** Units N29 W20-22 soil profile.

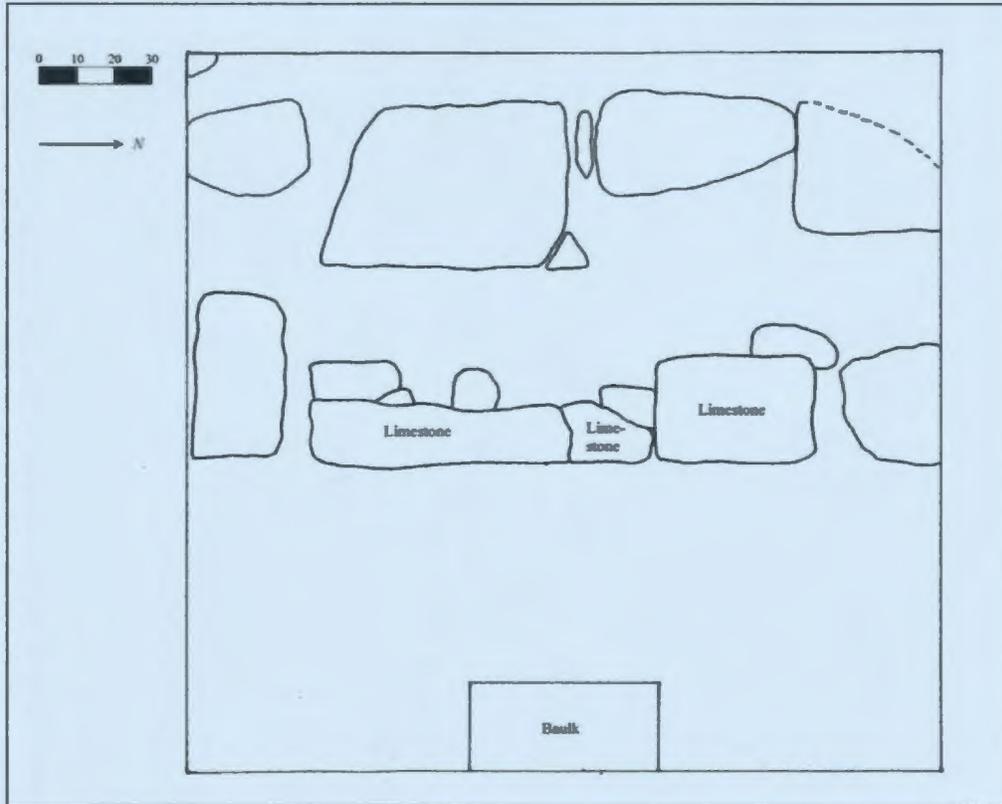
**Figure 4.4:** Plan of center of east wall (N30-31 W19-20).

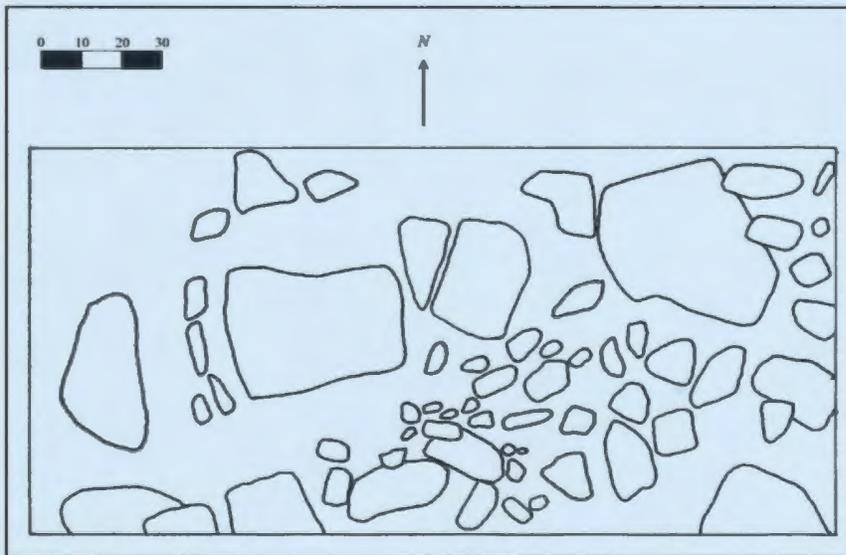
**Figure 4.5:** Plan of northwest corner of house (N37 W28-29).

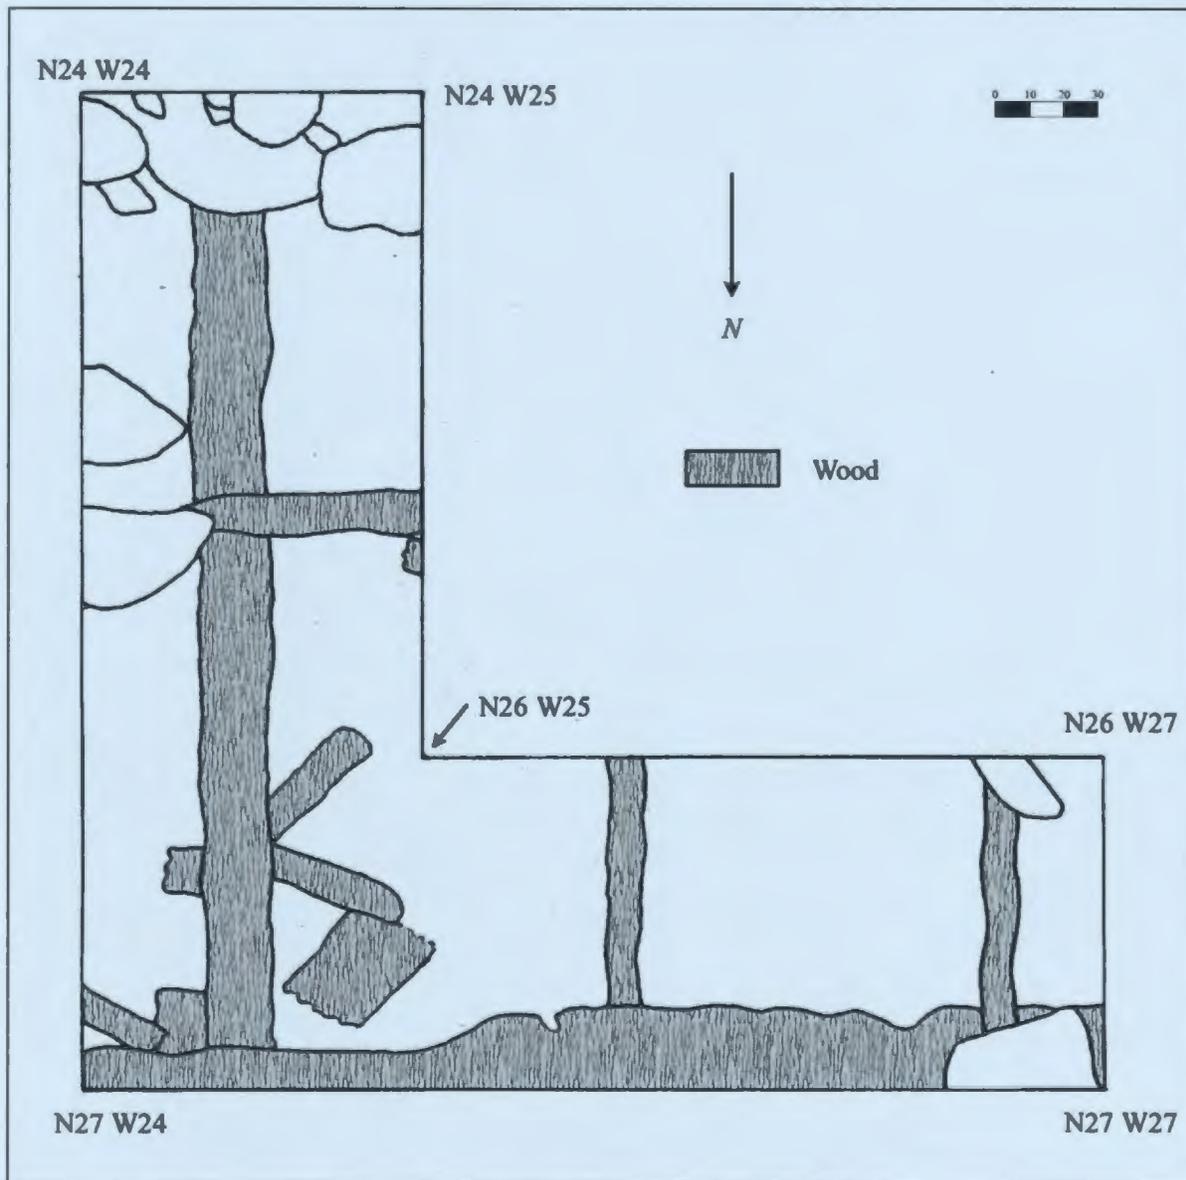
**Figure 4.6:** Buried wood beams in south end of house.

The most interesting aspect of the feature was the exquisite preservation of wooden structural remains. In the south end of the house, units were excavated down to a layer of thick mottled clay which surrounded a central support beam near the center of the house (Figure 4.6, Plate 9). Adjacent units to the west revealed perpendicular secondary support beams. It was decided not to extend excavation past these wood beams in order to preserve their integrity for possible future research. In the southeast quadrant of the house, units were excavated down to a uniform layer of dressed wood planks (Figure 4.7, Plate 10). This layer appeared too contrived to be the remains of collapse from upper floors. Instead, this area of the foundation may have been a cellar with a wooden

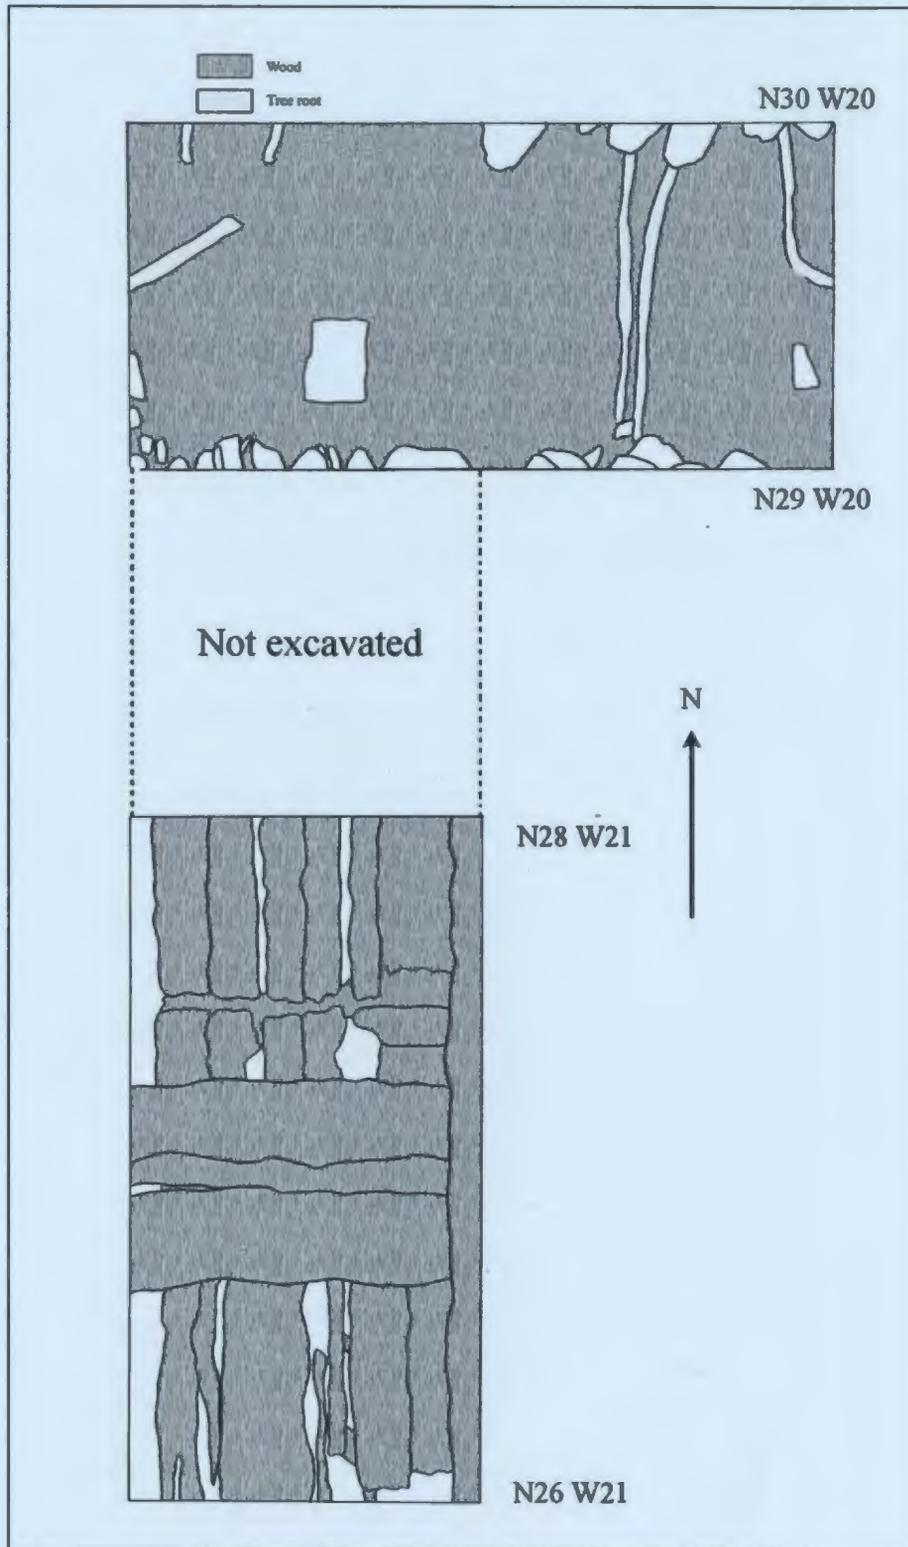
**Figure 4.7:** Wood platform in southeast quadrant of house.

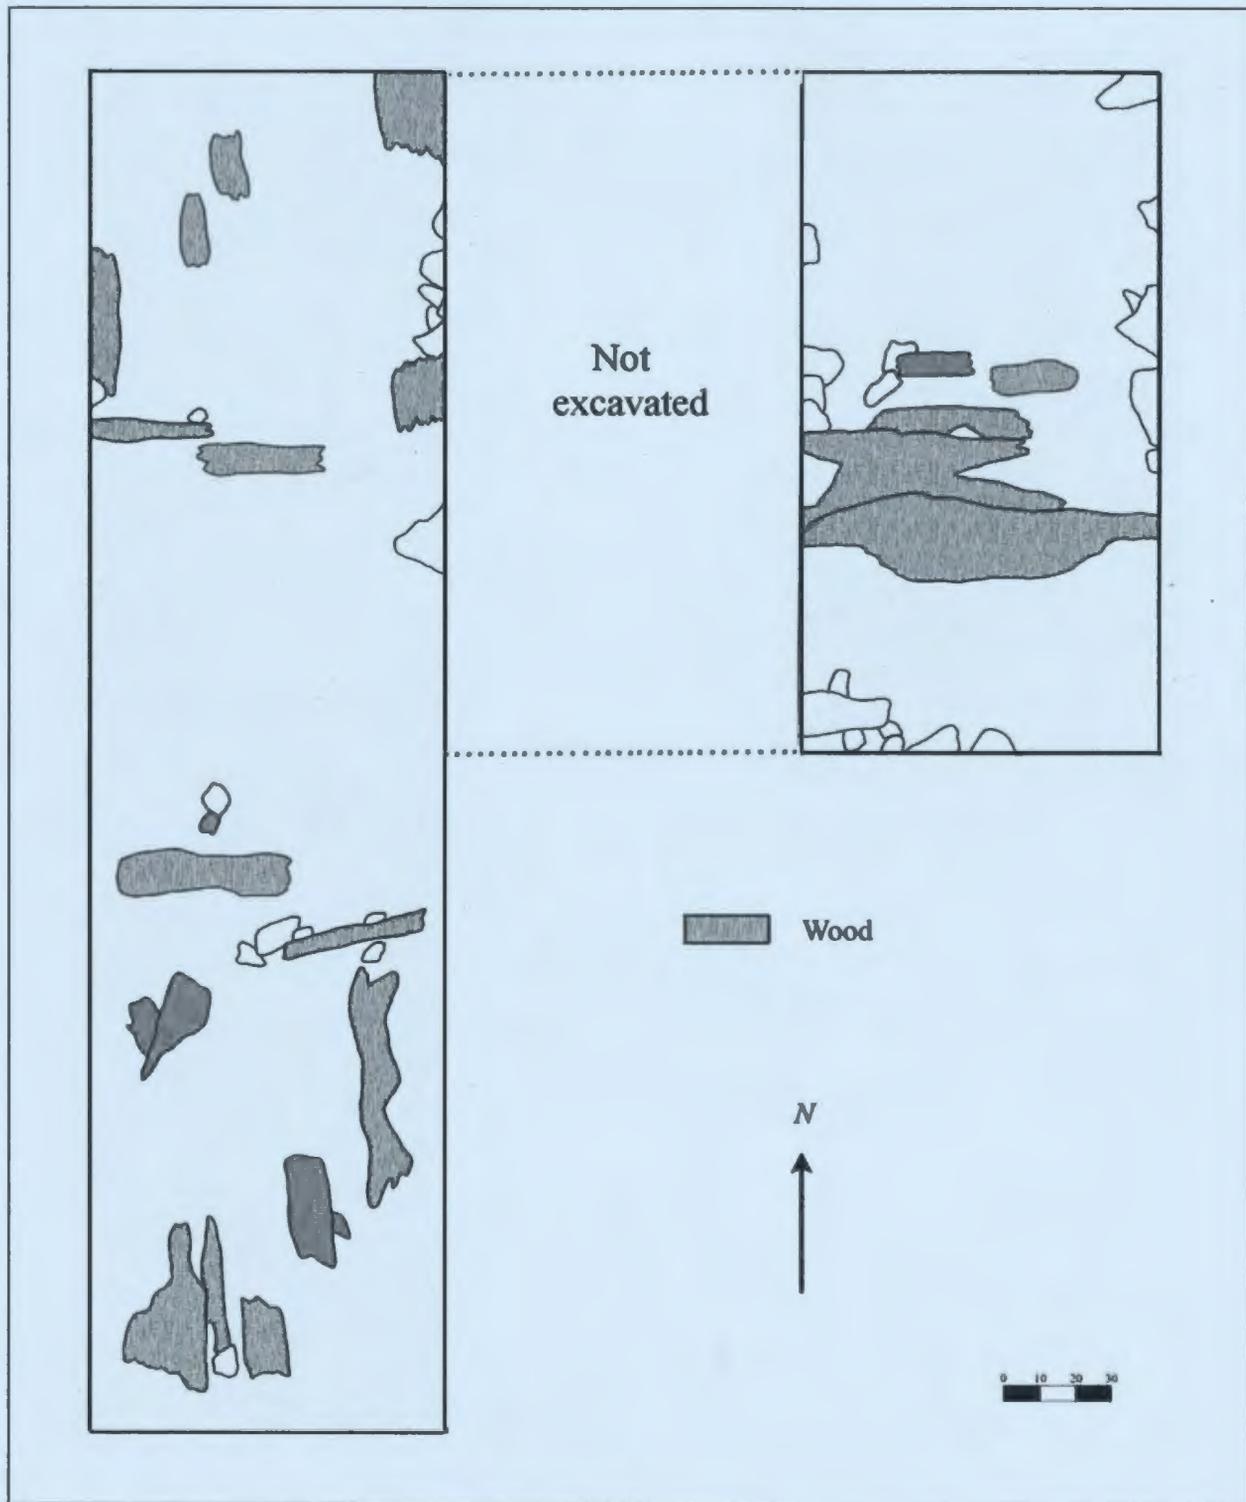
**Figure 4.8:** Wood in north end of foundation.

platform for storage. Wood remains in the north end of the house were not as well preserved as those in the south end of the house. The wood here does not exist as a uniform layer and it appears that the wood has been broken and its arrangement is more random with pieces running at oblique angles to one another (Figure 4.8).

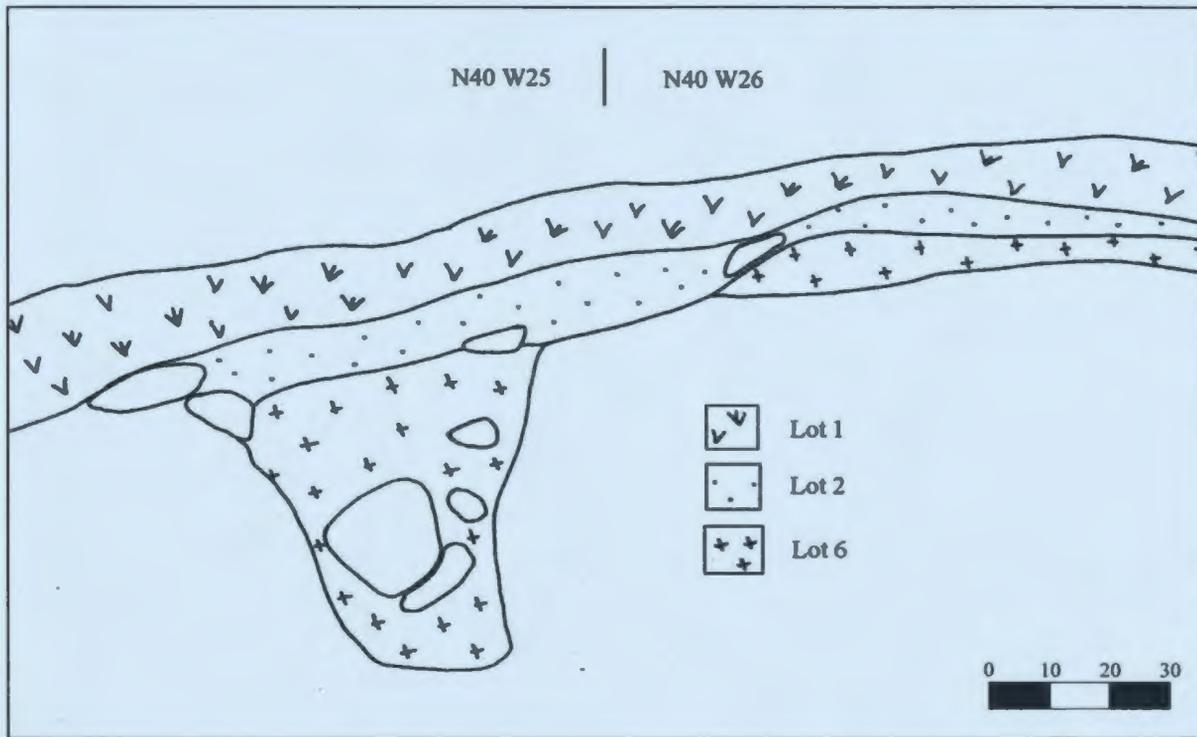
**Figure 4.9:** South wall section (N40 W24-26) showing stone-lined posthole.

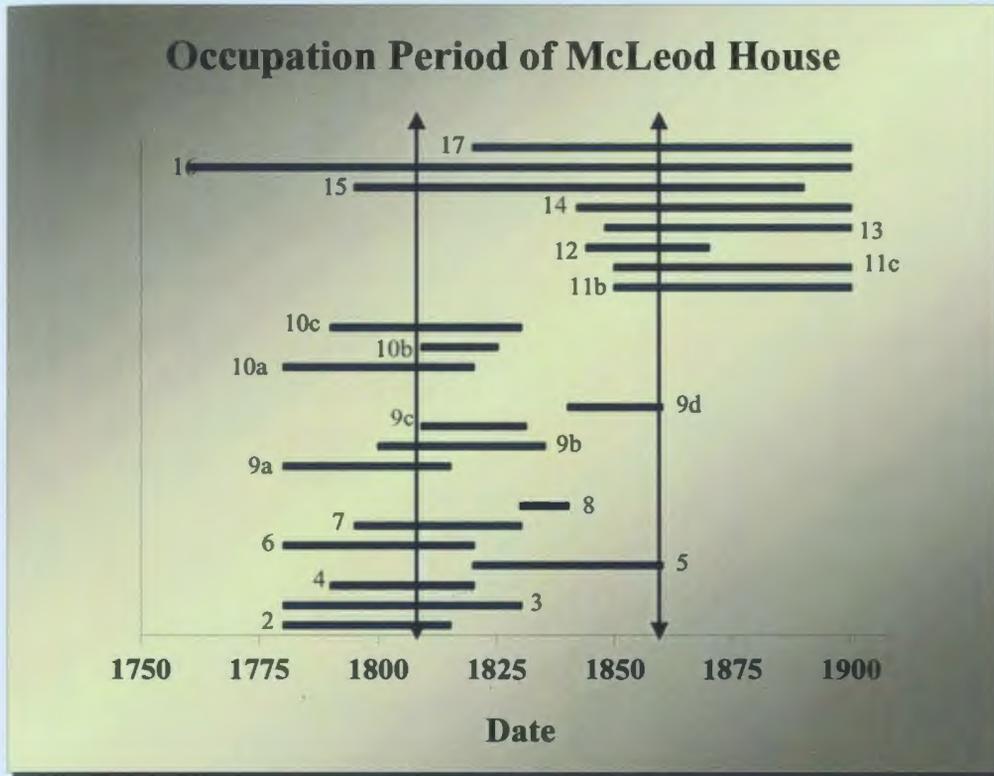
**Figure 5.1: Ceramic Date Range for Feature 1 (after South 1977:214-217).**

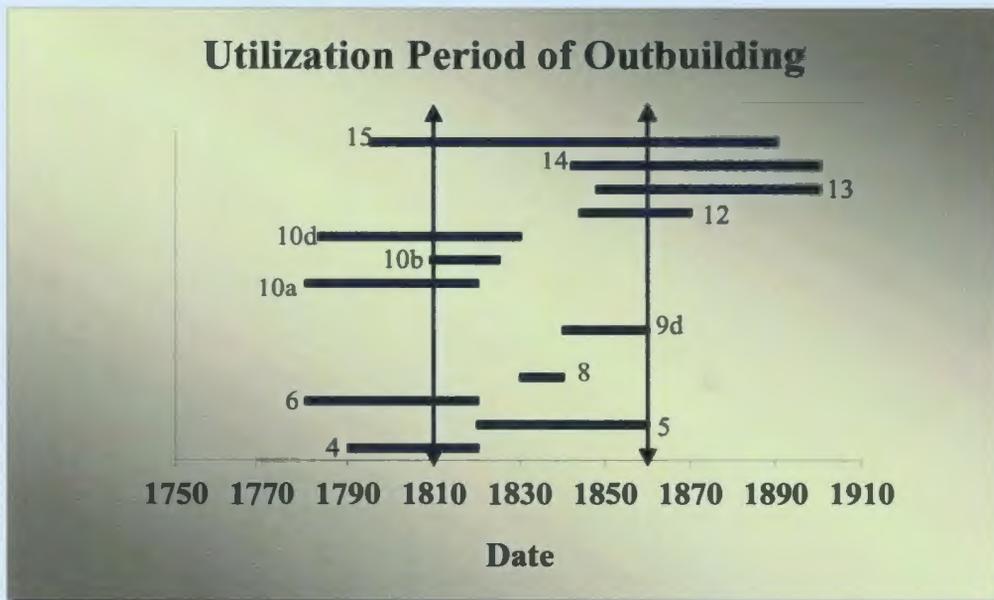
**Figure 5.2: Ceramic Date Range for Feature 2 (after South 1977:214-217).**

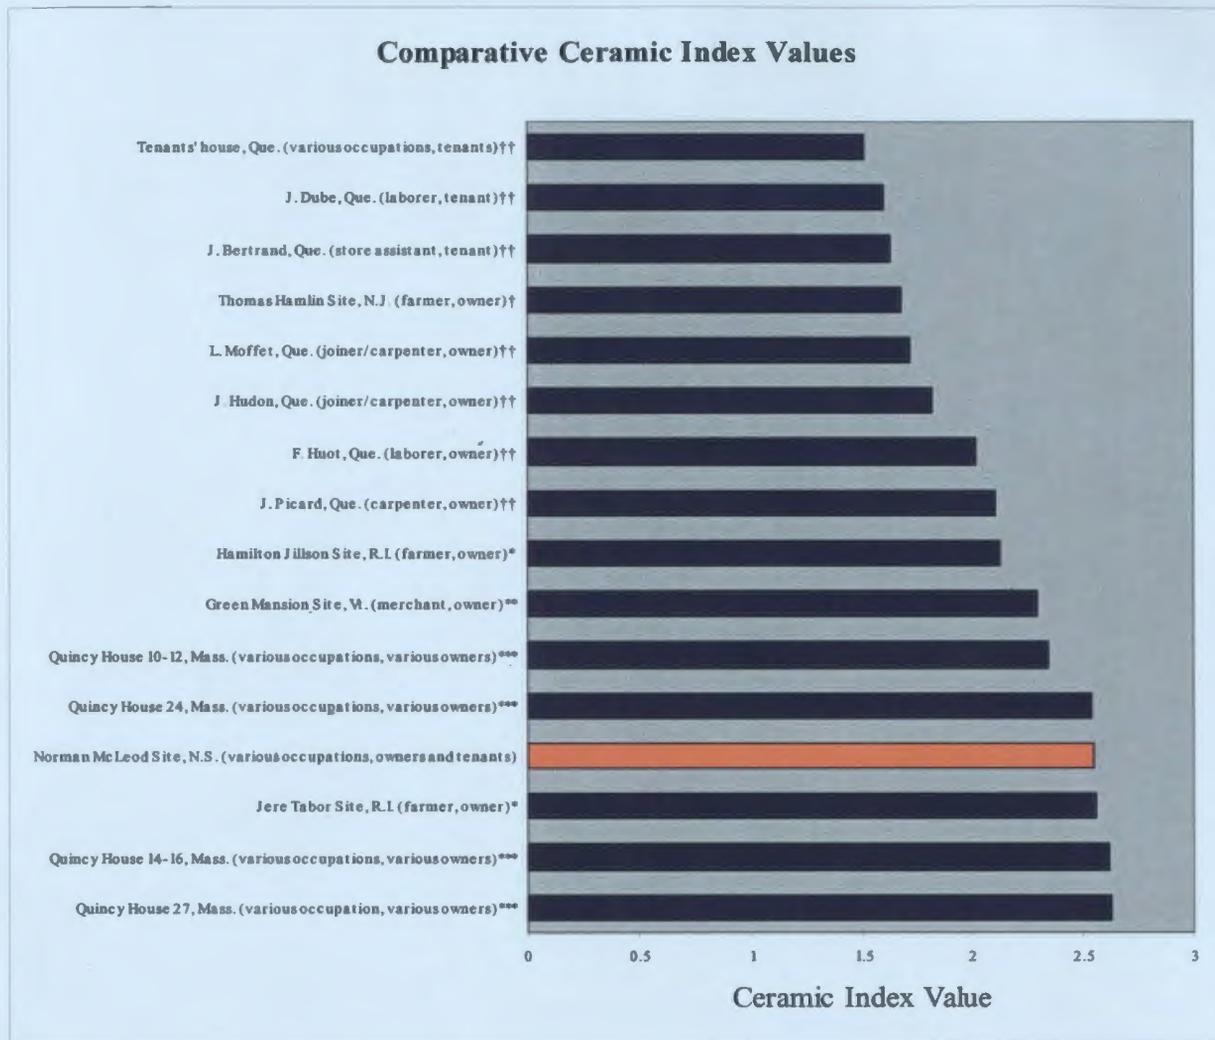
**Figure 5.3:** Comparative CC Index Values from Sites in Canada and the Northeastern United States. Sources: Hamilton Jillson Site, Jere Tabor Site (Cook 1982:144-145); Green Mansion Site (Spencer-Wood and Heberling 1987:62-72); Quincy House 10-12, Quincy House 14-16, Quincy House 24, Quincy House 27 (Spencer-Wood 1984:96); Thomas Hamlin Site (Klein 1991:82); Tenants' house, J. Dube, J. Bertrand, L. Moffet, J. Hudon, F. Huot, J. Picard (Cloutier 2001:116-126).

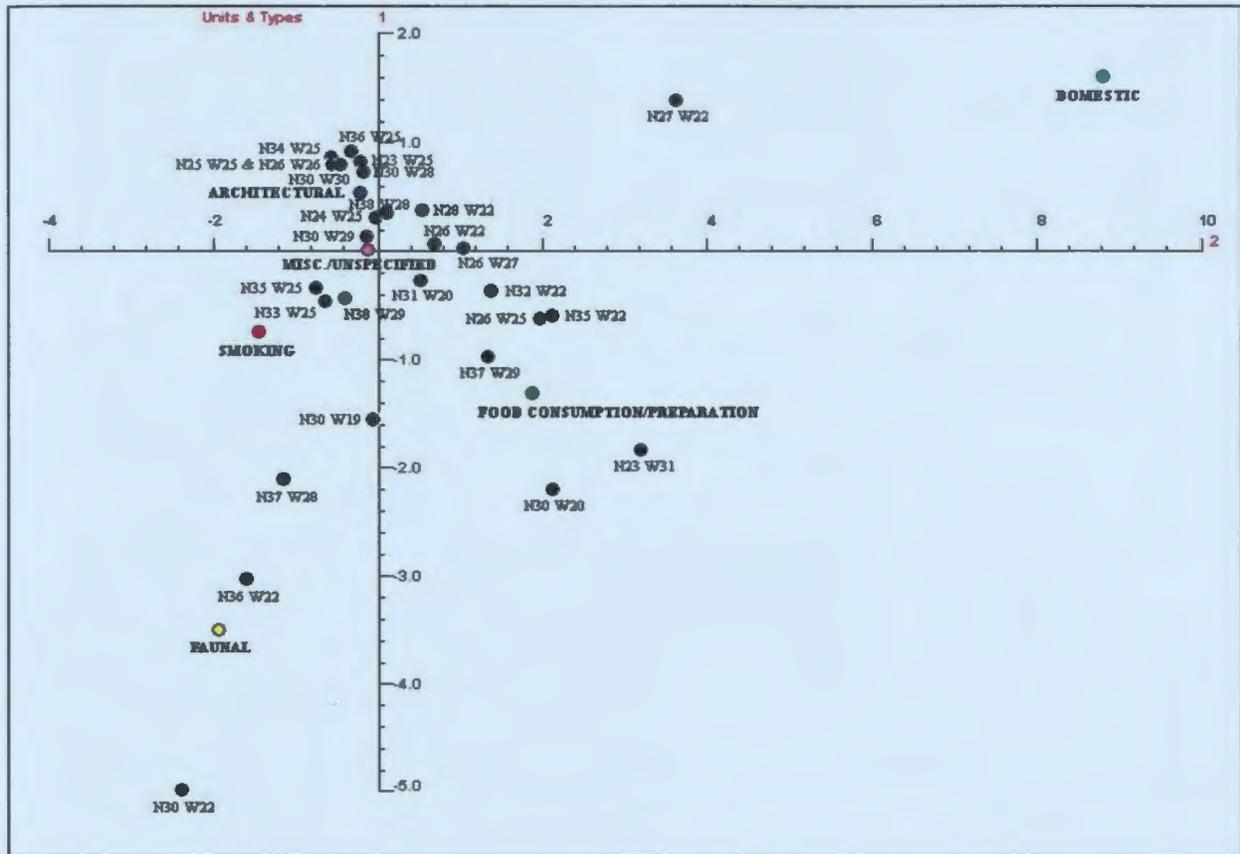
**Figure 6.1:** Correspondence analysis showing association of artifact classes and excavation units. A relationship between food consumption/preparation artifacts and the south end of the house is apparent as well as between faunal remains and the southeast quadrant of the house.

It is reasonable to assume, given the internal arrangement of the typical temple house and the external positioning of the McLeod house as well as the results of correspondence analysis, that the kitchen was located in the south end of the house. This can be supported by the discovery of cast iron stove and pot fragments in the southeast quadrant of the house. Given the positioning of the front door on the north gable and central location of the chimney, rooms would have been accessed from a hallway running north-south along the west wall of the house. The parlour, typically located at the front of the house in most, if not all, eighteenth- and nineteenth-century houses, would have been situated east of the hallway with a view of the church and harbour to the north and the roadway to the east.

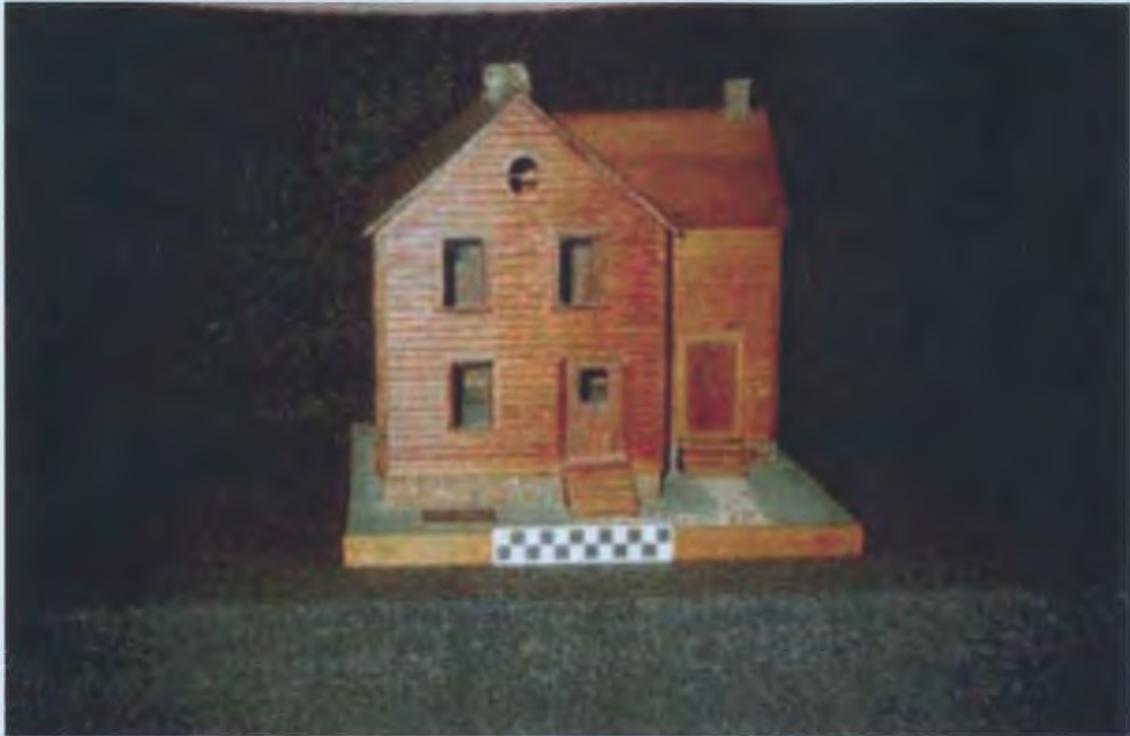
**Plate 3:** Front view of the McLeod house model.

The excavation strategy soon became influenced by new information provided by a scaled model of the McLeod house we were previously unaware of (Plate 3).<sup>3</sup> The model shows that the house was 2 ½ stories high with an addition on one side along the long axis of the house. The front door is positioned on the short axis of the house and is off-center. There is a second door on the ell facing the same direction as the front door.

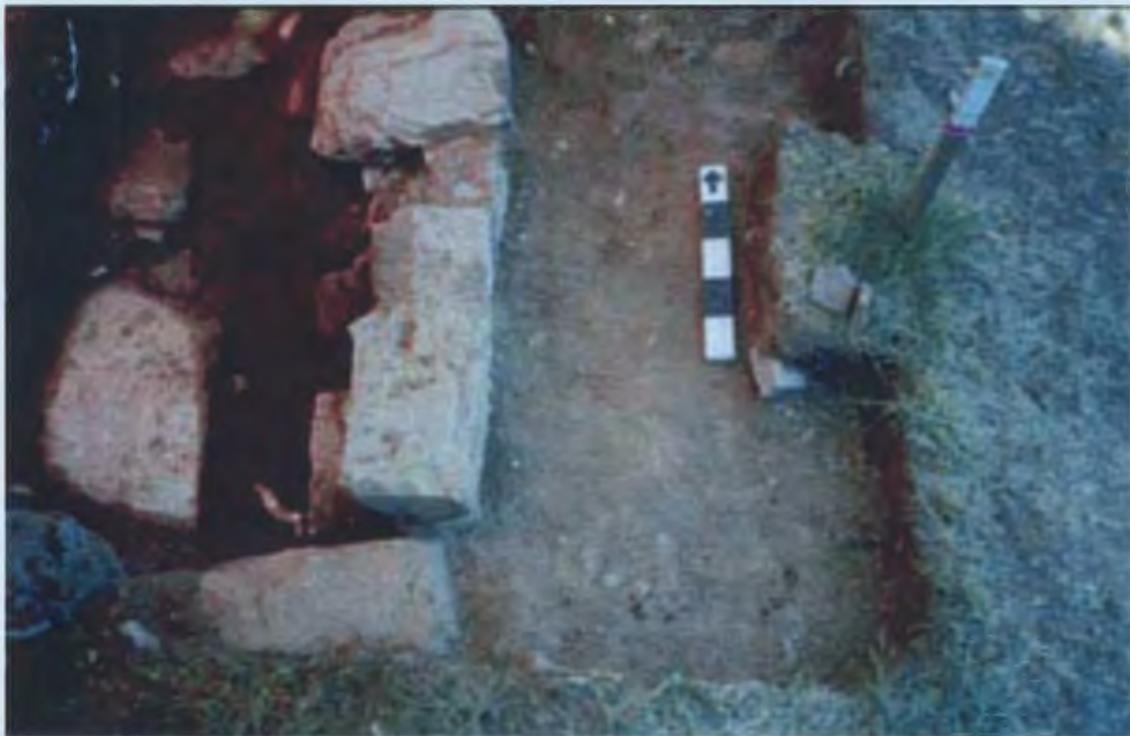
**Plate 4:** Plan of center of east wall (N30-31 W19-20).

The house foundation was constructed of mortared granite field stones and was built into the natural slope of the land so that the walls of the foundation would have had to be levelled during construction. On the east wall of the foundation at the center of the wall was an anomalous, flat mortared limestone. Time did not allow further excavation of the east wall and the significance of this stone in relation to the rest of the wall is not known. However, further excavation of units to the north and west of this unit did suggest that the east wall, or at least this portion of it, was *double-skinned* meaning that the space between two parallel walls of larger stones placed approximately one-half meter apart was in-filled with smaller stones (Figure 4.4, Plate 4). Extensive stone rubble at the northwest corner of the house suggests that this area of the wall may also have been double-skinned but not mortared (Figure 4.5, Plates 5 and 6). However, excavation at the center of the north wall revealed an intact mortared wall (Plate 7). The west and south walls suffered too much collapse to discern any structure although the soil stratigraphy
