**House and Home:  
Scottish Domestic Architecture in Nova Scotia and  
the Rev. Norman McLeod Homestead**

A thesis submitted to the  
School of Graduate Studies  
in partial fulfillment of the  
requirements for the degree of  
Master of Arts  
Anthropology

Memorial University of Newfoundland  
St. John's, Newfoundland  
April 2005

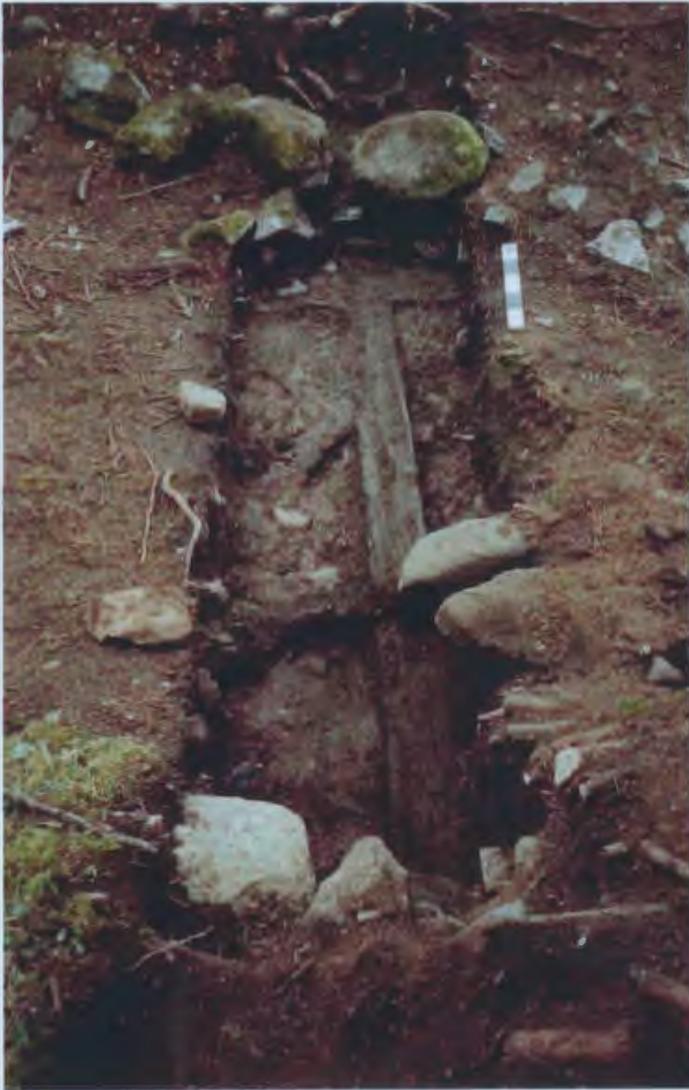
**Plate 8:** Ridge on southwest end of foundation, tested for evidence of addition to house.

Approximately 1 m outside the west foundation wall, near the wall's center, was a narrow band of hard clay nodules about 0.5 m long running parallel to the longitudinal axis of the foundation. This appears to have been a drip line, likely from the roof of the house suggesting that the peak of the roof ran parallel with the longitudinal axis of the house (north-south). This would then suggest that there was no addition to the house in this area, as the model suggests. To test the validity of this aspect of the model, four units of 1 m<sup>2</sup> were excavated on the west wall near the south end of the foundation. The units were excavated to sterile soil which was very shallow (less than 4 cm). The natural and cultural soils (lots 1 and 2) in the four units were very thin and only one unit (N23 W31) contained any artifacts - ten ceramic sherds and a fragment of dark green bottle glass dating to the late nineteenth century. No stone structures were encountered in this area and there was no anomalous landscape that would suggest a chimney (Plate 8).

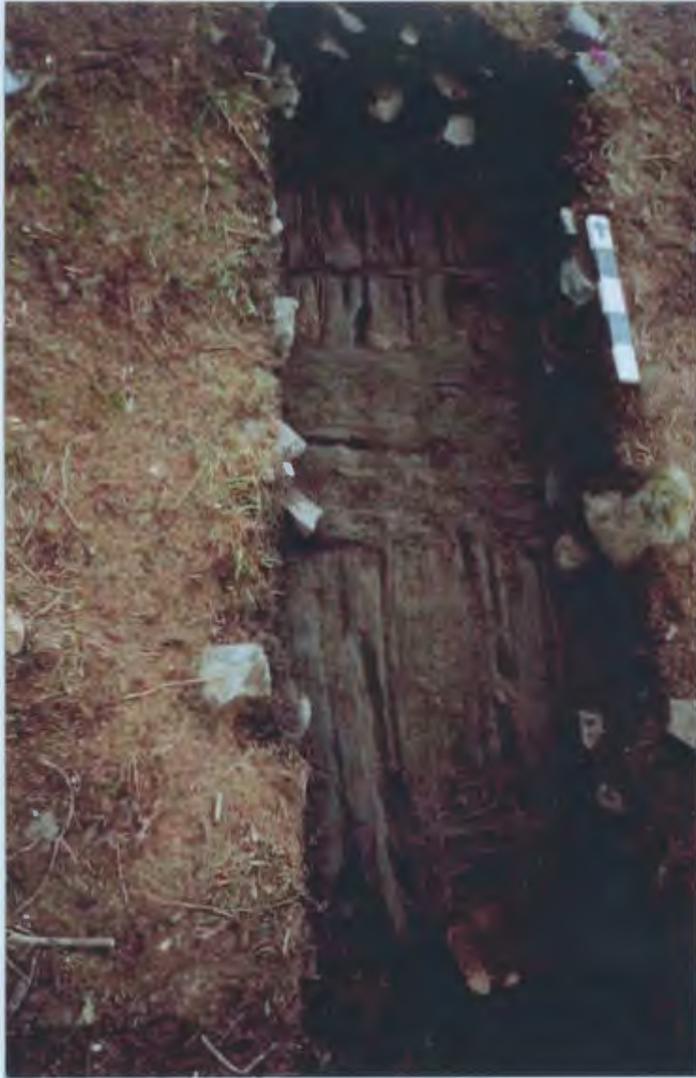
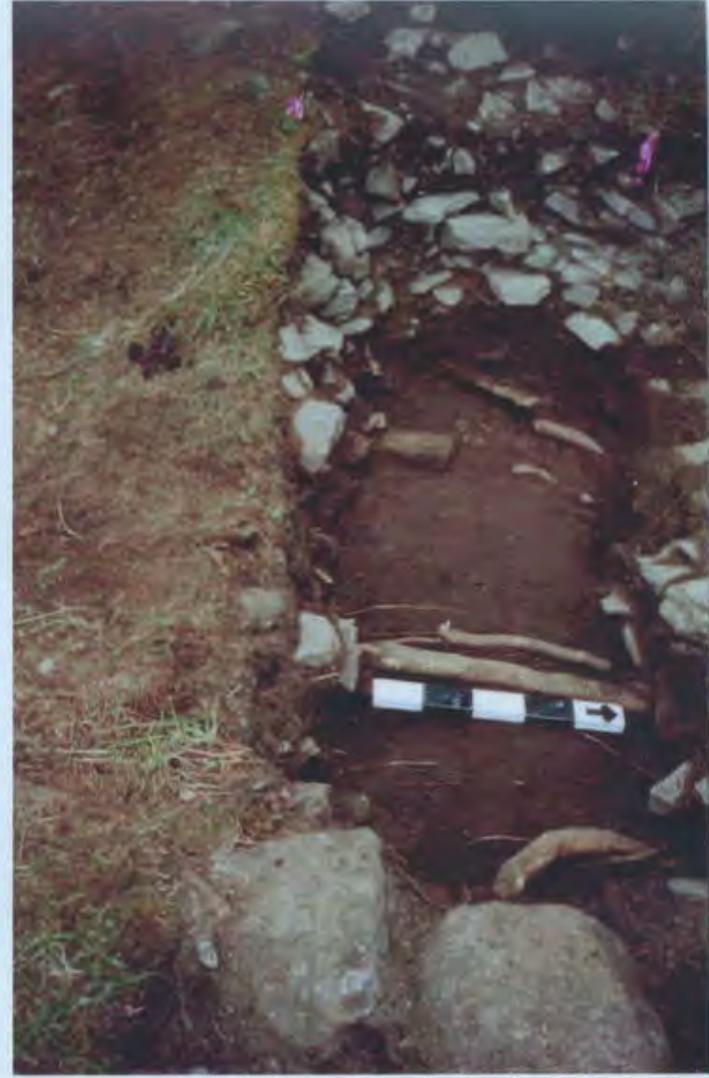
**Plate 10:** Wood platform in southeast quadrant of cellar (a) N27-28 W22, (b) N30 W21-22.

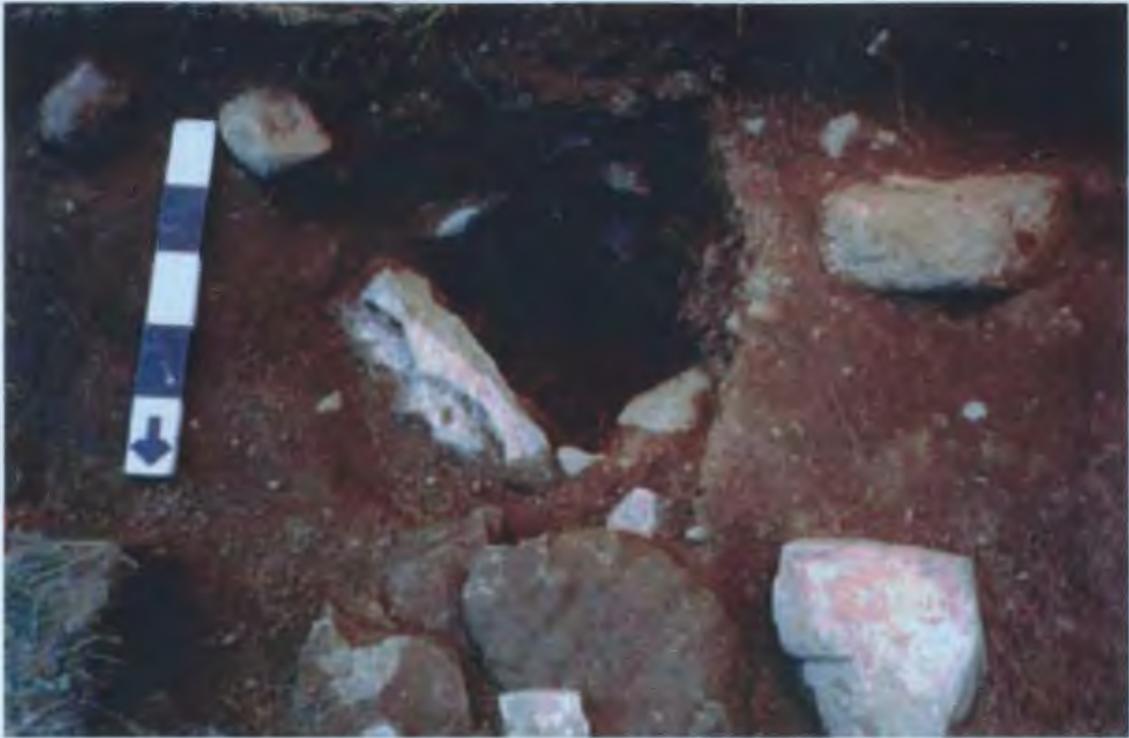
**Plate 11:** Stone-lined posthole in trench to north of foundation.

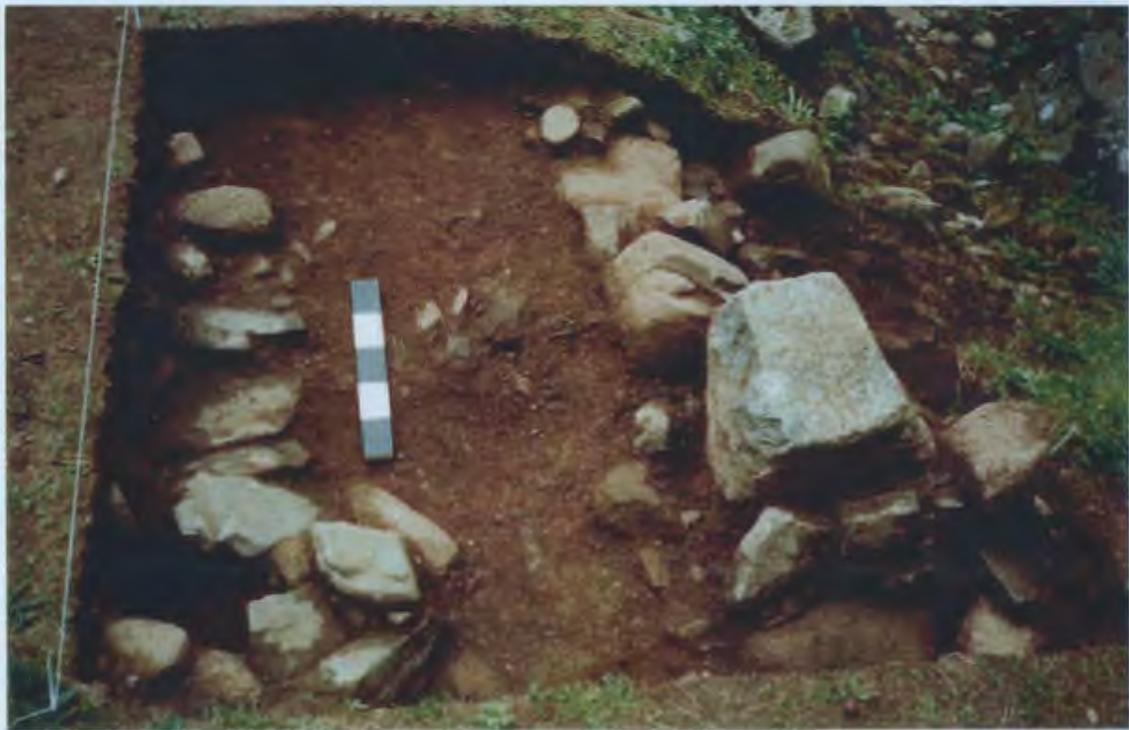
**Plate 12:** Stone-lined posthole near northwest corner of foundation.

Outside the house, a 14 m-long trench was excavated in 1 m<sup>2</sup> units approximately 2 m north of the foundation. This trench revealed midden materials, likely dropped en route to another location, possibly downslope of the house to the north. Artifacts here dated to the early to late nineteenth century and were of various artifact classes including food preparation/consumption, architectural, personal, medicinal/hygiene, and faunal. The trench also revealed a stone-lined posthole which contained early nineteenth-century artifacts including four complete or near-complete vessels (Figure 4.9, Plate 11). The discovery of this posthole led to excavation of four units adjacent to the trench on the south side. It was thought that this posthole may be related to a door step, as suggested by the model, and that another posthole would be found near the north wall of the foundation. This was not the case, although a second stone-lined post hole was excavated near the northwest corner of the house, approximately 1 m north of the corner and 2 m southwest of the first post hole (Plate 12).

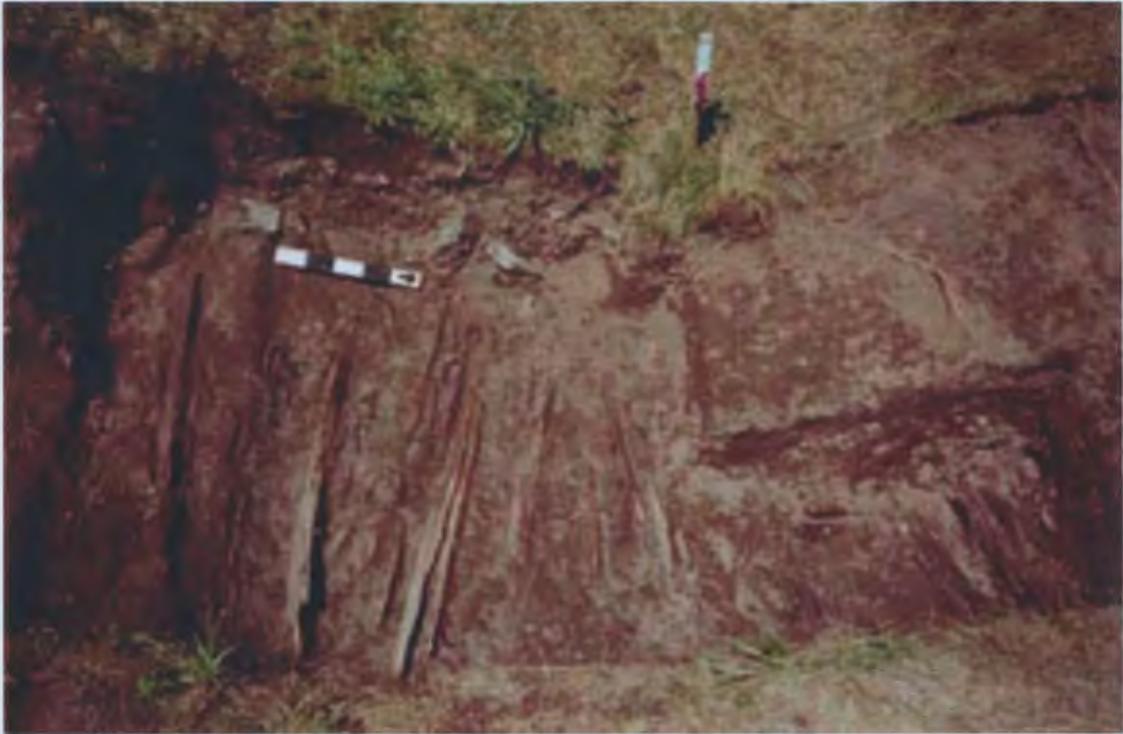
**Plate 13:** Layer of wood logs in outbuilding.

An associated outbuilding was identified 6 m north of the foundation and measured approximately 7 m in diameter. Ten m<sup>2</sup> of this structure were excavated down to a layer of wood logs (Plate 13). It was unclear whether this represented a wood-lined bottom or post-abandonment collapse. Little structural information was obtained from future investigation and excavation of the structure was abandoned. However, burned wood and charcoal was found throughout the feature in lot 2 and on top of the logs, although the logs themselves were not burned suggesting that burned refuse was deposited here. In addition, a red ochre-like substance was found in the north end of the feature and may have been used to paint the outbuilding. Artifacts in this structure included ceramics, window glass, nails, and unidentified iron, dating mostly to the late nineteenth century. It is possible that the outbuilding was constructed of logs removed from McLeod's original log cabin at the head of the peninsula.

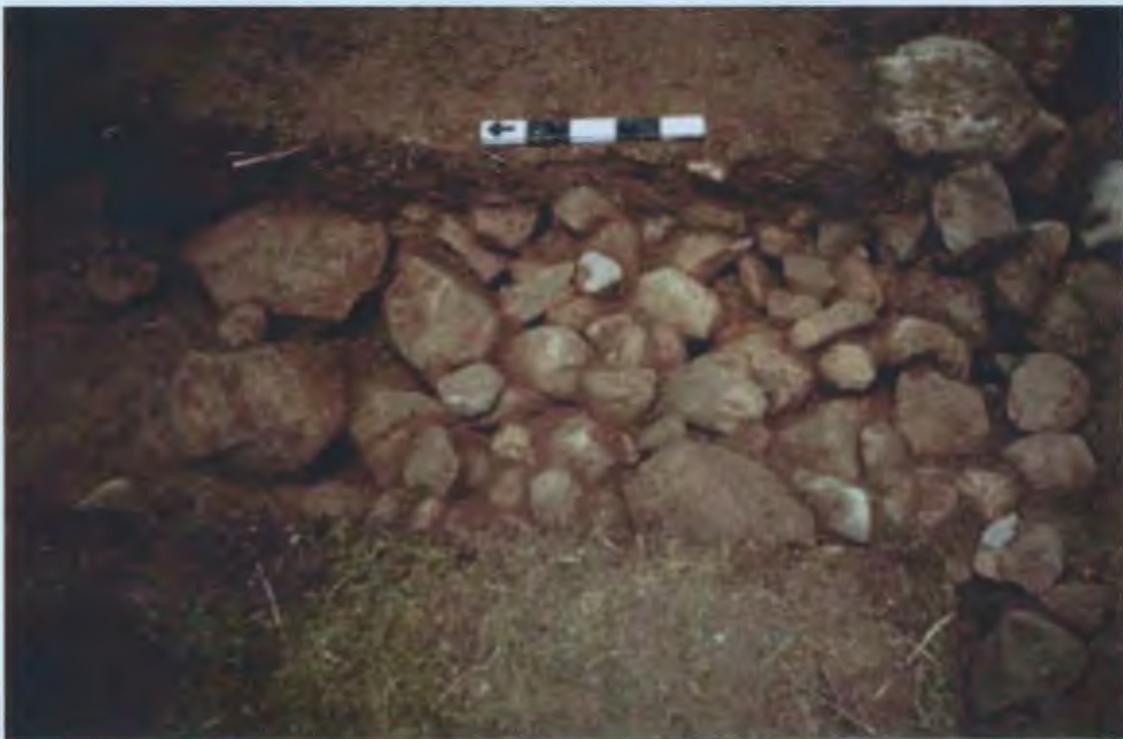
**Plate 14:** Boulder fill in privy (lot 1).

Finally, a privy was discovered 17.5 m west of the foundation and revealed early to mid-nineteenth century artifacts including a Nova Scotia Penny Token dating to 1843 and a creamware chamber pot. The privy was filled in with large boulders and again, due to time constraints, it could not be excavated in its entirety and it was decided to preserve the integrity of this feature for future research (Plate 14). The boundaries of this feature were not reached and no structural information was obtained through excavation.
