ANALYSIS OF COASTAL GEOMORPHOLOGICAL  
PROCESSES ON A BOREAL COARSE CLASTIC BARRIER:  
LONG POND BARACHOIS, CONCEPTION BAY, NEWFOUNDLAND

A thesis submitted to the School of Graduate Studies  
in partial fulfilment of the requirements  
for the degree of Master of Science

Department of Geography  
Memorial University of Newfoundland

2004

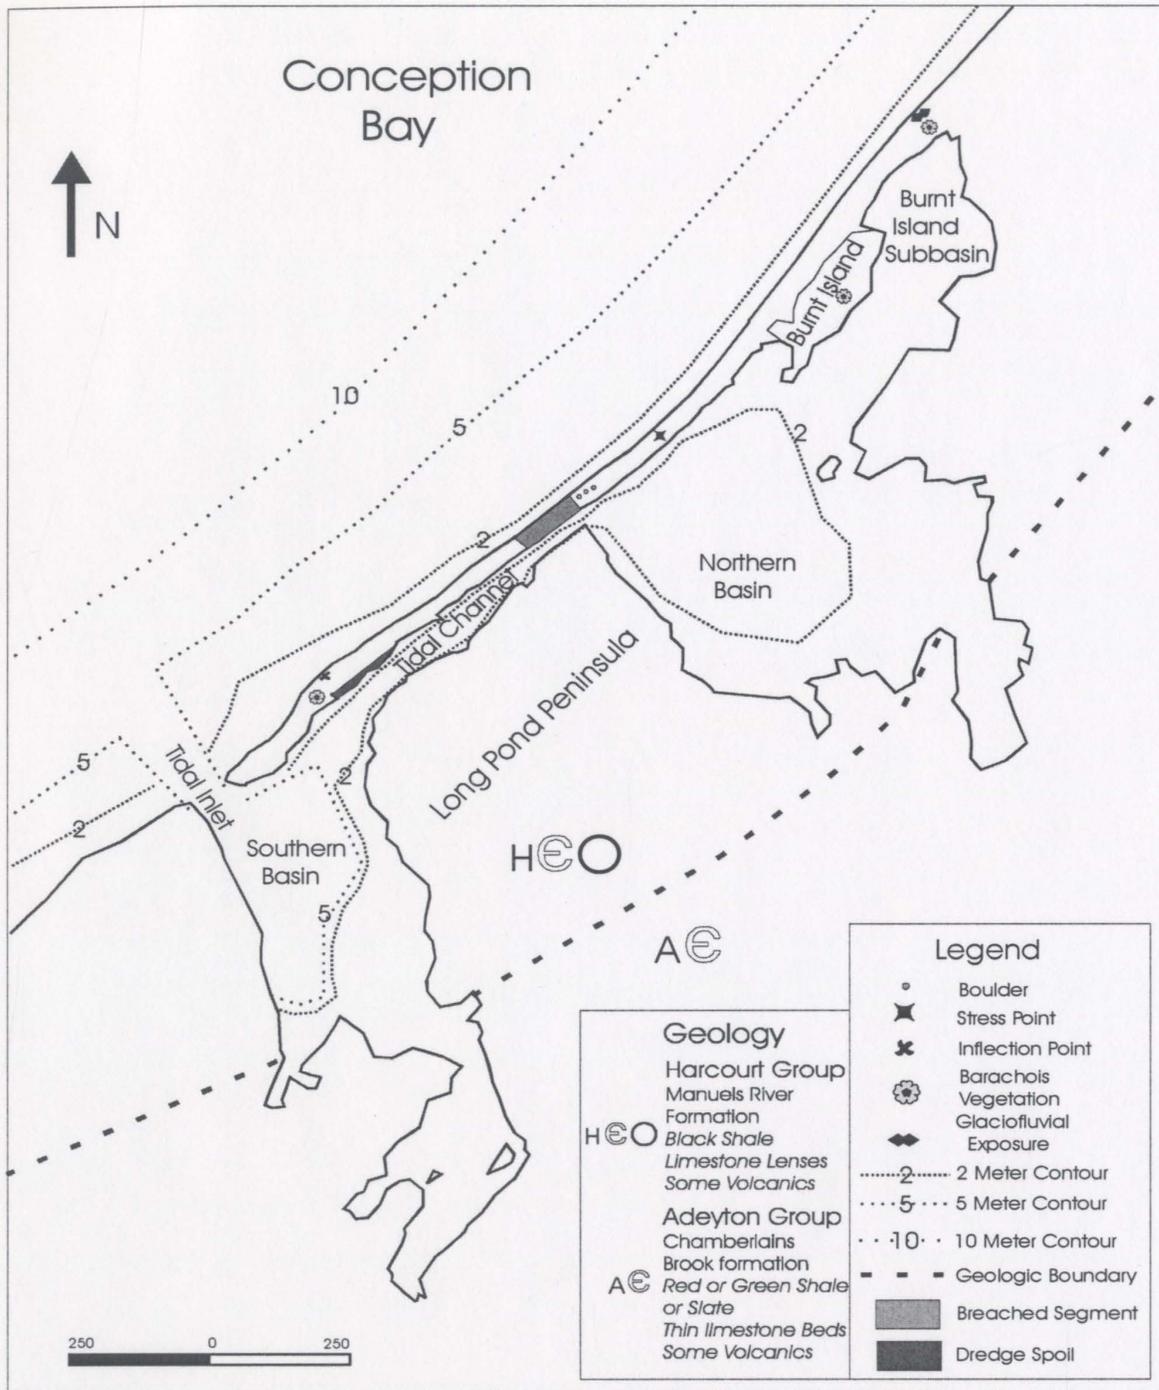
Figure 1.2. Long Pond: Biophysical Features. Geological features from King (1988). Bathymetric features from Canadian Hydrographic Service (1987).

Long Pond was separated from Conception Bay by a narrow, single ridged, baymouth gravel barrier (or barachois) approximately 1.75 km in length and 20 - 40 m in width. The barachois was aligned approximately parallel to the coast, trending from southwest to northeast. The barrier planform was arcuate (concave seaward) over most of its length, averaging 040° azimuth north of the stress point (Fig. 1.2) and 055° azimuth to the south

The barachois was sparsely vegetated except for the dredge spoil and crest segment between the inflection point and tidal inlet (Fig. 1.2). The dredge spoil hosted silts and sands, which may have been conducive to vegetative colonization (Plate 1.2 e). The inflection point crest was colonized by grasses and smooth hawksbeard (*Crepis capillaris*) despite the open-work gravel substrate (Plate 1.2 f). Several species of gull (*Larus* spp.) often congregated on this barrier segment, which also hosted a common tern (*Sterna hirundo*) nesting site. Several species of shorebirds were observed as well.

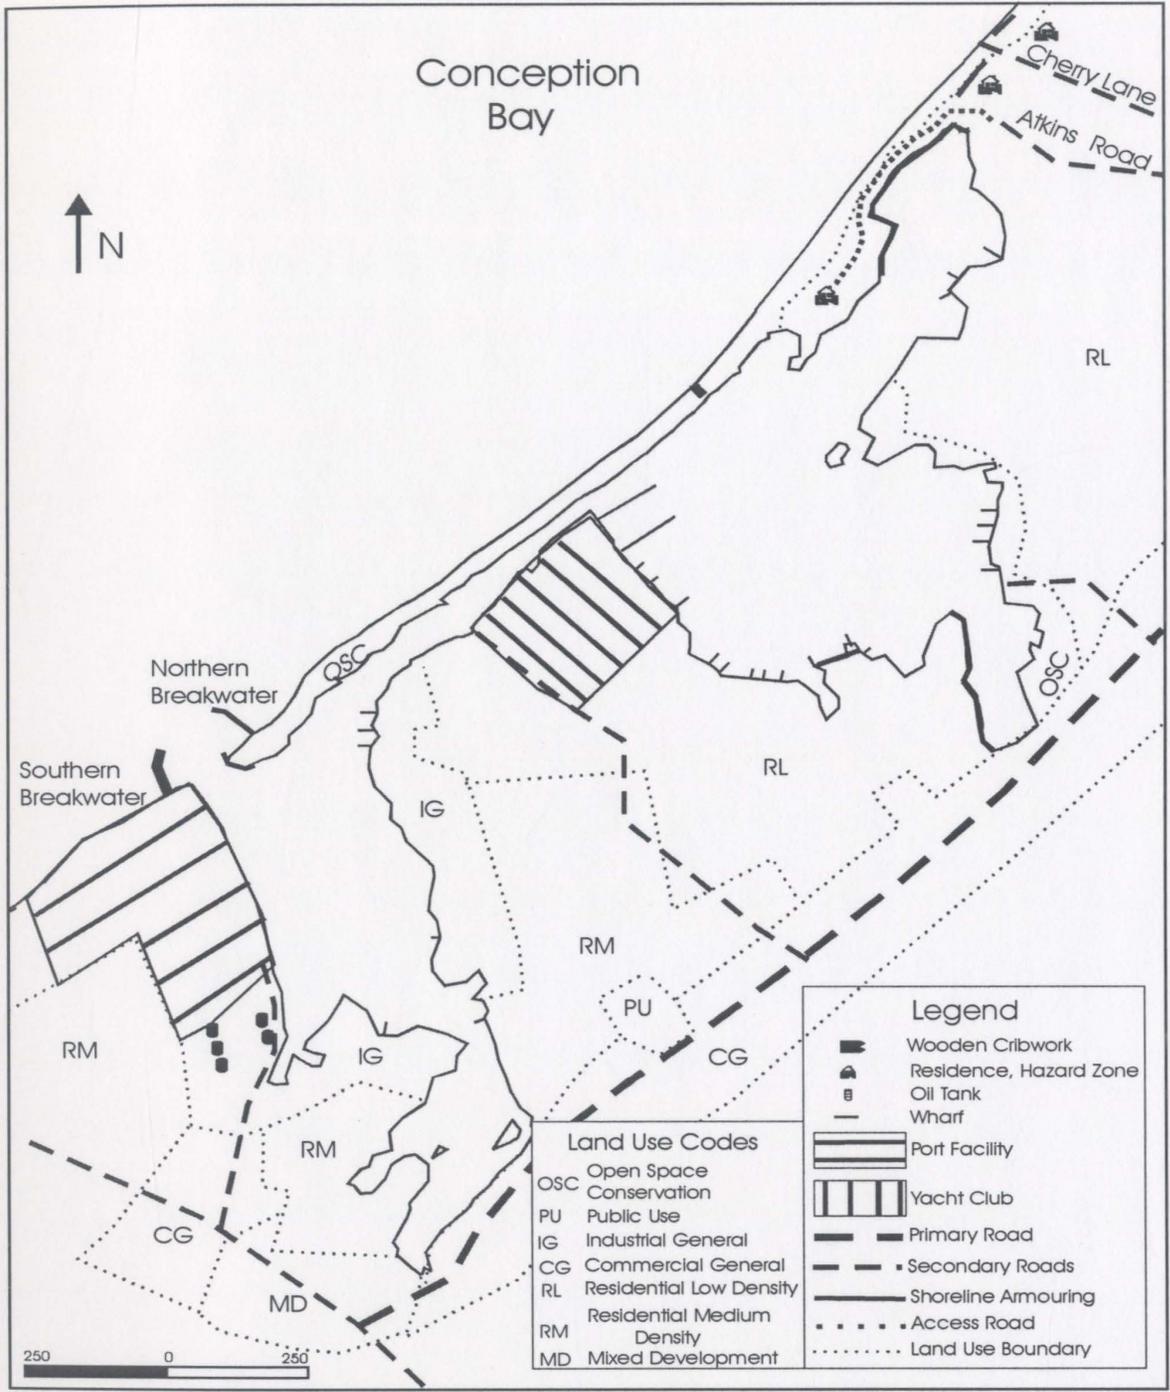
Figure 1.3. Long Pond: Infrastructure and land use. Land use zones adapted from D. W. Knight & Associated Ltd (1993).

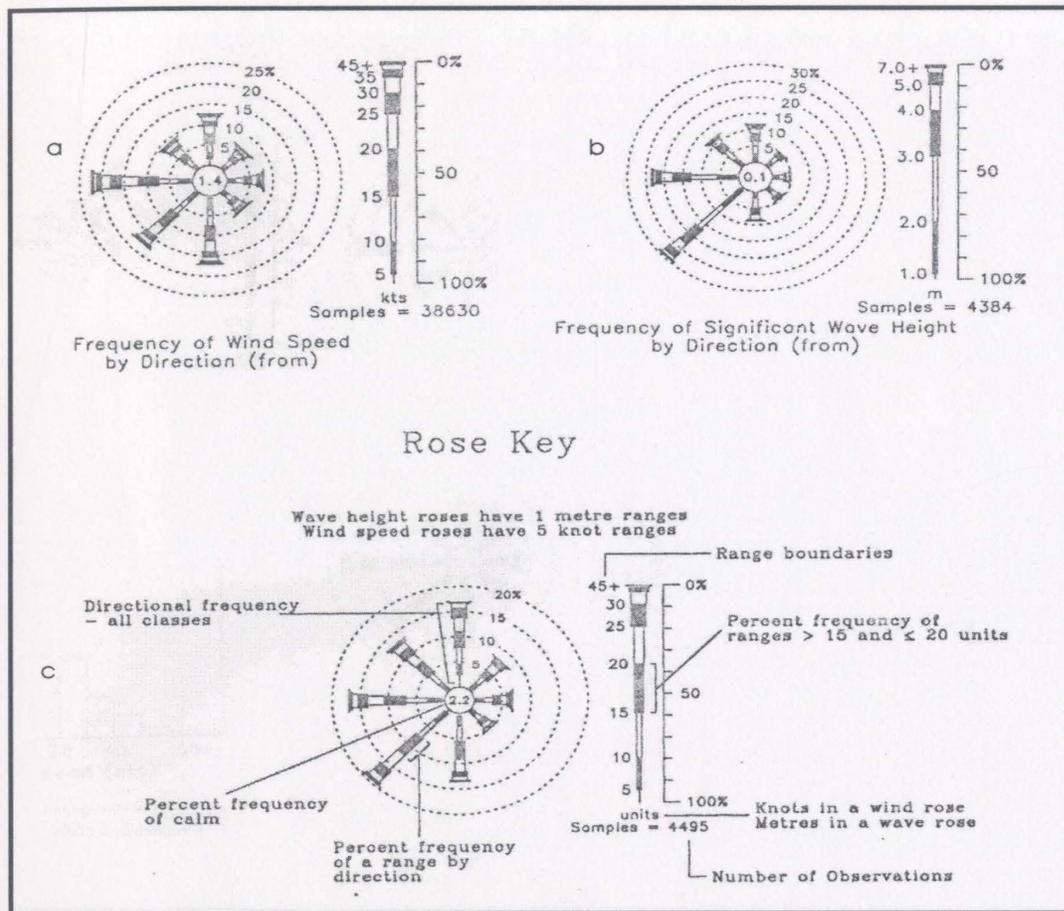
Figure 1.4 a. Frequency of wind speed by direction, Northeast Avalon.  
 b. Frequency of significant wave height by direction (from), Torbay monitoring station.  
 c. Rose Key (MacLaren Plansearch Ltd, 1991).

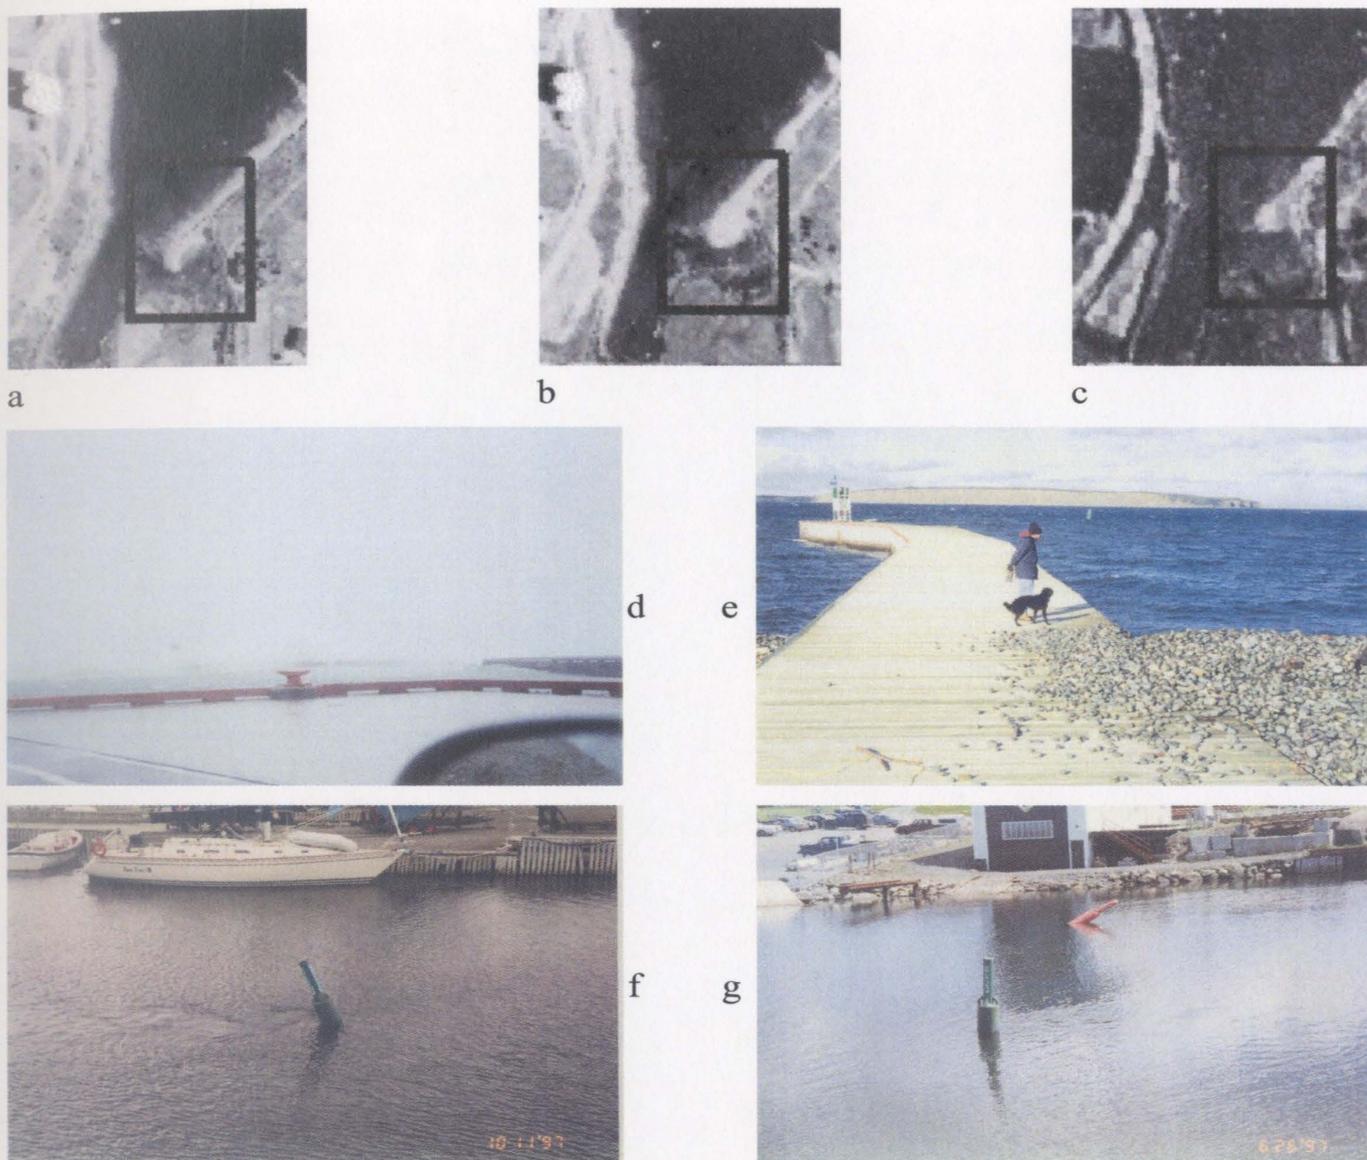
- Plate 1.1
- a. Recurved spit in southern basin, 2001. Spit is approximately 30 m in length.
  - b. Poorly developed spit, 1995.
  - c. Incipient spit, 1978.
  - d. Waves breaking against breakwater, Hurricane Gabrielle (20/09/01).
  - e. Overwash on breakwater (19/11/98).
  - f. Flood tide current in channel (11/10/97).
  - g. Ebb tide current in channel (26/06/97).

Long Pond was microtidal with a mean tidal range of 0.9 m (Canadian Hydrographic Service, 1997). Tides were mixed semidiurnal, with peaks and nadirs spaced 6 to 6.5 hours apart. Ocean tides controlled the wave elevation but did not directly transport gravel. The small tidal range and steep beach slope inhibited cross-shore swash extension during fairweather conditions. Tidal exchange facilitated regular flushing of the lagoon. Flow constriction through the tidal channel generated strong currents (Plates 1.1 f, g).

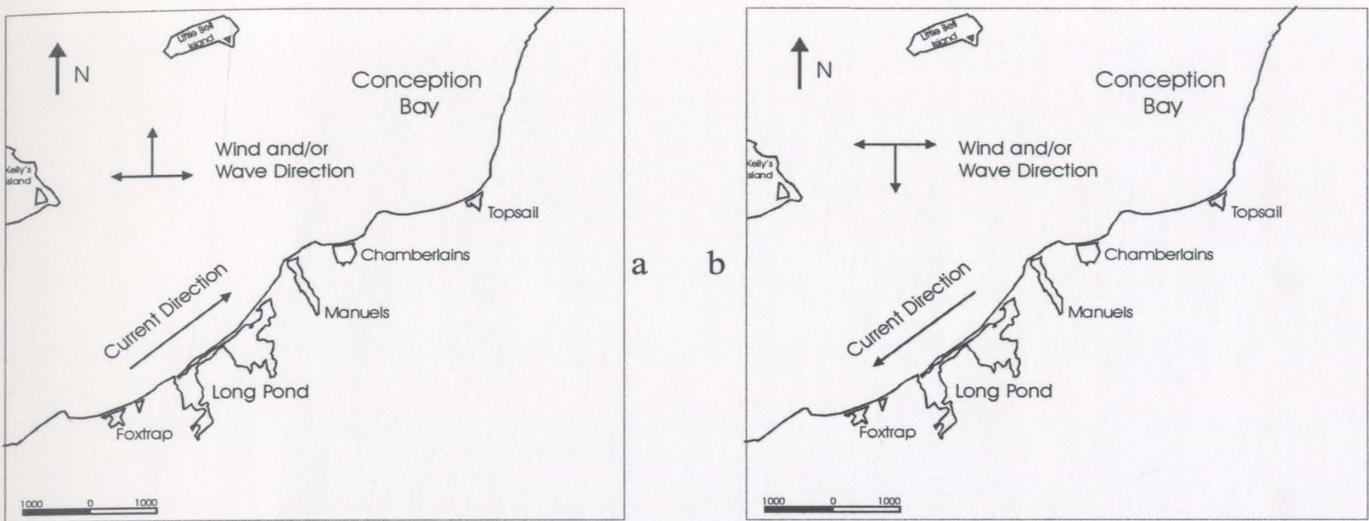
Figure 1.6 a. Longshore current generation, southeastern Conception Bay.  
 b. Current reversal generation, southeastern Conception Bay.

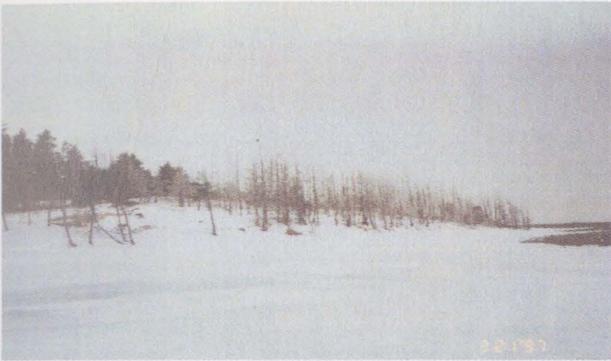
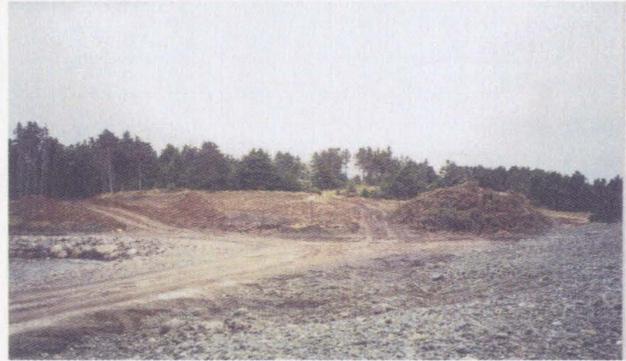
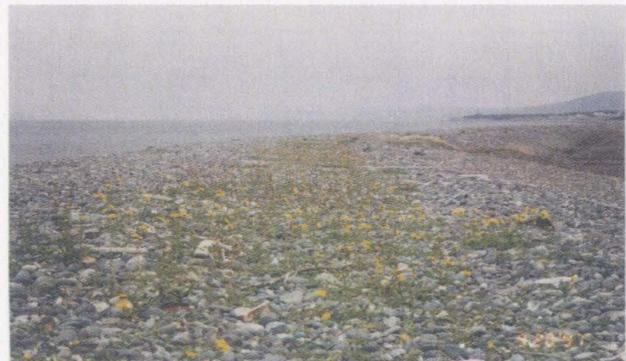
- Plate 1.2
- a. Stump protruding through beach gravels, western Burnt Island.
  - b. Exposed tree roots, Burnt Island. Note harvested timber, top left.
  - c. Fire-killed trees, northwestern Burnt Island.
  - d. Trees removed due to residential development.
  - e. Silt lens on dredge spoil. Note colonization by grasses.
  - f. Vegetative colonization on crest. Note inflection point, top center.

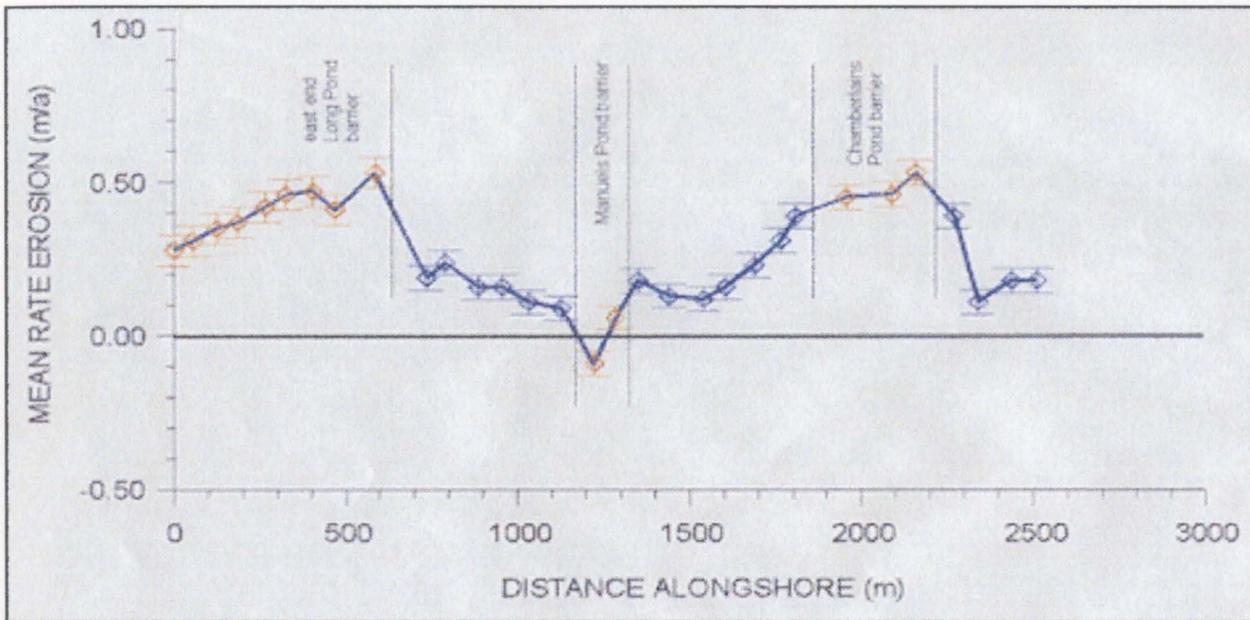
Figure 1.7. Mean estimated erosion rate (m/year) 1951-1995 for southern Long Pond to Chamberlains. Barrier retreat rates are in orange, cliff erosion rates are in blue. Low retreat rates at 1100 and 2400 m alongshore correspond to emerging headlands (unpublished data courtesy of Dr. Don Forbes, Geological Survey of Canada, Bedford Institute of Oceanography).

0.3 m/yr on average (Fig. 1.7). Burnt Island was also a glaciofluvial unit and prior to armouring, the lagoon shoreline was characterized by near-vertical scarps (Plate 1.2 b).

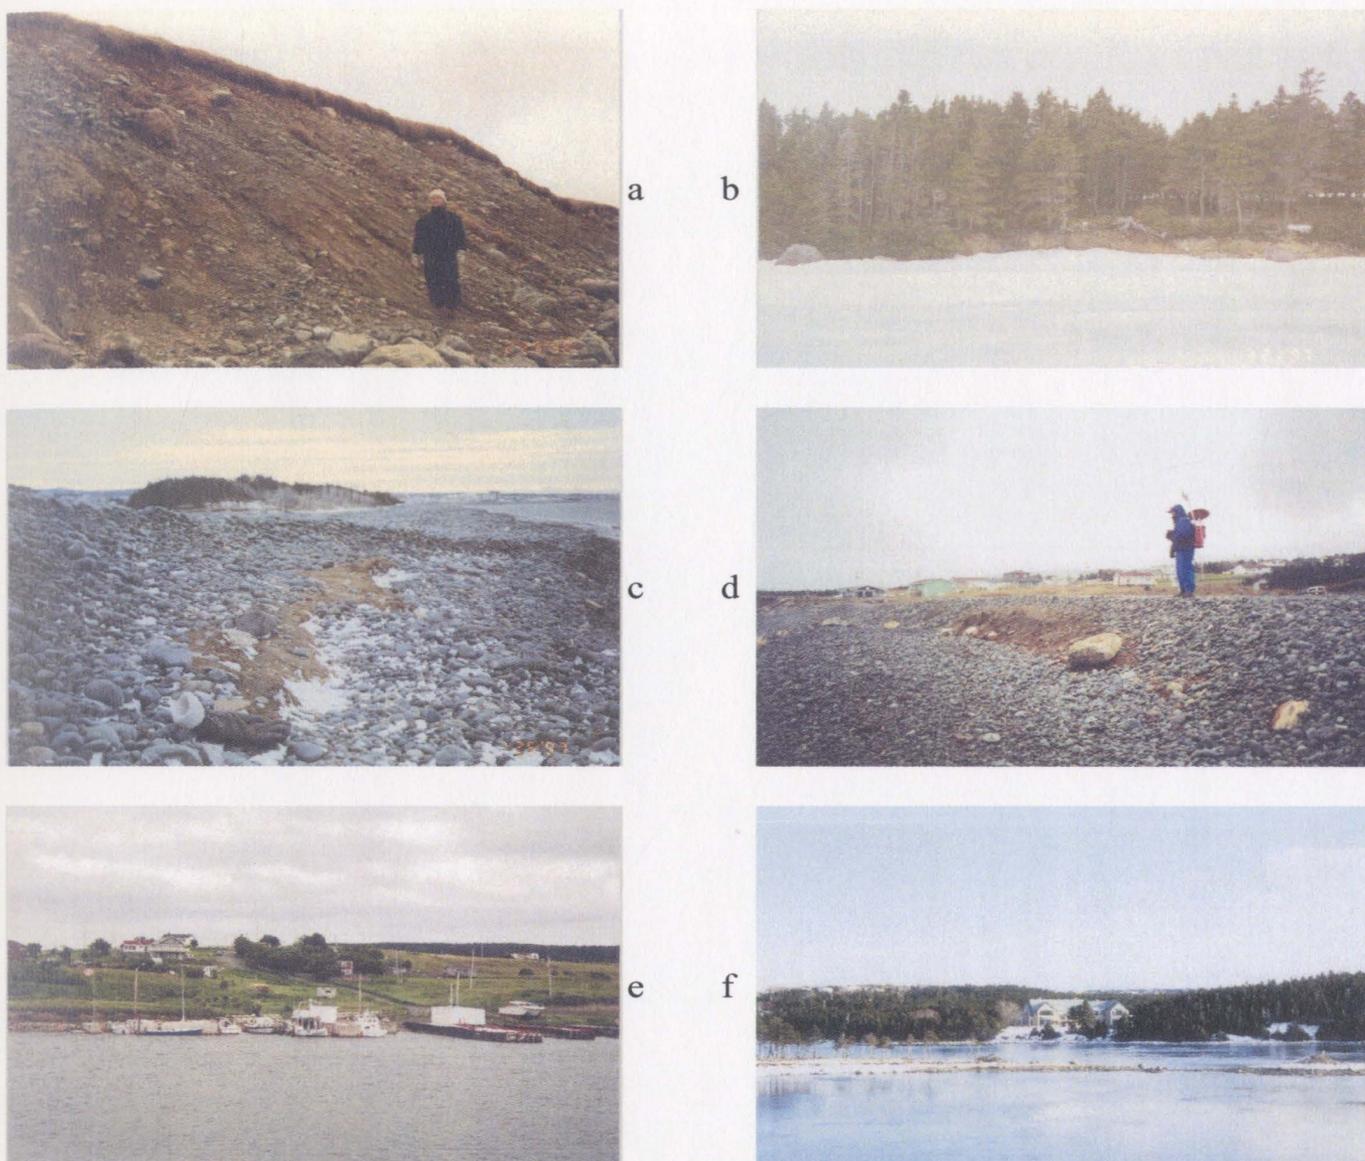
- Plate 1.3
- a. Bluff face, Conception Bay. Field assistant is 1.65 m in height.
  - b. Scarping, Burnt Island.
  - c. Glaciofluvial exposure in cusp, 25/01/97. Glove is 20 cm in length.
  - d. Glaciofluvial exposure, 04/11/00. Field assistant is 1.62 m in height.
  - e. Residential development, tidal channel (note the generous setback).
  - f. Residential development, northern basin.

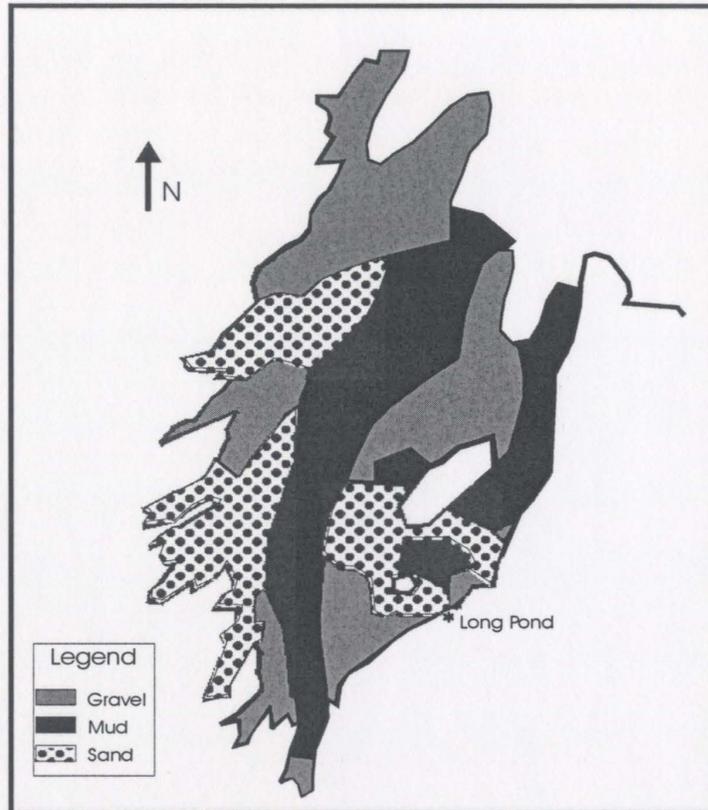
Figure 1.8. Marine substrate texture, Conception Bay (adapted from Wells, 1966).

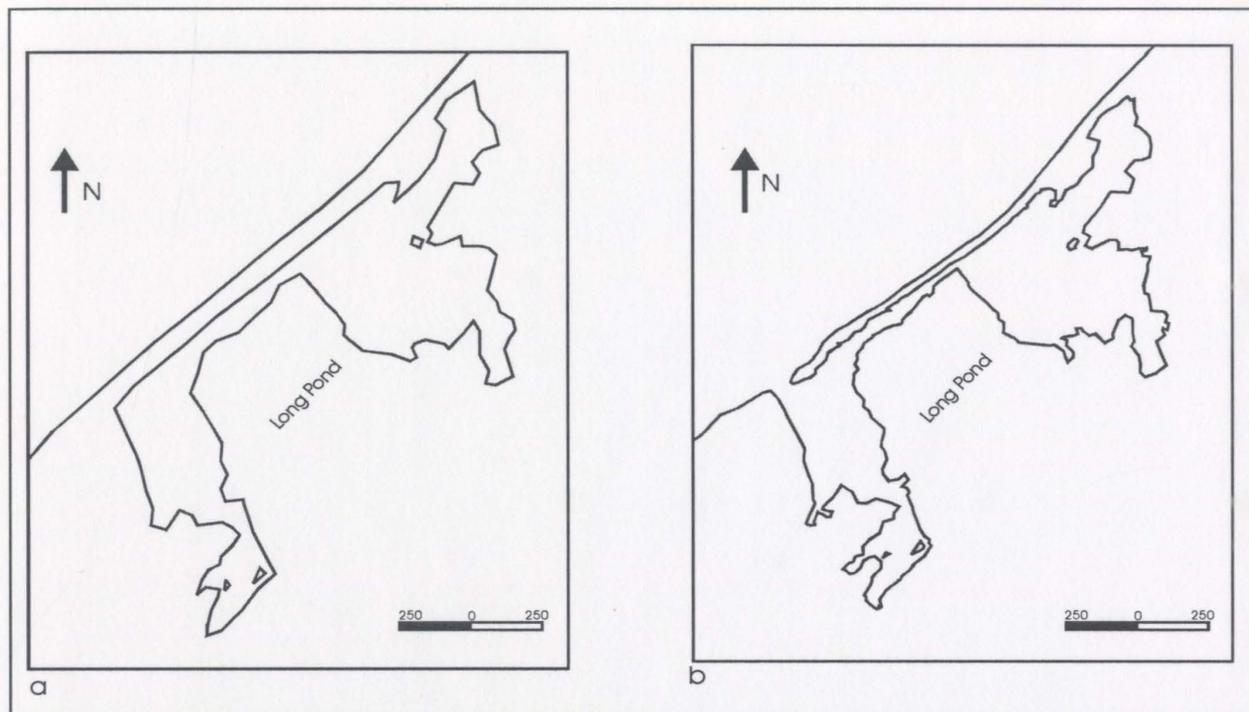
Figure 1.9 a. Approximation of barrier planform circa 1868. Adapted from Orlebar & Kerr (1868).  
 b. Barrier planform, 1995.

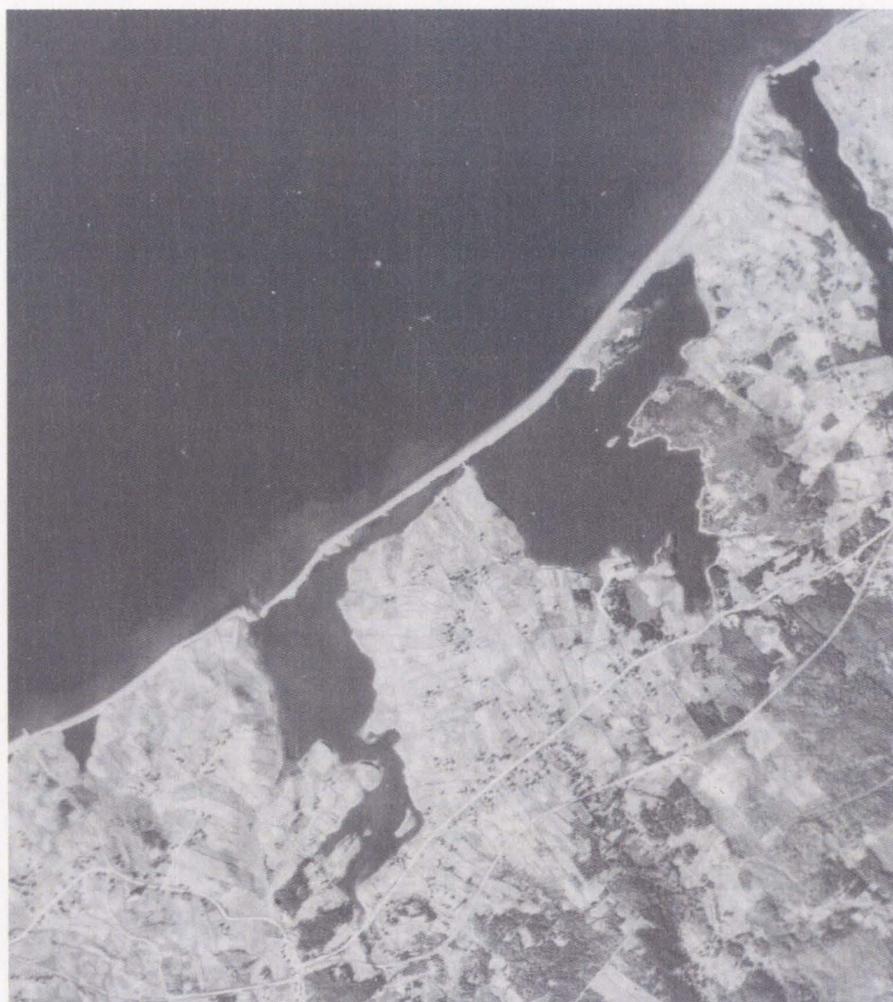
Plate 1.4. Long Pond, 1941 (NF14-612). Scale approximately 1:20,000, cut from original photo, scale 1:40,000.

Gravel barriers often exhibit long periods of slow evolution punctuated by periods of rapid reorganization (Forbes *et al.*, 1995). A barrier adjustment, which included stretching and the formation of a tidal inlet, probably occurred between 1910 (Public Works of Canada reprint, 1910) and 1941 (Plate 1.4). There was no apparent increase in storm frequency during this period (B. Whiffen, *pers. comm.* 2002) that might have triggered this response. Terrestrial water flux did not change quickly or substantially. Inlet formation suggested that barrier volume decreased dramatically.

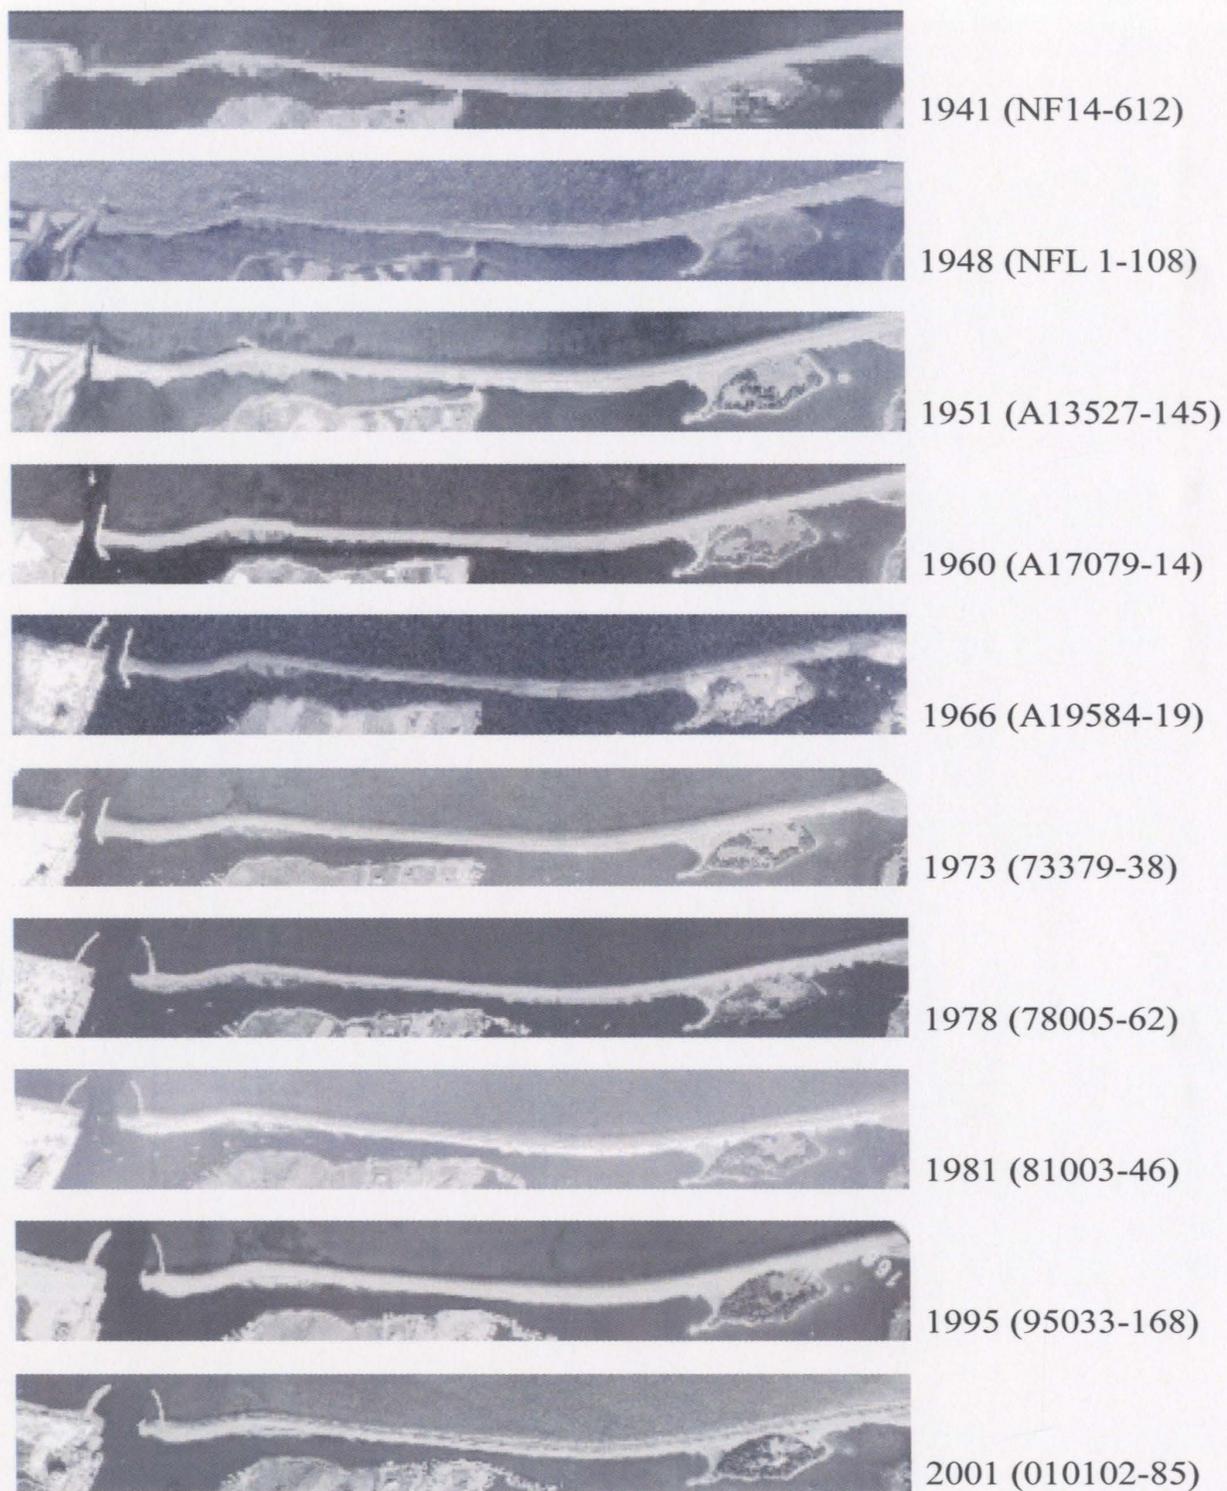
Plate 1.5. Time sequence of aerial photographs, Long Pond Barachois.

yacht club was based at Topsail from 1936 to 1957 (<http://www.nyc.nf.ca>, 2003). The tidal inlet was stabilized by 1951 (Plate 1.5), but a port facility was not developed until circa 1957 (Plates 1.6 b, c), when stabilization infrastructure was improved, the inlet and adjacent basin were dredged, and a wharf was constructed (Public Works of Canada, 1957). The tidal channel was dredged to facilitate the relocation of the yacht club to the Long Pond Peninsula. The tidal inlet, basin, and tidal channel were periodically dredged, the inlet stabilization structures have been repaired and reconfigured and the wharf has been repaired on several occasions (Appendix 2). Long Pond has evolved into the main port facility in CBS. South of the inflection point, the barrier has widened and built vertically since the 1960's (Plates 1.5, 1.6 d).

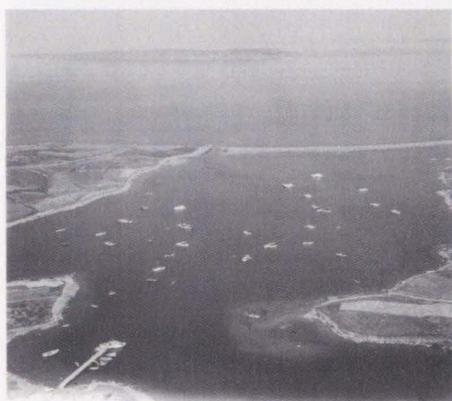
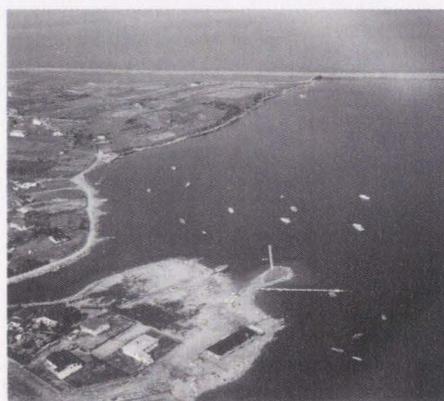
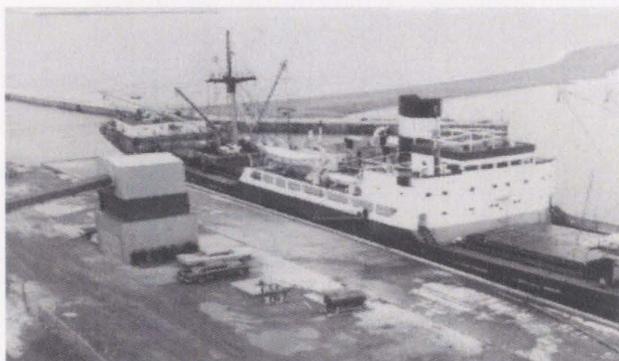
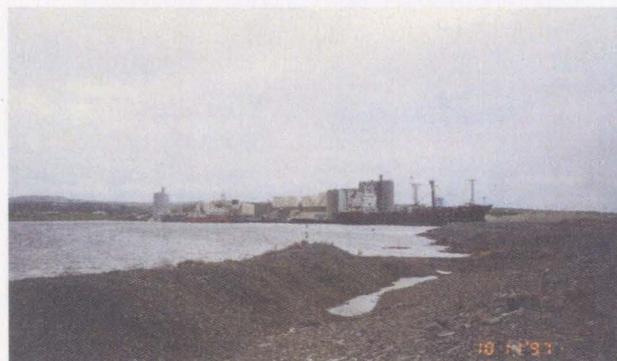
Plate 1.6 a. Burnt Island sub-basin, 1924.

A trolley track was apparently built at Long Pond to transport gravel from the barrier prior to export. The track was not maintained after the project was abandoned. The beach segment adjacent to the Burnt Island sub-basin appeared to have been higher than at present, with a steeper backbeach (Plate 1.6 a). There was an attempt to dredge a channel at Long Pond (Public Works of Canada reprint, 1910), possibly to support the gravel

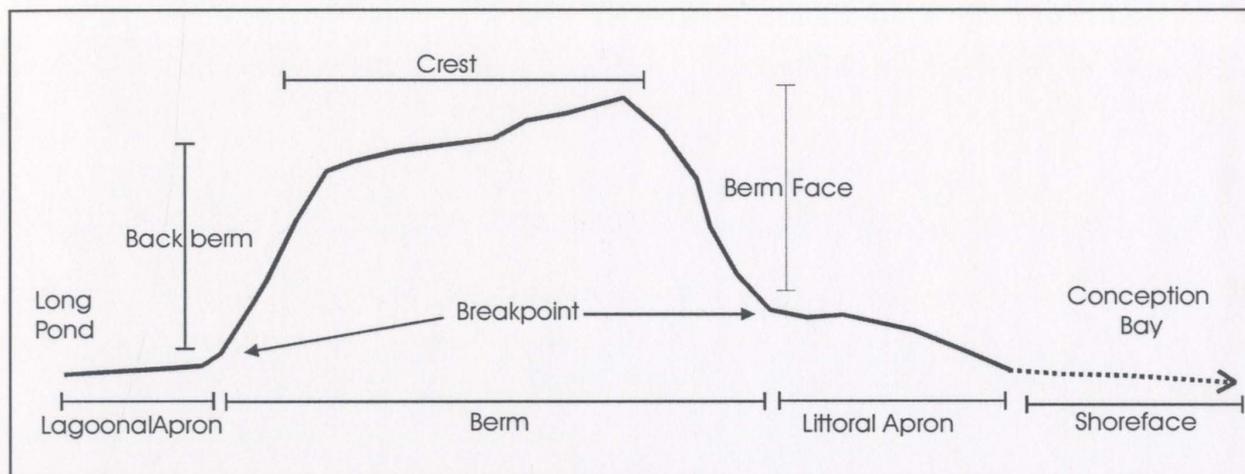
Figure 3.1. Profile terminology employed in this study.

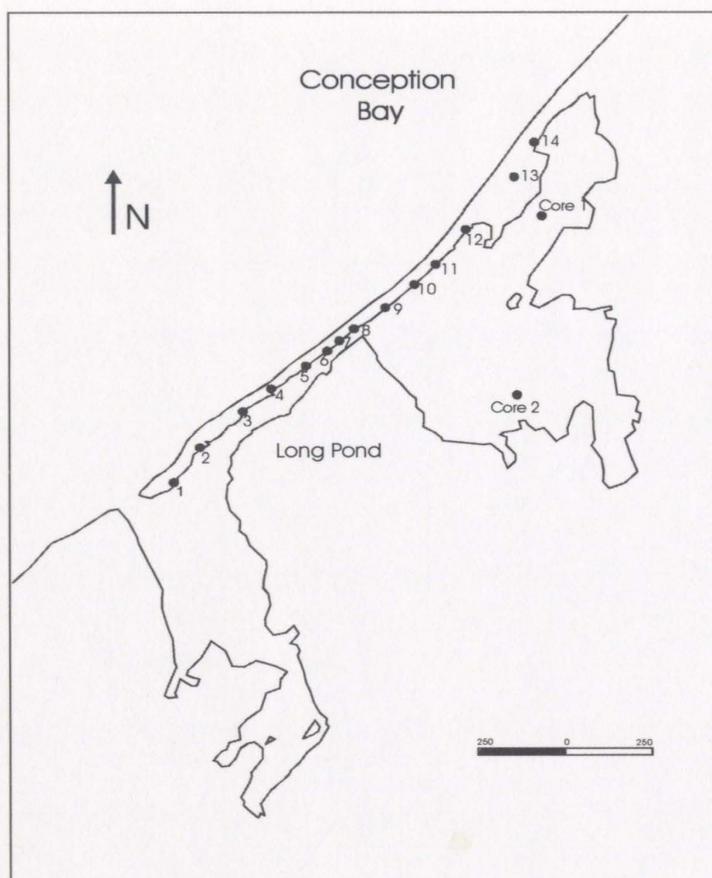
Figure 3.2. Transect and core locations, Long Pond.

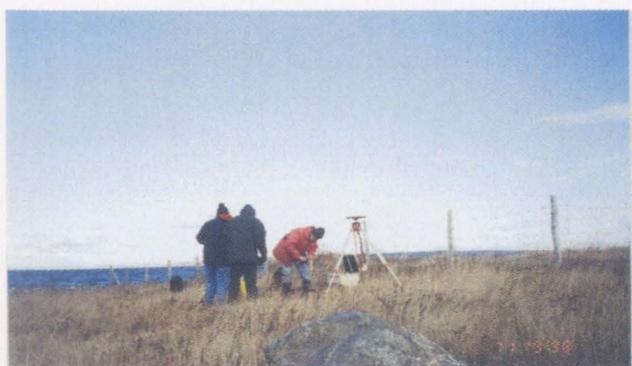
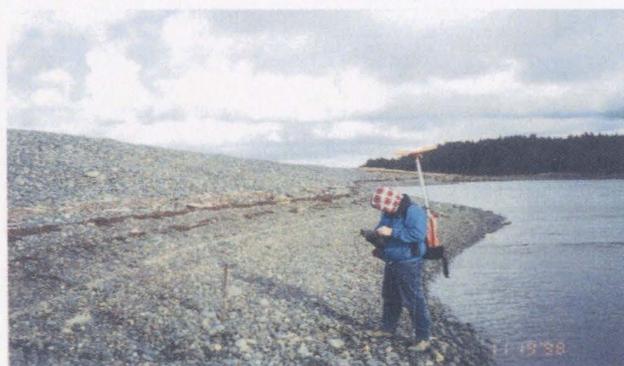
Plate 3.1 a. Establishment of RTK-DGPS base station.  
b. Recording benchmark position, Transect 11.

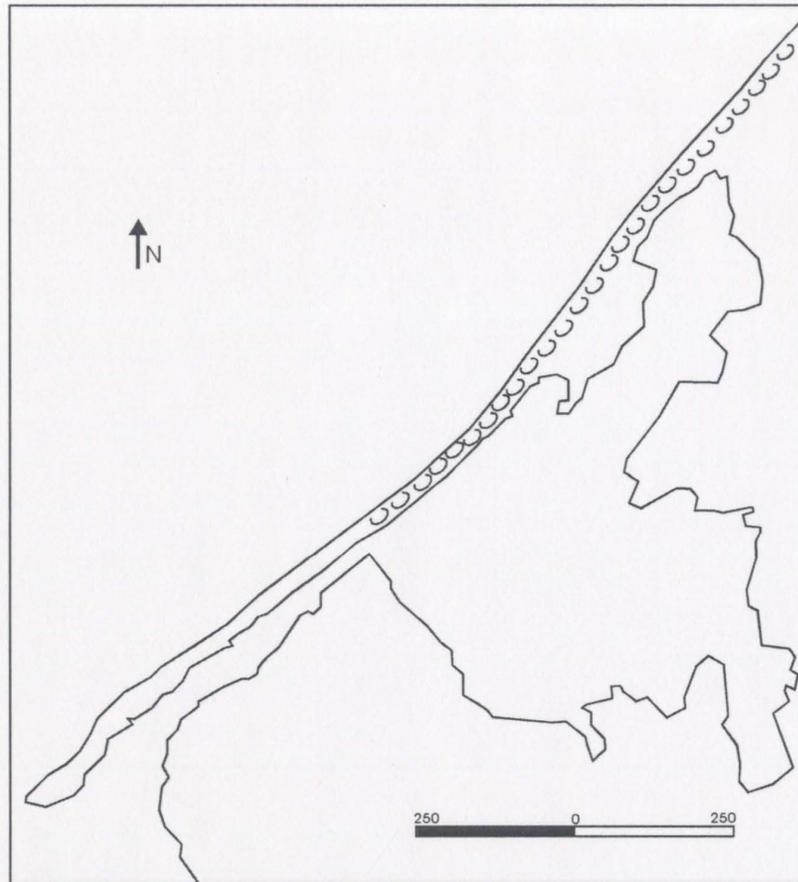
Figure 5.1. Schematic diagram of berm cusp occurrence at Long Pond.

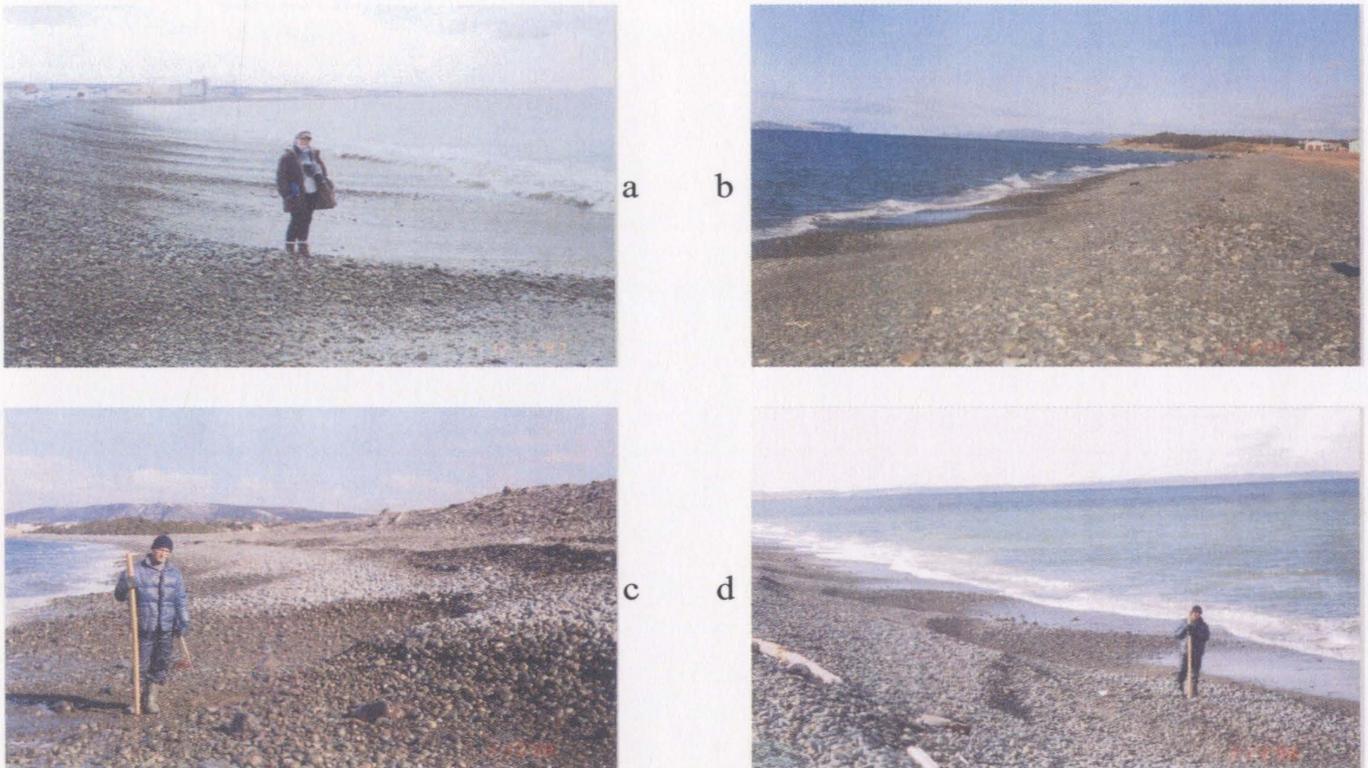
- Plate 5.1 a. Apron cusps looking south from Burnt Island 15/12/97. Field assistant approximately 150 cm in height.
- b. Apron cusps skewed north, 23/02/98, looking north from Transect 14.
- c. Apron cusps skewed north, 23/02/98, looking north from Transect 6. Field assistant approximately 185 cm in height.
- d. Apron cusps skewed south, 23/02/98, looking south from Transect 12. Field assistant approximately 185 cm in height.

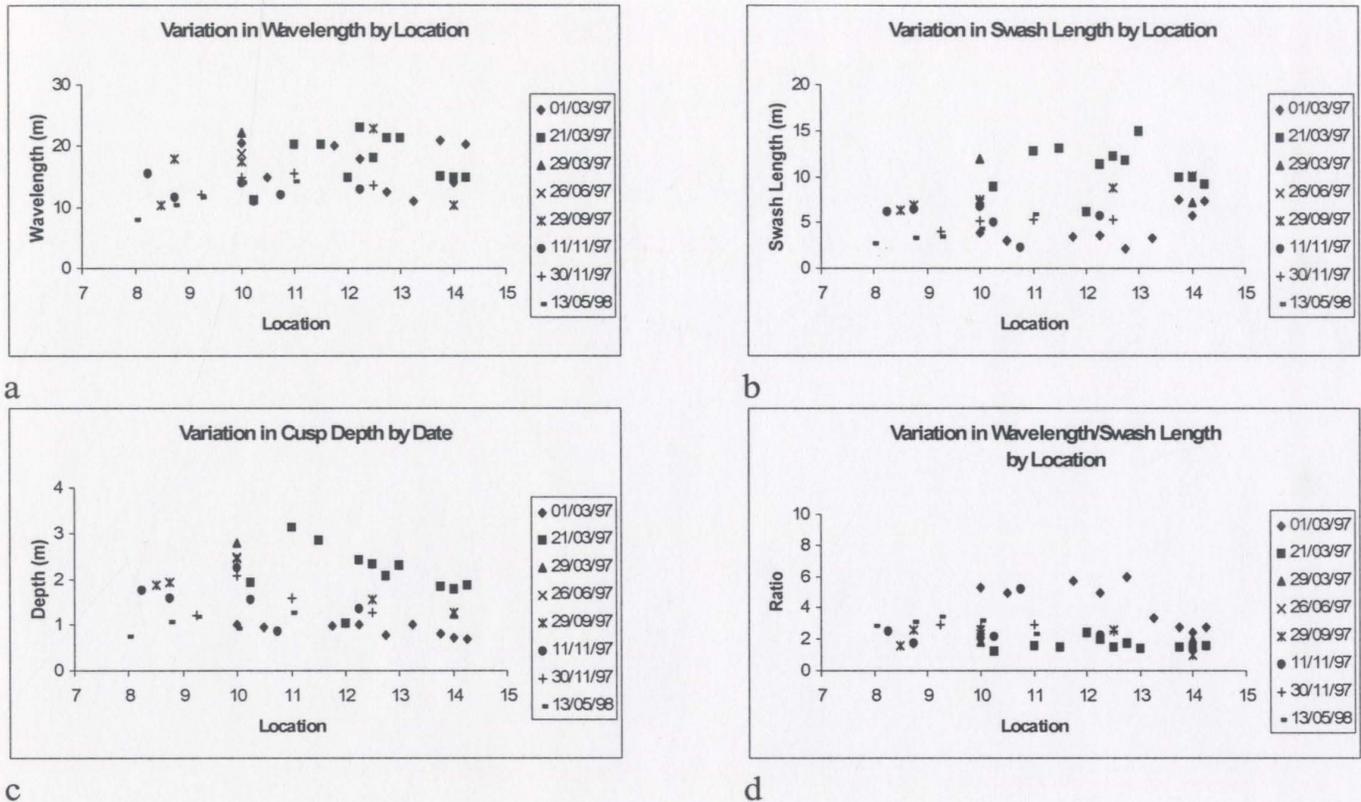
Figure 5.3 a. Variation in berm cusp wavelength by date and location.  
 b. Variation in berm cusp swash length by date and location.  
 c. Variation in berm cusp depth by date and location.  
 d. Variation in berm cusp spacing/swash length ratio by date and location.
