ANALYSIS OF COASTAL GEOMORPHOLOGICAL  
PROCESSES ON A BOREAL COARSE CLASTIC BARRIER:  
LONG POND BARACHOIS, CONCEPTION BAY, NEWFOUNDLAND

A thesis submitted to the School of Graduate Studies  
in partial fulfilment of the requirements  
for the degree of Master of Science

Department of Geography  
Memorial University of Newfoundland

2004

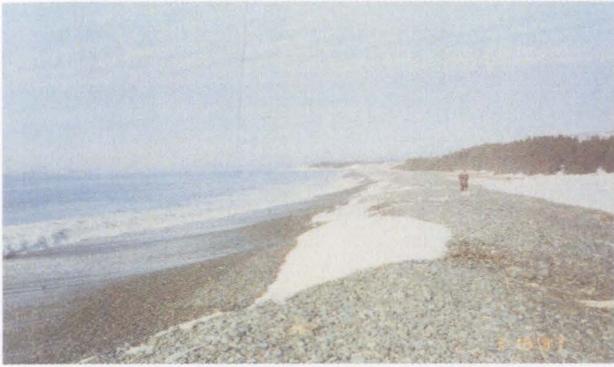
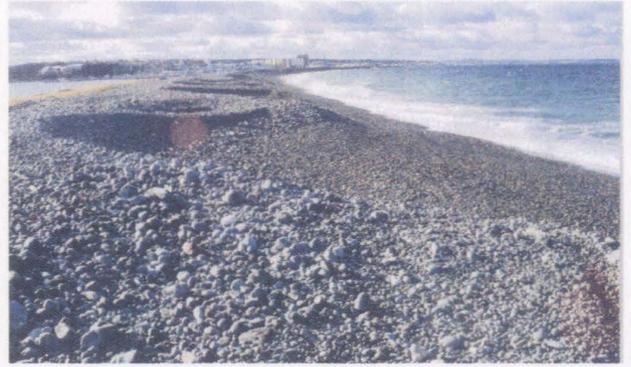
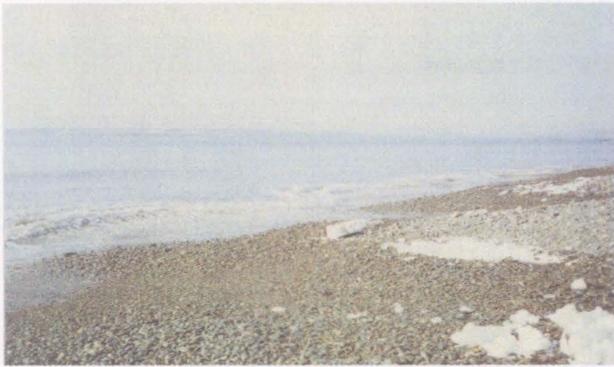
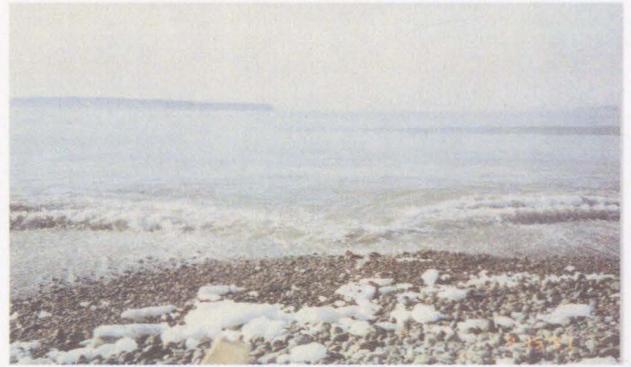
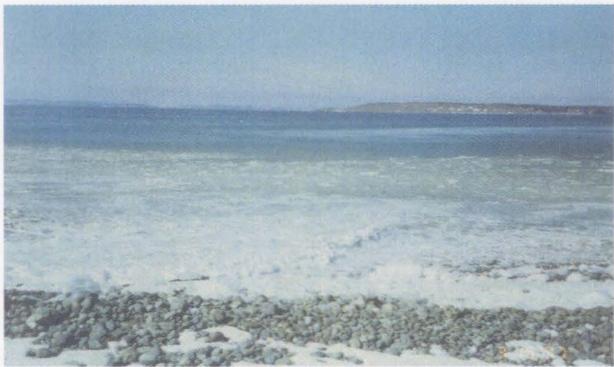
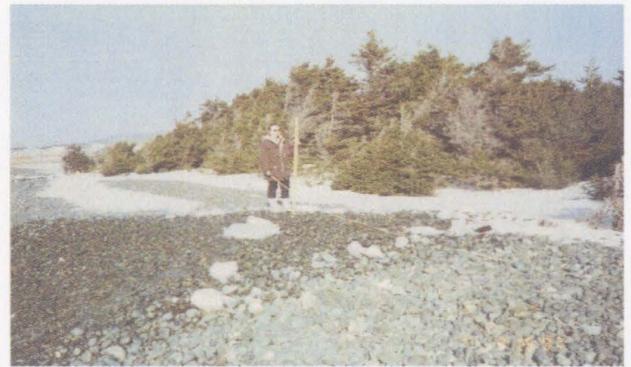
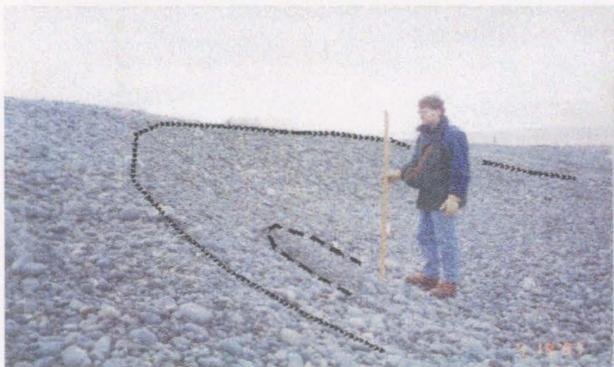
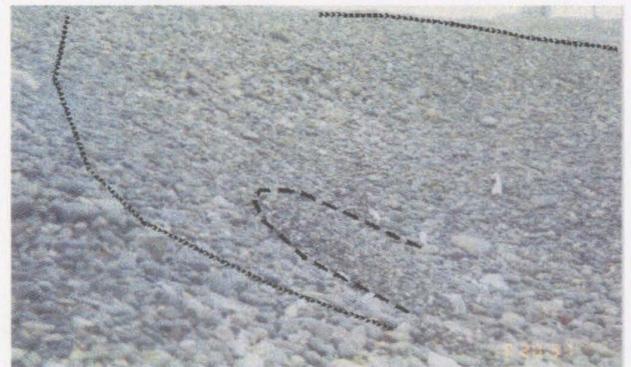
- Plate 5.2
- a. Arrhythmic berm cusps, north from Transect 11 (bays snow-filled).
  - b. Rhythmic berm cusps south from Transect 12 (courtesy D. Forbes).
  - c. Arcuate standing waves generated by differential interference between backwash and incident breakers at horns and bays.
  - d. Incipient swash jet at horn.
  - e. Intersection of adjacent cusp cells at horn near swash excursion peak.
  - f. Limit of swash excursion near Burnt Island. Photo taken within 20 minutes of Plate 5.2 a.
  - g. Triangular structure on cusp wall, 19/04/97.
  - h. Same triangular structure on cusp wall, 20/09/97.

Berm cusp size could vary significantly by location (Fig. 5.3 a - d). Cusps were usually spatially grouped (Plate 5.2 a), although rhythmic cusps were observed during the crest survey on 18/11/99 (Plate 5.2 b). Cusp bay texture was often similar to the adjacent substrate except for the common occurrence of coarse deposits at the nadir.

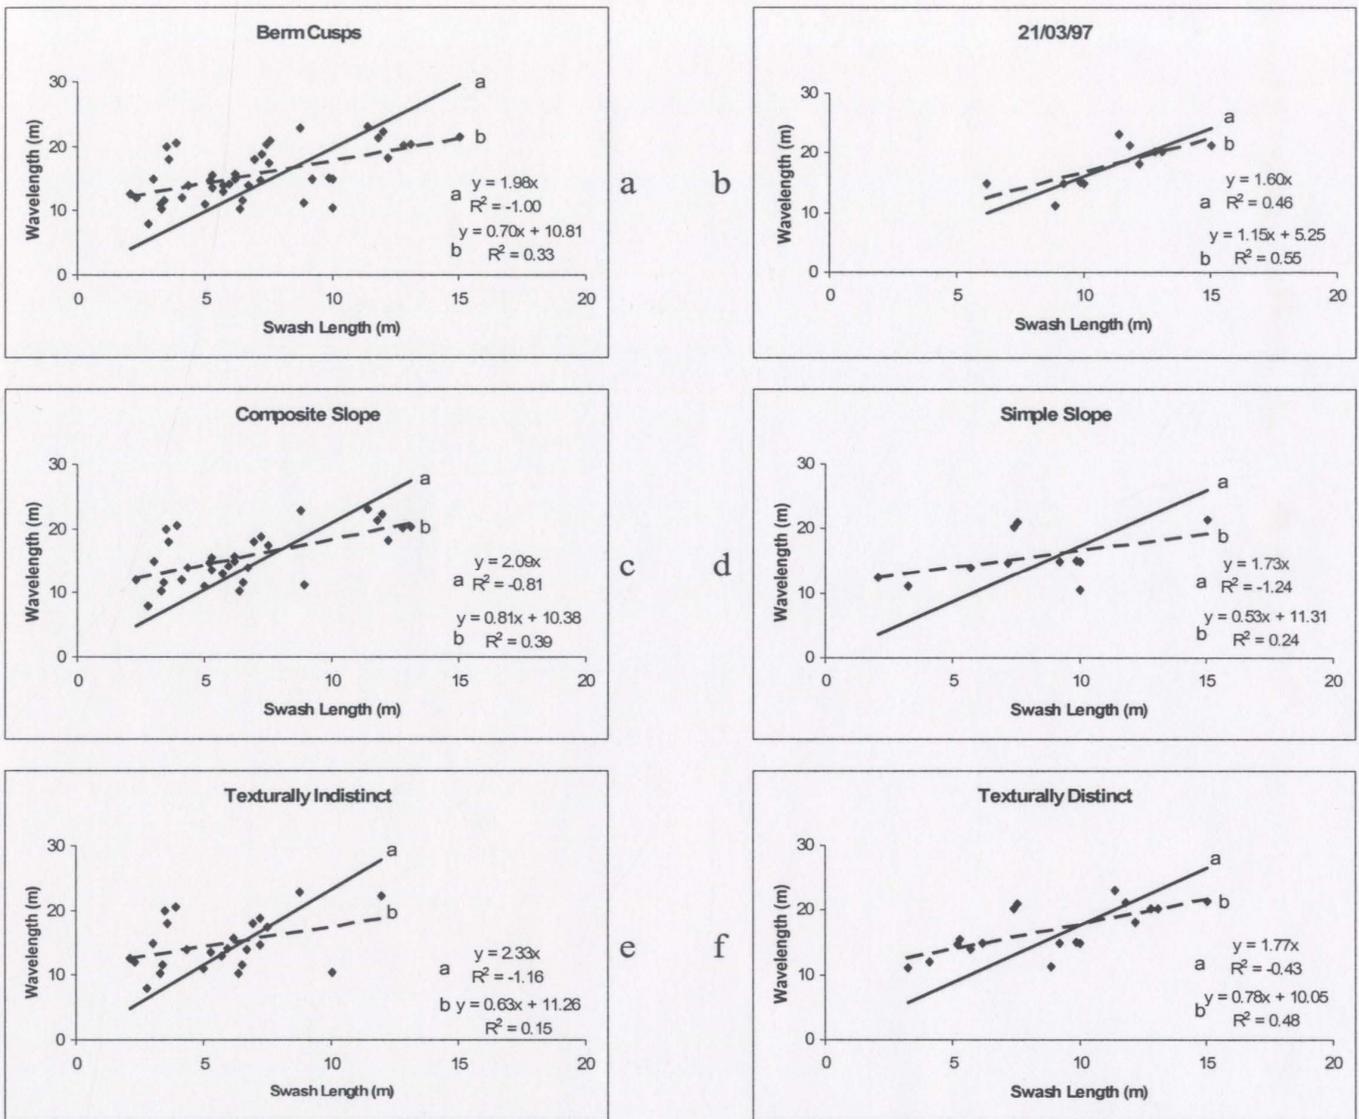
Figure 5.4 a. Regression analysis, berm cusp spacing and swash length, full data set (a: regression forced through origin, b: regression not forced).  
 b. Regression, berm cusp spacing and swash length, 21/03/97.  
 c. Regression, berm cusp spacing and swash length, composite slopes.  
 d. Regression, berm cusp spacing and swash length, simple slopes.  
 e. Regression, berm cusp spacing and swash length, indistinct horns.  
 f. Regression, berm cusp spacing and swash length, distinct horns.

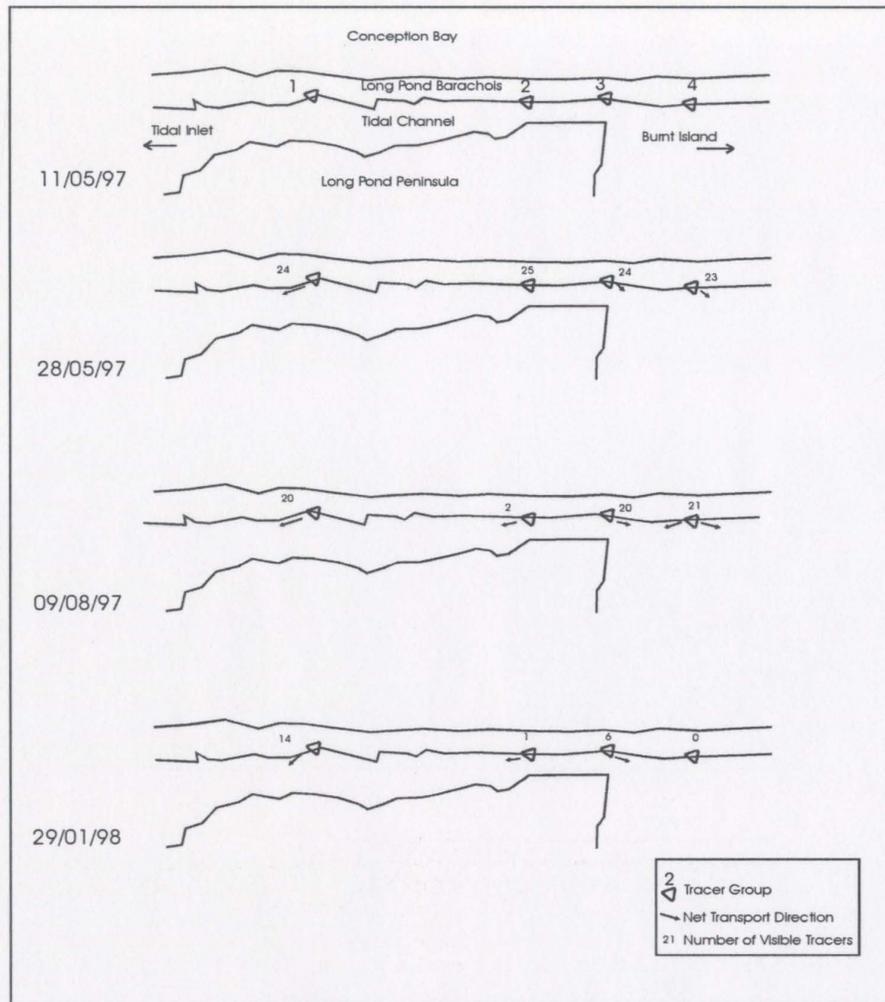
Figure 6.1. Tracer movement in the tidal channel, 11/05/97 - 29/01/98.

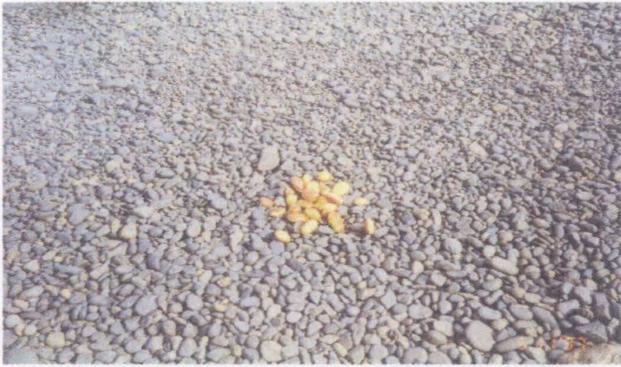
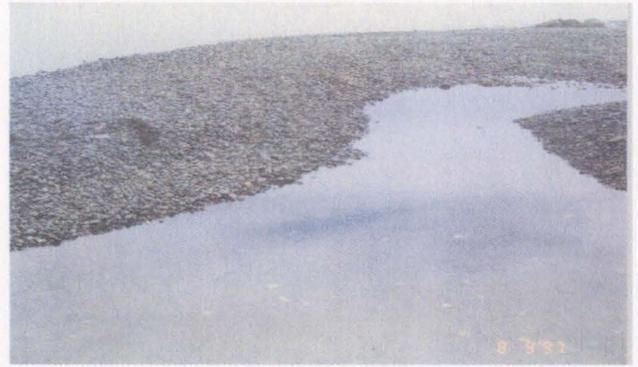
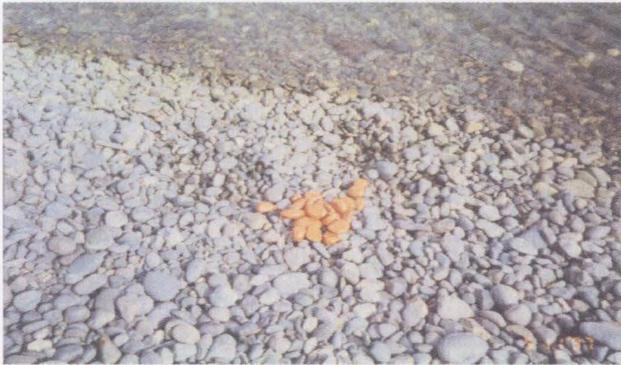
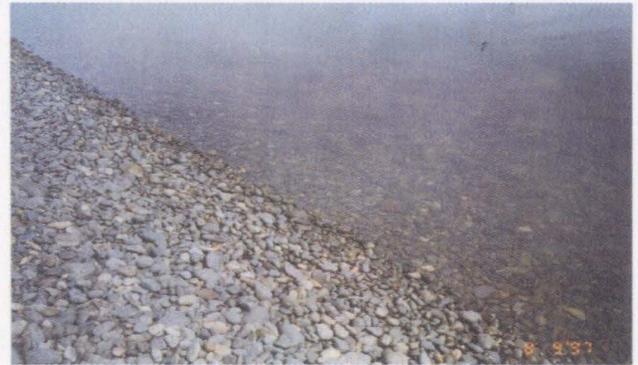
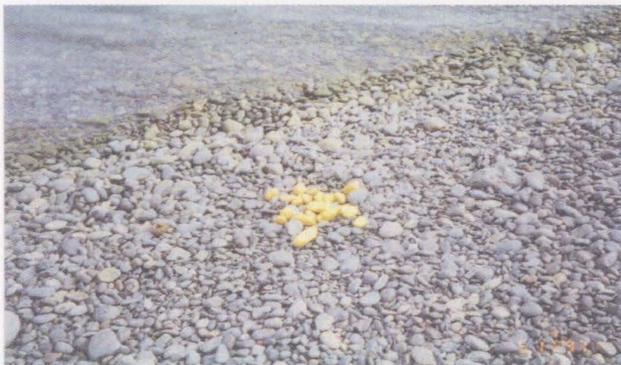
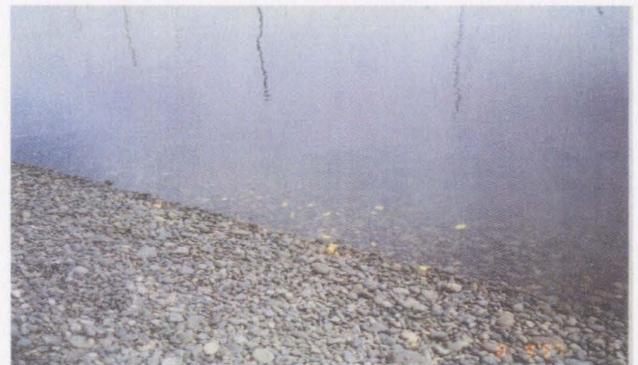
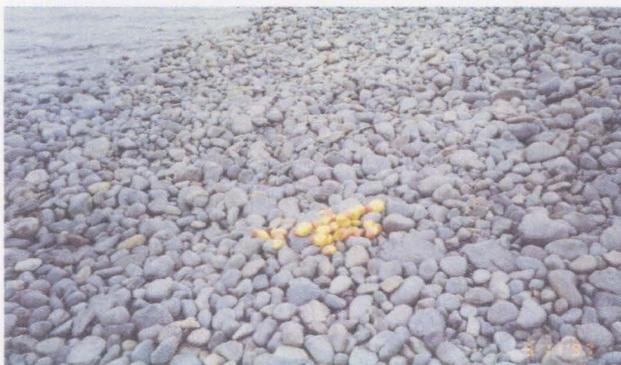
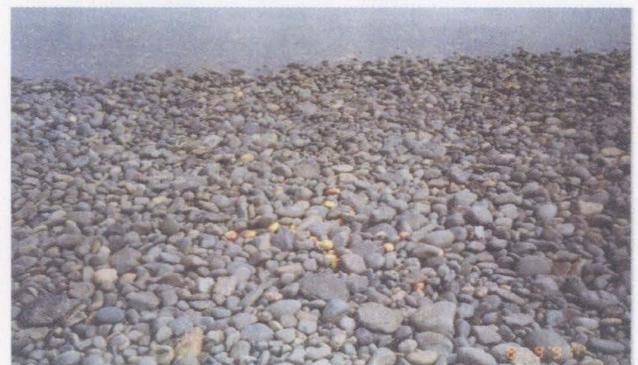
- Plate 6.1 a. Tracer group 1, Transect 3 (i 11/05/97, ii 09/08/97).  
 b. Tracer group 2, Transect 6 (i 11/05/97, ii 09/08/97).  
 c. Tracer group 3, Transect 8 (i 11/05/97, ii 09/08/97).  
 d. Tracer group 4, Transect 9 (i 11/05/97, ii 09/08/97).

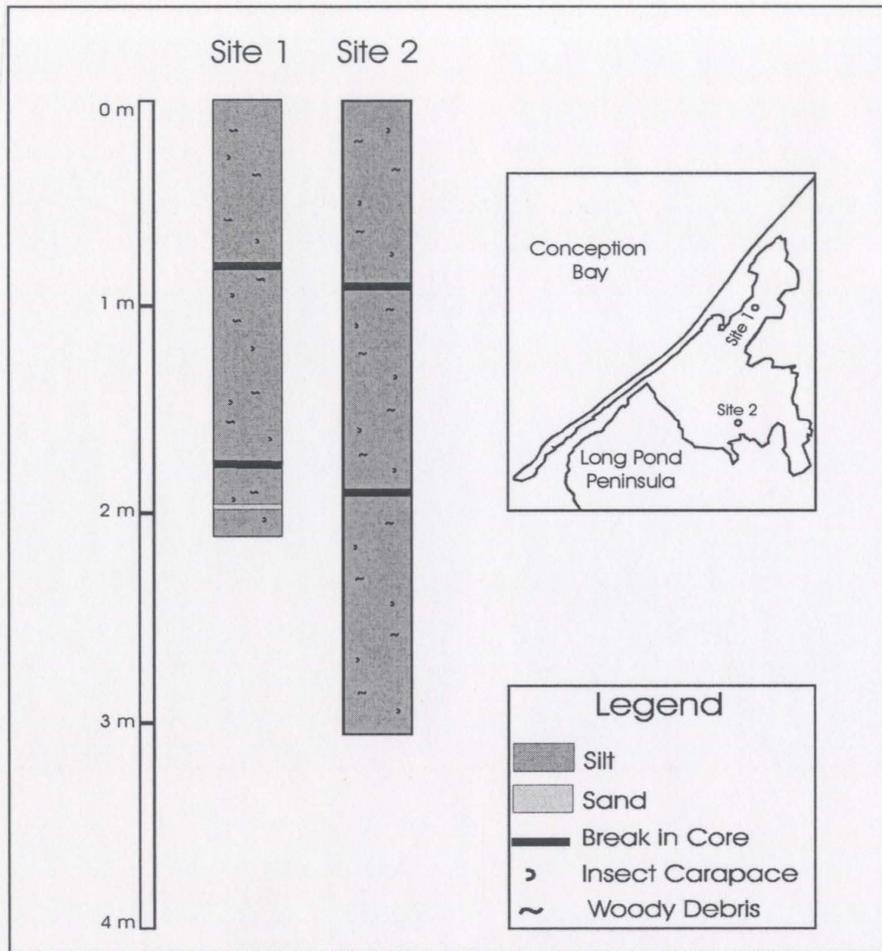
Figure 6.2. Core samples obtained from northern basin, Long Pond.

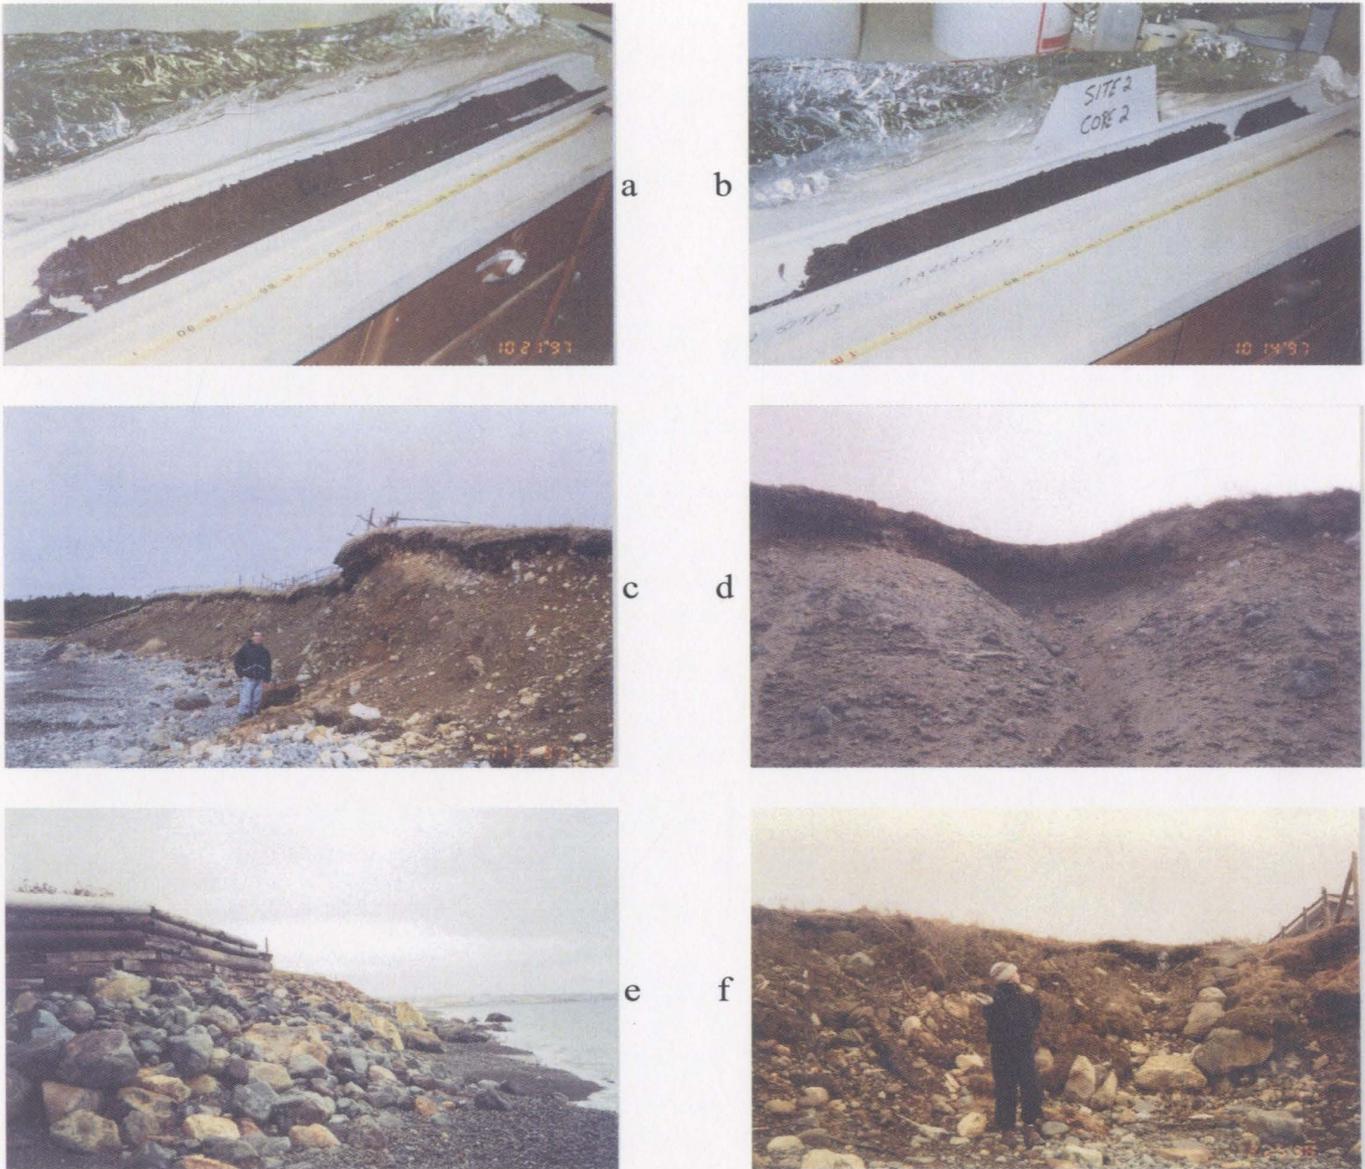
- Plate 6.2 a. Core sample, Site 1.  
 b. Core sample, Site 2.  
 c. Bluffs directly north of Long Pond (Field assistant 1.85 m in height).  
 d. Channel erosion from overland runoff.  
 e. Seawall, north of Cherry Lane.  
 f. Flanking scour, north of seawall (Field assistant 1.65 m in height).

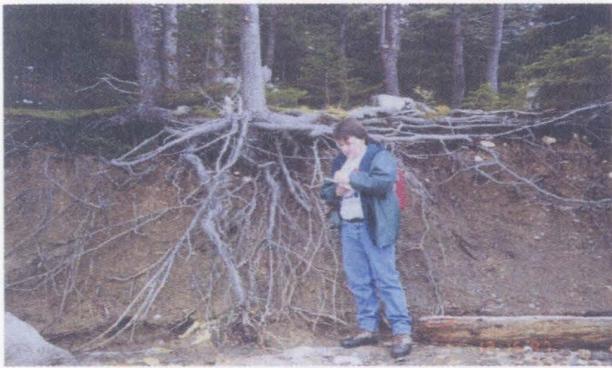
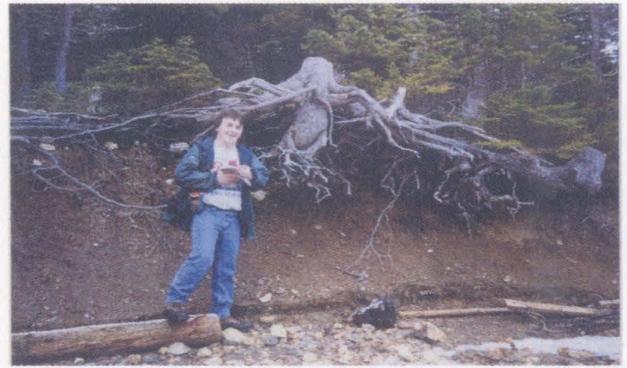
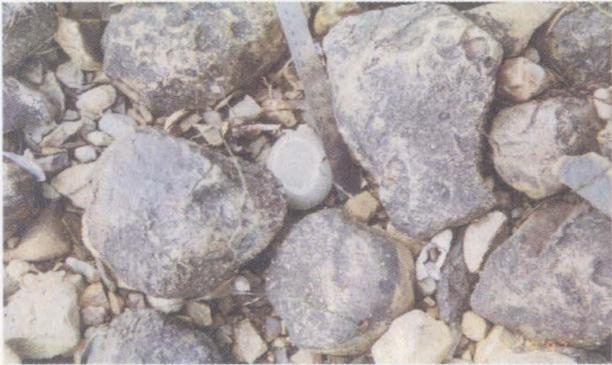
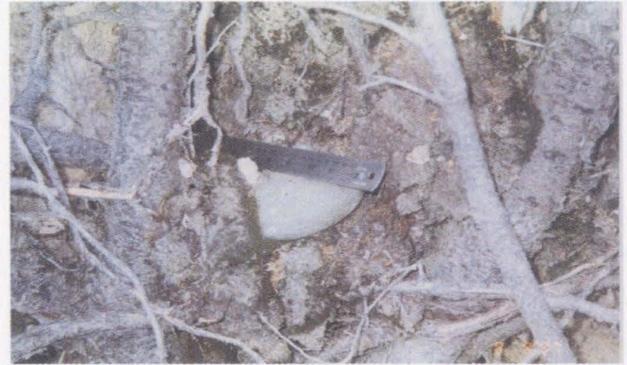
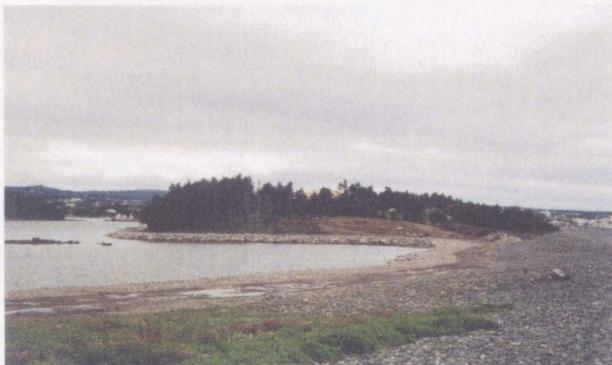
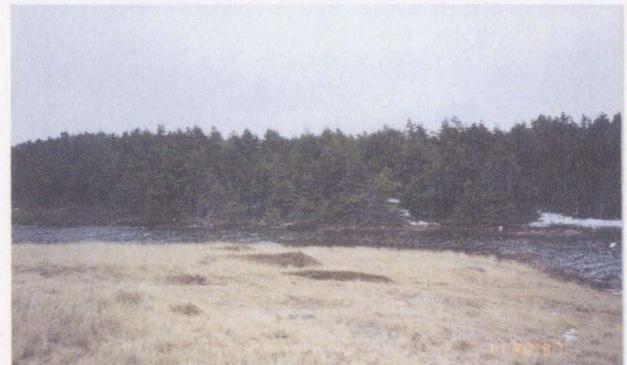
- Plate 6.3 a. Scarping, eastern Burnt Island. Note exposed tree roots and abrasion zone at the base. Researcher is 1.62 m in height.
- b. Scarping, eastern Burnt Island. Note exposed tree roots, abrasion zone at the base and subangular clast deposit below tree roots, adjacent to log.
- c. Well-rounded clast interspersed among angular clasts on platform.
- d. Well-rounded clast interspersed amongst vegetation.
- e. Shoreline armouring and access road, Burnt Island and adjacent beach.
- f. Elevated water level, southern Burnt Island. This is the only instance where flooding was observed.

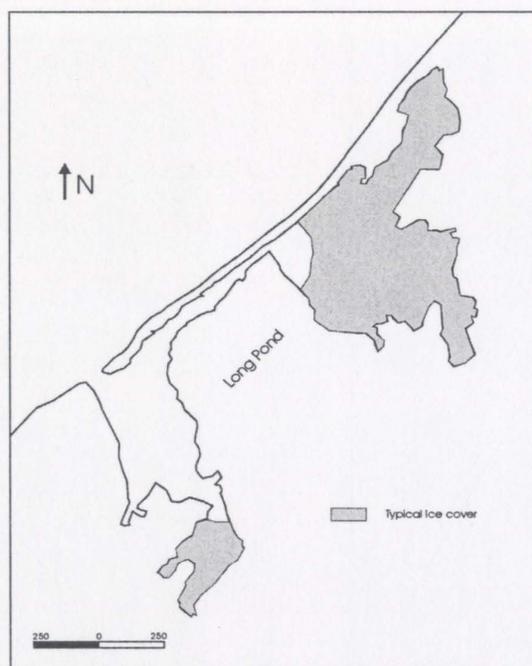
Figure 6.3. Typical winter ice cover at Long Pond, December - mid March.

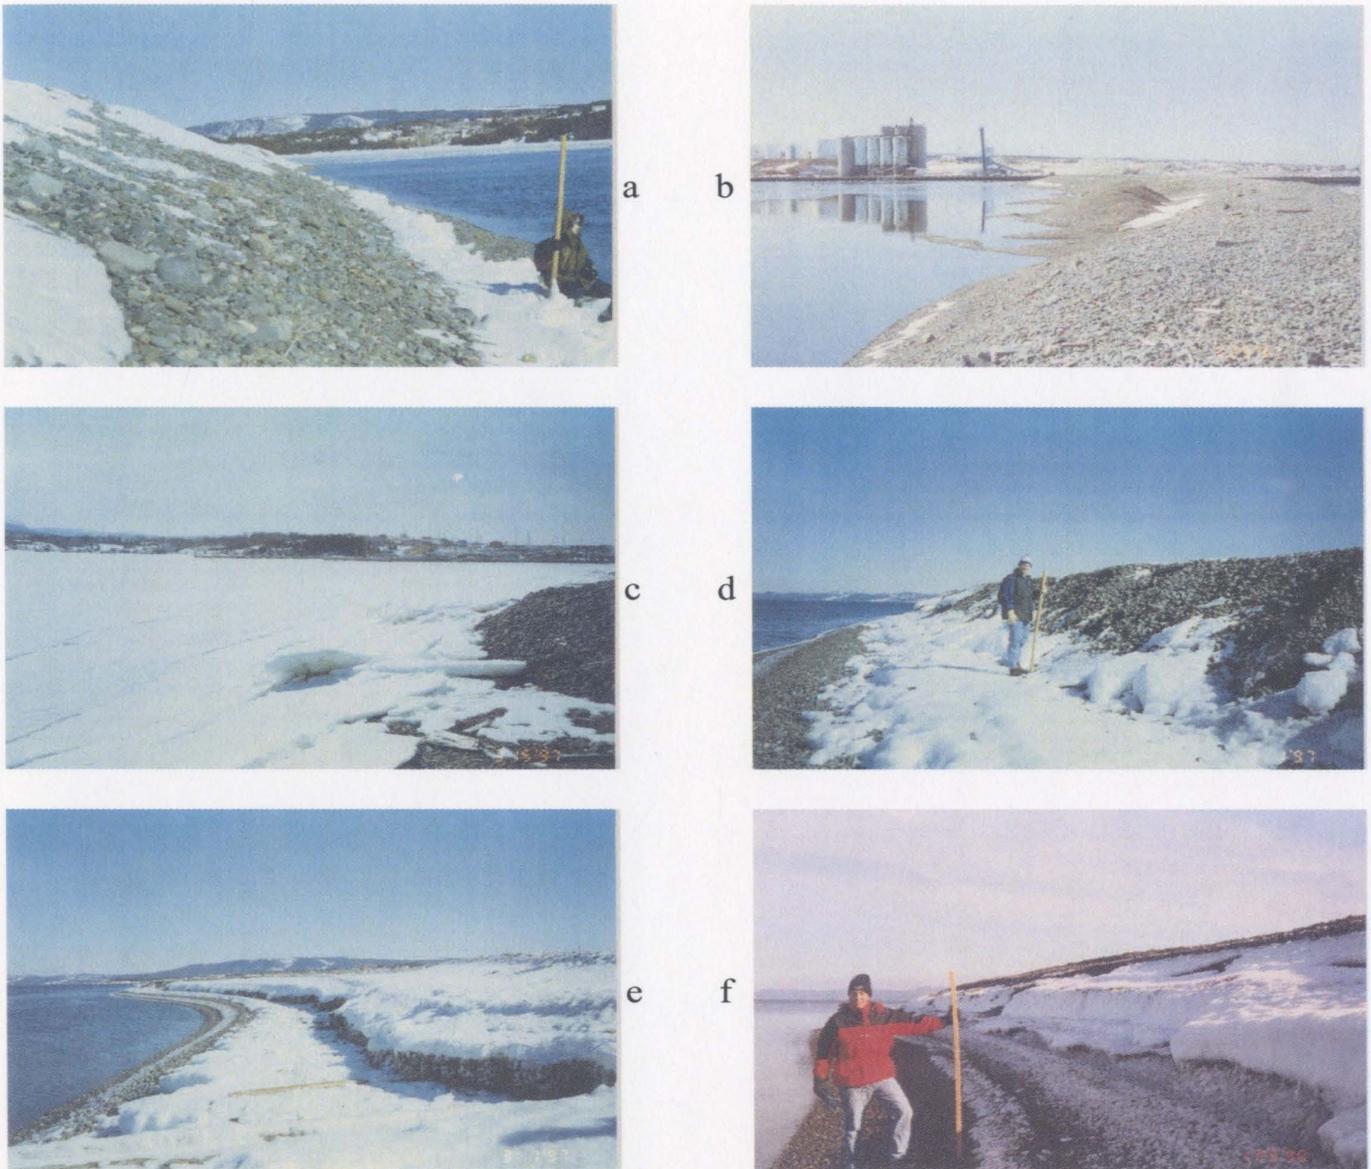
- Plate 6.4
- a. Icefoot development on the lagoonal apron (1997). Note the extent of ice cover in the northern basin at the top of the photo.
  - b. Lack of ice cover, southern basin (1997).
  - c. Pressure ridging in the northern basin (1997).
  - d. Icefoot development on the littoral apron(1997).
  - e. Interstitial ice and associated scarping (1997). Note the icefoot.
  - f. Interstitial ice and associated scarping (1998). Note the lack of icefoot.

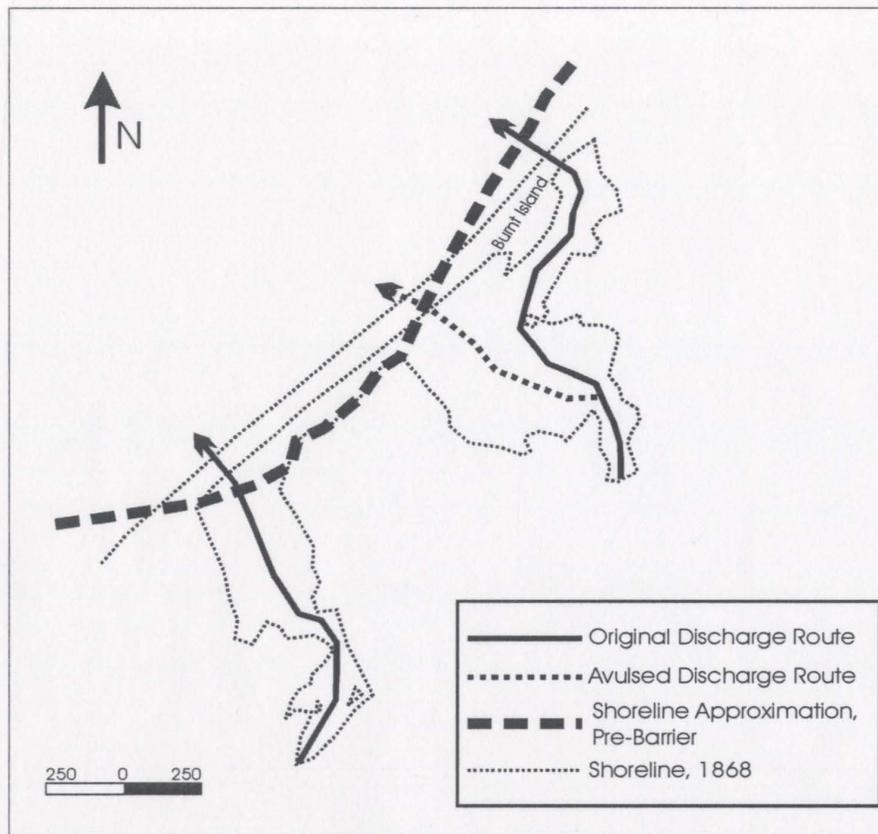
Figure 7.1. Discharge from what is now the northern basin was originally directed north of Burnt Island. The stream avulsed at some point, taking a more direct approach south of the island and separating the island from the mainland. Stream avulsion eroded a broad valley. Discharge from the southern basin was more consistent, eroding a long narrow valley.

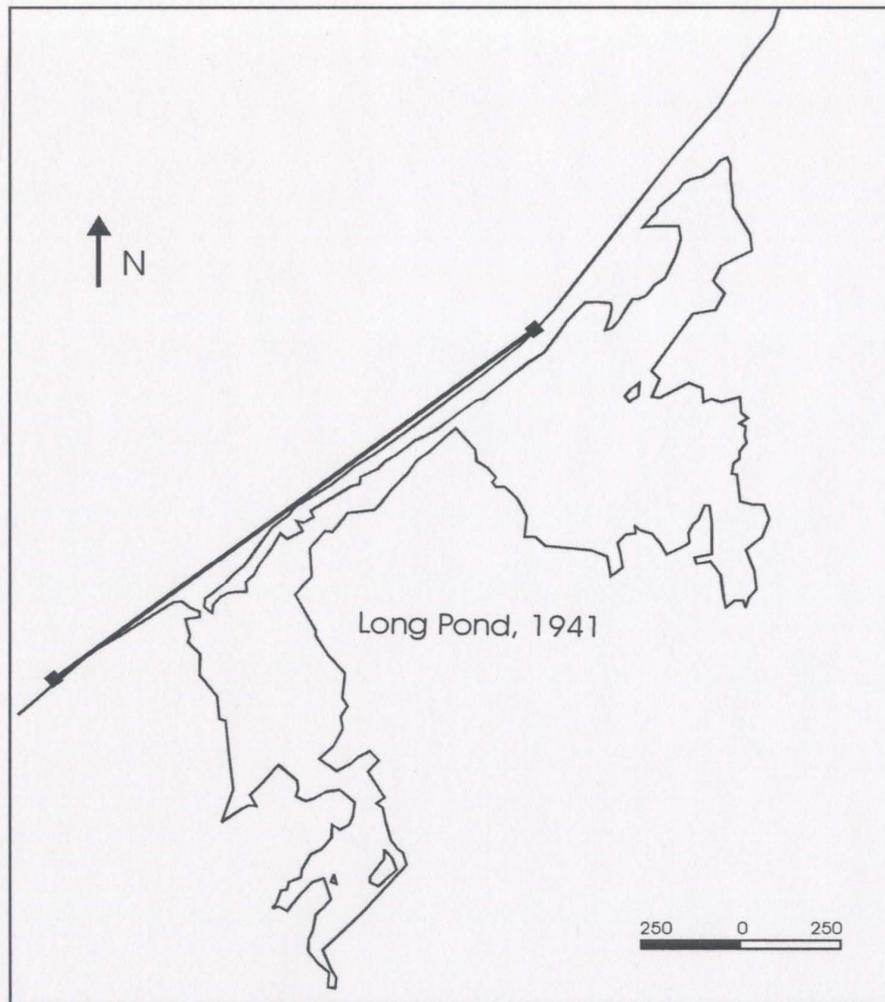
Figure 7.2. Hypothetical straight line between southern shoreline, inflection point, and stress point.

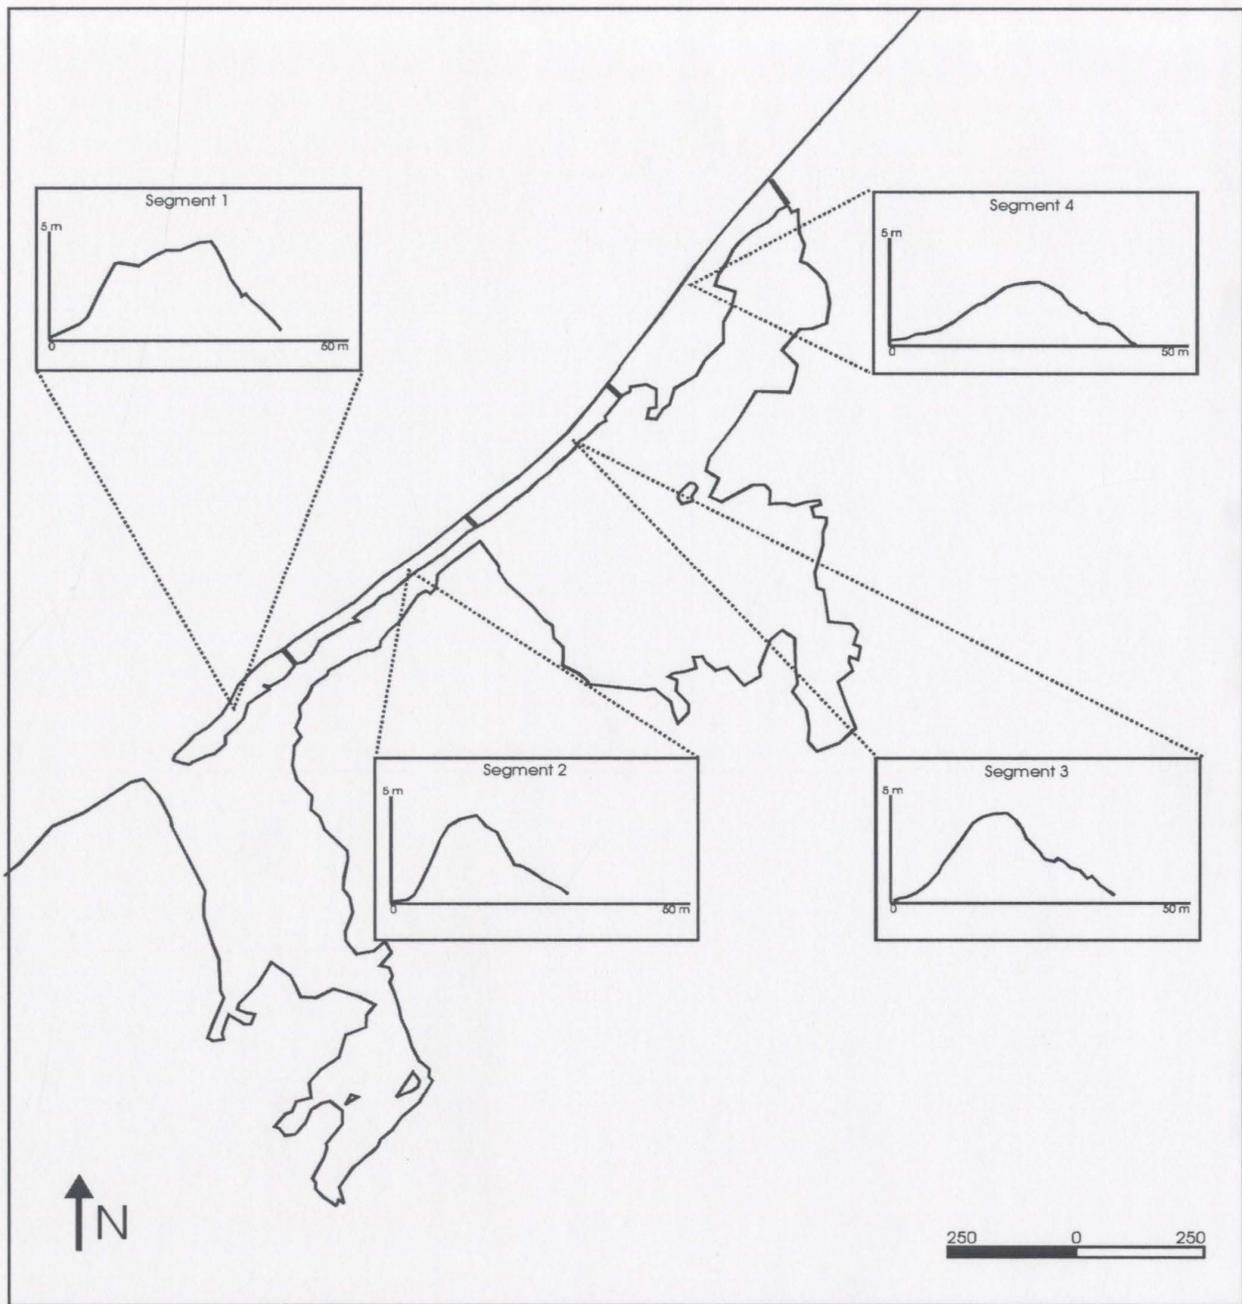
Figure 7.3. Beach segments at Long Pond, based on process and profile variations.

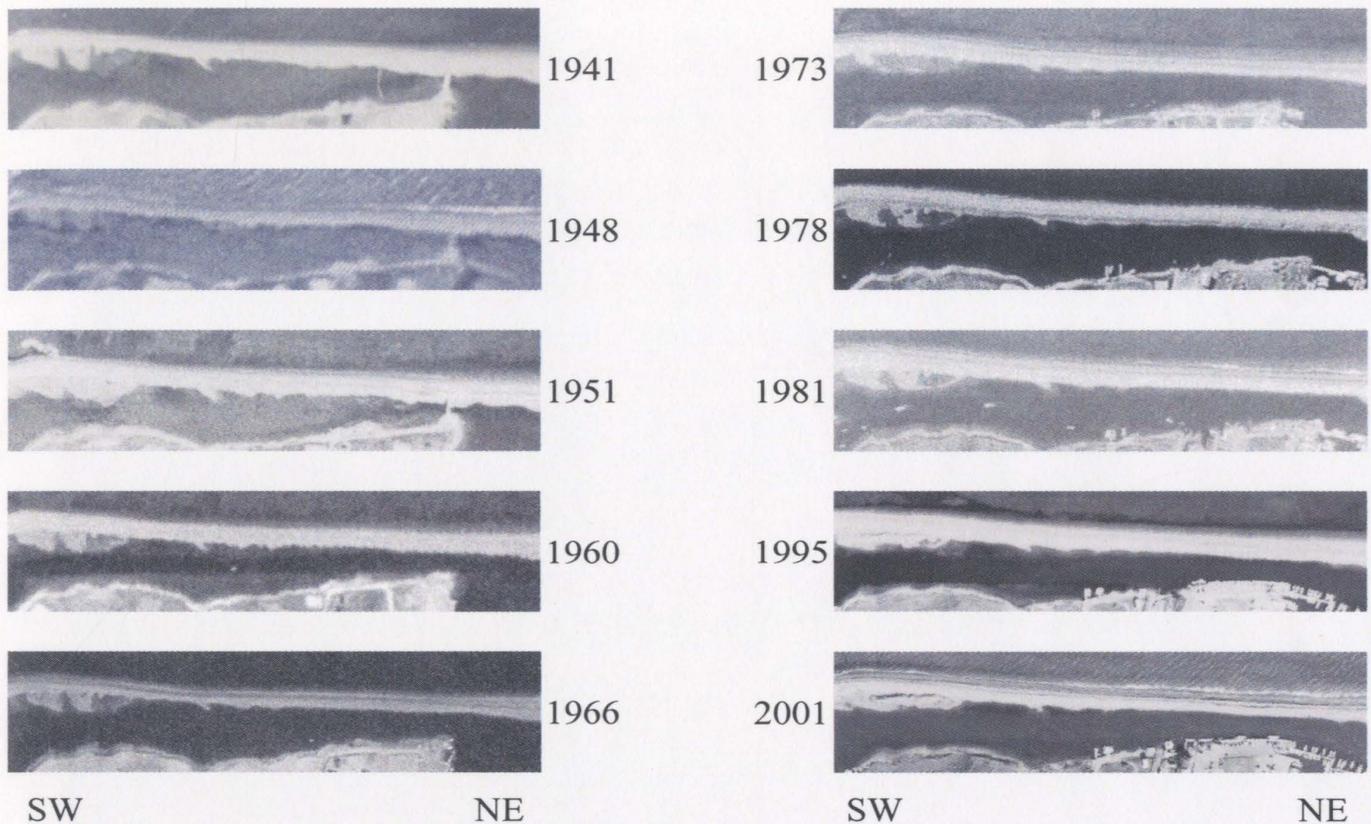
Plate 7.2. Time sequence of aerial photographs, Segment 2, 1941 - 2001 (Scale approximately 1:10,000). Note: (i) stability of mainland shoreline through entire sequence; (ii) barrier narrowing advancing NE; (iii) spit development on lagoon shore of inflection point (1941 - 1981) and dredge spoil body (1995 - 2001); (iv) removal of footbridge between 1951 and 1960 and subsequent evolution of marina facility; (v) localized channel narrowing due to spit development at footbridge, 1941 - 1951; (vi) channel dredging and removal of spit, 1960.

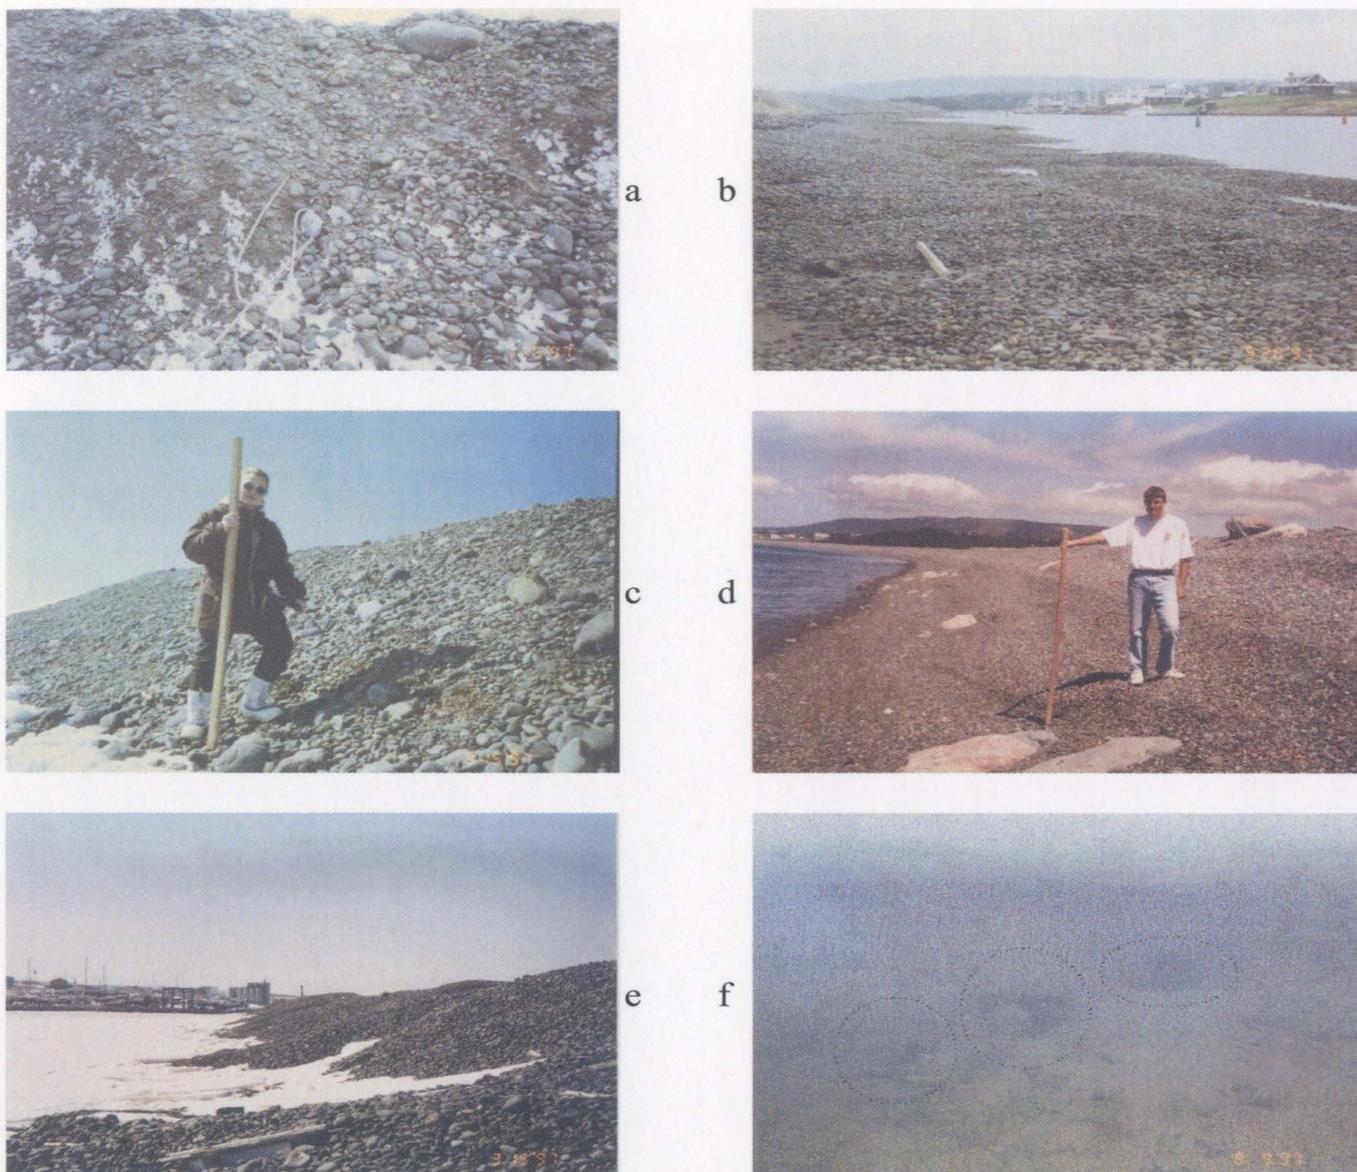
- Plate 7.3
- a. Breach fill diamict, Transect 7. Note silt and debris content.
  - b. Spit and swale structures adjacent to dredge spoil, Segment 2.
  - c. Back berm of breach site, Transect 6. Line of coarse clasts at field assistant's feet, silt lens at knee level.
  - d. Boulders on berm and littoral apron, south of Transect 8.
  - e. Overwash fans highlighted by lagoonal ice, Transect 11.
  - f. Seepage hollows, Burnt Island sub-basin (located within dotted lines).

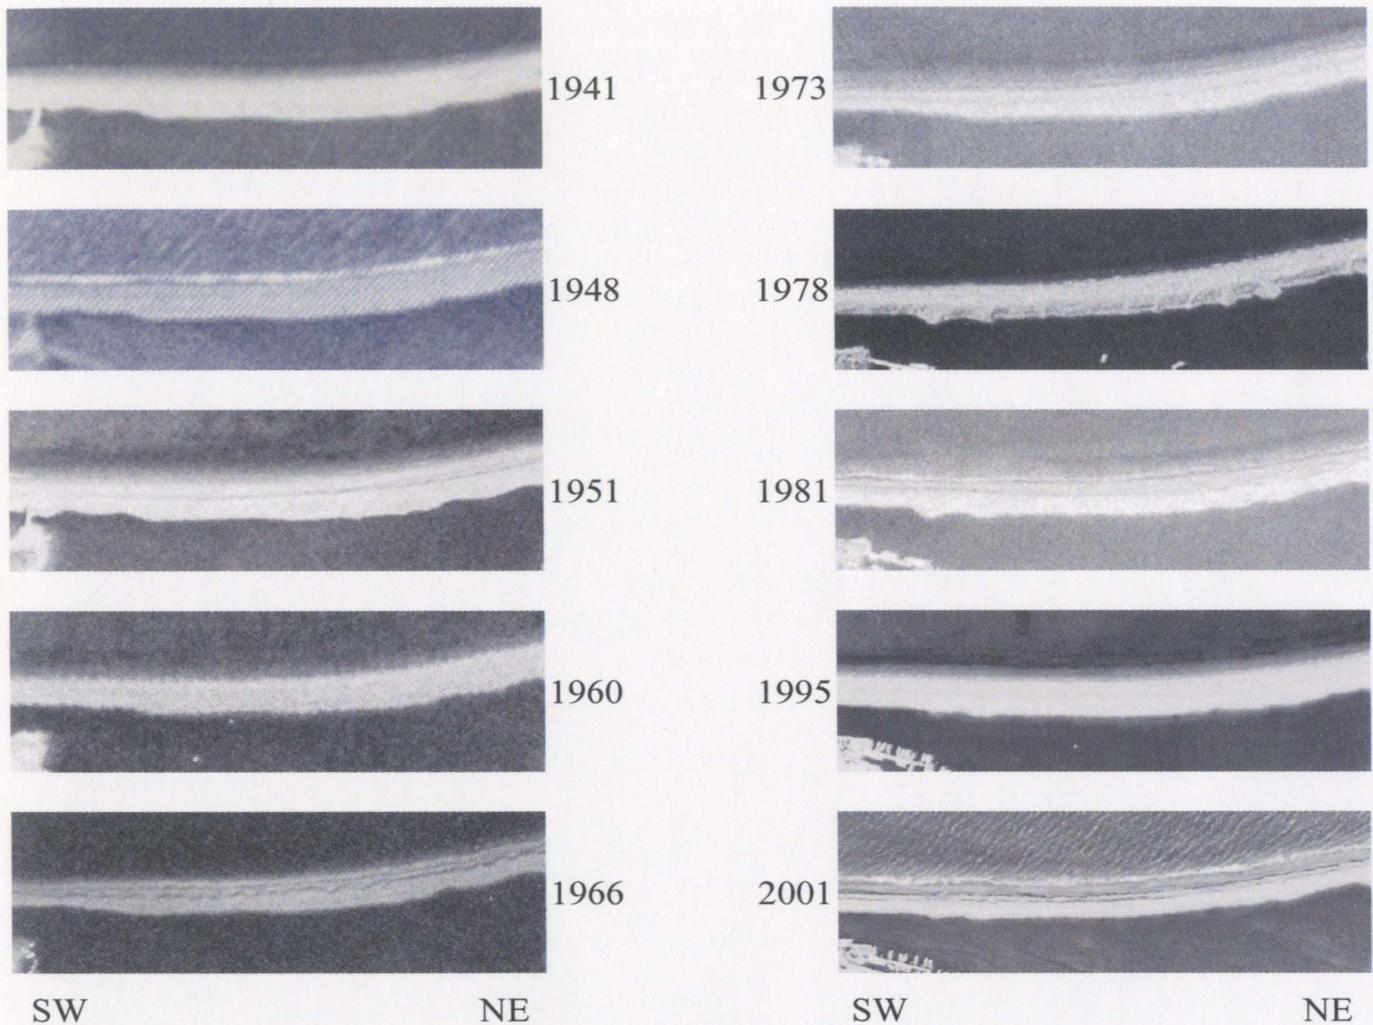
Plate 7.4. Time sequence of aerial photographs, Segment 3, 1941 - 2001 (Scale approximately 1:7500). Note: (i) transition between Segment 2 and 3 (barrier widens) migrating north; (ii) berm cusps, 1966 and 2001; (iii) fresh overwash fans visible only on 1978 photo; (iv) overwash fans aligned southeast, reflecting slightly north of normal incident extra local wave alignment; (v) overwash fans visible on 1941 photos but resolution insufficient to qualitatively assess age; (vi) backbarrier smoothing, particularly between 1978 and '81.

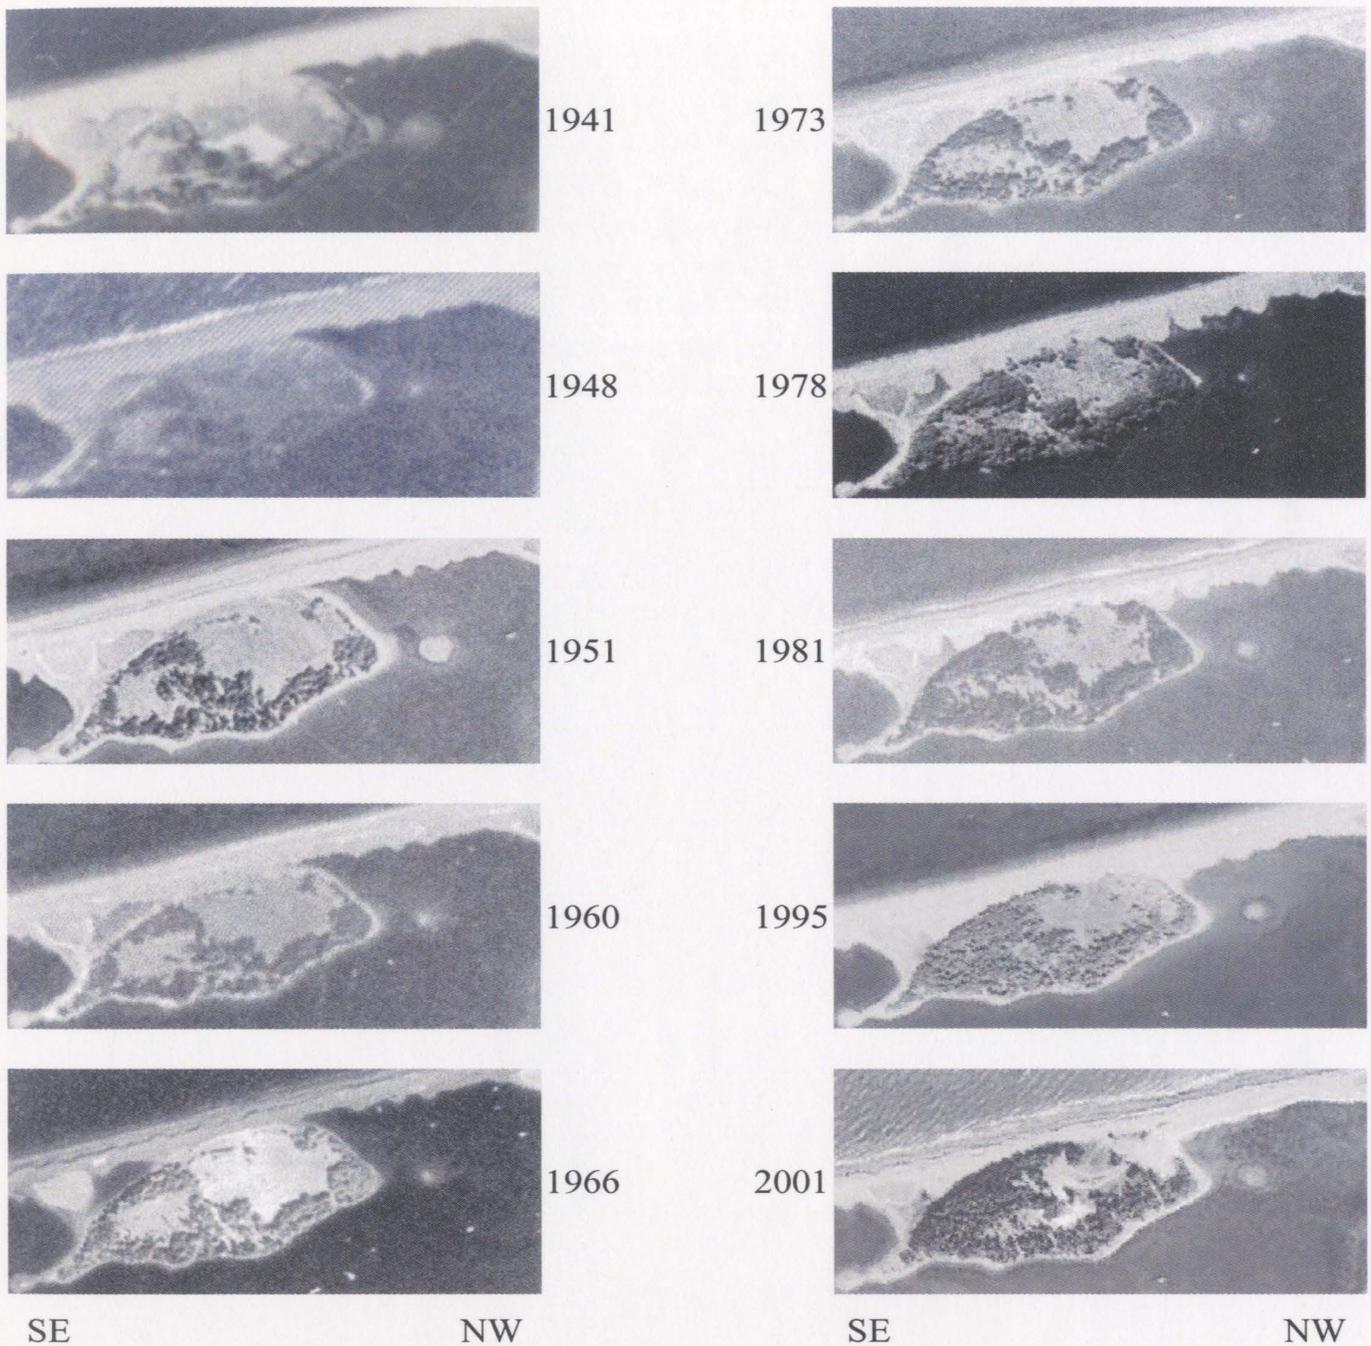
Plate 7.5. Time sequence of aerial photographs, Segment 4, 1941 - 2001 (Scale approximately 1:7000). Note: (i) beach narrowing at Burnt Island; (ii) beach narrowing at sub-basin 1941 - '73, widening by backbarrier retreat until 1995, and subsequent narrowing; (iii) possible overwash between 1948 and '51; (iv) massive overwash between 1973 and '78; (v) backbarrier smoothing; (vi) island narrowing, 1966 - 1973; (vii) access road, backbarrier armoring and residential development, 2001.

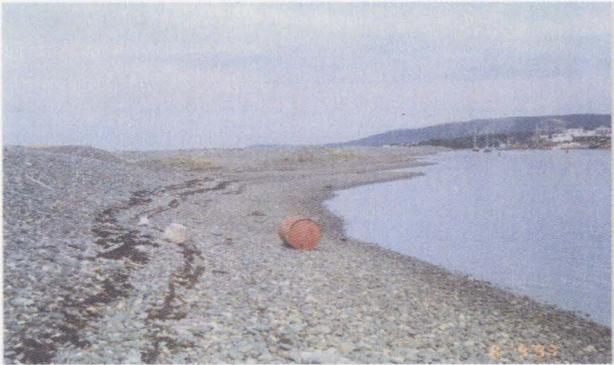
c

- Plate 8.1
- a. Probable site of 1910 channel excavation, located between Transects 9 and 10. Silt content is noticeably higher than in the adjacent berm. A berm cusp has developed nearby.
  - b. Remains of an old fishing flake, south of Transect 12.
  - c. Industrial litter on the lagoonal apron, tidal channel.
  - d. Backberm destabilisation by ATV, Segment 2.
  - e. Seawall-protected property and adjacent pier, northern basin.
  - f. Riprap-protected property with small sailboat, northern basin.
  - g. Residential litter on the lagoonal apron, Transect 3.
  - h. "No Wake" permitted by marina traffic in tidal channel, Segment 1.
