ANALYSIS OF COASTAL GEOMORPHOLOGICAL  
PROCESSES ON A BOREAL COARSE CLASTIC BARRIER:  
LONG POND BARACHOIS, CONCEPTION BAY, NEWFOUNDLAND

A thesis submitted to the School of Graduate Studies  
in partial fulfilment of the requirements  
for the degree of Master of Science

Department of Geography  
Memorial University of Newfoundland

2004

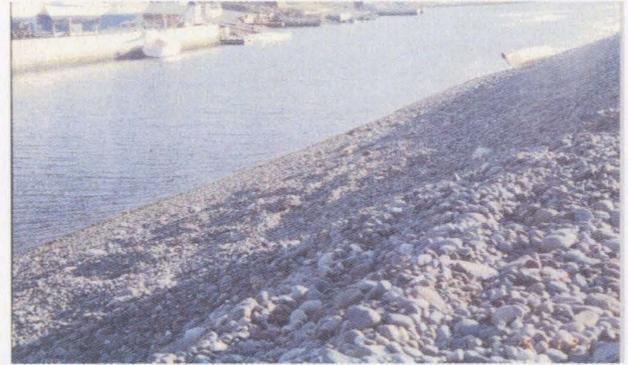
d

- Plate 8.1
- a. Probable site of 1910 channel excavation, located between Transects 9 and 10. Silt content is noticeably higher than in the adjacent berm. A berm cusp has developed nearby.
  - b. Remains of an old fishing flake, south of Transect 12.
  - c. Industrial litter on the lagoonal apron, tidal channel.
  - d. Backberm destabilisation by ATV, Segment 2.
  - e. Seawall-protected property and adjacent pier, northern basin.
  - f. Riprap-protected property with small sailboat, northern basin.
  - g. Residential litter on the lagoonal apron, Transect 3.
  - h. "No Wake" permitted by marina traffic in tidal channel, Segment 1.

The port facility hosted considerable ship traffic (cf. Plate 1.6 e). There have been a number of small oil spills in the Long Pond basin (Taylor, 1994) and litter discharge is a concern (cf. Plate 8.1 c) in terms of environmental degradation. Given the prolonged stability of the tracer groups at Transects 6, 8, and 9 during heavy traffic periods (Table 6.1), ship wakes had little impact on shoreline morphology.

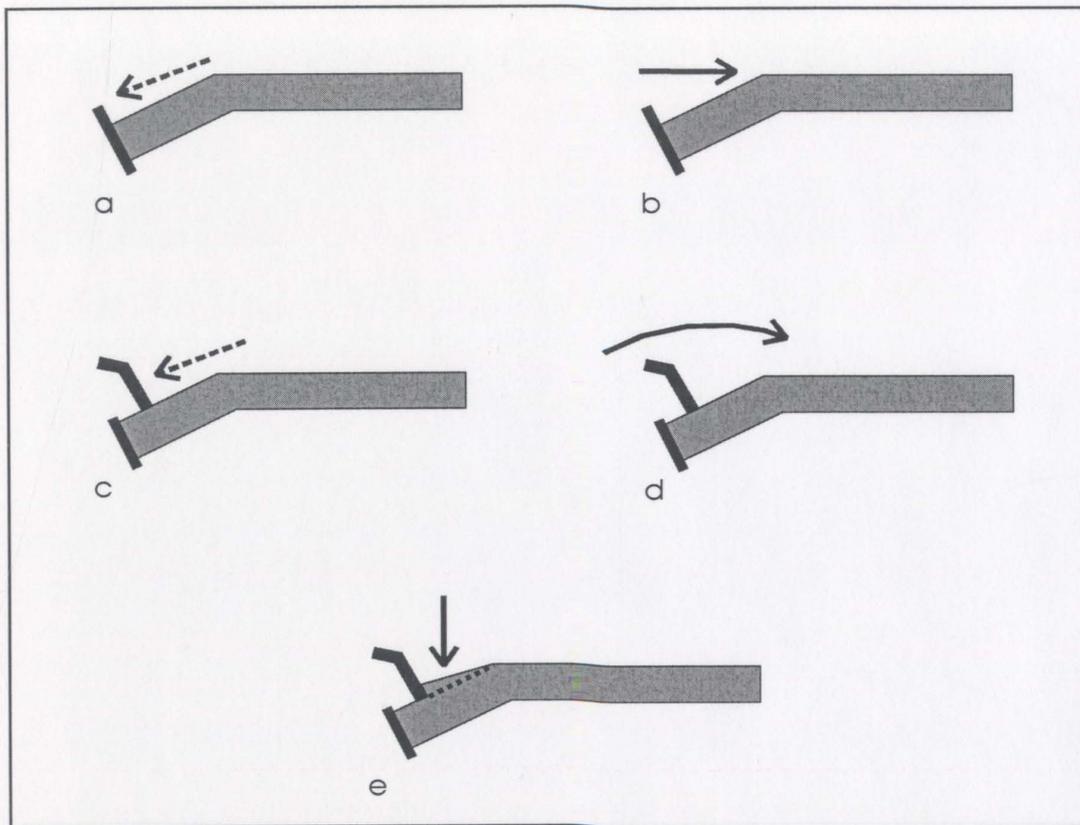
Figure 8.1. Schematic diagram of progradation at Segment 1. Prior to 1974, current reversals transported sediment south to the inlet (a), and longshore currents redistributed sediments north along the barrier (b), resulting in no net gain. After the breakwater was established, sediment transported by current reversals was trapped by the breakwater (c). The breakwater deflected longshore currents offshore (d) and sediment remained in the nearshore until swash transported sediment onshore, resulting in net progradation between the breakwater and inflection point (e).

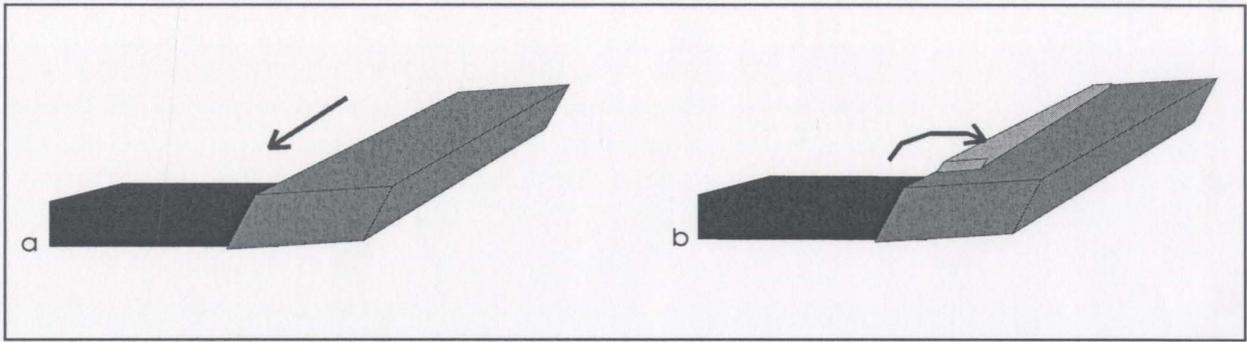
Figure 8.2. Schematic diagram of vertical construction at Segment 1. Incident waves meet the perpendicular juncture of the barachois and the breakwater (a). Wave momentum is expended against the juncture, locally raising the sea level and the base upon which subsequent waves operate, increasing swash excursion height and overtopping potential (b), manifesting a higher elevation (or step) at the crest lip.

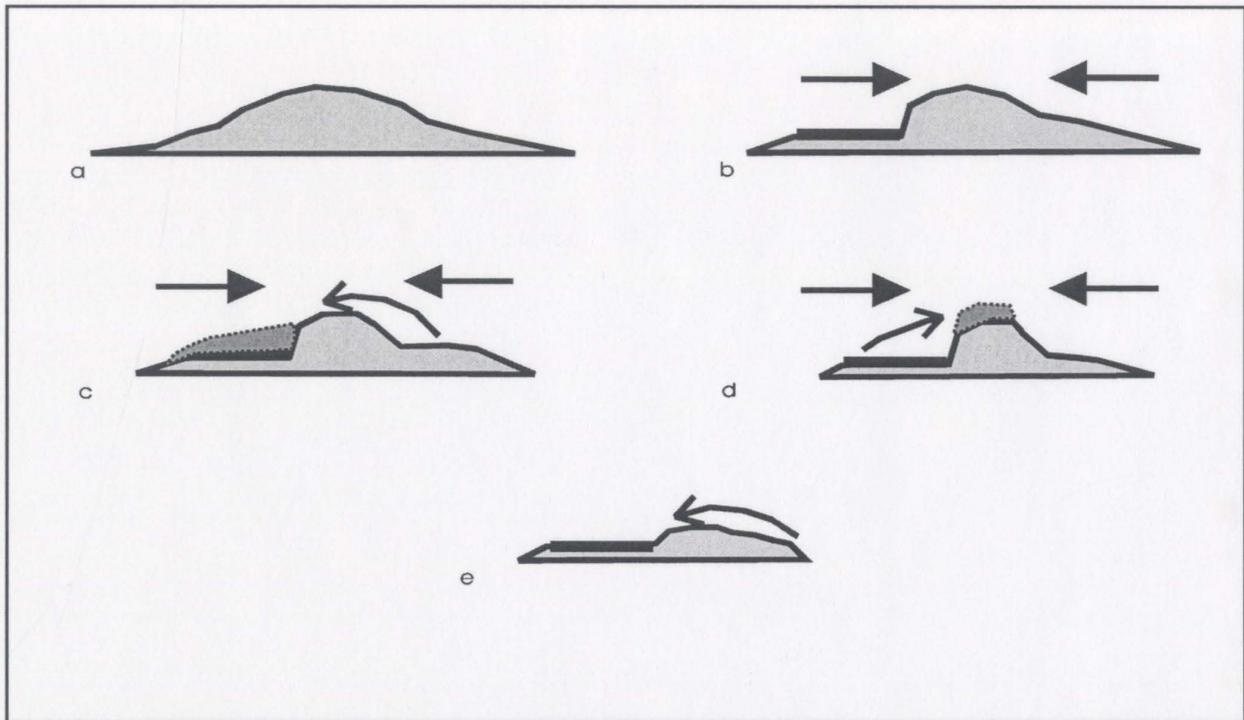
Figure 8.3. Schematic diagram of the impact of road construction. Prior to road construction, the barrier was low but wide (a). Road construction narrowed the berm and flattened and compacted the back-barrier while RSLR drives an erosional front that narrows the berm and littoral apron and raises the lagoon level (b). Berm and barrier narrowing facilitate massive overwash which extends to the road and beyond (c). The road is cleared, reducing potential accommodation space. Overwashed gravel is transferred to the narrowed berm with the aim of protecting the road from another overwash event, oversteepening the berm (d) and rendering the barrier prone to a rapid adjustment. Road maintenance and shoreline erosion will eventually eliminate accommodation space and a berm will not be tenable (e). In the absence of hard protection, overwash occurs regularly until the road is abandoned or the barrier breaks down.

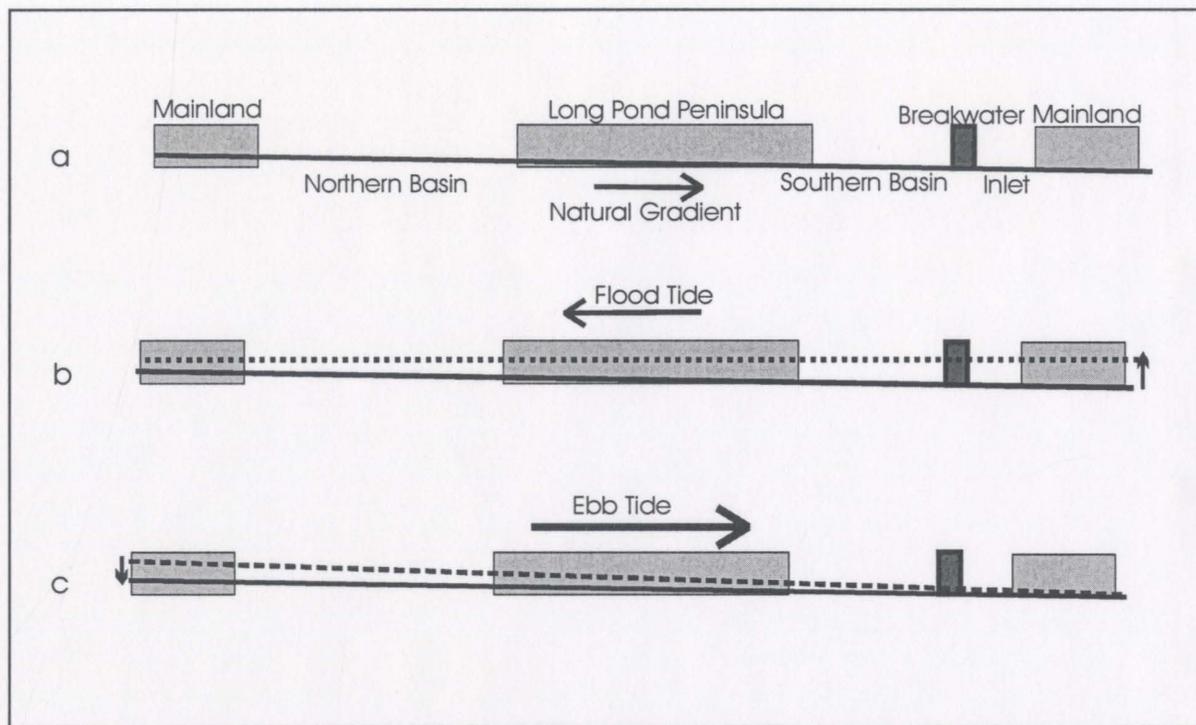
Figure 9.1. Schematic diagram illustrating changes in hydraulic gradient. The ambient hydraulic gradient (solid line) at Long Pond is oriented north-to-south, draining the basin (a). During flood tide, the hydraulic gradient is oriented south-to-north (dotted line), generating south-to-north flow. The ambient gradient is oriented against the flood gradient, decreasing the gradient height and weakening flood tidal currents (b). The ebb tidal hydraulic gradient is aligned north-to-south (dashed line), generating north-to-south flow. The ambient gradient is aligned with the ebb gradient, increasing gradient height and strengthening ebb tidal currents. Currents persisted until an equilibrium water level was achieved.

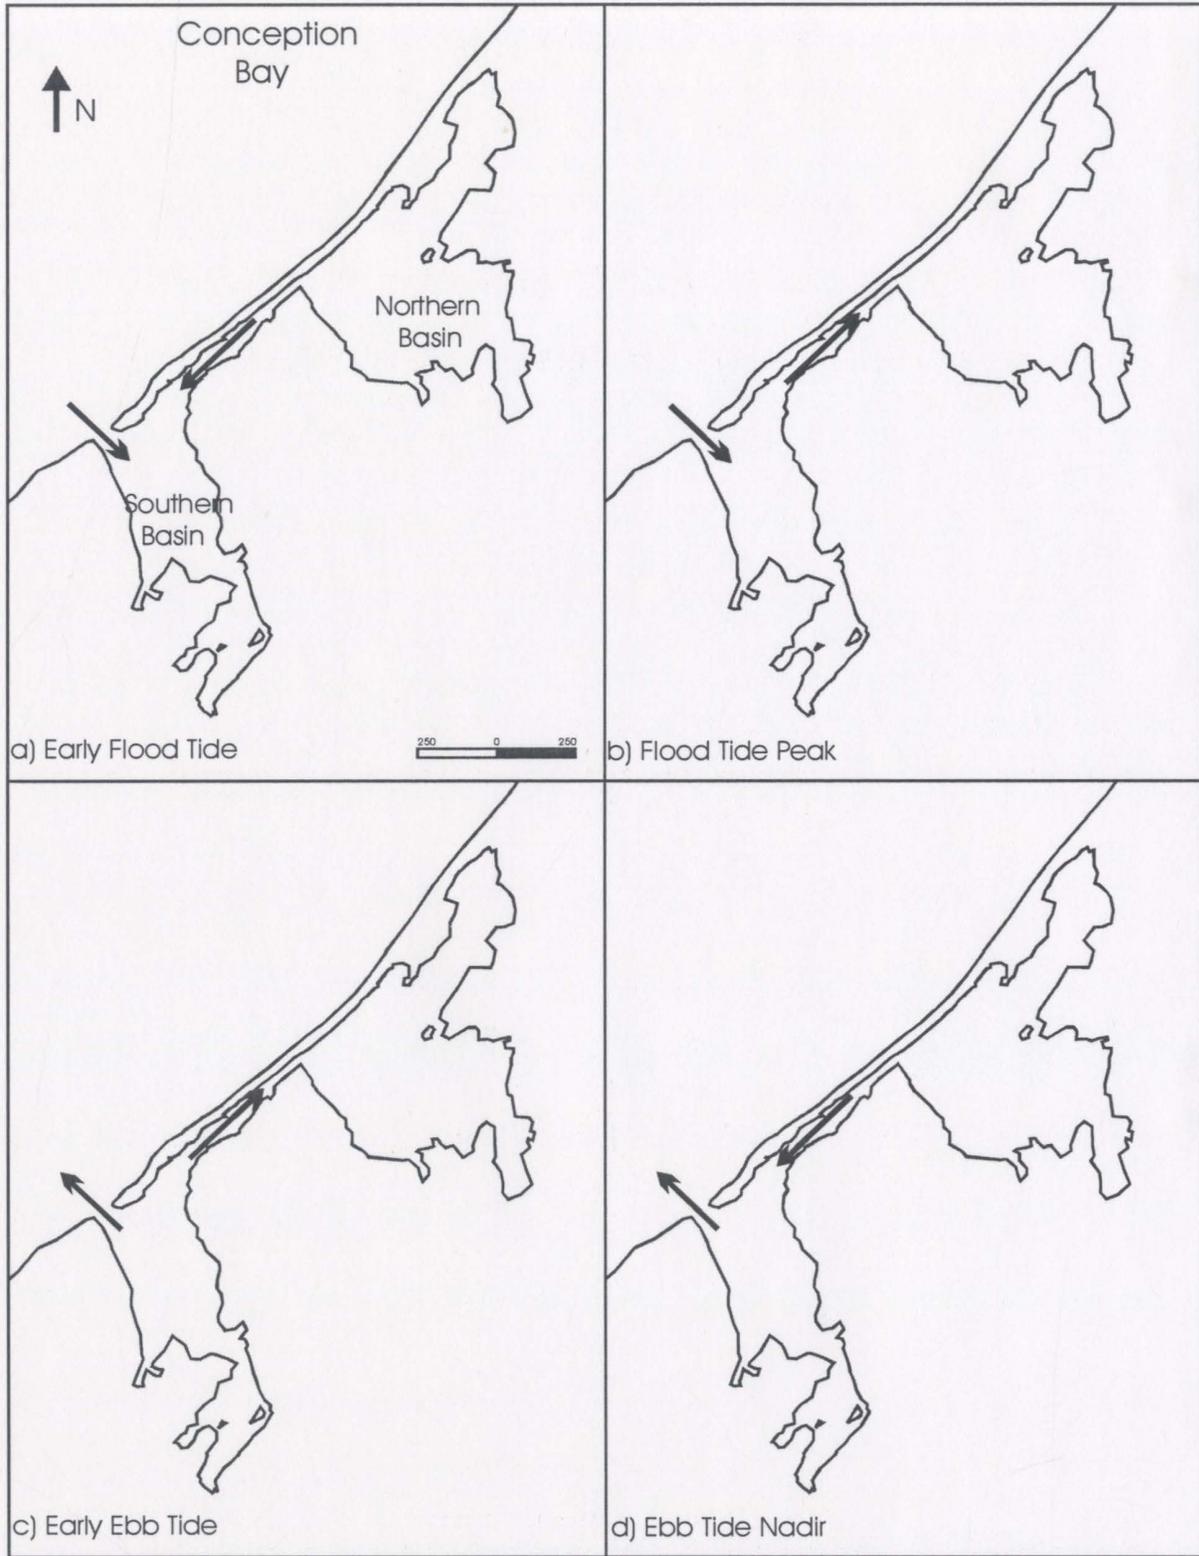
Figure 9.2. Tidal currents in Long Pond are driven by reversals of the hydraulic gradient associated with the semidiurnal tide regime in Conception Bay. Tidal flow is complicated: i) flow constriction through the inlet and channel limit flooding/ebbing rates, ii) the inlet possesses a greater tidal prism than the channel, creating an asymmetry in flow capacity and the temporal lag, iii) the asymmetry of basin volumes, iv) the natural north-to-south flow pattern, and v) water level fluctuations associated with the lunar cycles and meteorological conditions. The net result is a non-linear relationship between the tidal range, which decreases from bay to southern to northern basins, and the duration and strength of tidal currents over the lunar cycle. In early stages of flood tide (a), a rise in Conception Bay tide initiates flooding into the southern, which remains below the northern level for a time and ebb currents persist in the channel. As the flood tide progresses (b), the southern basin is elevated above the northern basin, reversing the channel current. As the tide begins to ebb (c), the southern basin drains into Conception Bay but remains elevated above the northern basin for a time, and flood currents persist. As the ebb tide progresses (d), the water level in the southern basin falls below the northern basin and the channel current reverses.

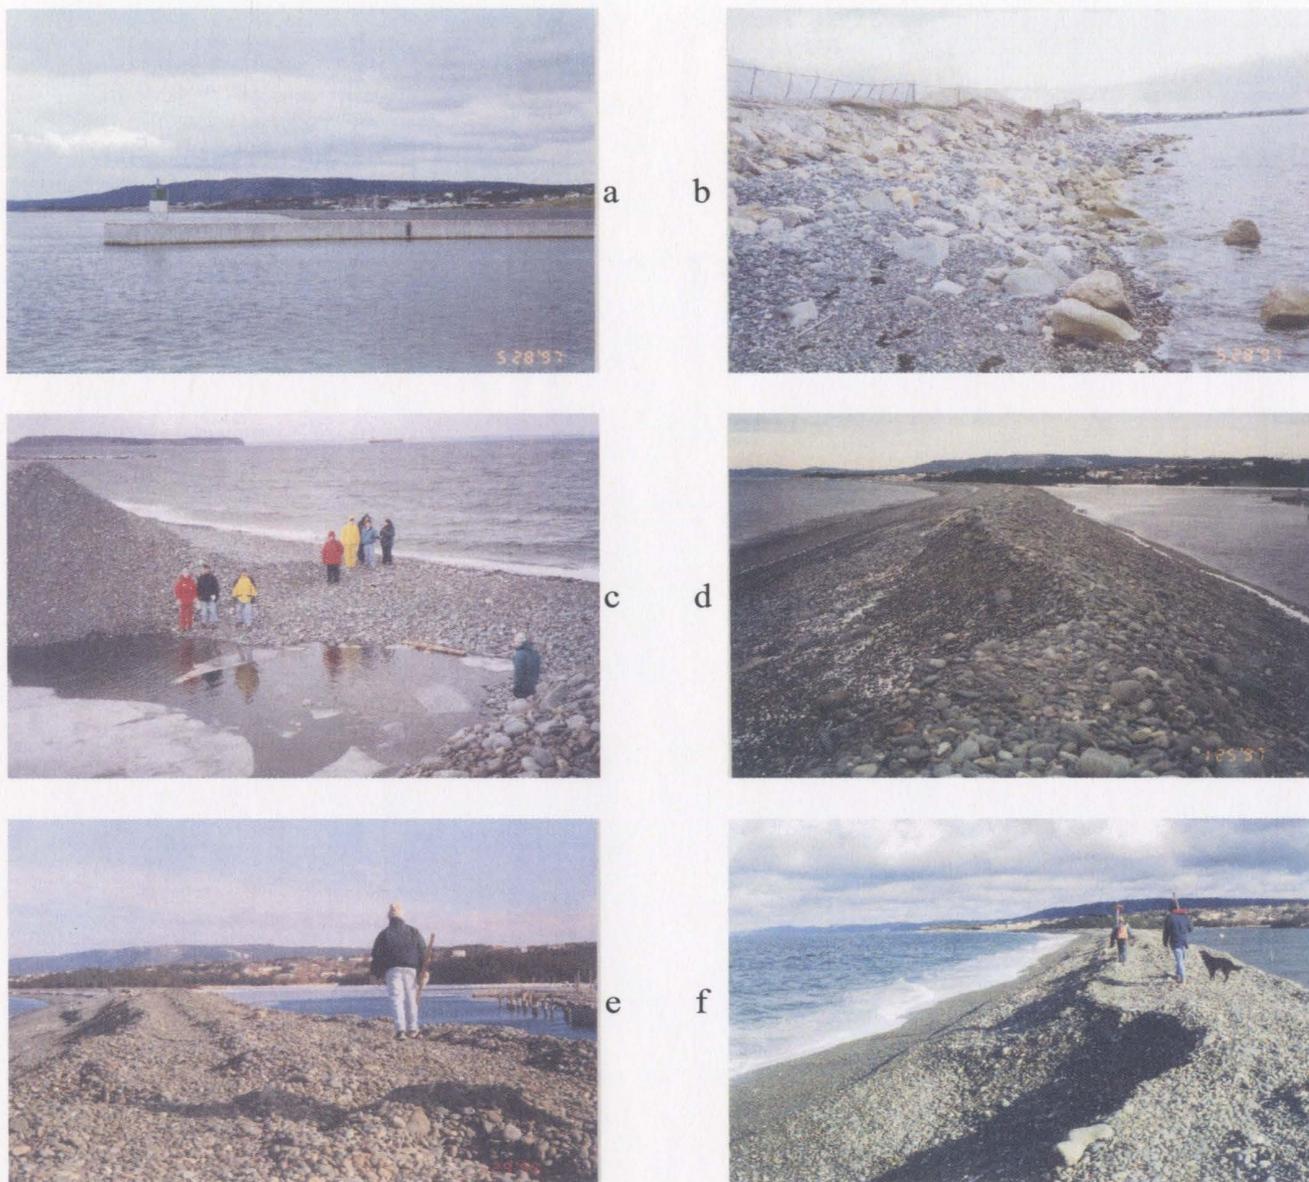
- Plate 10.1
- a. Barrier configuration looking north from southern breakwater.
  - b. Shoreline armoring, lack of accommodation space, and low sediment flux, looking south from southern breakwater.
  - c. Excavated channel, Chamberlains Beach. Note the steep barrier slopes on either side.
  - d. Arcuate scarping at Transect 7, pre-reinforcement.
  - e. Reinforced berm at Transect 7.
  - f. Arcuate scarping at Transect 7, post reinforcement.

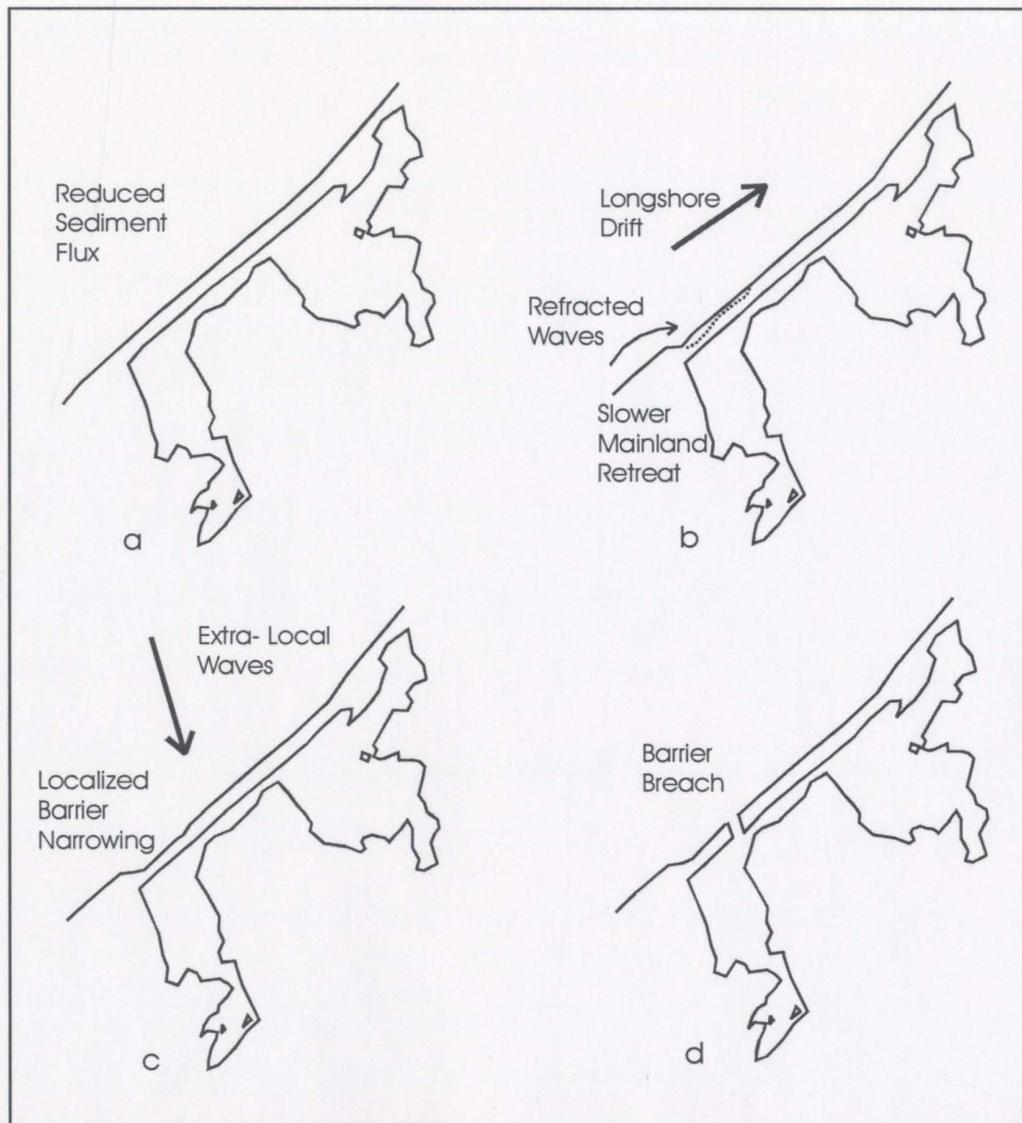
Figure 10.1. Updrift sediment flux reduction (a) induced a greater rate of barrier narrowing than adjacent bluff erosion (b). The disequilibrium refracted longshore waves which eroded and oversteepened the adjacent barrier (c). Extra-local waves breached the narrowed barrier (d).

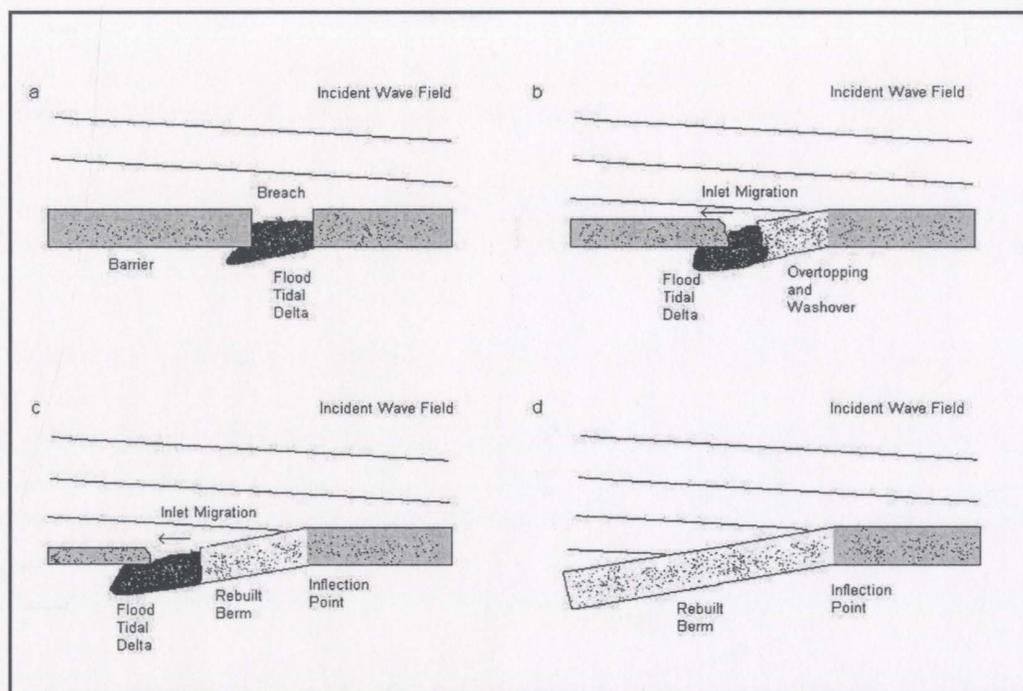
Figure 10.2. Schematic diagram of updrift tidal inlet migration. The storm surge deposits a flood tidal delta through the breached barrier (a). The delta provides a structural basement, attracting overtopping and overwashing by extra-local waves which shifts the barrier further inland while the updrift barrier segment is cannibalized and destabilized by incident waves, rendering it prone to further erosion (b). Extra-local waves erode the updrift barrier and deposit successive tidal deltas, each shifting the barrier further inland (c). The inlet eventually stabilizes and the berm is rebuilt by overtopping and overwashing but the alongshore orientation has been changed, generating an inflection point (d).

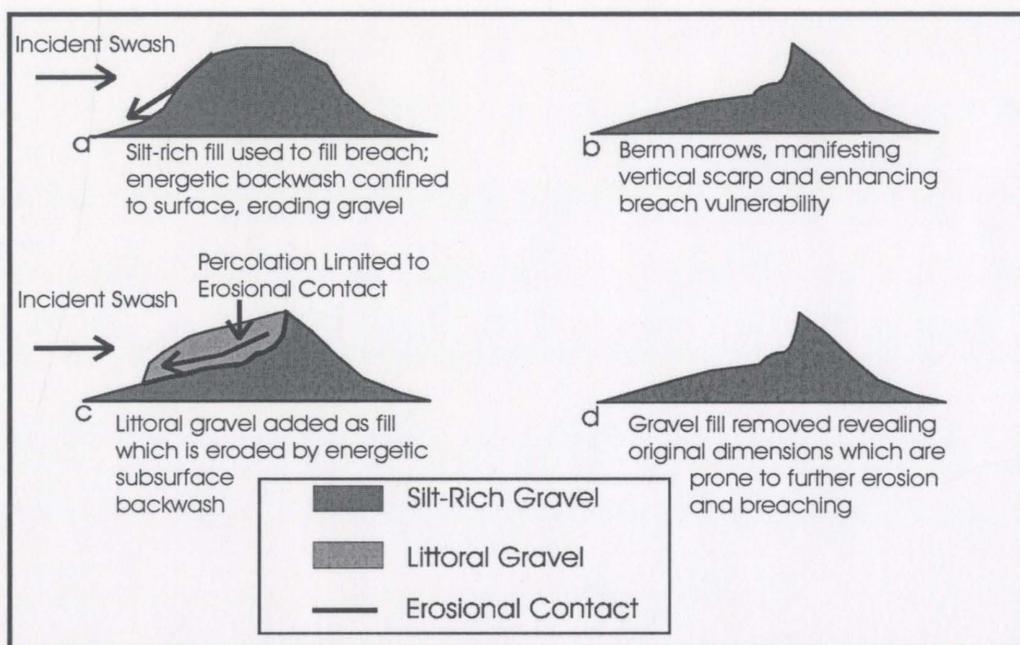
Figure 10.3. Schematic diagram of erosional problems associated with silt rich dredge spoil. Silt-rich dredge spoil was used to rebuild the barrier (a) and proved very prone to erosion, narrowing the berm and posing a breach risk (b). Gravel was borrowed from the adjacent beach to reinforce the berm but was not incorporated into the berm structure. Instead it rested on an erosional contact. Swash percolated through the littoral gravels but again could not penetrate the impermeable silt-rich berm, eroding the loose littoral gravel until the berm was again vulnerable to breaching.

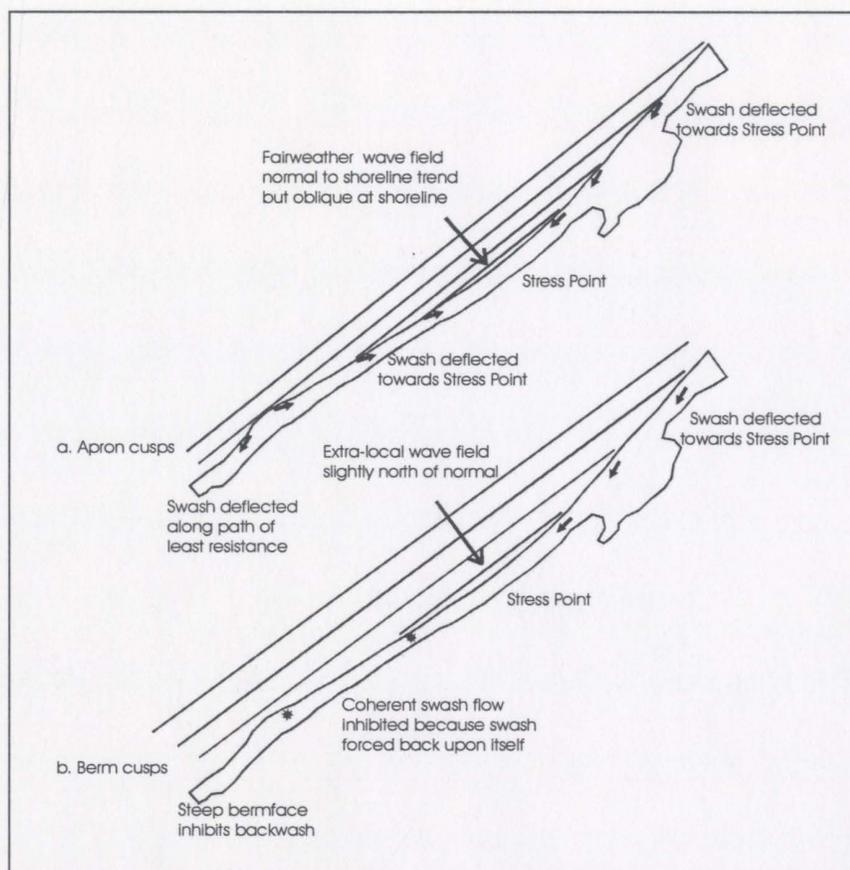
Figure 11.2 a. Fairweather waves are aligned normal to the average shoreline trend. Swash is deflected along the path of least resistance, generating opposing apron cusp skews on either side of the stress point.

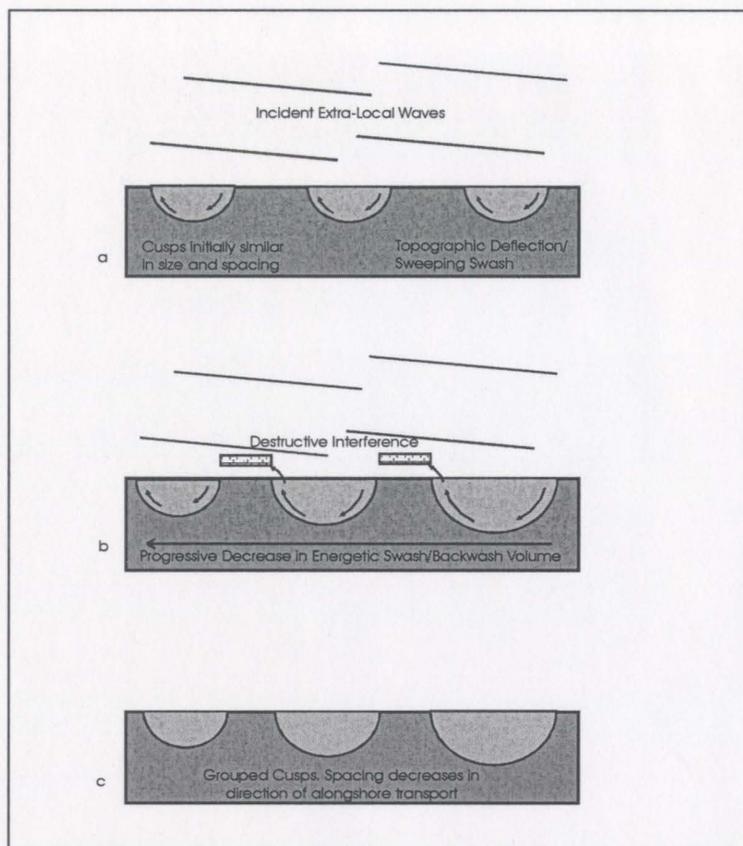
Figure 11.3. Schematic diagram of cusp grouping. Slightly oblique incident swash is topographically deflected, initially generating similar cusps (a). Backwash from the northern cusp destructively interferes with adjacent cusp circulation, reducing incident energy and cusp growth (b). This occurs progressively until incident swash energy is depleted, facilitating deposition at the southern end of the cusp group. The net result is a discrete cusp group with spacing that decreases from north to south.

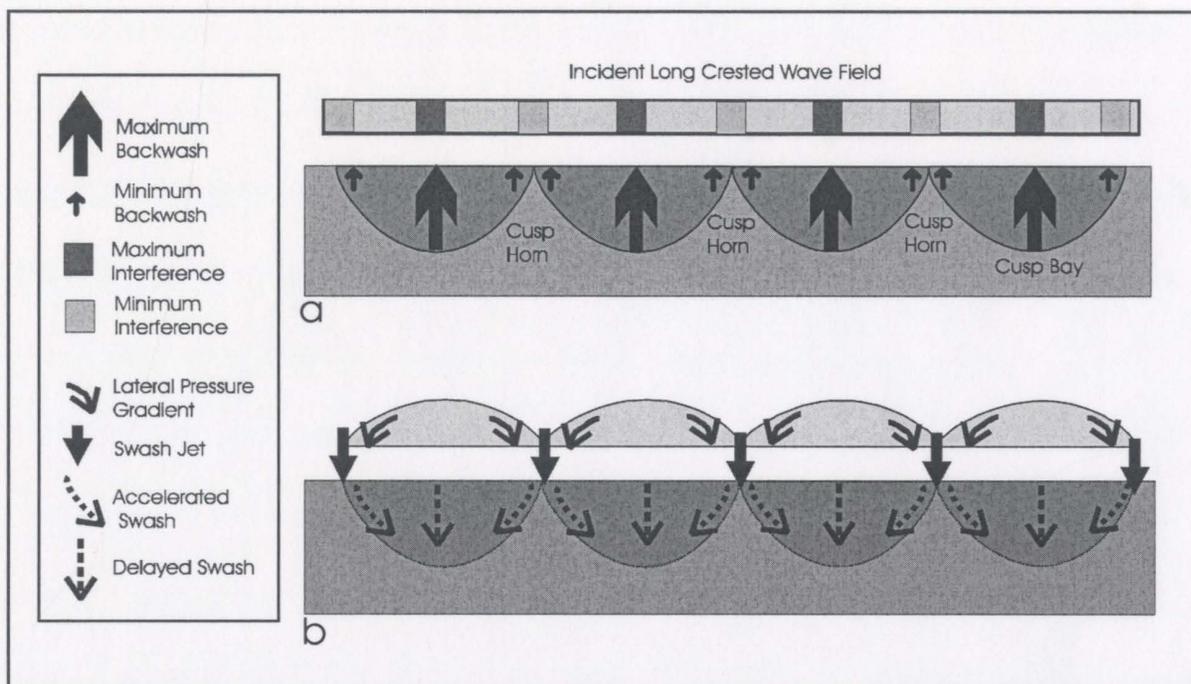
Figure 11.5. Schematic diagram of swash jet generation. Differential backwash volumes generate differential interference with incident waves when the cusp cell circulation period is approximately in phase with the wave period (a). This stimulates lateral pressure gradients which accelerate flow towards the interference minima (b). The interference minima direct converging flows cross-shore as swash jets, centred on the horns. Swash in the bay is sluggish and lags behind the jets, facilitating an energetic backwash that induces cusp bay erosion.

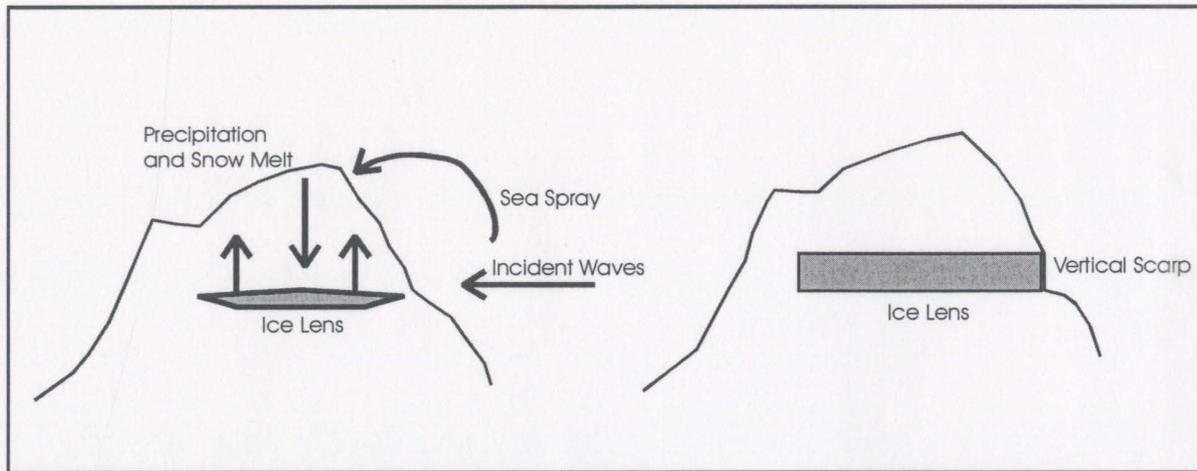
Figure 12.1. Schematic diagram of interstitial ice development. An ice lens forms when the interior barrier cools to the point where clasts act as nuclei for ice development. Precipitation, snow melt and possibly sea spray percolate to the lens, which grows vertically, forming an impermeable three-dimensional structure that locks gravels in place. Incident waves thermoerode the side of the lens, producing a vertical scarp that persists until the ice melts.

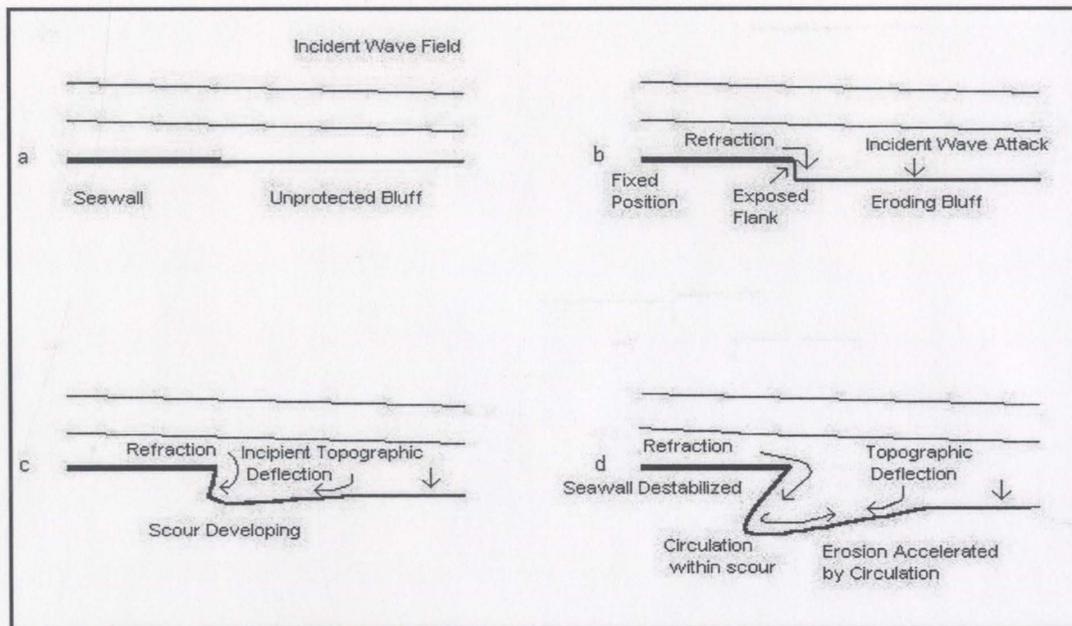
Figure 13.1. Schematic diagram of flanking scour. While the seawall protected the property, adjacent bluffs continued to erode (a) manifesting a scarp oriented approximately normal to the seawall (b). The scarp was exposed to energetic extra-local waves and preferentially attracted swash (c) which accelerated erosion. This further focussed swash and established a circulation pattern (d), generating flanking scour.

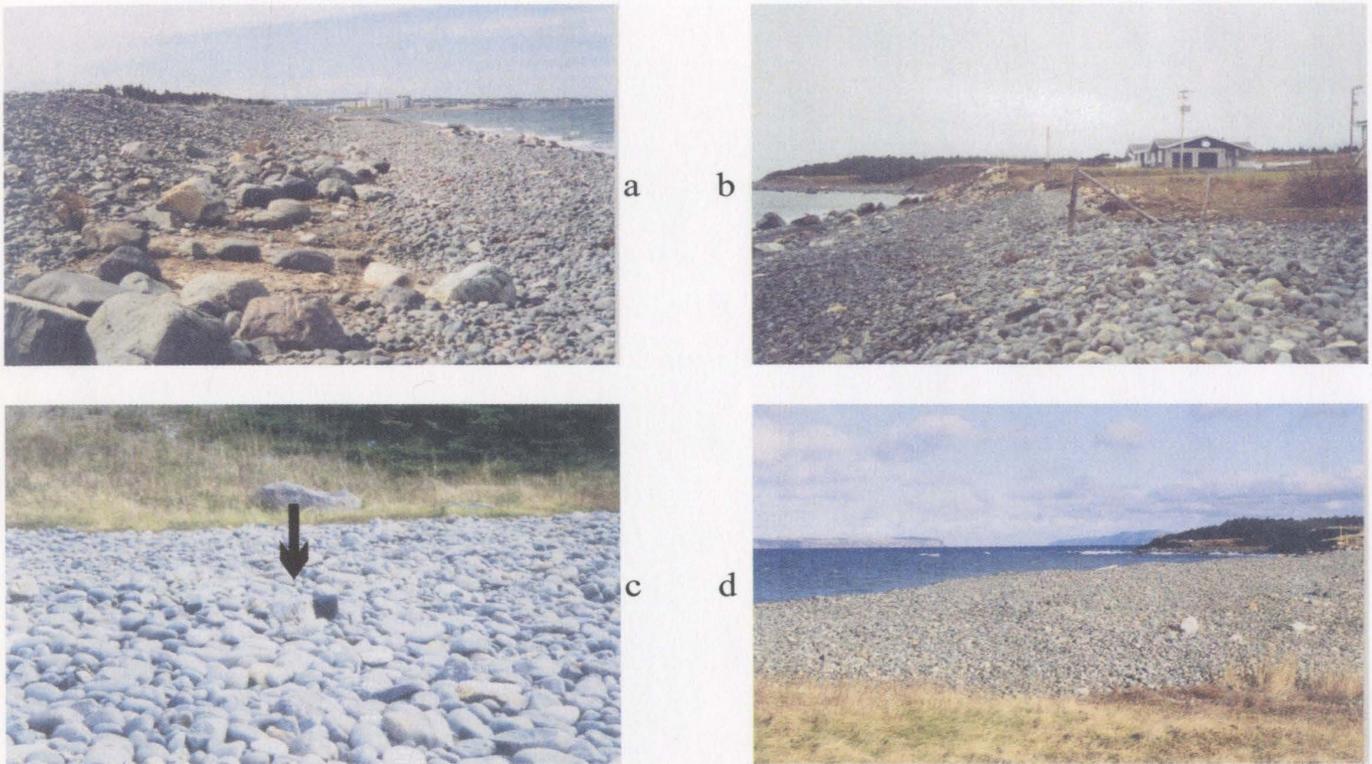
- Plate 13.1
- a. Exposed glaciofluvial deposit. Coarse boulders are probably lag deposits as crest retreats.
  - b. Gravel transported past fence post, north of Long Pond. Bluffs are visible in the background.
  - c. Tree stump (denoted by arrow), Burnt Island.
  - d. Crest elevation consistent with elevation of glaciofluvial structure, north of Long Pond. Bluffs are visible in the background.

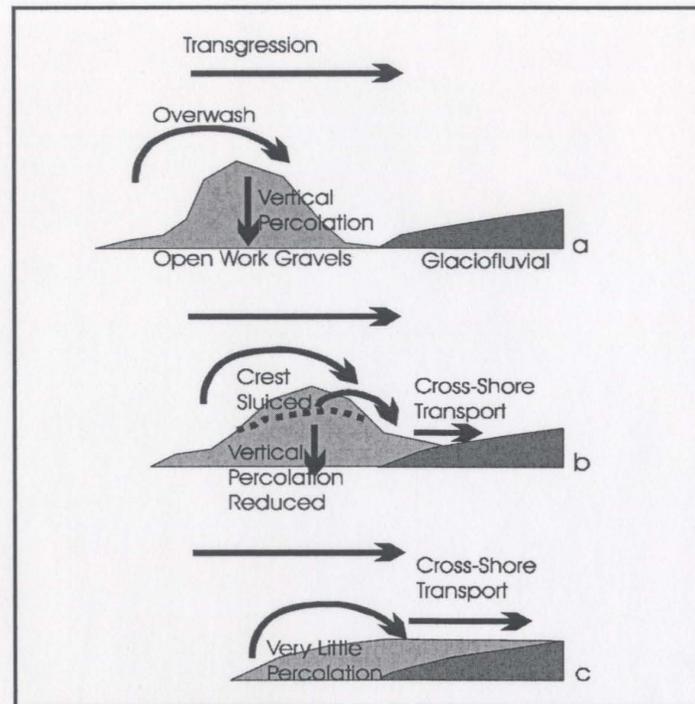
Figure 13.2 a. Schematic diagram of topographic control. Transgression forces the barrier towards the glaciofluvial basement. Overwashed swash is partially lost to percolation, facilitating the retention of a high crest.

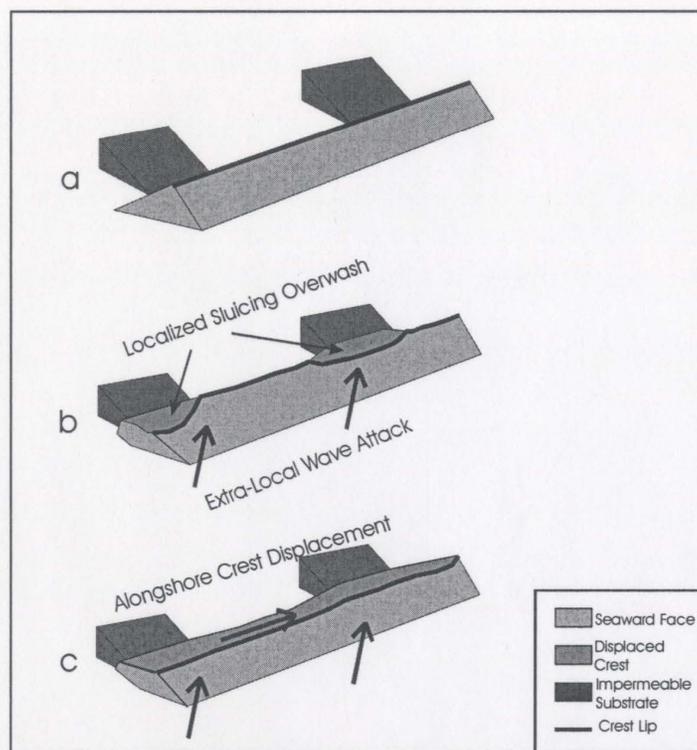
- Figure 13.3 a. Schematic diagram of alongshore crest displacement. Extra-local waves and RSLR drive the barrier towards Burnt Island and the laterally-adjacent mainland.
- b. Sluicing overwash occurs as per Figure 13.2 at the topographic obstacles, displacing crestal sediment to the backbarrier. The lagoon-backed barrier crest becomes elevated above the sluiced crest, becoming vulnerable to sluicing overwash due to the exposure to extra-local waves. Crestal displacement widens the barrier.
- c. Sluicing overwash erodes the entire barrier segment to the height and slope of the glaciofluvial deposits. This influence also extends a short distance south of Burnt Island, due to the incident extra-local wave angle.

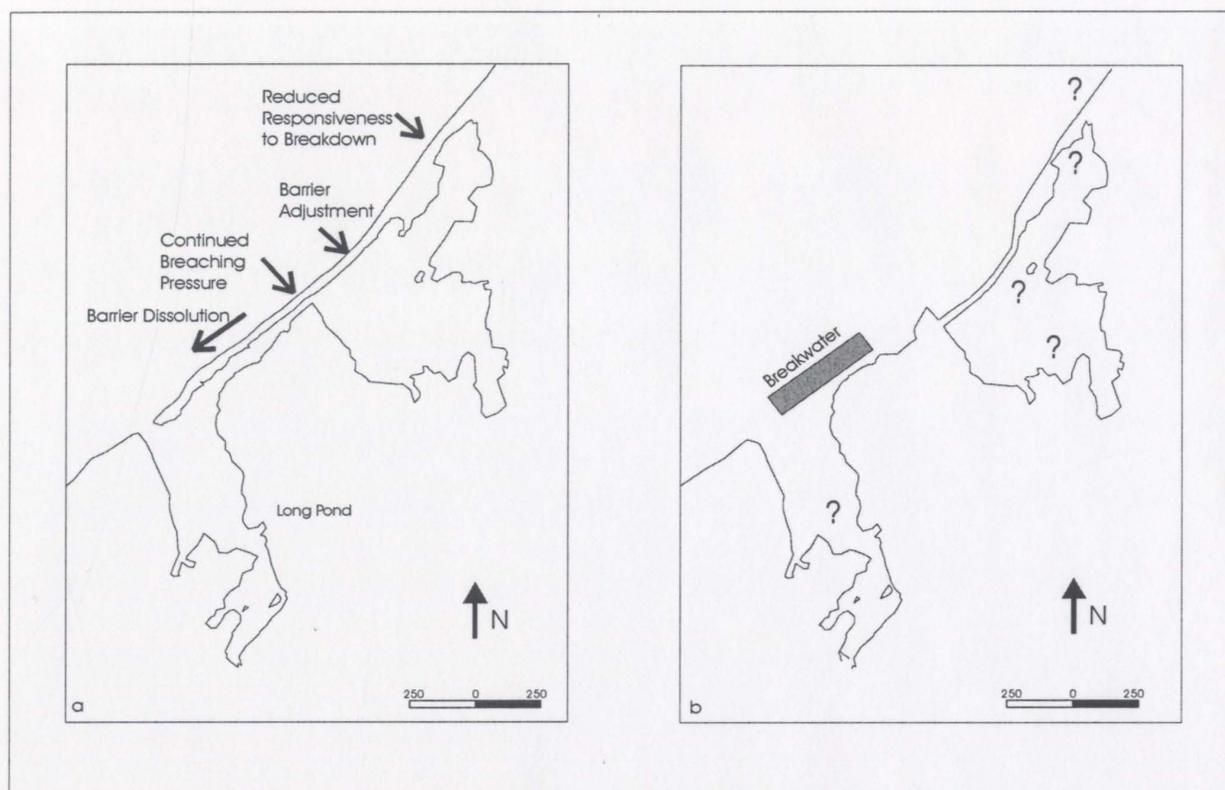
Figure 14.1. a. Continued breaching pressure due to RSLR, in-place narrowing, and high silt content will eventually trigger barrier breakdown. Segments 1 and 2 will disintegrate as they migrate into the deep backbarrier.

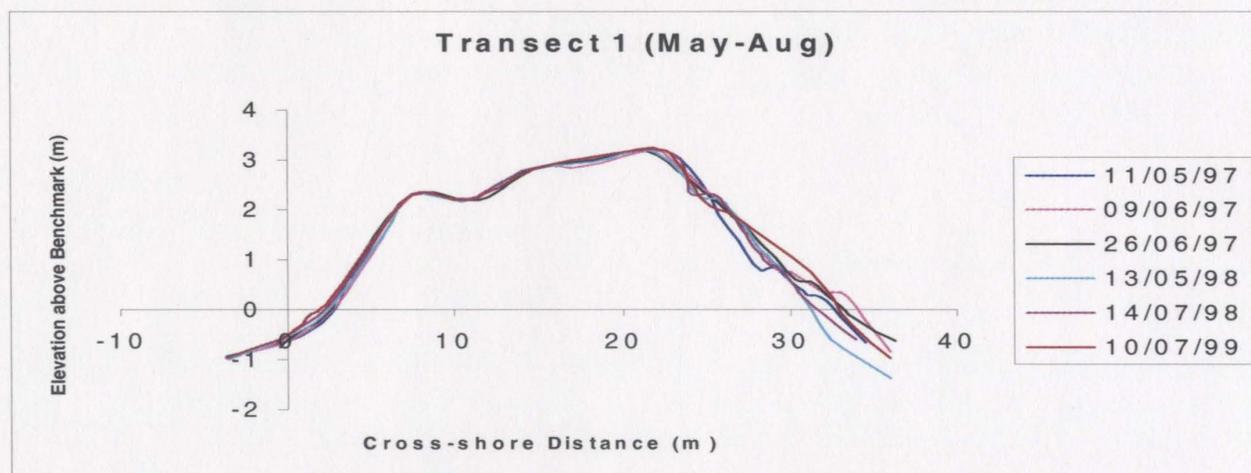
Figure A3.1b. Cross-sectional profile, Transect 1 (May - Aug.). Vertical Exaggeration x2.5.

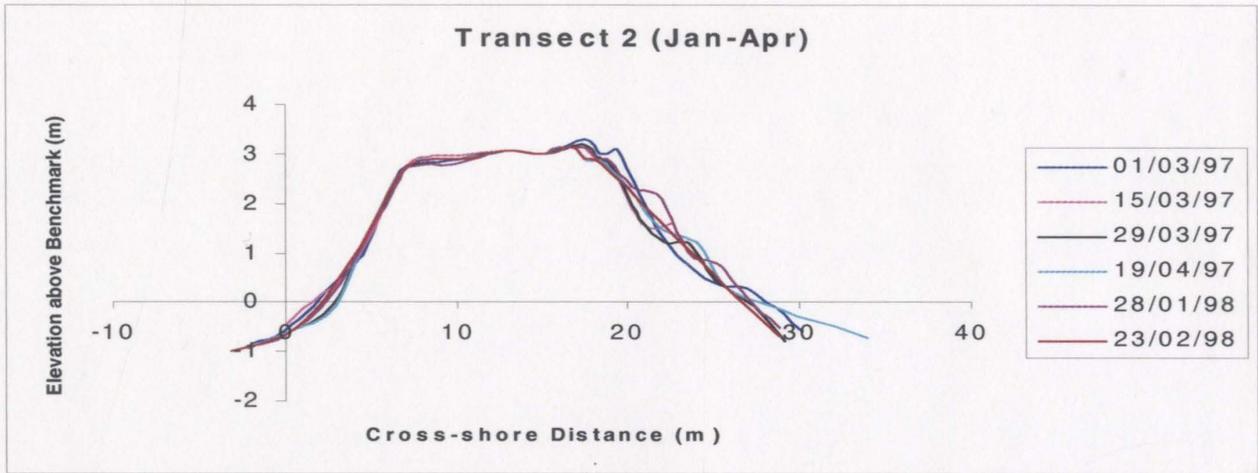
Figure A3.2a. Cross-sectional profile, Transect 2 (Jan. - April). Vertical Exaggeration x2.5.

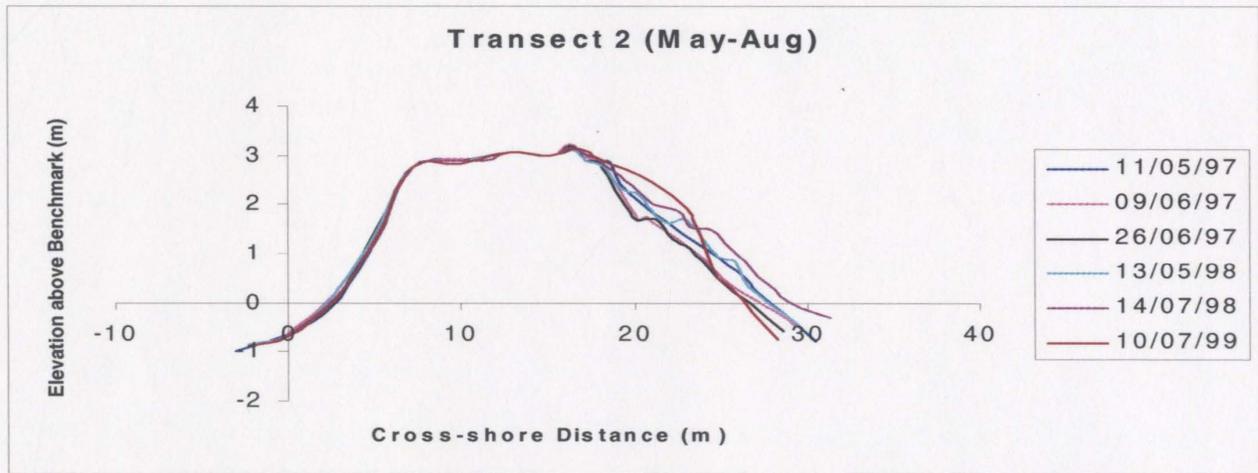
Figure A3.2b. Cross-sectional profile, Transect 2 (May - Aug.). Vertical Exaggeration x2.5.

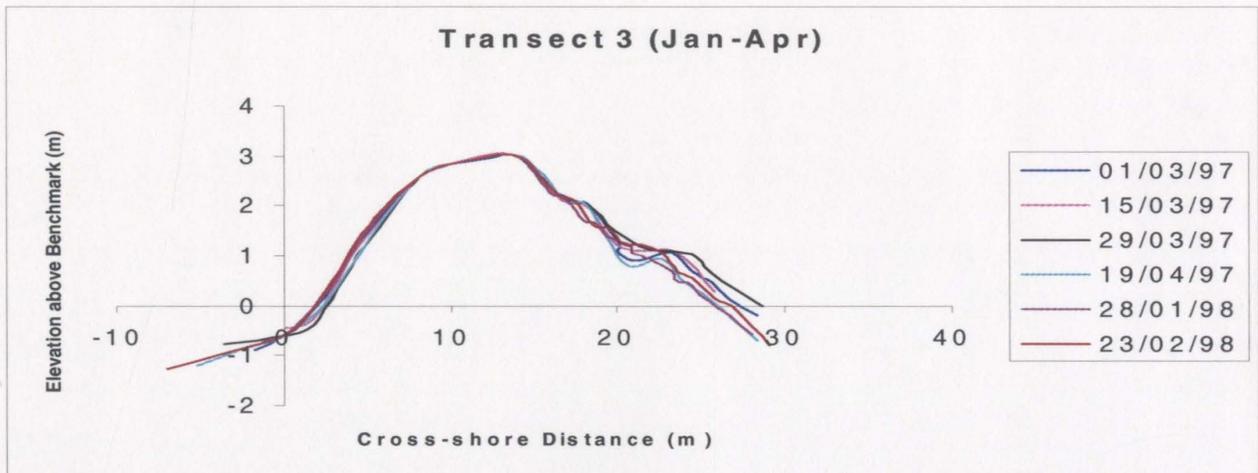
Figure A3.3a. Cross-sectional profile, Transect 3 (Jan. - April). Vertical Exaggeration x2.5.

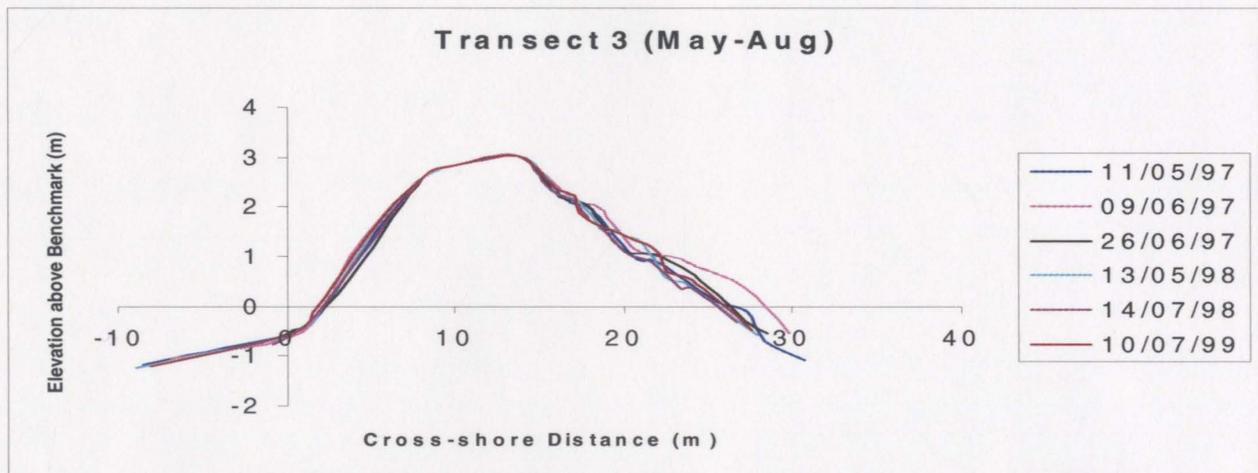
Figure A3.3b. Cross-sectional profile, Transect 3 (May - Aug.). Vertical Exaggeration x2.5.

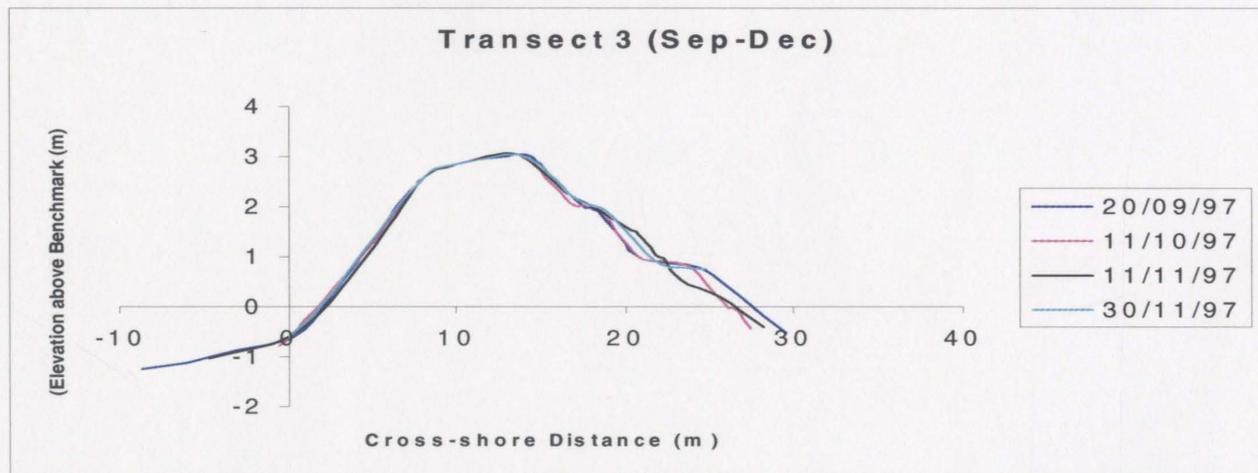
Figure A3.3c. Cross-sectional profile, Transect 3 (Sept. - Dec.). Vertical Exaggeration x2.5.
