ANALYSIS OF COASTAL GEOMORPHOLOGICAL  
PROCESSES ON A BOREAL COARSE CLASTIC BARRIER:  
LONG POND BARACHOIS, CONCEPTION BAY, NEWFOUNDLAND

A thesis submitted to the School of Graduate Studies  
in partial fulfilment of the requirements  
for the degree of Master of Science

Department of Geography  
Memorial University of Newfoundland

2004

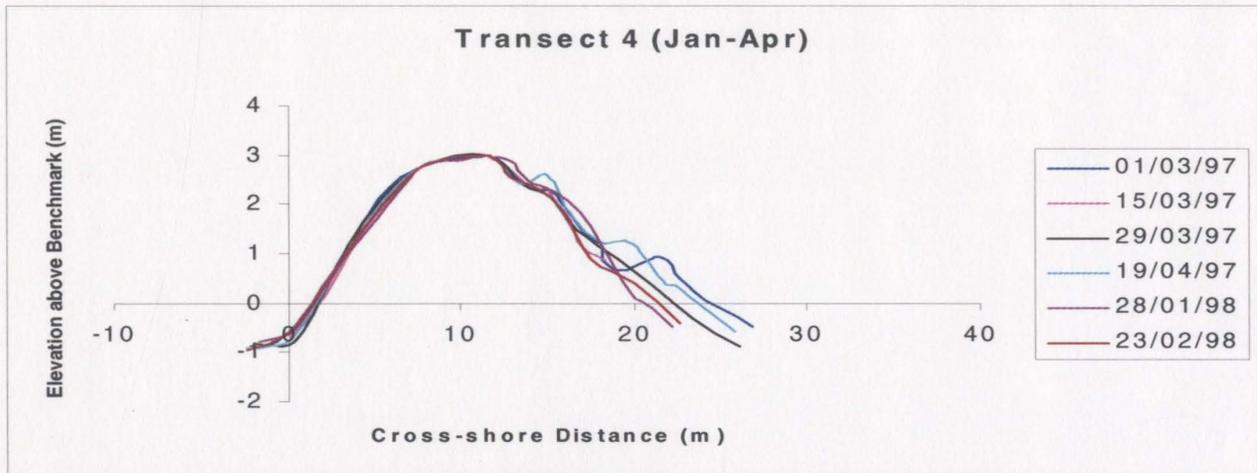
Figure A3.4a. Cross-sectional profile, Transect 4 (Jan. - April). Vertical Exaggeration x2.5.

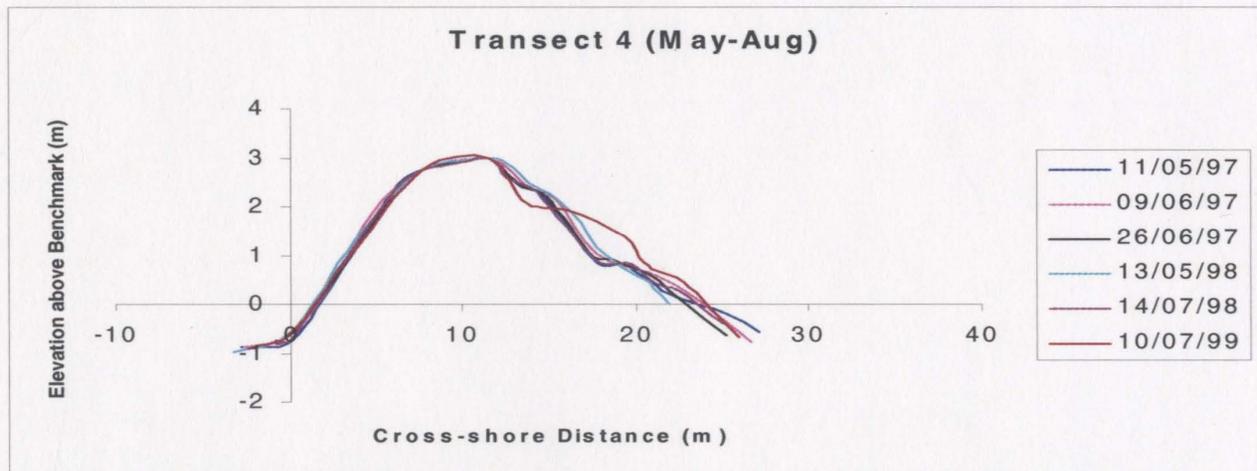
Figure A3.4b. Cross-sectional profile, Transect 4 (May - Aug.). Vertical Exaggeration x2.5.

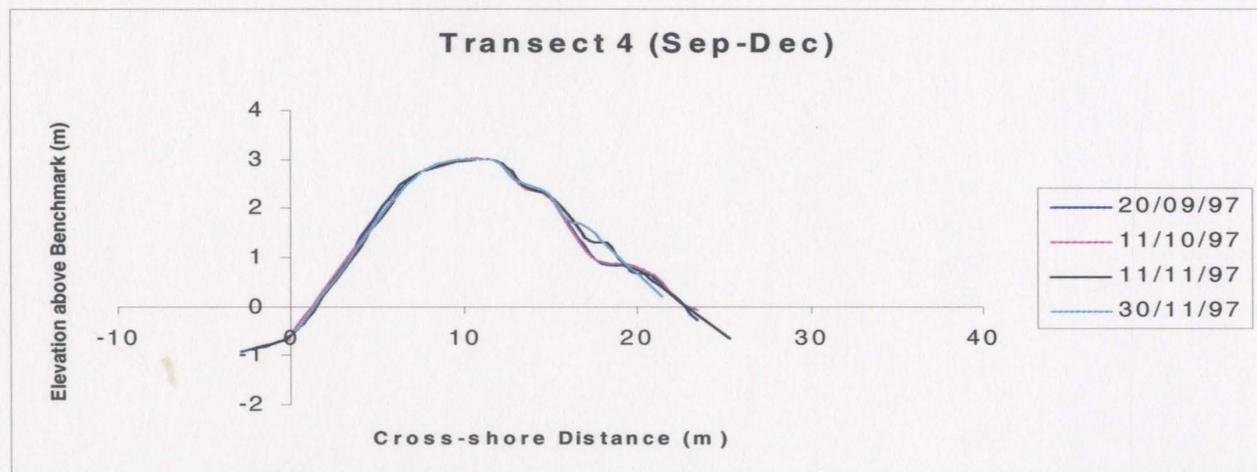
Figure A3.4c. Cross-sectional profile, Transect 4 (Sept. - Dec). Vertical Exaggeration x2.5.

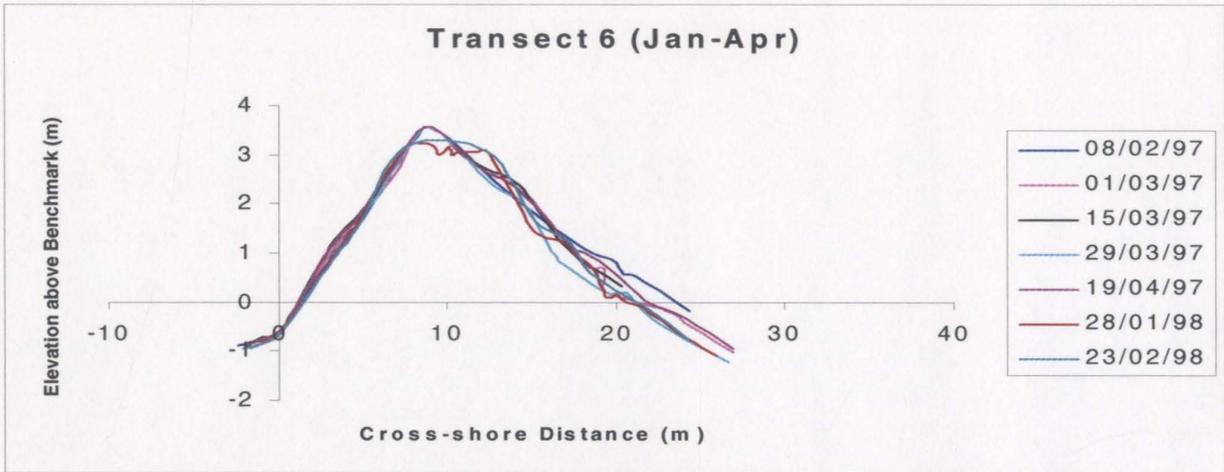
Figure A3.6a. Cross-sectional profile, Transect 6 (Jan. - April). Vertical Exaggeration x2.5.

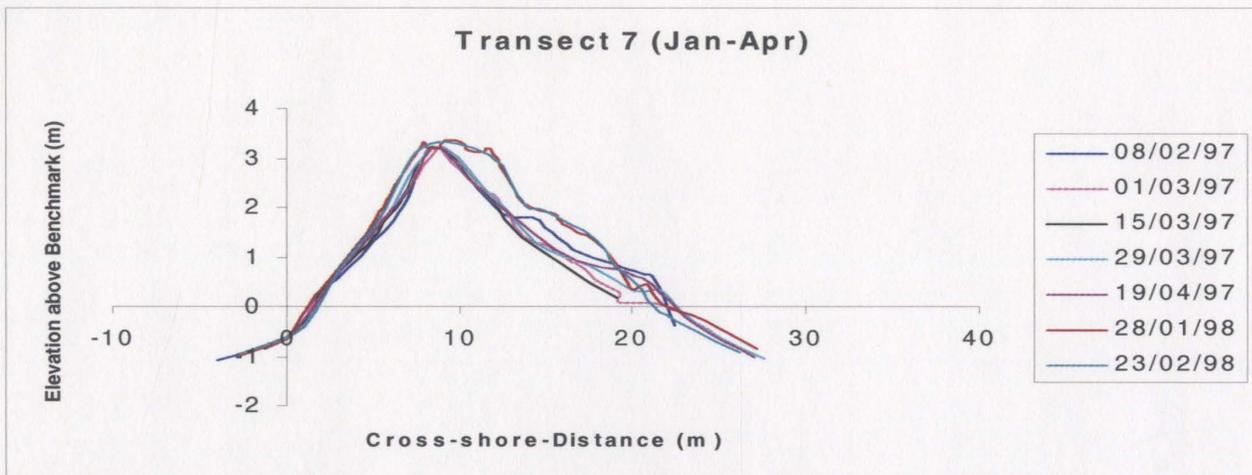
Figure A3.7a. Cross-sectional profile, Transect 7 (Jan. - April). Vertical Exaggeration x2.5.

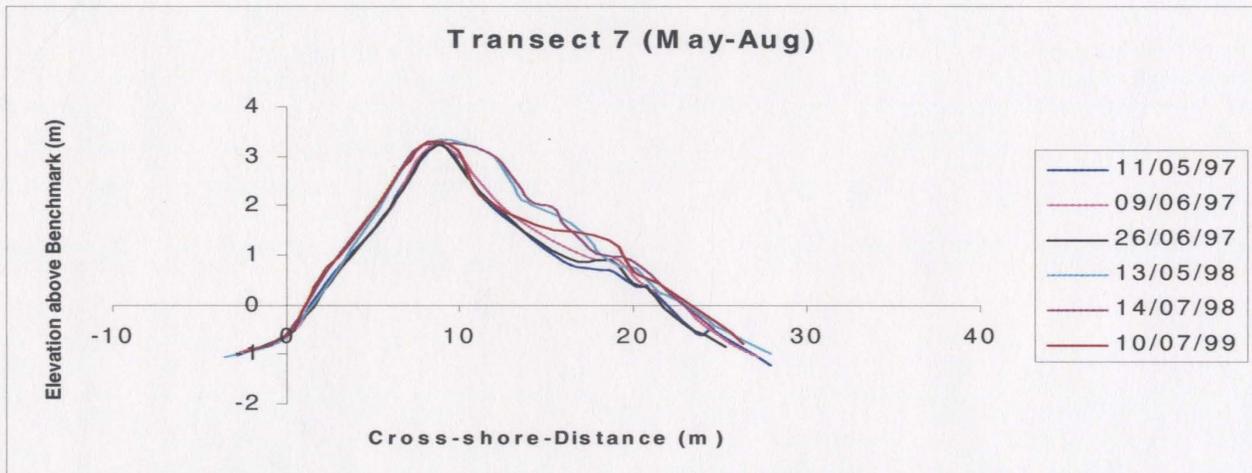
Figure A3.7b. Cross-sectional profile, Transect 7 (May - Aug.). Vertical Exaggeration x2.5.

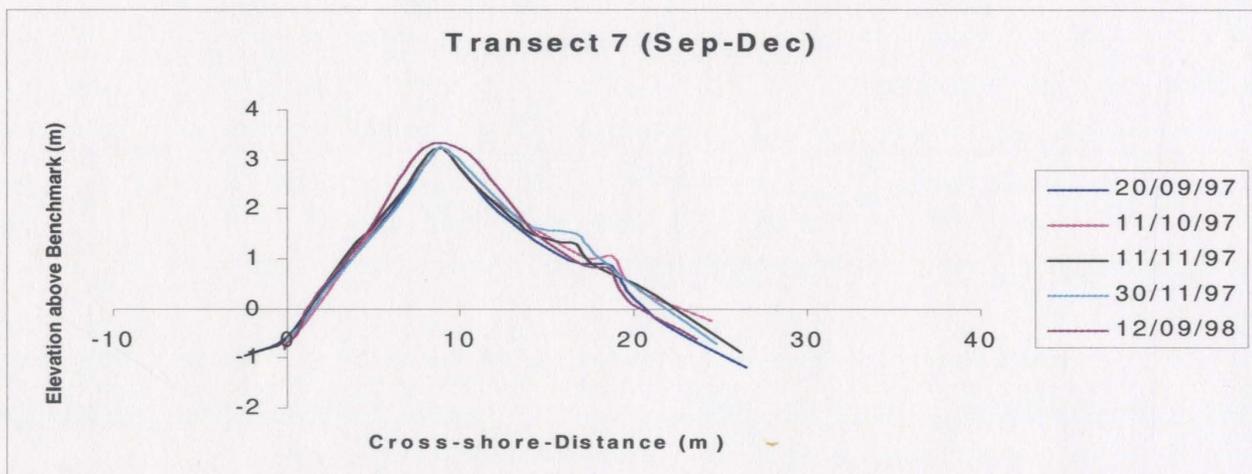
Figure A3.7c. Cross-sectional profile, Transect 7 (Sept. - Dec.). Vertical Exaggeration x2.5.

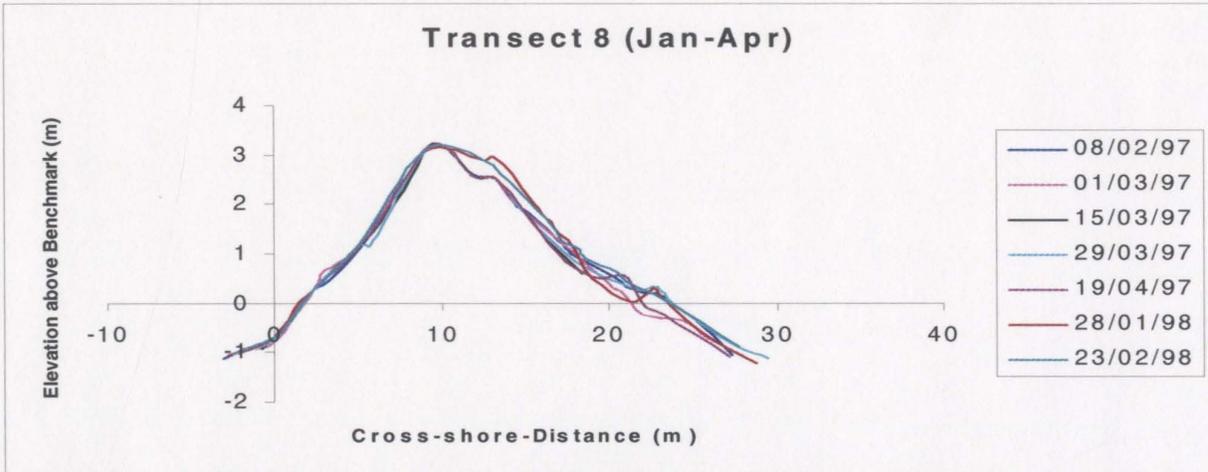
Figure A3.8a. Cross-sectional profile, Transect 8 (Jan. - April). Vertical Exaggeration x2.5.

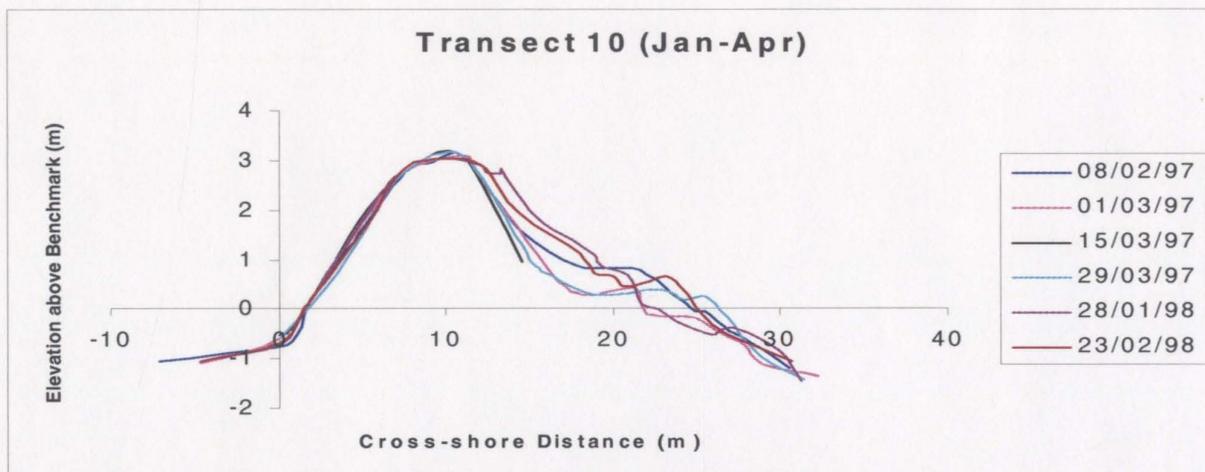
Figure A3.10a. Cross-sectional profile, Transect 10 (Jan. - April). Vertical Exaggeration x2.5.

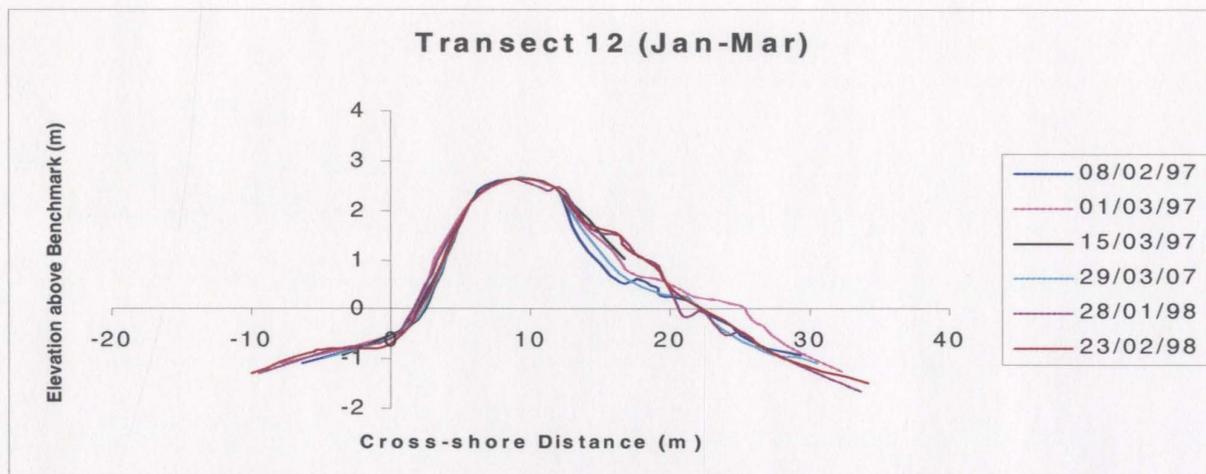
Figure A3.12a. Cross-sectional profile, Transect 12 (Jan. - Mar.). Vertical Exaggeration x2.5.

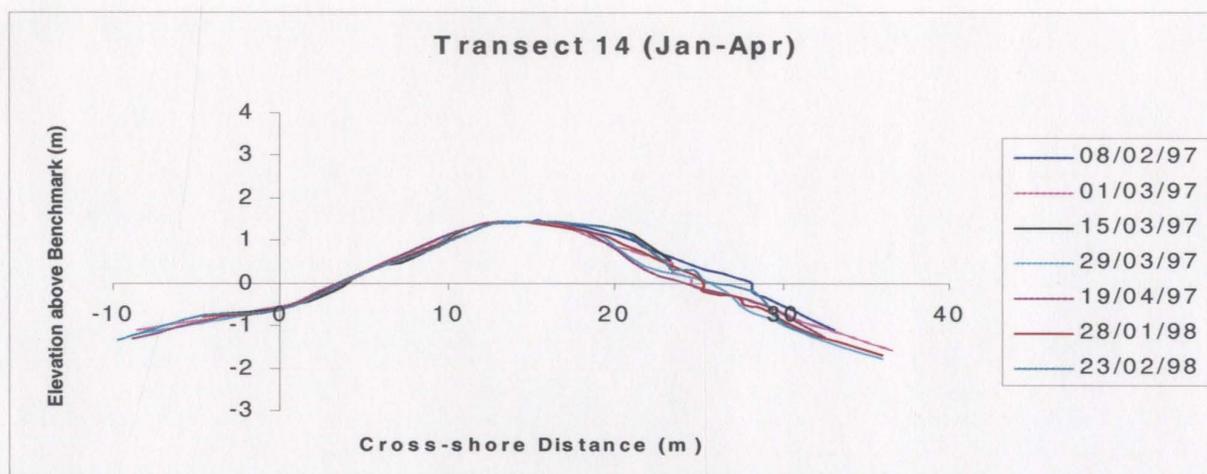
Figure A3.14a. Cross-sectional profile, Transect 14 (Jan. - April). Vertical Exaggeration x2.5.
