HOFFNUNGSTHAL: THE ARCHAEOLOGY AND ARCHITECTURE
OF THE FIRST MORAVIAN MISSION TO THE LABRADOR INUIT,
1752

A thesis submitted to the
School of Graduate Studies
in partial fulfilment of the
requirements for the degree of
Master of Arts

Department of Anthropology/ Archaeology Unit
Memorial University of Newfoundland

October 2004

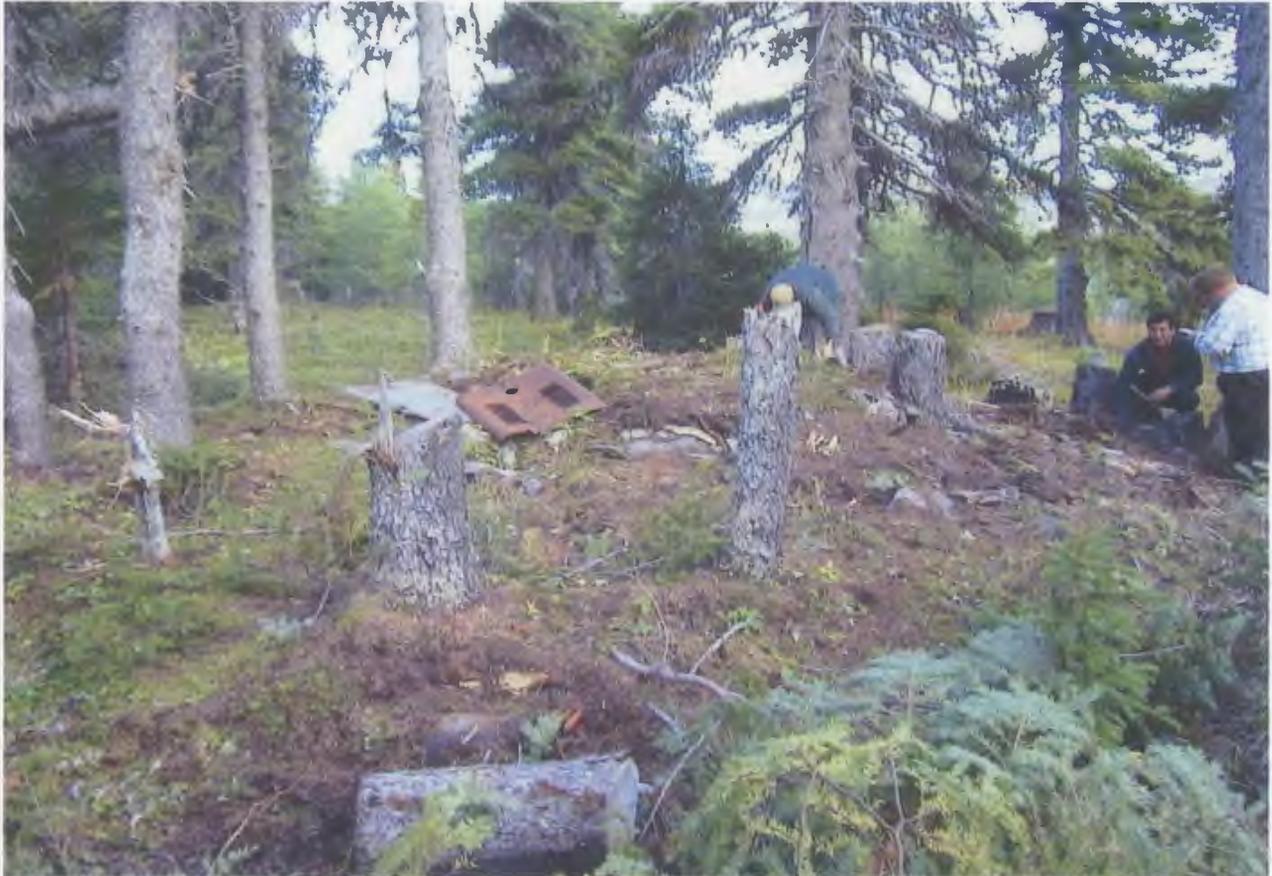
Figure 3: Ruins of the Hoffnungsthal mission as discovered in 2000, facing southeast. The northwest cornerstone is in the foreground, between the log and stump. Randy Edmunds (middle) and Steve Mills (extreme right) are standing near the building's southwest corner while the author (extreme left) is standing near the southeast cornerstone (Photo by G. Price).

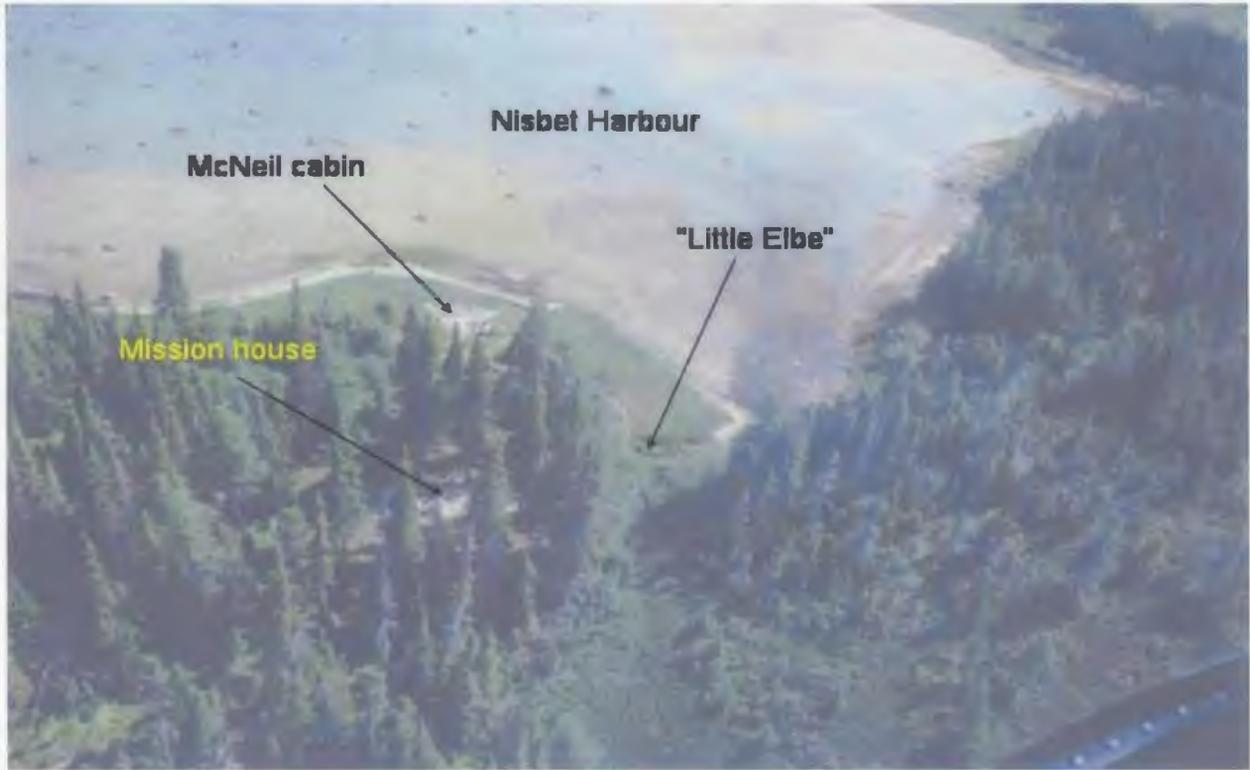
Figure 7: Nisbet Harbour and the Hoffnungsthal mission from the air, facing south (Photo by H. Cary)

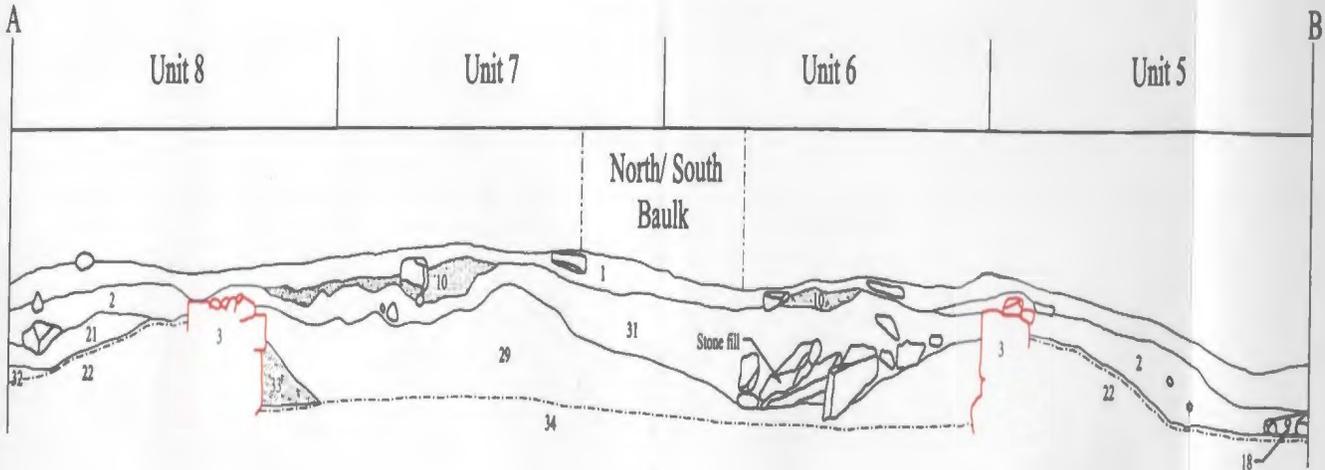
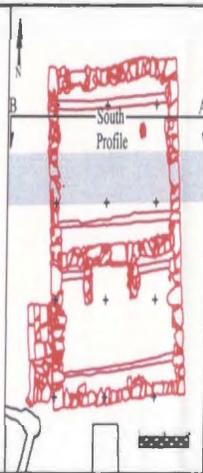
SOUTH WALL PROFILE

- 1 Recent sod and soil development - black coloured moss
- 2 Post 1752/3 soil development - yellowish brown sandy clay
- 2B 1752/3 occupation/floor - brown sand/silt
- 3 House foundation - large, flat Upper Aillik felsic in olive-grey clay matrix
- 10 Post 1753 wind blown sand - light brown sand
- 18 Rock pile (c. 1903?) - large, angular Upper Aillik felsic in brown sand/silt matrix
- 21 "B" Horizon development outside foundations - olive-grey silty clay
- 22 1752 landscaping fill outside foundations - brown sand/silt with some angular and rounded stone
- 29 1752/3 levelling fill - brown sand/silt with small rounded stone
- 31 1752 mixed clay, sand and stone fill
- 32 Pre-1752 surface outside foundations - pinkish-grey and black sand/silt
- 33 1752 sand fill banked against foundations - brown sand/silt
- 34 Pre-1752 surface inside foundations - pinkish-grey and black sand/silt

GgBs-1 Hoffnungsthal
2001 Excavations
Nisbet Harbour Labrador
Figure 15: South Wall Profile
Drawn by: H. Cary from originals by
H. Cary (GgBs-1 Profile 1)
Scale: As shown

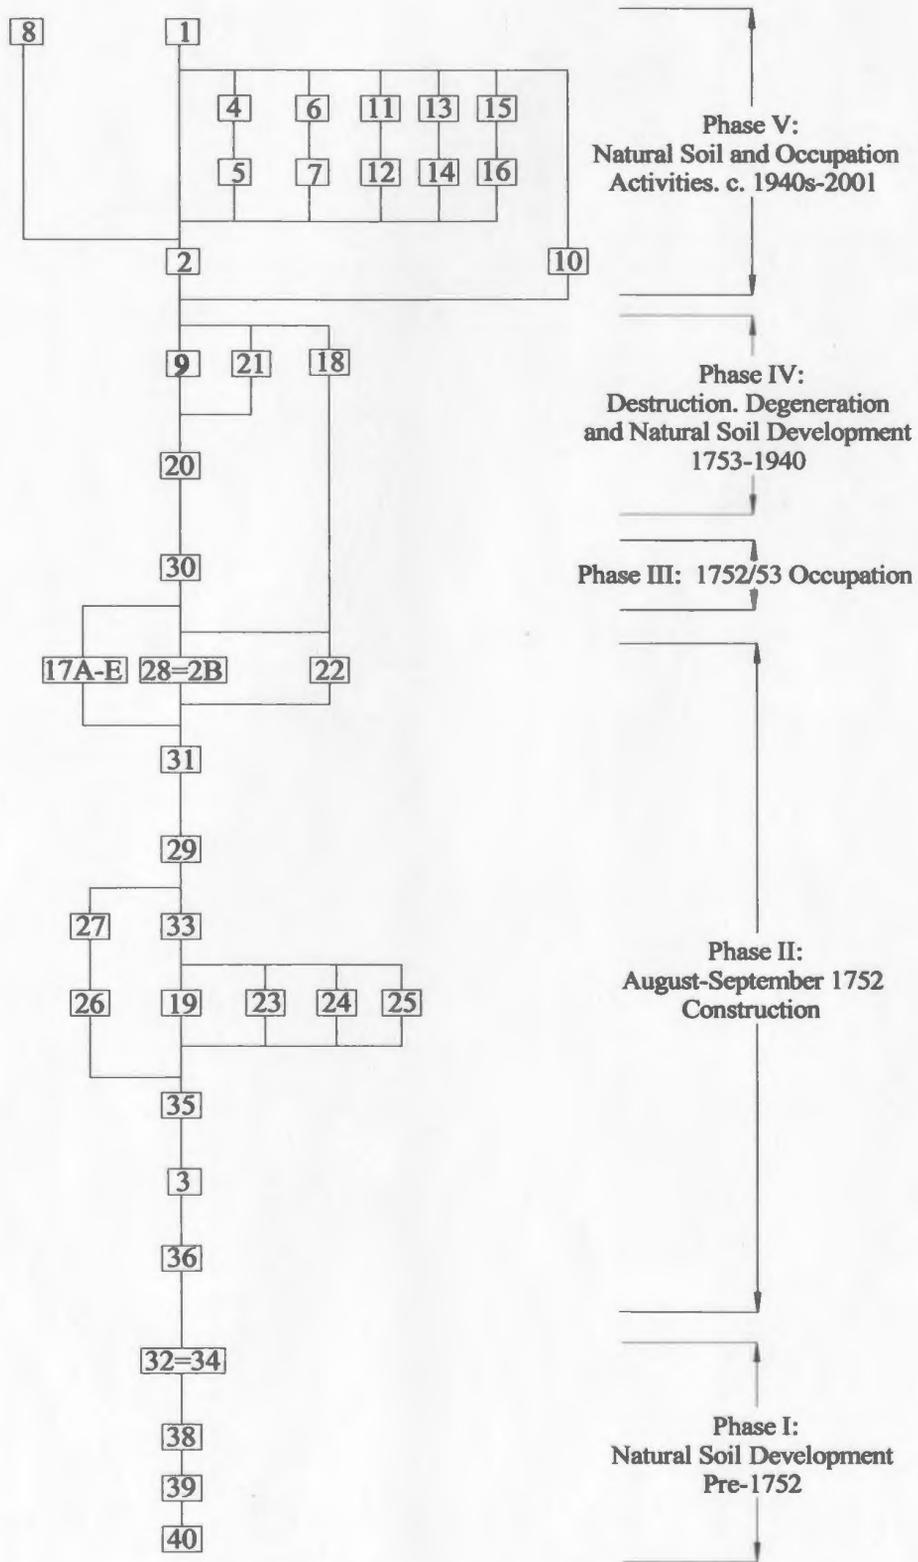
Figure 17: Harris Matrix and phasing of deposits and features uncovered at Hoffnungsthal in 2001. Because of a clerical error, Lot 37 was not assigned to a stratigraphic unit.

Contemporaneous deposits are shown on the matrix by placing two or more lots next to each other. For example, Figure 17 shows Lots 26, 3, 10, 23, 24 and 25 on the same horizontal plane, denoting my belief that these lots were deposited at roughly the same time. Sometimes, lot numbers are assigned to two apparently separate layers that are later found to be two glimpses of the same deposit. This was the case with Lots 2B and 28. Lot 2B was found inside the south foundation walls, while Lot 28 was identified inside the hearth under a burn layer (Lot 30). Initially, I could find no relationship between the two strata, but further excavation revealed the lots to be part of the same fill episode. To reflect this interpretation in

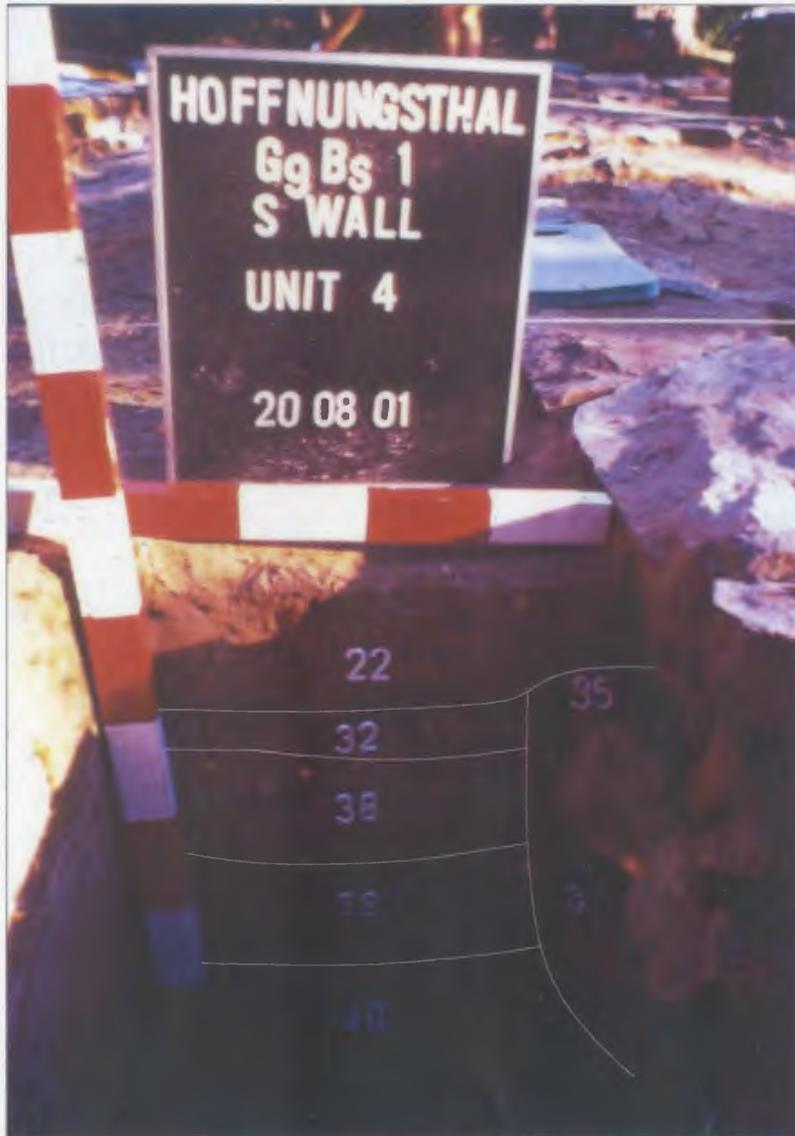
Figure 18: The natural soil sequence uncovered in the Unit 4 test shaft, facing south. The cut for the foundation pit (designated Lot 36) was clearly evident where it was filled by Lot 35 (Photo by H. Cary).

After clearing vegetation at the site, the missionaries' first action was to dig a rectangular pit for the house foundation. Evidence of this cut (Lot 36) was found in the Unit 4 test shaft, and it is believed to continue around the foundation's perimeter (Figure 18). The cut was through natural strata between 6-12 cm from the foundation exterior. As the foundation was constructed, the space between the walls and the cut interface was back-filled with hard-packed, olive-green clay (Lot 35), probably acting to bond the foundation stones.

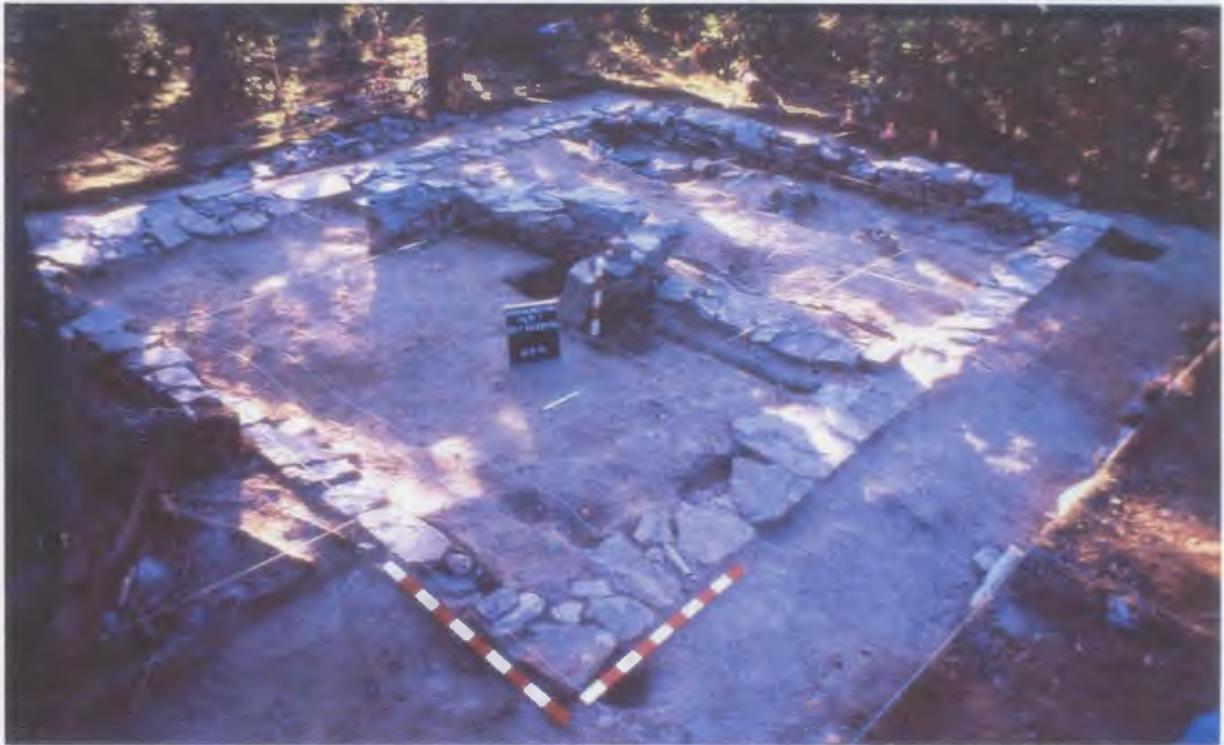
Figure 19: The house foundations facing northwest (Photo by H. Cary).

The house foundations were rectangular in shape and measured 6.96 m (22 feet 8 inches) north/south and averaged 5.13 m (16 feet 8 inches) east/west. The walls' width ranged from 24-60 cm and was constructed of large, flat stones between 20 × 20 cm to 60 × 40 cm in size (Figures 16, 19-23, and 27). These large stones formed the basis of the wall, with smaller

house— were two stone footings (Lot 23) (Figures 14, 16, 19-22, and 27). The eastern footing was 1.60 m long while the western one was 1.10 m in length. Both ranged in width from 25-45 cm and were one course high. Their proximal termini overlapped the foundation walls (Figure 16). As in the foundation and fireplace, large, Upper Aillik felsic stones formed the footing with smaller ones filling the gaps. Highly compacted, olive-grey clay bonded the stones.

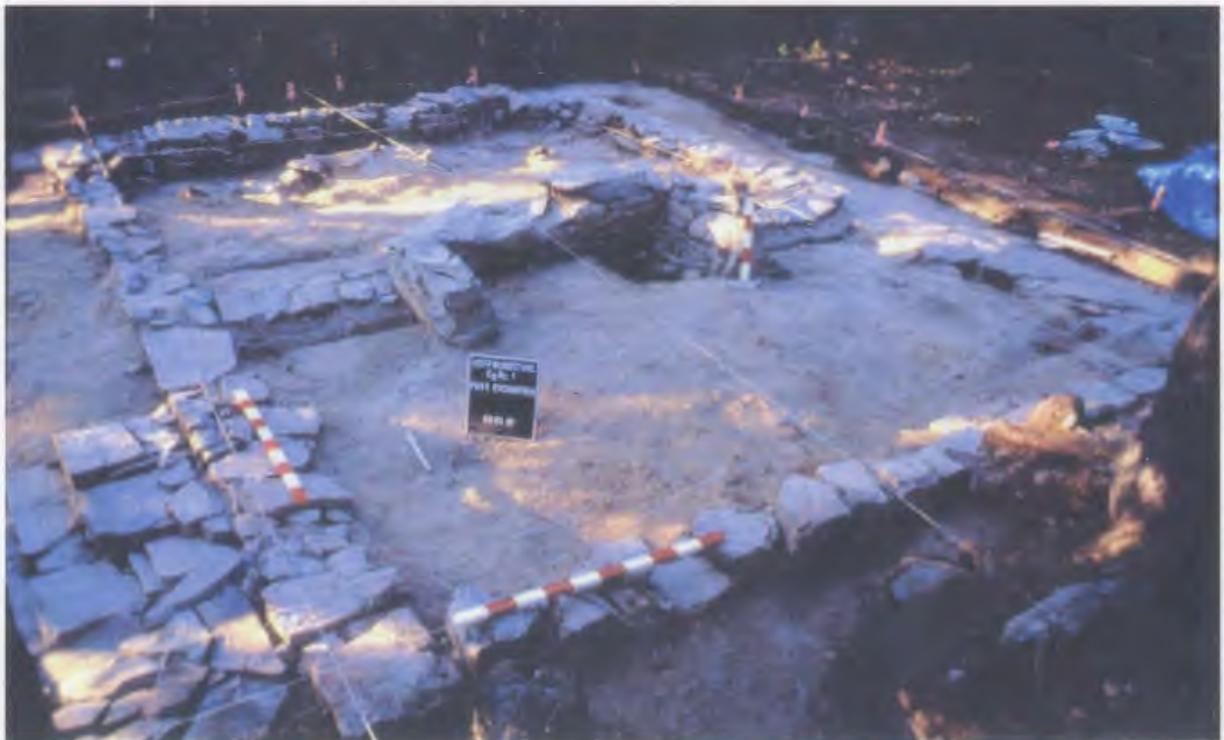
Figure 20: Facing northeast (Photo by H. Cary)

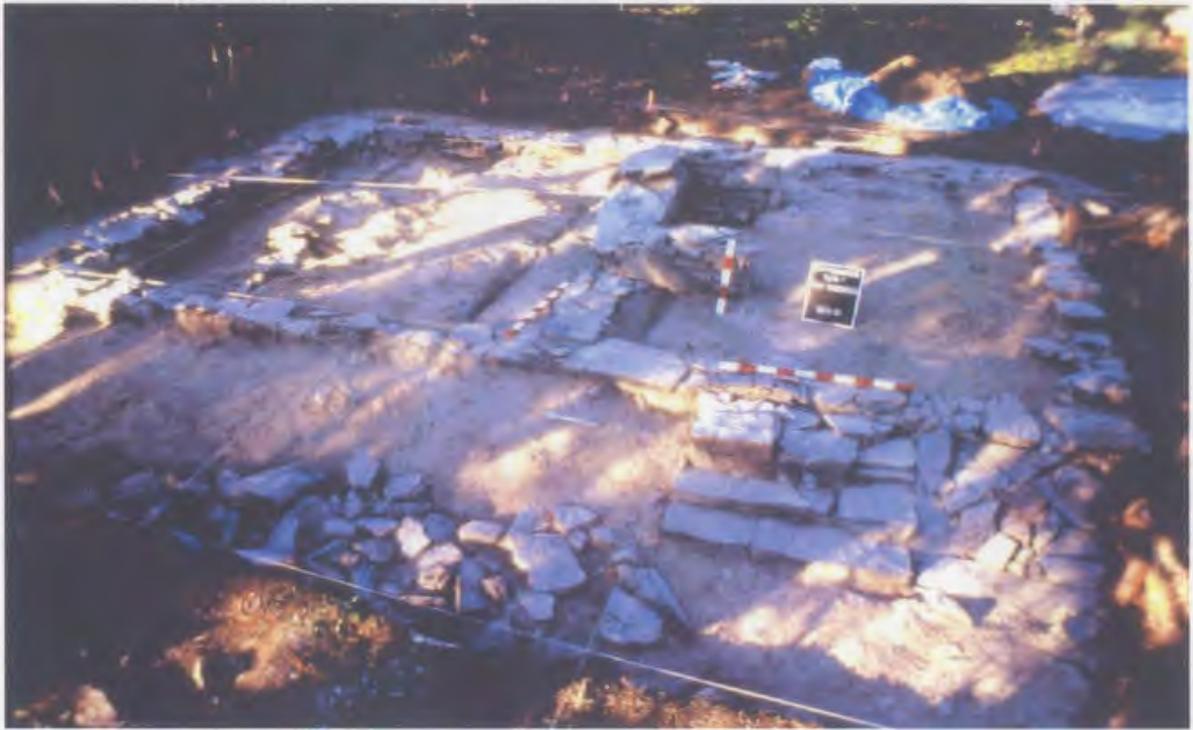
Figure 21: Facing east (Photo by H. Cary).

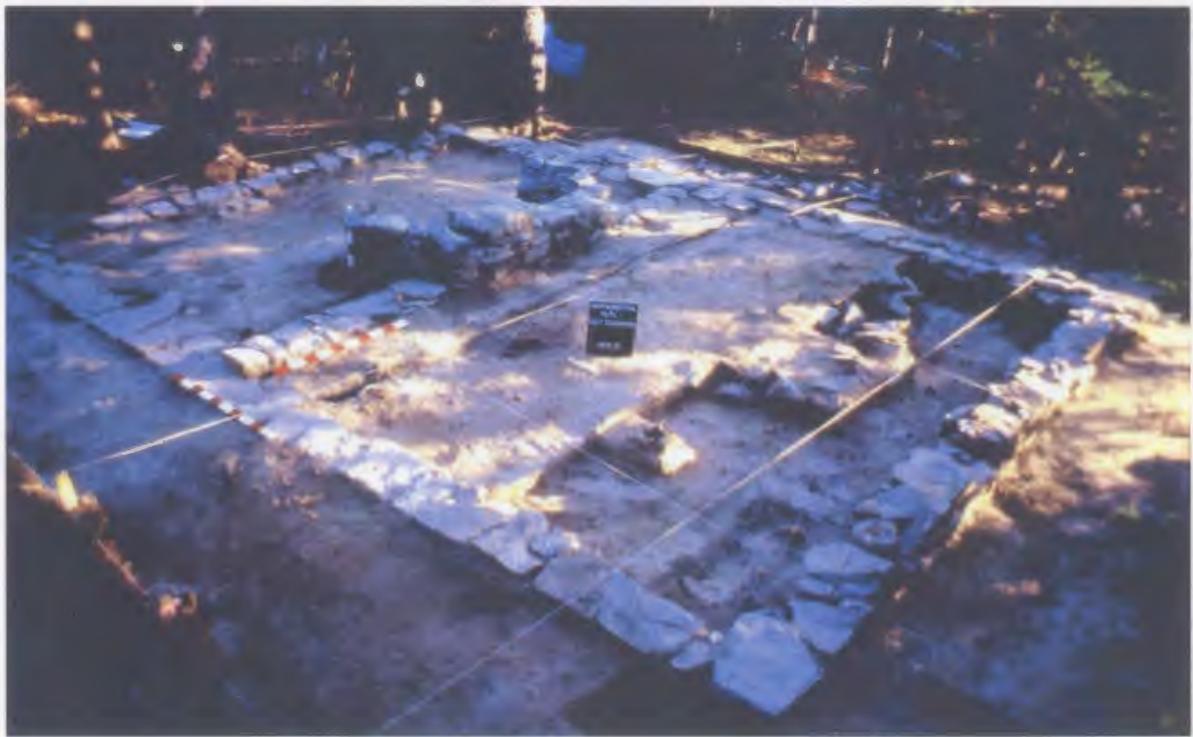
Figure 22: Facing southwest (Photo by H. Cary).

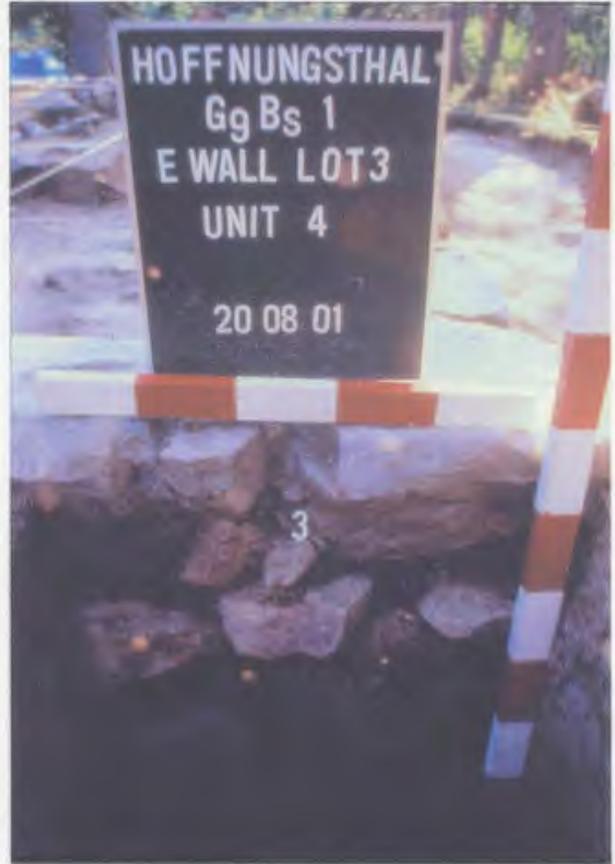
Figure 23: Profile of the foundation wall as revealed in the Unit 4 test shaft, facing west (Photo by H. Cary).

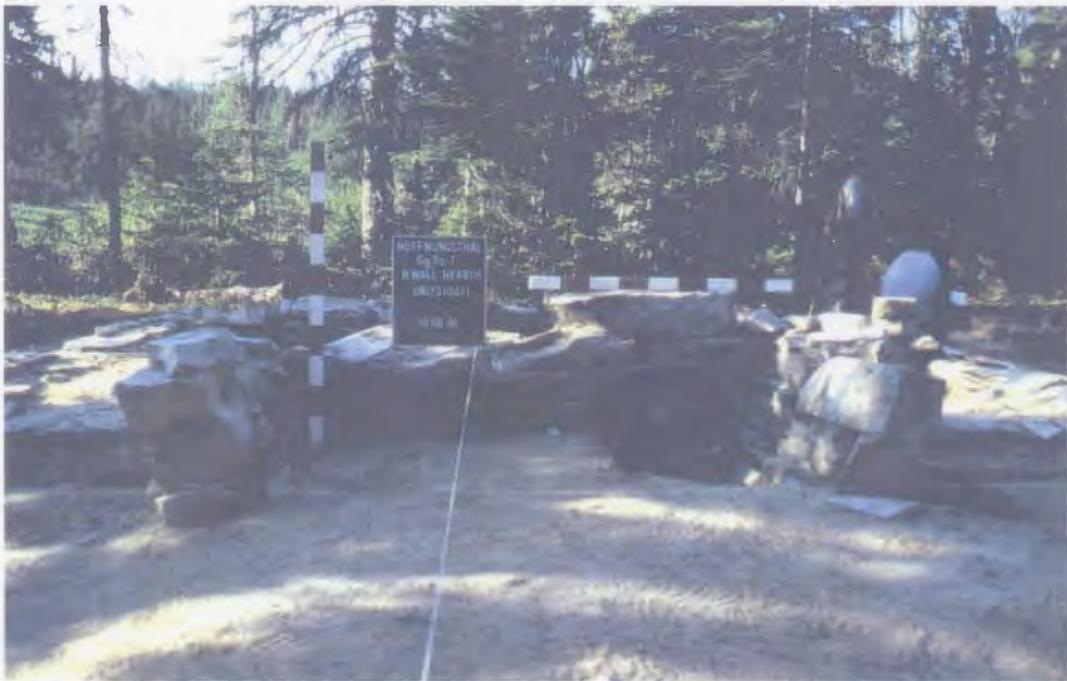
Figure 24: The stone fireplace interior, facing north (Photo by H. Cary).

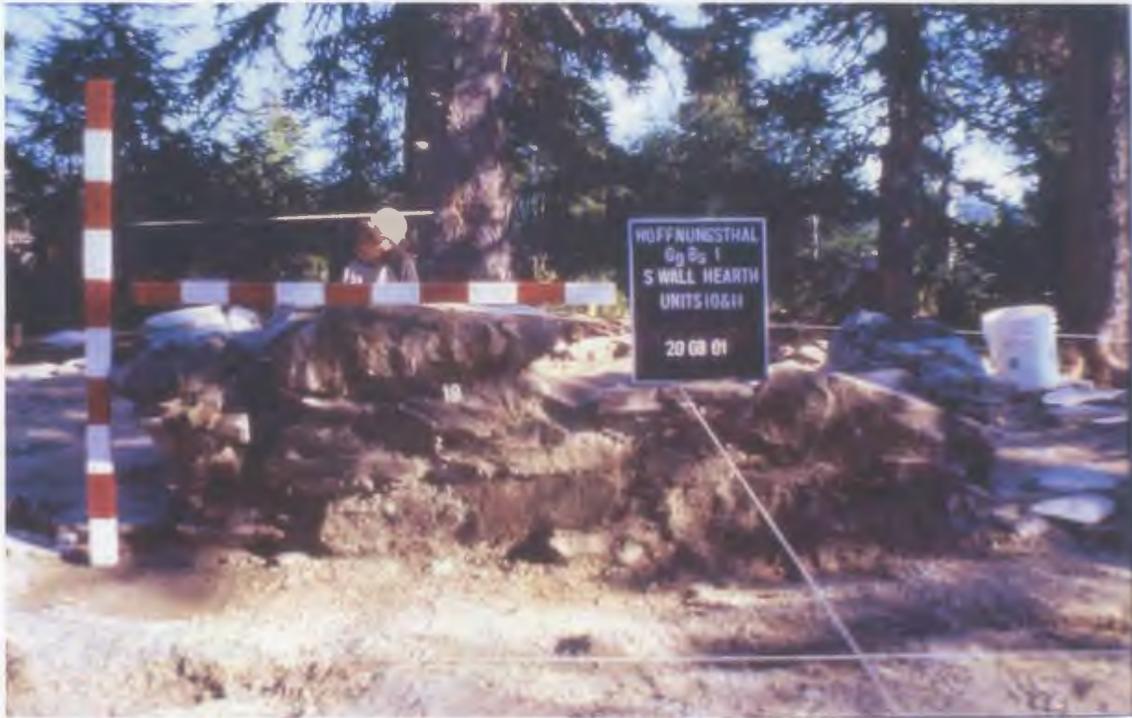
Figure 25: The stone fireplace firebox wall, facing south (Photo by H. Cary).

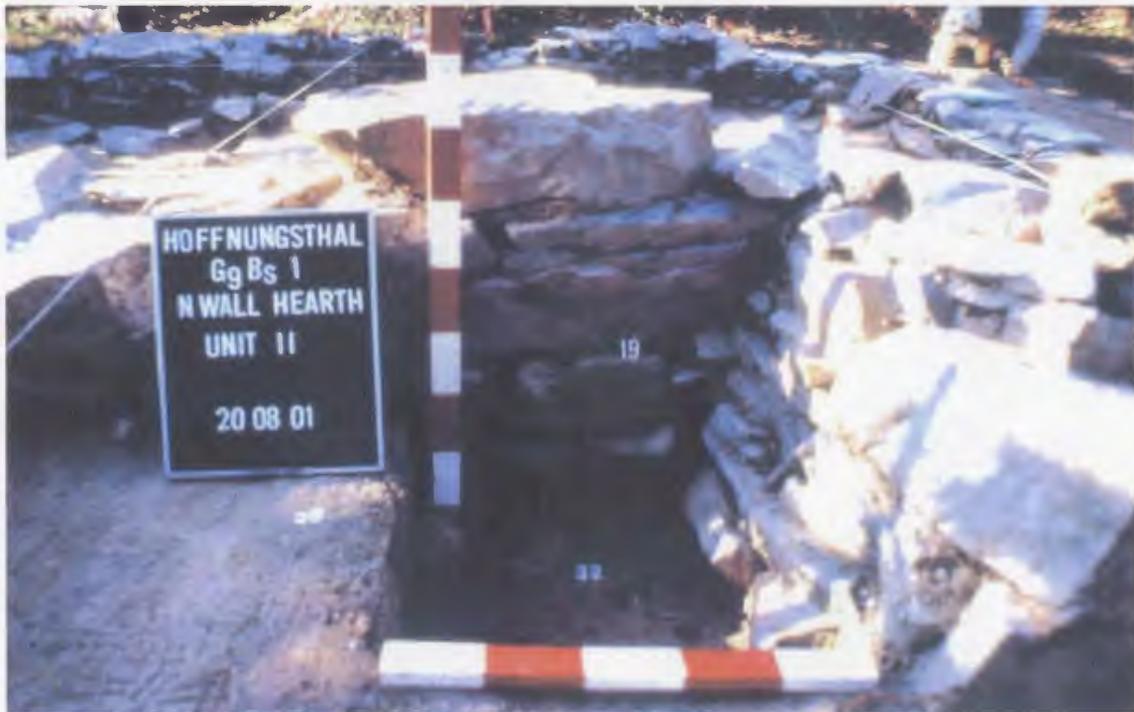
Figure 26: Unit 11 test shaft inside the fireplace hearth, facing the north firebox wall (Photo by H. Cary).

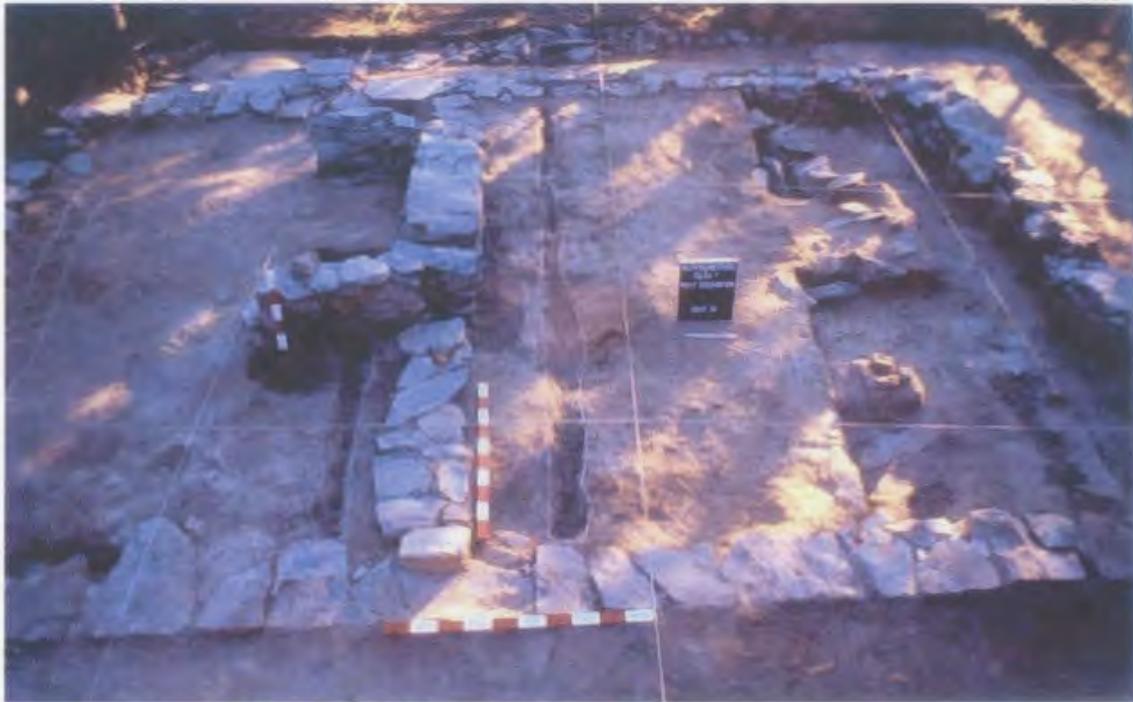
Figure 27: The house remains facing west (Photo by H. Cary).

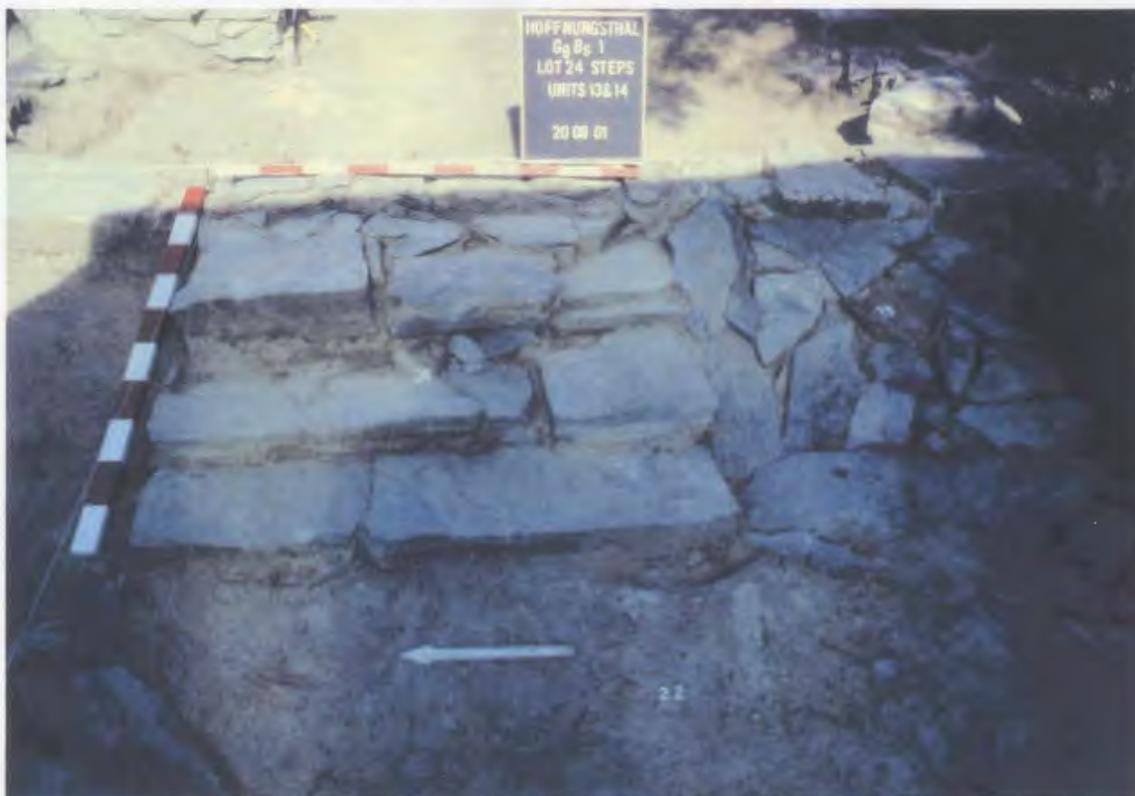
Figure 28: The stone steps (Lot 24) and ramp (Lot 25) (Photo by H. Cary)

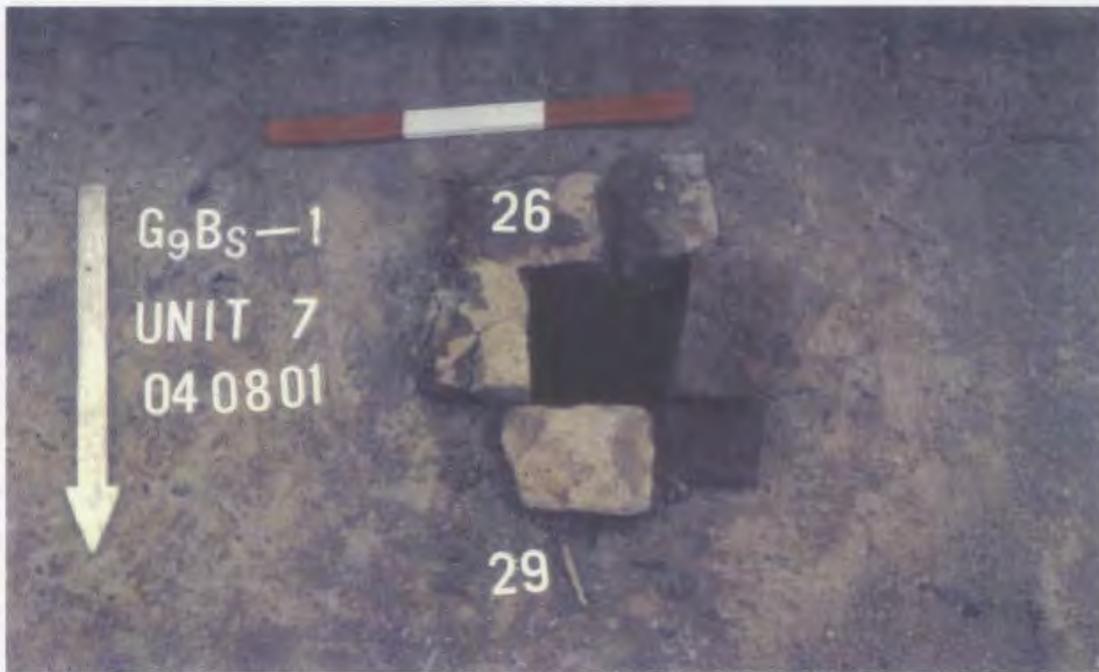
Figure 29: The brick feature in Unit 7 (Photo by H. Cary).

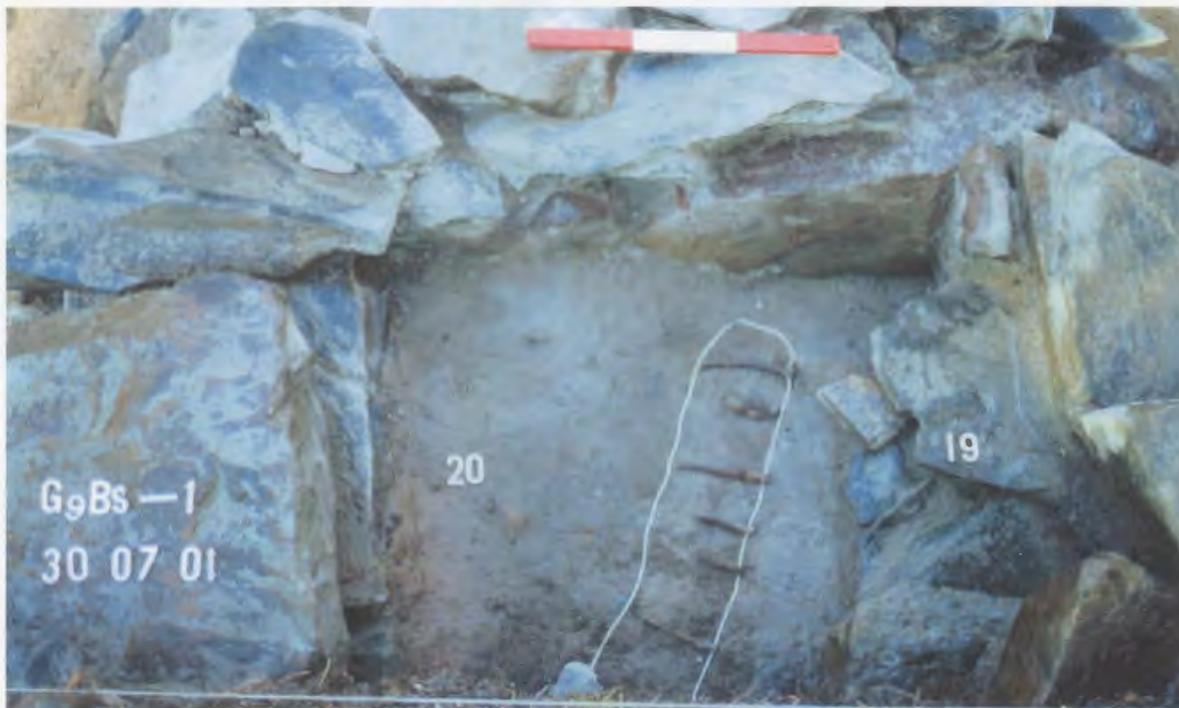
Figure 30: Organic stain of a plank (outlined with white string) inside the fireplace fill (Lot 20) that had been punctured with nails, facing east (Photo by H. Cary).

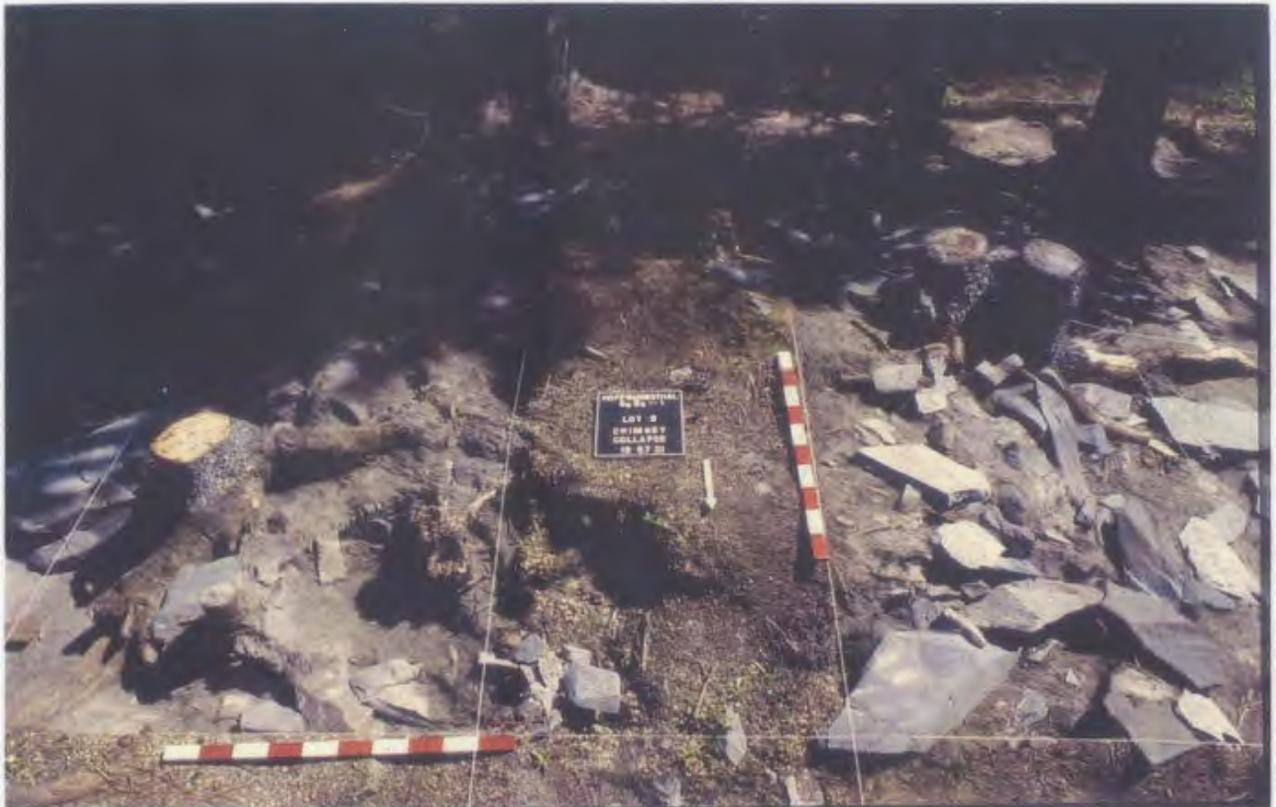
Figure 31: The chimney collapse and debris level (Lot 9) prior to excavation, facing south (Photo by H. Cary).

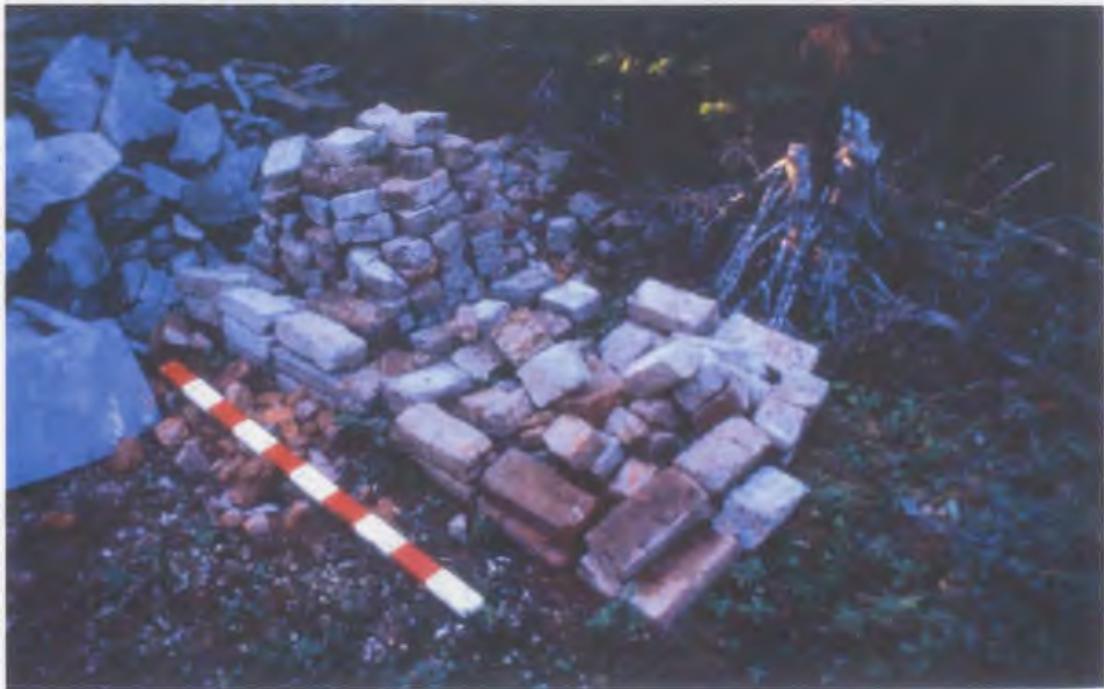
Figure 33: Whole and partial brick fragments excavated from the collapse debris (Lot 9) (Photo by H. Cary).

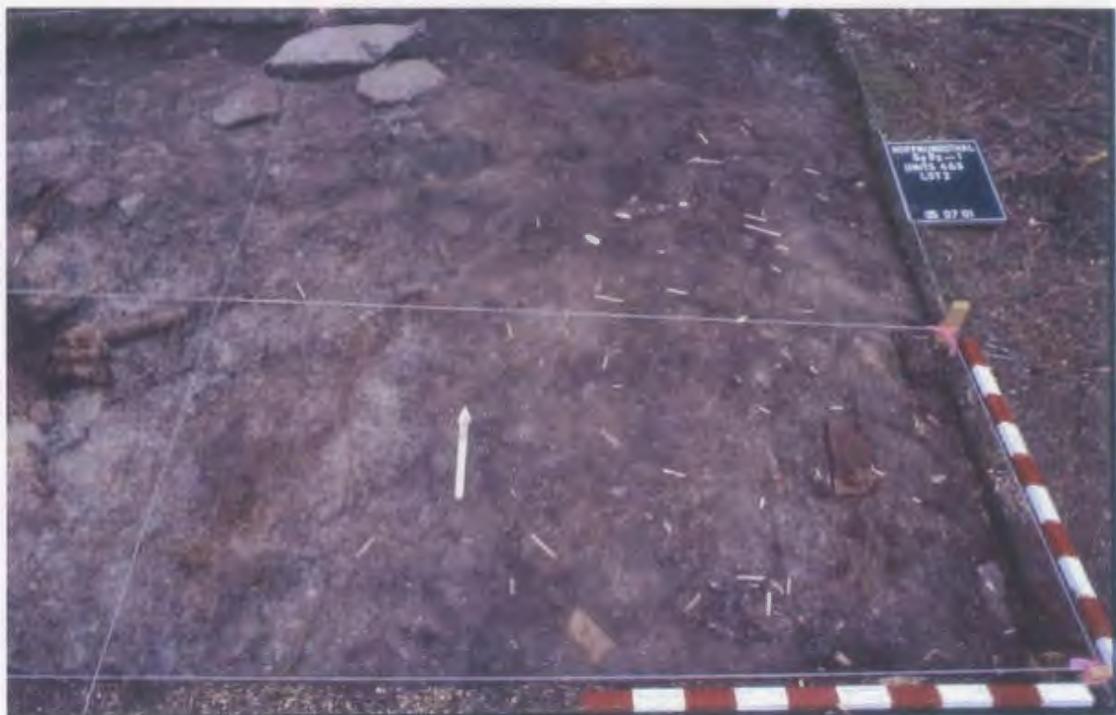
Figure 34: Clay tobacco pipe fragments appearing in the natural stratum (Lot 2) immediately below the sod overburden (Lot 1), facing north (Photo by H. Cary).

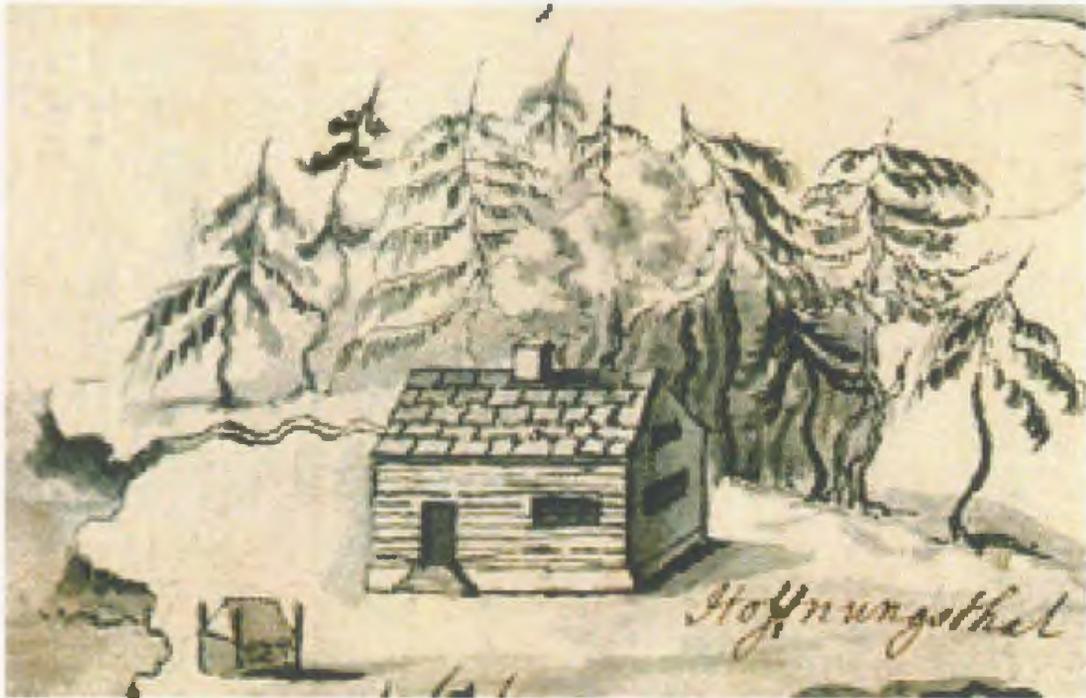
Figure 36: Detail from the “New Britain” map (Figure 36) of the mission house and temporary dwelling. The “Little Elbe” is shown behind the house (Courtesy H. Rollmann and Unity Archives).

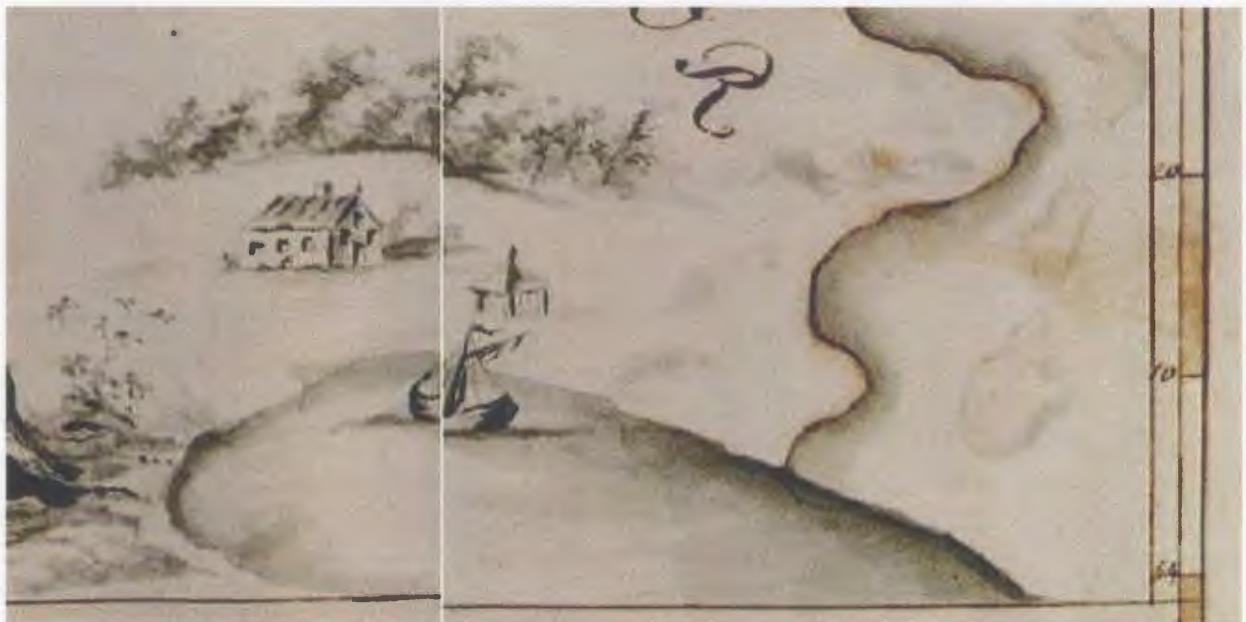
Figure 37: Detail from another 1753 map showing the mission house and temporary dwelling. Note the location of the “Little Elbe” (Courtesy H. Rollmann and Unity Archives).

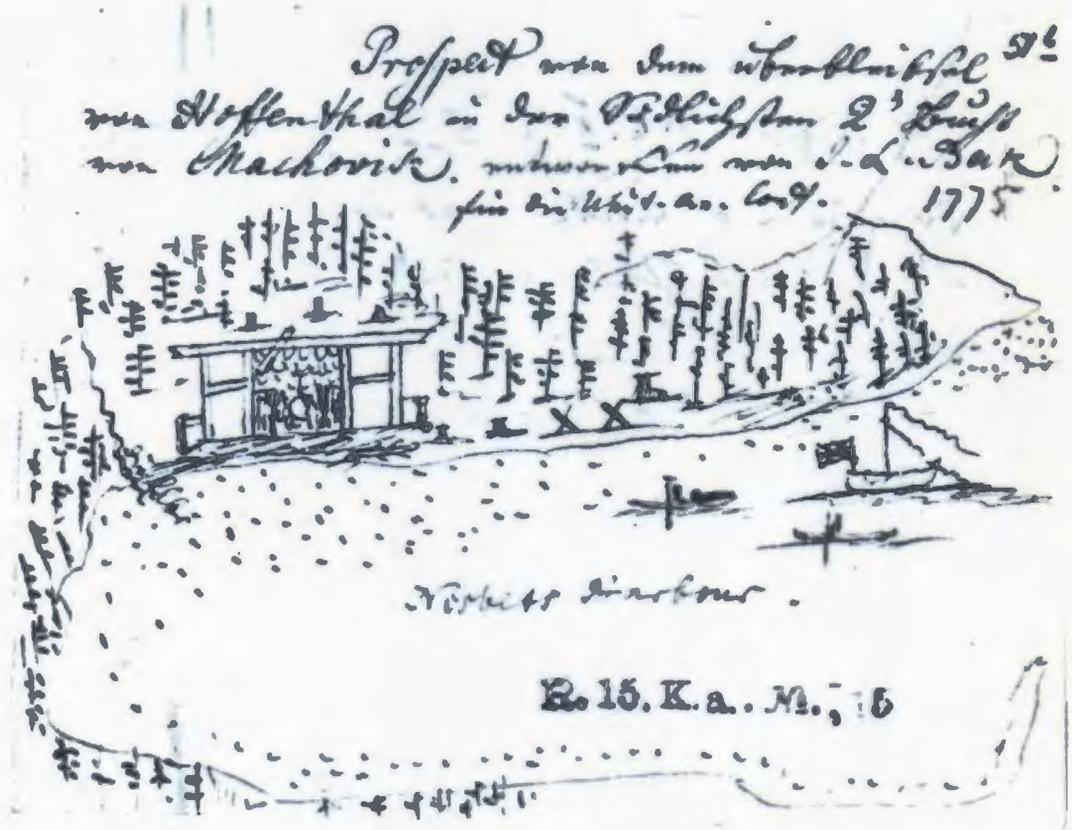
Figure 38: J.L. Beck's sketch of the Hoffnungsthal ruins during Jens Haven's visit in 1775. The caption reads: "Prospect of the remnants of Hoffenthal in the southernmost second bay of Machovik [sic]. sketched by J.L. Beck for the Unity Elders Conference 1775" (Courtesy H. Rollmann and Unity Archives).

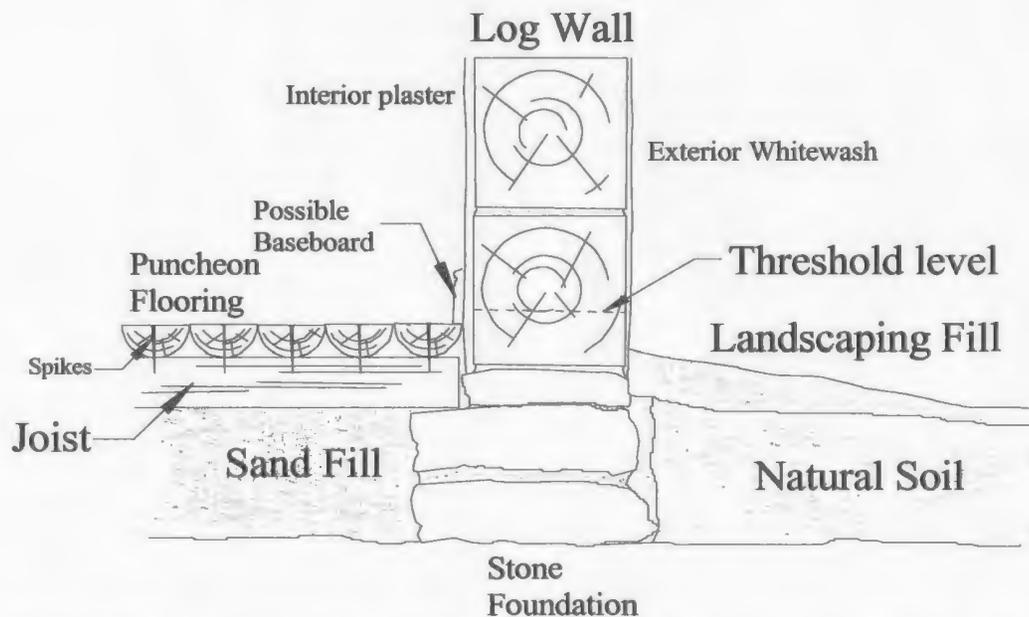
Figure 40: Conjectural cross-section of the foundation, walls, floor and surrounding fill at Hoffnungsthal (drawing by H. Cary from sketch by J. Larson, 2004).

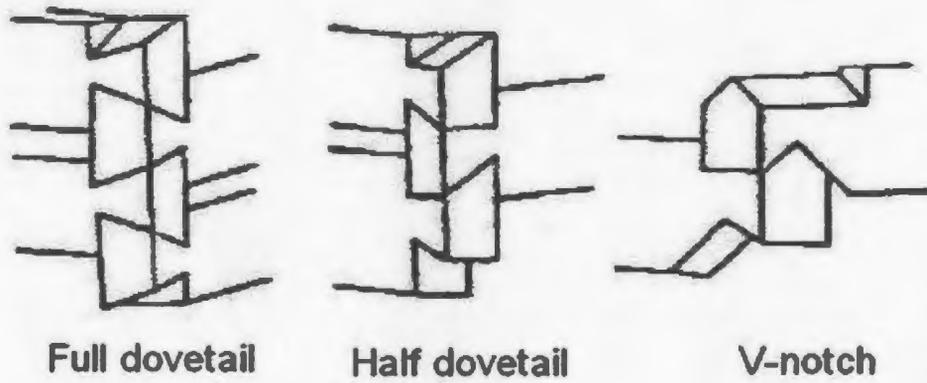
Figure 41: Three corner notching techniques that may have been used at Hoffnungsthal.
