HOFFNUNGSTHAL: THE ARCHAEOLOGY AND ARCHITECTURE
OF THE FIRST MORAVIAN MISSION TO THE LABRADOR INUIT,
1752

A thesis submitted to the
School of Graduate Studies
in partial fulfilment of the
requirements for the degree of
Master of Arts

Department of Anthropology/ Archaeology Unit
Memorial University of Newfoundland

October 2004

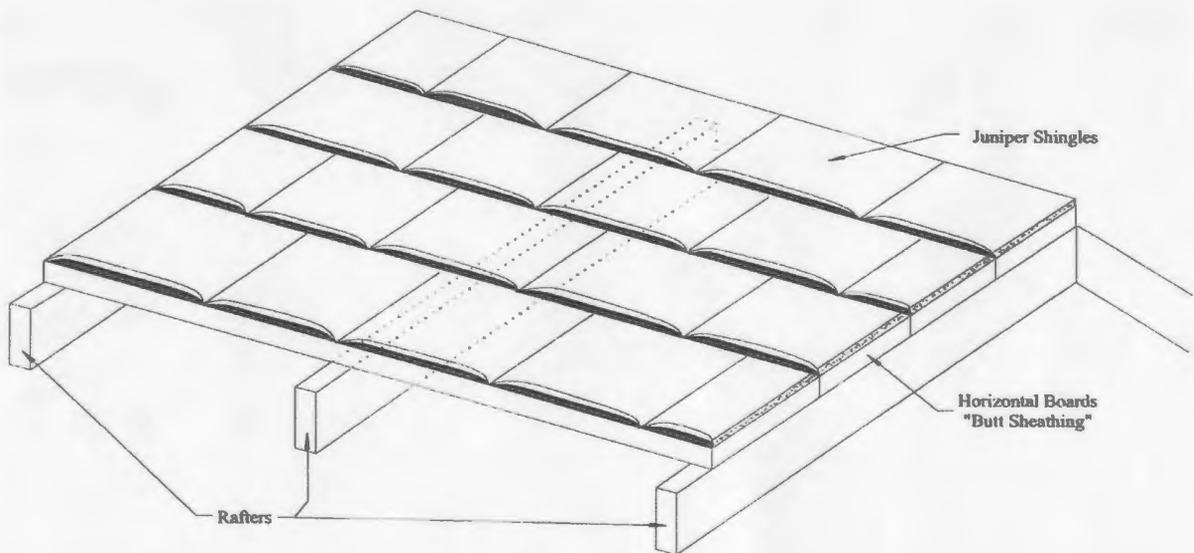
Figure 42: Shingles laid over butt sheathing and rafters.

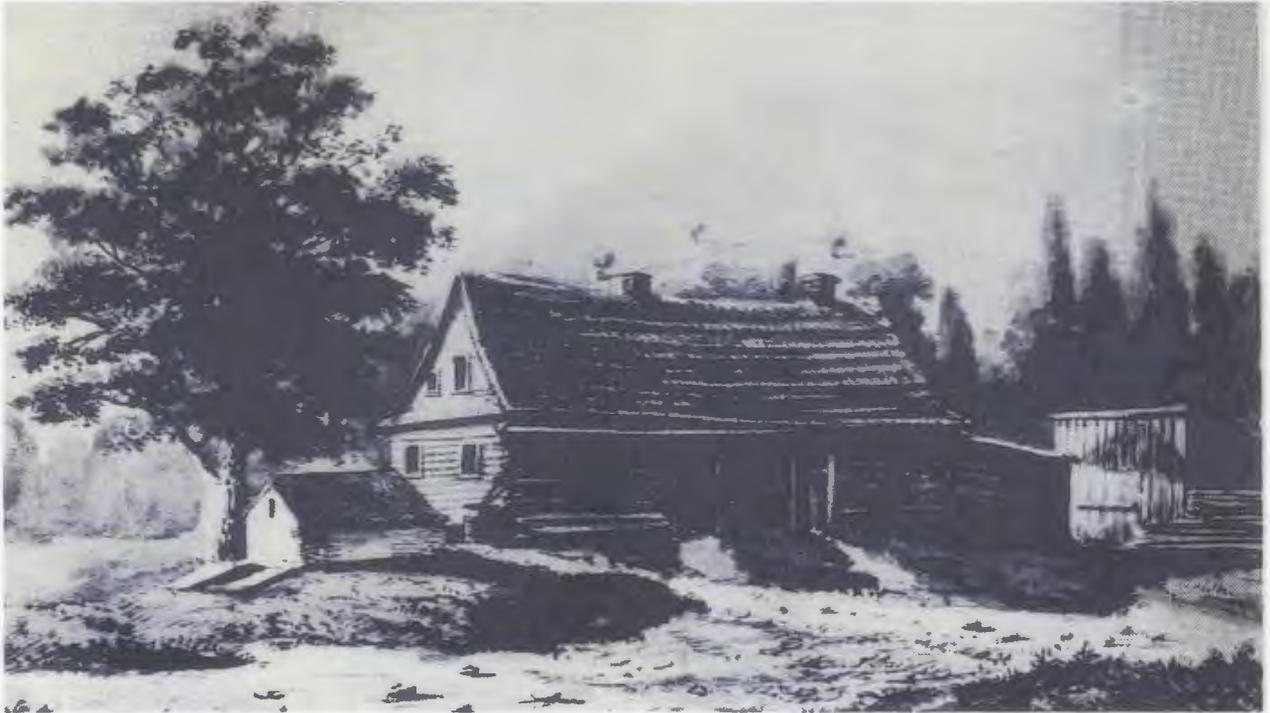
Figure 43: Artist's conception of Bethlehem, Pennsylvania's first Moravian building. Note the kick roof construction at the eaves (From Jordan 1974:2).

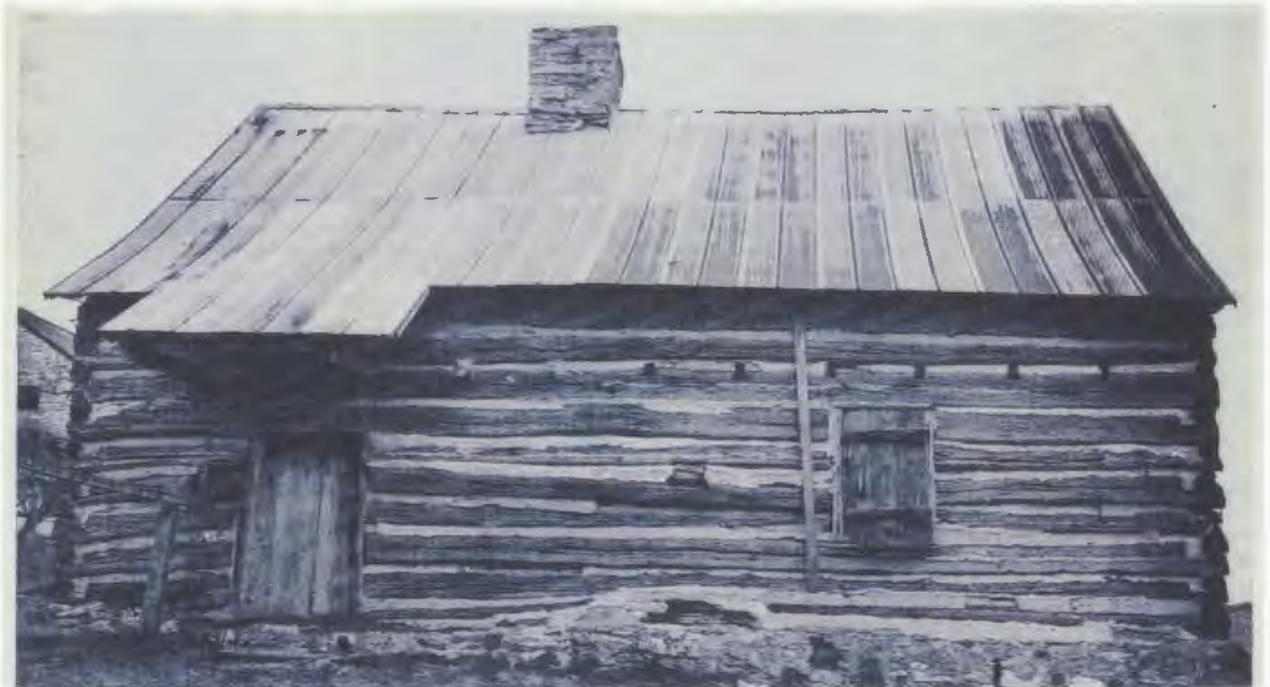
Figure 44: The Bertolet House of Berks County, Pennsylvania showing a pent roof over the doorway (From Glassie 1968:39).

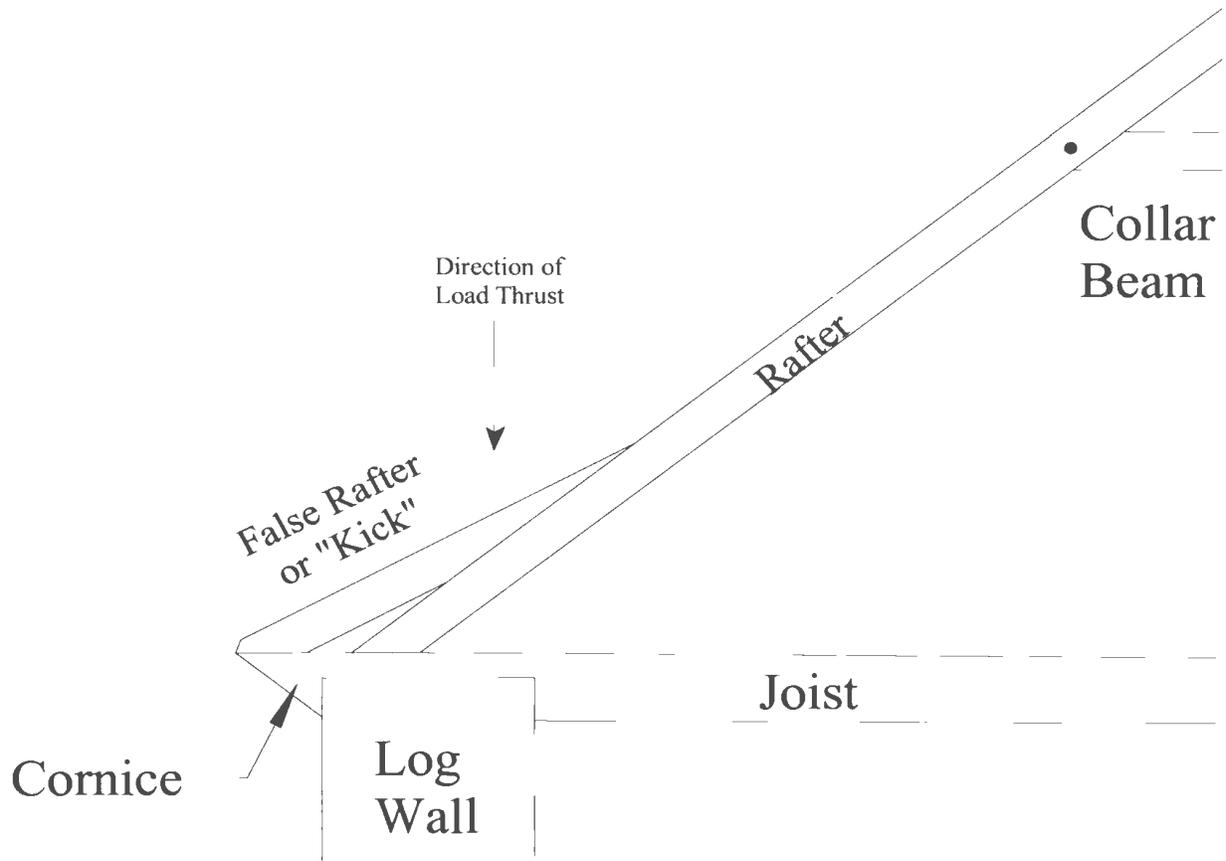
Figure 45: Conjectural cross-section of the “kick” rafter and truss arrangement for Hoffnungsthal’s roof. The bevelled cornice is taken from Beck’s 1775 sketch (Figure 38) (drawn by H. Cary from a sketch by J. Larson, 2004).

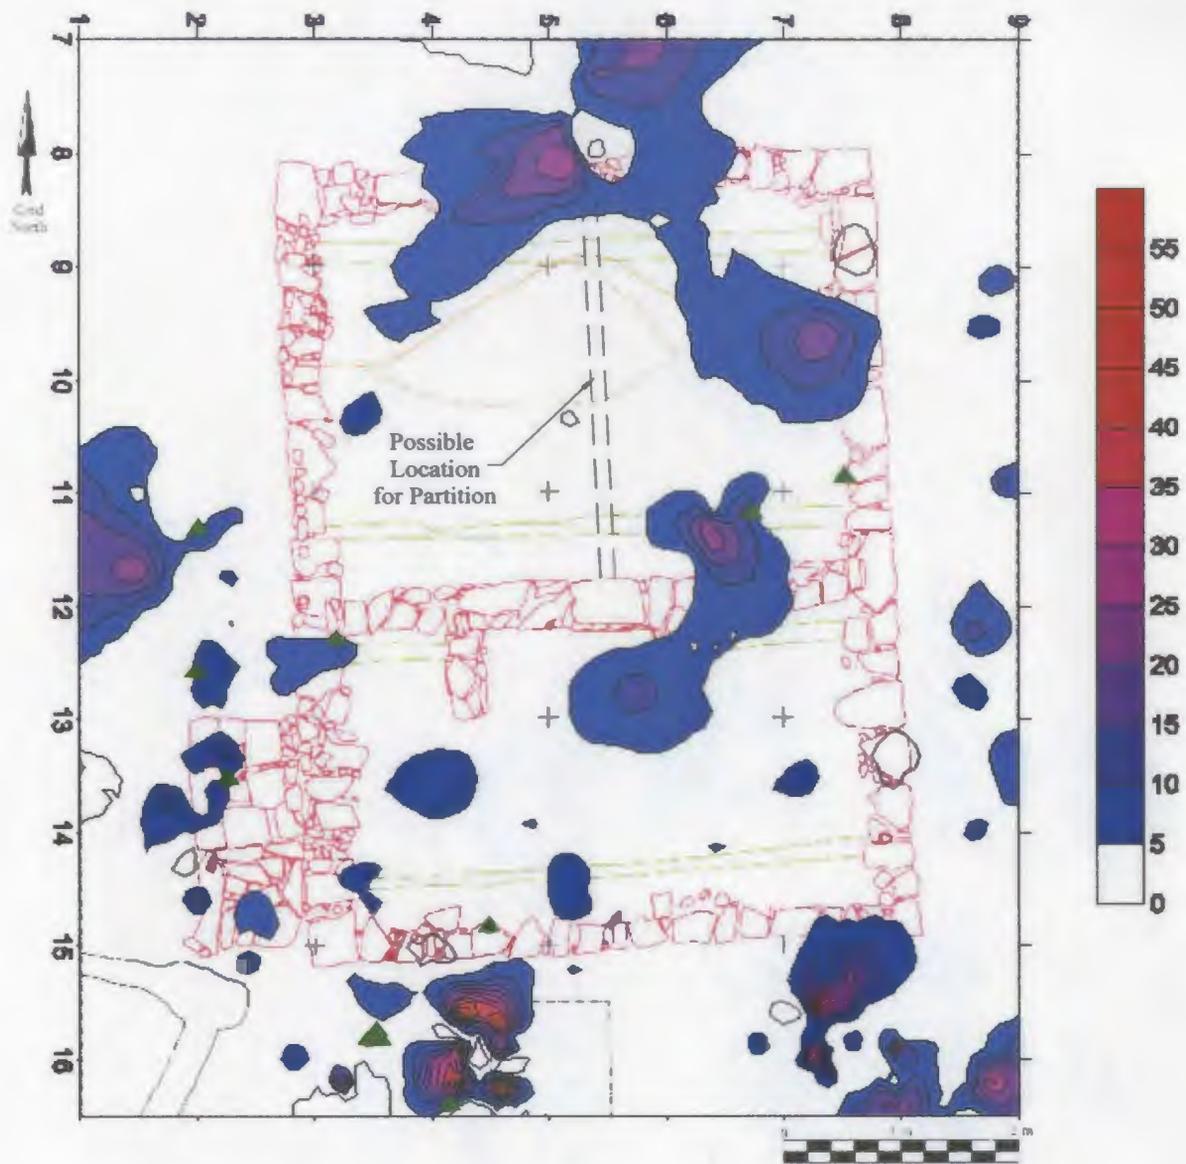
Figure 46: Surfer© plot of the window glass frequencies and lead coming find spots (marked with green triangles) (n=3079) uncovered at Hoffnungsthal (Plan by H. Cary and J. McKay, Surfer© plan by H. Cary).

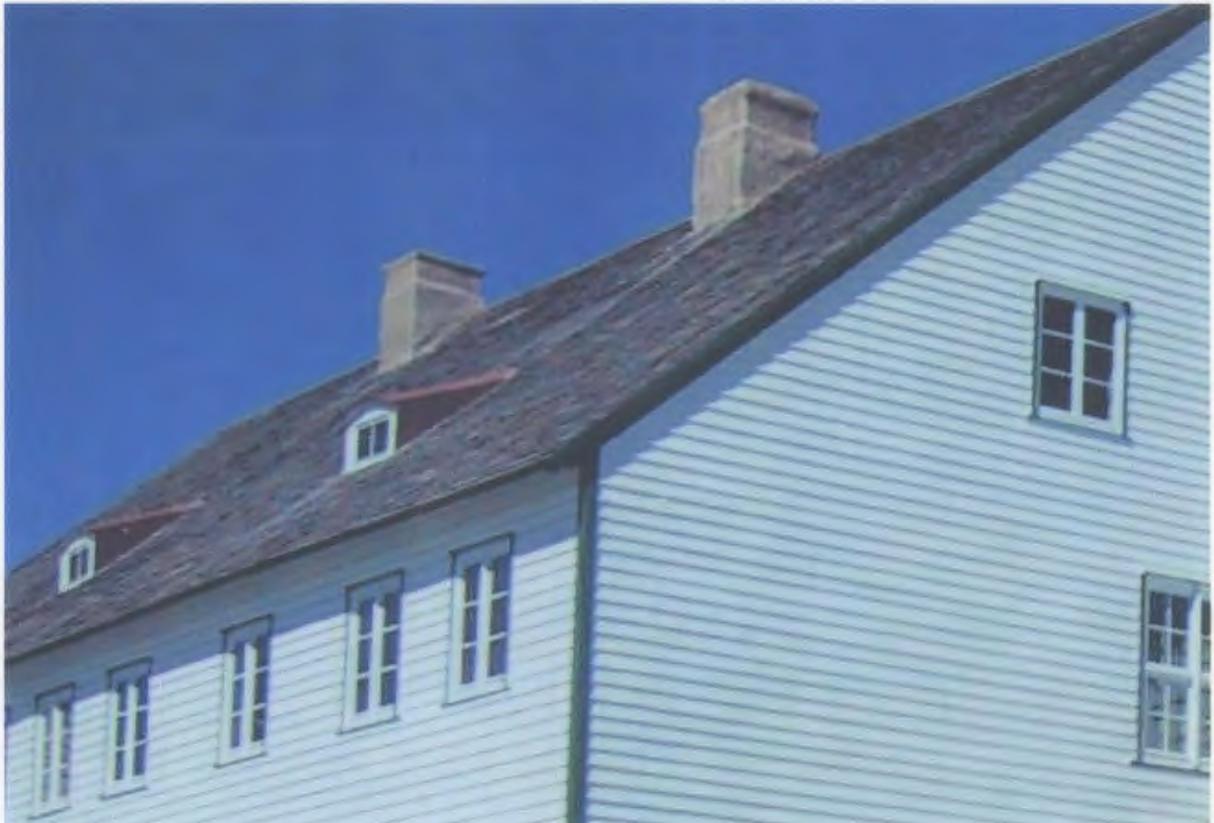
Figure 47: Simple shed dormers on the mission building at Hopedale. (Photo by G. Price).

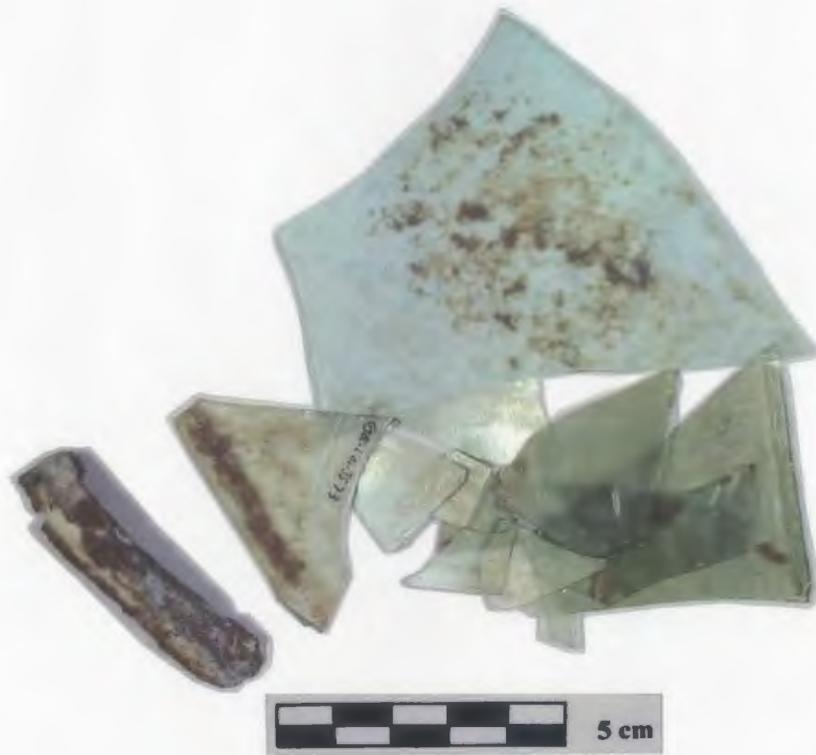
Figure 48: A sample of window came (far left) and glass fragments recovered from Hoffnungsthal. The glass piece nearest the came has traces of red paint along its border (Photo by H. Cary).

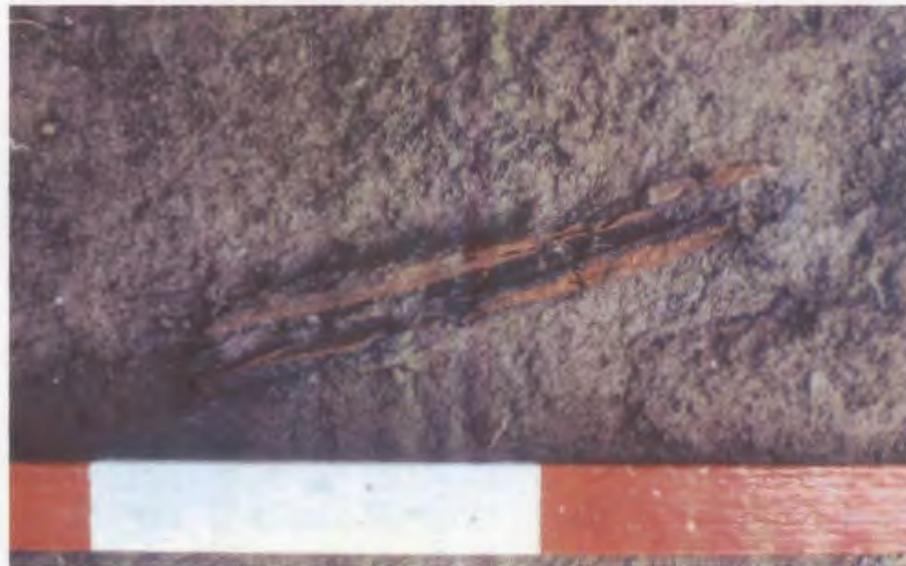
Figure 49: Red painted wood uncovered at Hoffnungsthal believed to originate from a window frame (Photo by H. Cary).

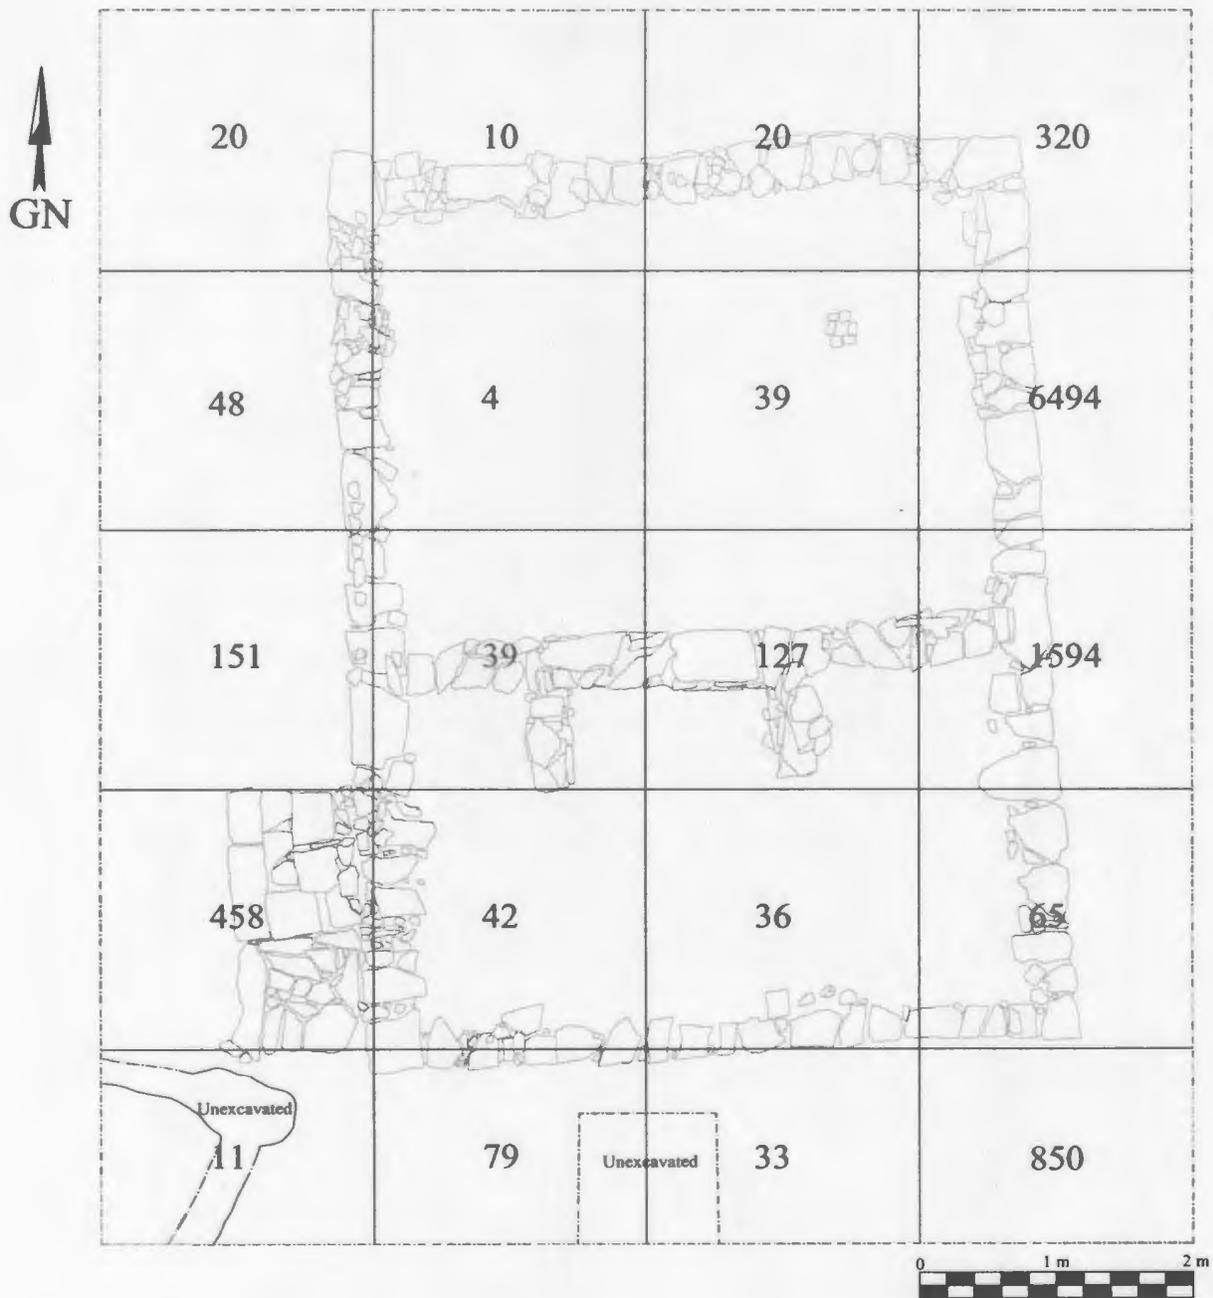
Figure 50: Total artefacts, excluding glass and coming fragments, recovered from each excavation unit (n=10 433). Note the high concentrations around the northeast corner and the stone steps (Map by H. Cary and J. McKay from originals by H. Cary).

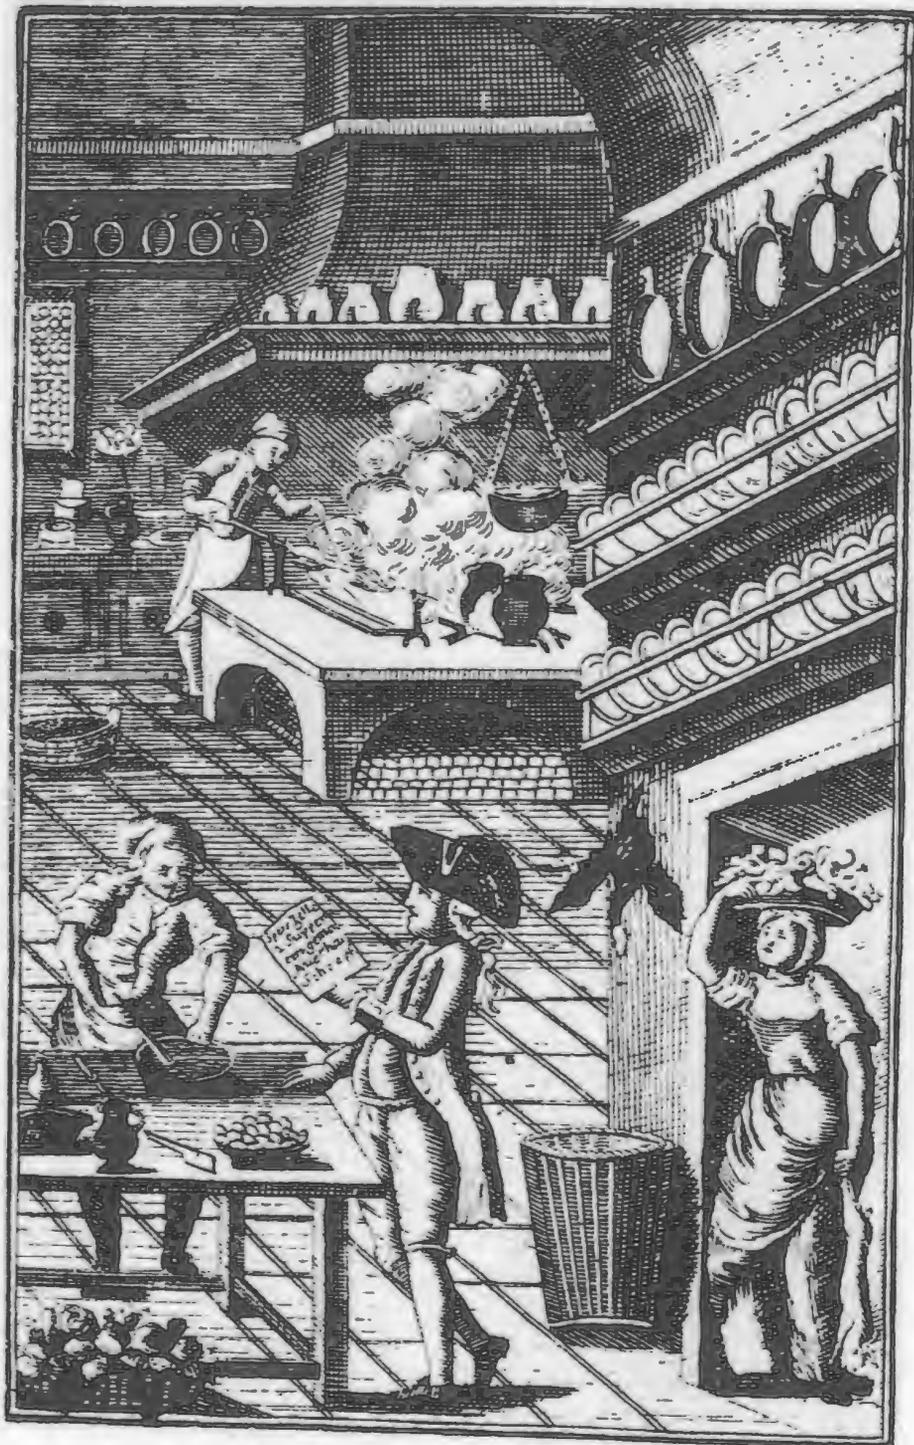
Figure 51: A raised hearth in an early nineteenth-century German kitchen (From *Grätzerisches Kochbuch Graz*: Johann Andreas Kienreich, 1802 frontis, reprinted in Weaver 1986:256).

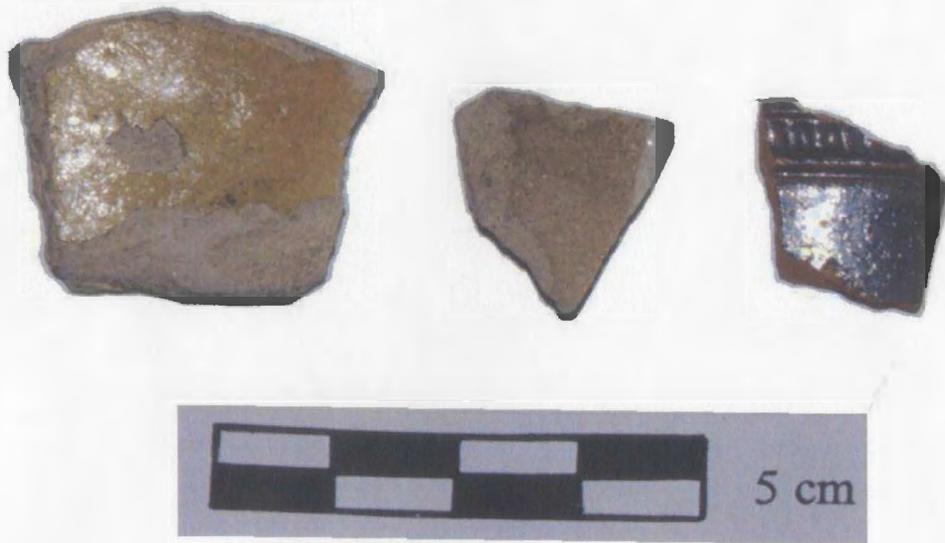
Figure 52: The three ceramic fragments recovered from Hoffnungsthal. The two fragments on the left mend together and are of buff earthenware with a glazed exterior. On the right is a rim fragment from a finer red earthenware vessel with decorative moulding (Photo by H. Cary).

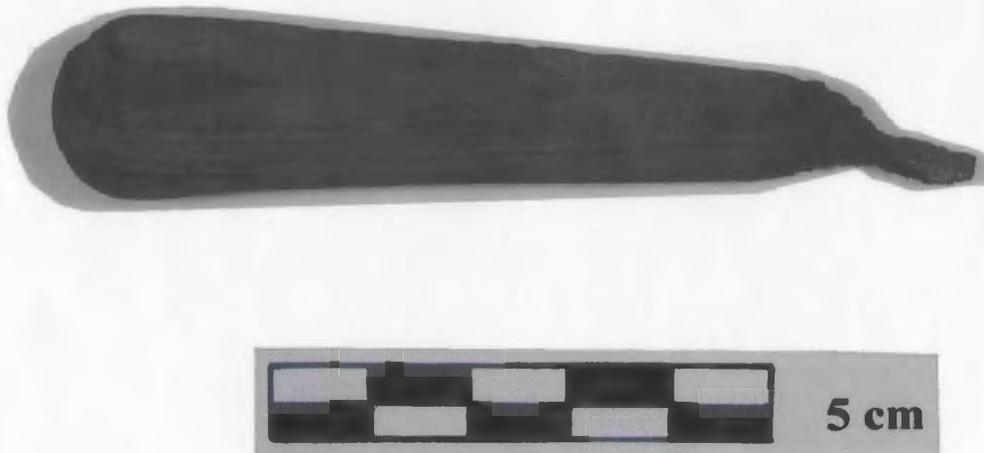
Figure 53: Wood fork handle uncovered outside the west foundation wall. The two tines were not found (Photo by H. Cary).

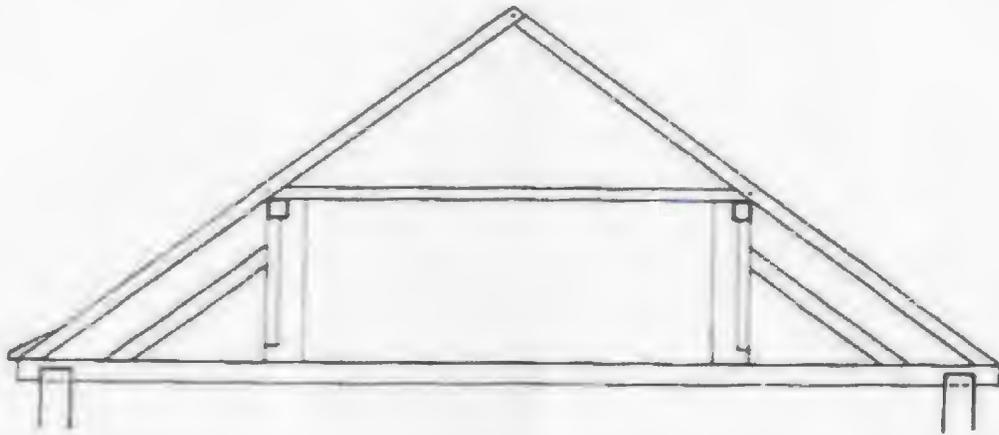
Figure 54: Rafter design of the Abraham Spitler House, Pennsylvania, also found on Moravian structures in Winston-Salem, North Carolina (From Chappell 1986:33 based on measurements by Dell Upton).

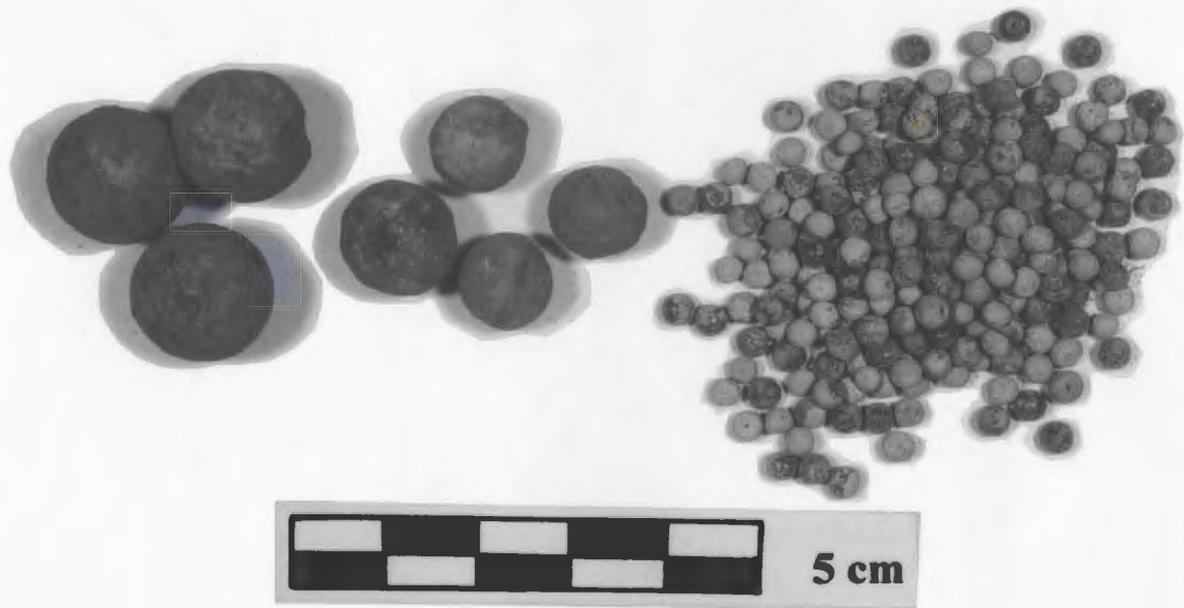
Figure 57: A sample of the musket balls and shot unearthed at Hoffnungsthal (Photo by H. Cary).

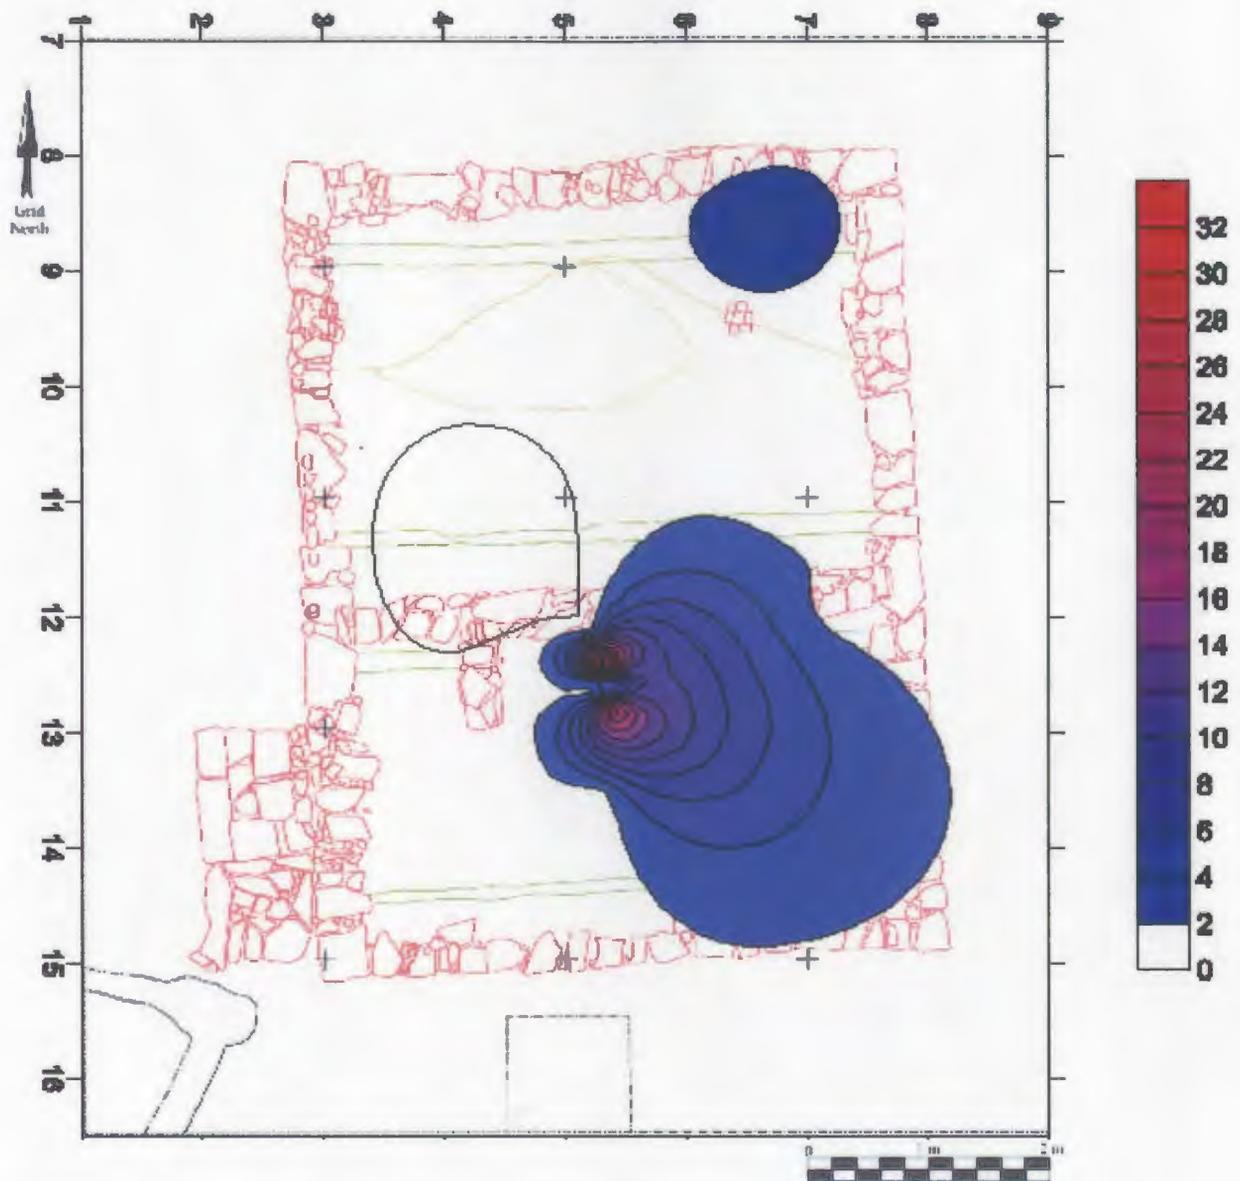
Figure 58: Surfer© plot of the nail and spike finds (n=164) at Hoffnungsthal. Compare the distributions shown here with the chimney collapse boundaries (Lot 9) illustrated in Figure 33 (Plan by H. Cary and J. McKay, Surfer© plan by H. Cary).

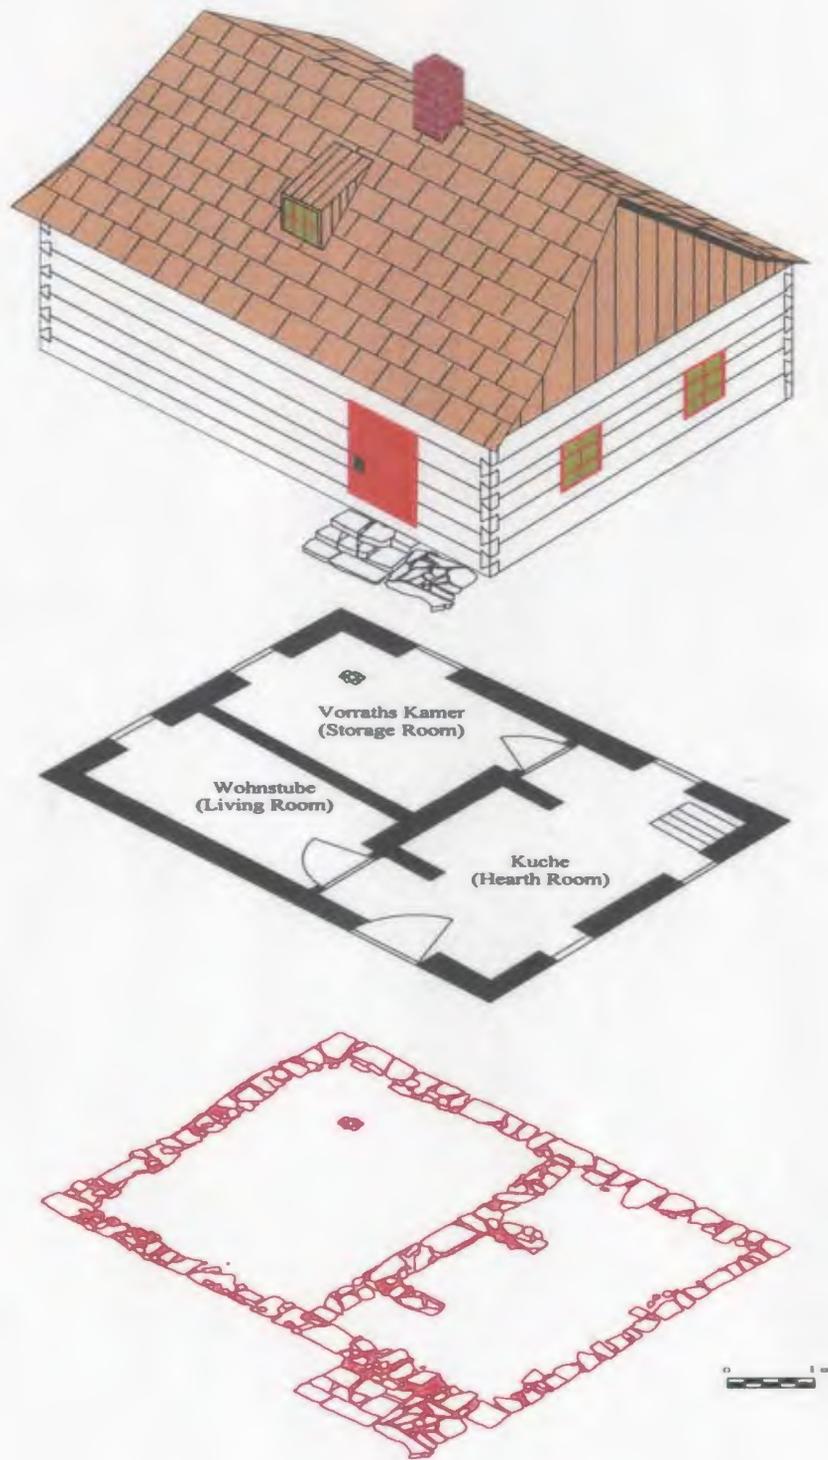
Figure 59: A conjectural reconstruction of the Hoffnungsthal mission house. For clarity the east dormer window is omitted.
