# **An Investigation of the Effectiveness of a Partial Cladding Pattern on Aluminum 7075 T651**

A thesis submitted to the  
School of Graduate Studies  
in partial fulfillment of the  
requirements for the degree of  
Masters of Engineering

Faculty of Engineering and Applied Science  
Memorial University of Newfoundland

January 2016

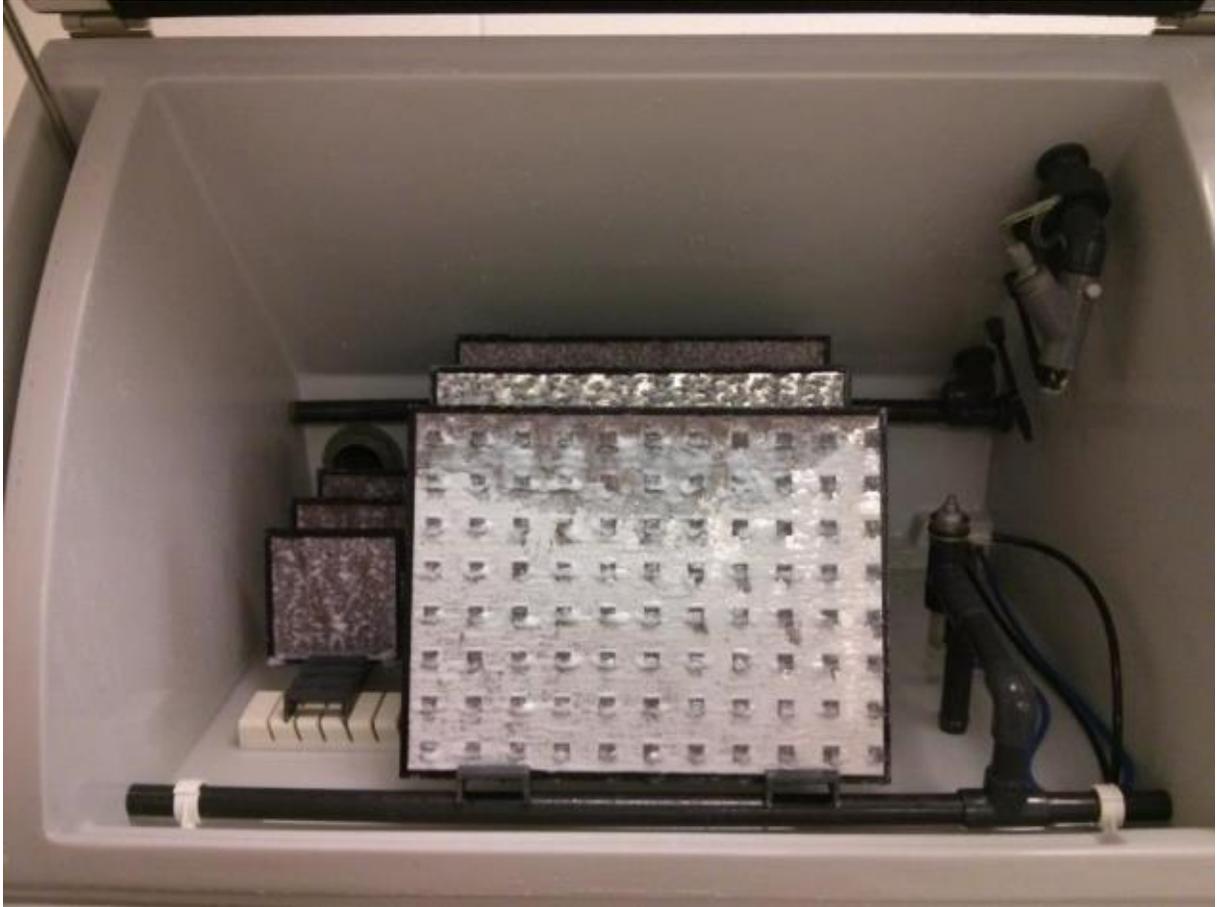
The samples were arranged in the salt spray cabinet at an angle of 10° and spaced out in such a way that the acetic salt fog collected on a sample would not drip onto other samples. An example of such an arrangement can be seen in Figure 4.1. The cabinet temperature was kept at 36°C. The rate of fog deposition within the salt spray chamber was adjusted to 1.0 to 2.0 mL per hour per 80 cm<sup>2</sup> horizontal area by varying the acetic salt spray solution flow rate and the air supply pressure to the fog atomizer. The rate of fog deposition was measured with two 10 cm diameter circular fog collectors, one placed near the fog atomizer and the other furthest possible away. The volume of collected fog was measured every 24 hours during the test (excluding weekends and holidays) and the pH and density were determined to ensure proper corrosion environment conditions in the salt spray chamber.

**Figure 4.1: Inside of the salt spray chamber**

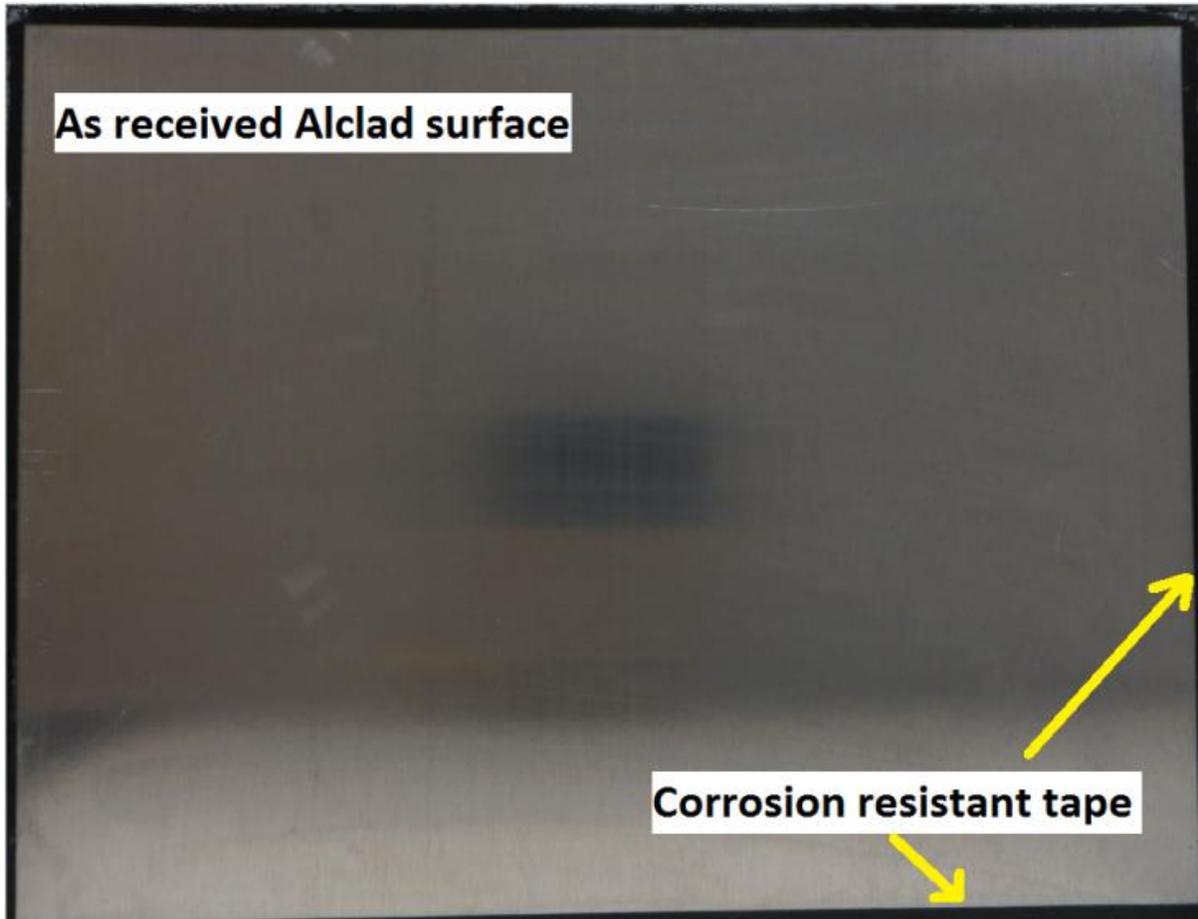
The goal of the medium sized test panels was to compare the corrosion resistance of fully clad, spot clad and bare aluminum 7075 T651 alloy in an acidic salt fog environment. The fully clad panel, seen in Figure 4.2, was cut from the original Alclad aluminum plate and was left in the as delivered condition.

**Figure 4.2: Fully clad medium sized test panel with corrosion resistant tape**

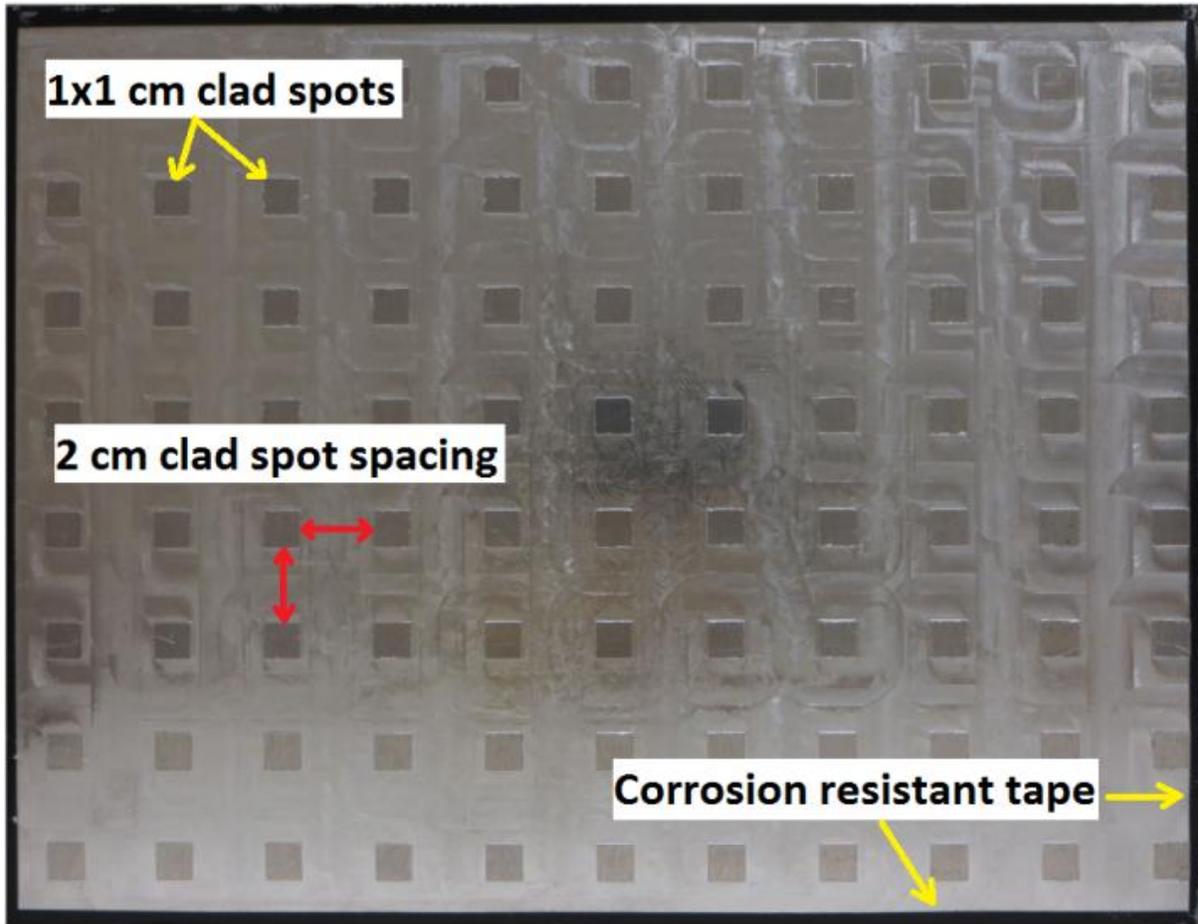
The front surface of the spot clad panel, seen in Figure 4.3, was machined by removing 0.19 mm from the plate thickness with a CNC milling machine to produce an array of 1x1 cm square clad spots spaced 2 cm from each other. The dimensions used in the spot clad pattern were determined from the first 1 cm<sup>2</sup> central clad spot corrosion experiment. Milling marks were not removed from the partially clad test panel.

**Figure 4.3: Partial cladding pattern medium sized test panel with corrosion resistant tape**

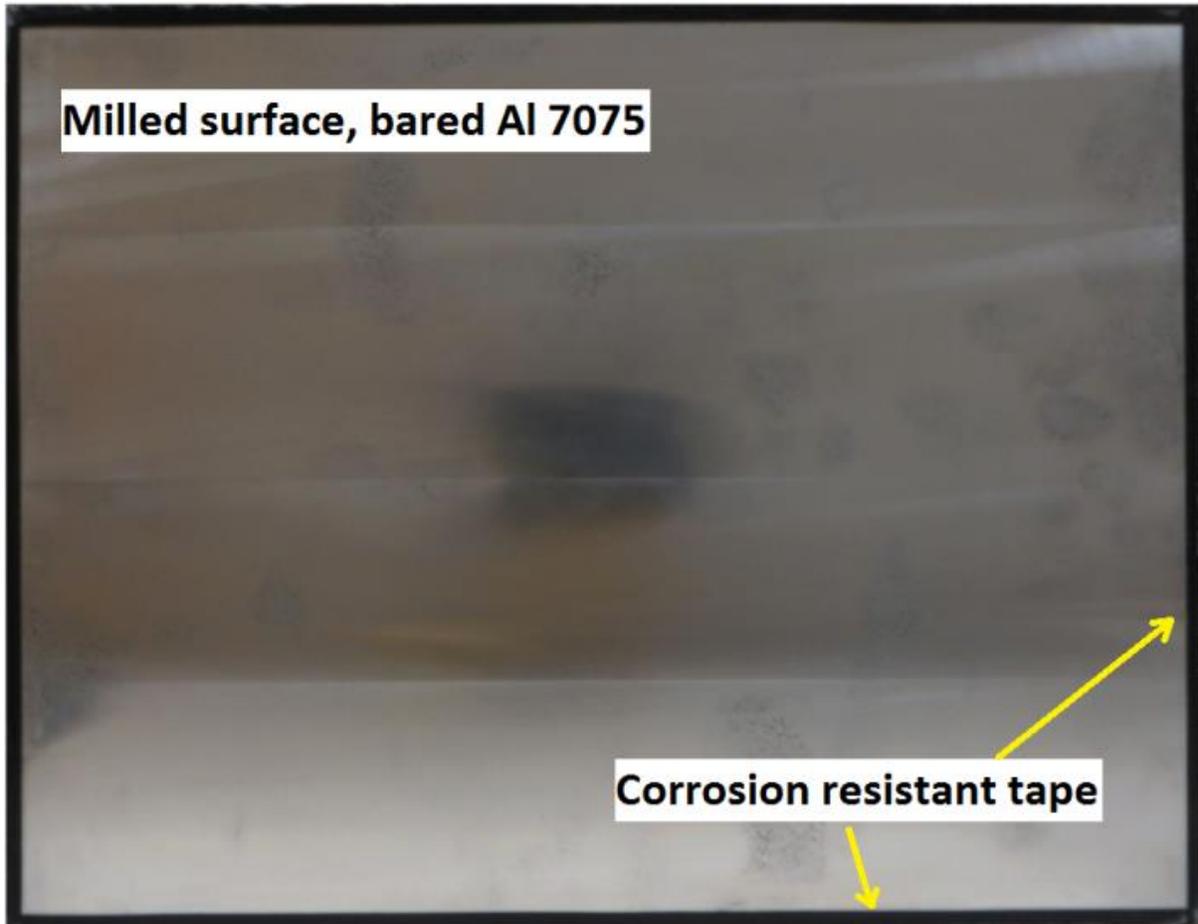
The bare aluminum 7075 T651 panel, seen in Figure 4.4, was produced by mechanically milling 0.19 mm from the entire plate thickness. Milling marks were not removed from the bare aluminum panel. All three panels have an exposed surface area of approximately 30x25 cm after the application of the corrosion resistant tape. After the 300 hour exposure to the acidic salt fog corrosion environment, tensile test specimens, fatigue test specimens and representative cross-sections were cut from each the medium sized test panels.

**Figure 4.4: Cladding removed medium sized test panel with corrosion resistant tape**

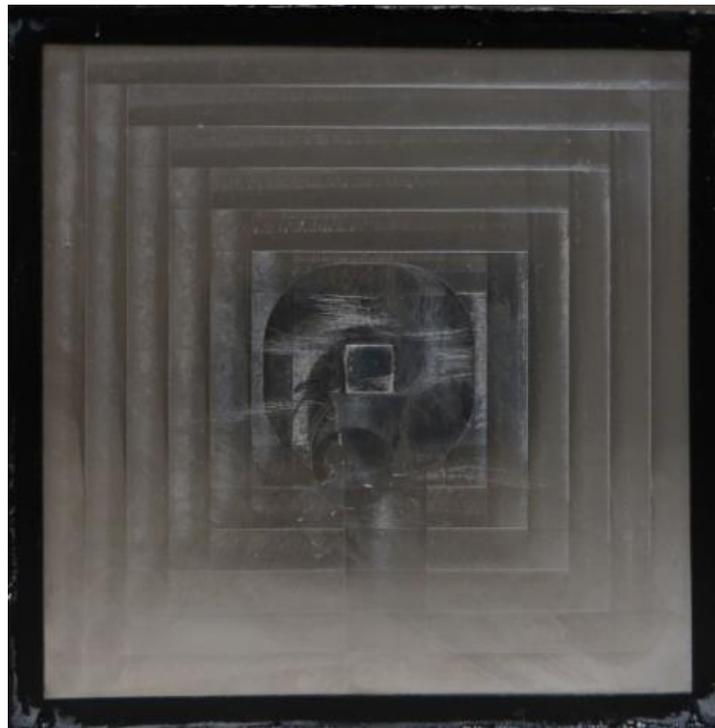
**Figure 4.5: 0.5 cm<sup>2</sup> central clad spot panel with corrosion resistant tape**

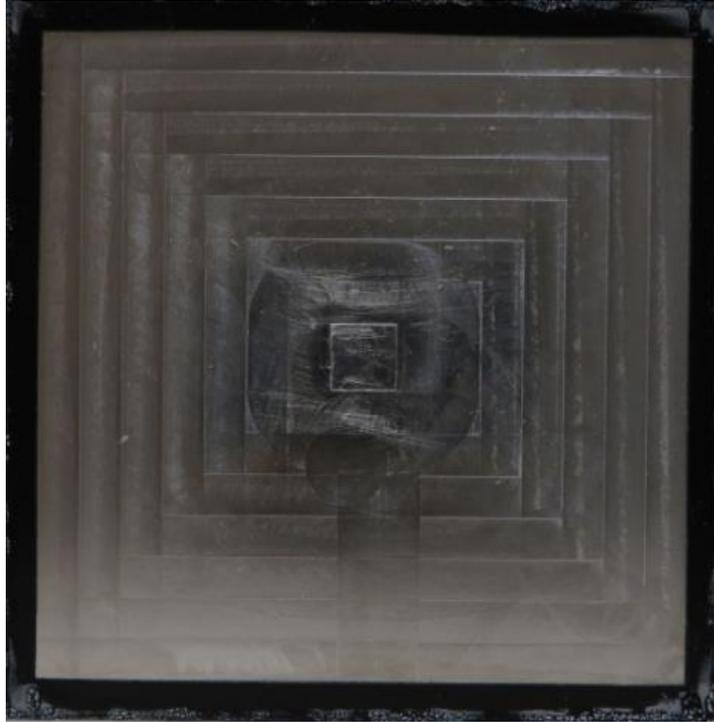
Figure 4.6: 1 cm<sup>2</sup> central clad spot panel with corrosion resistant tape

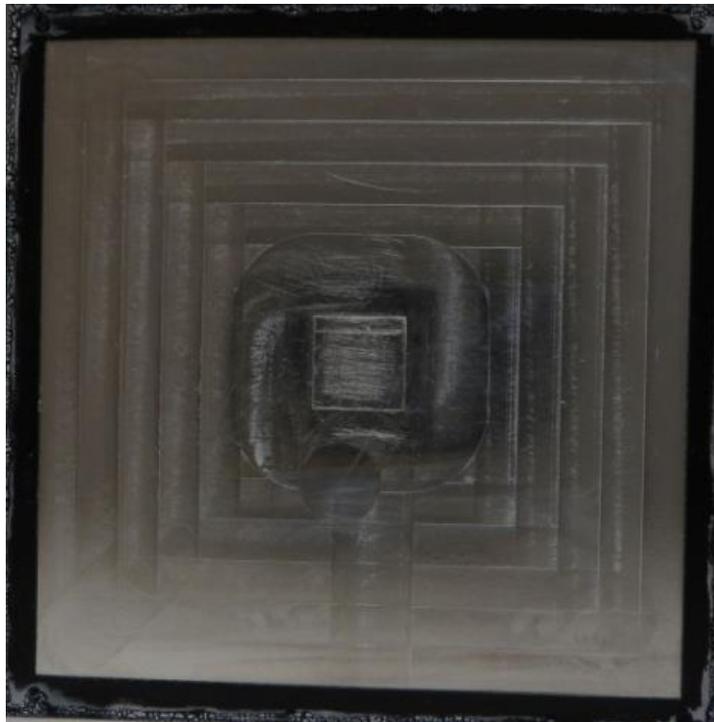
Figure 4.7: 2 cm<sup>2</sup> central clad spot panel with corrosion resistant tape

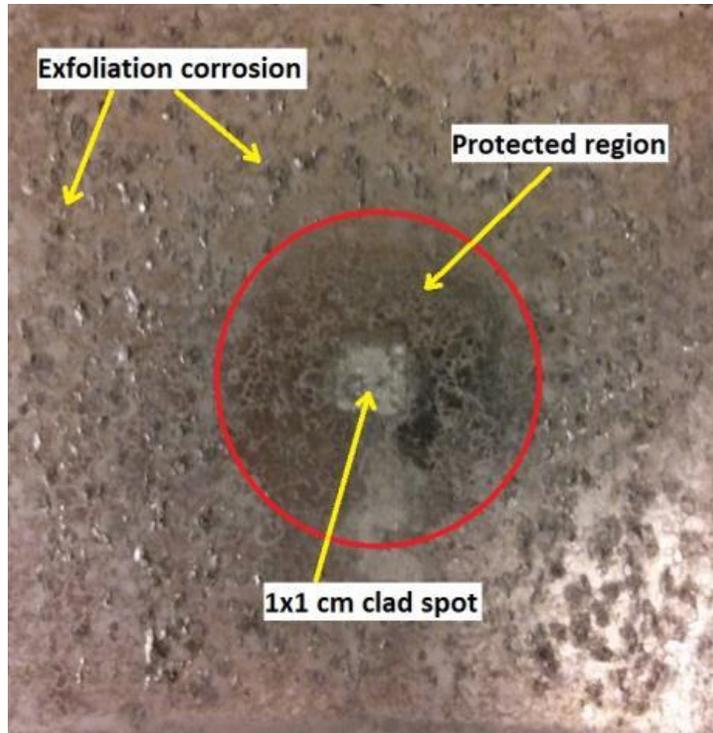
Figure 5.1: Cleaned central clad spot panel

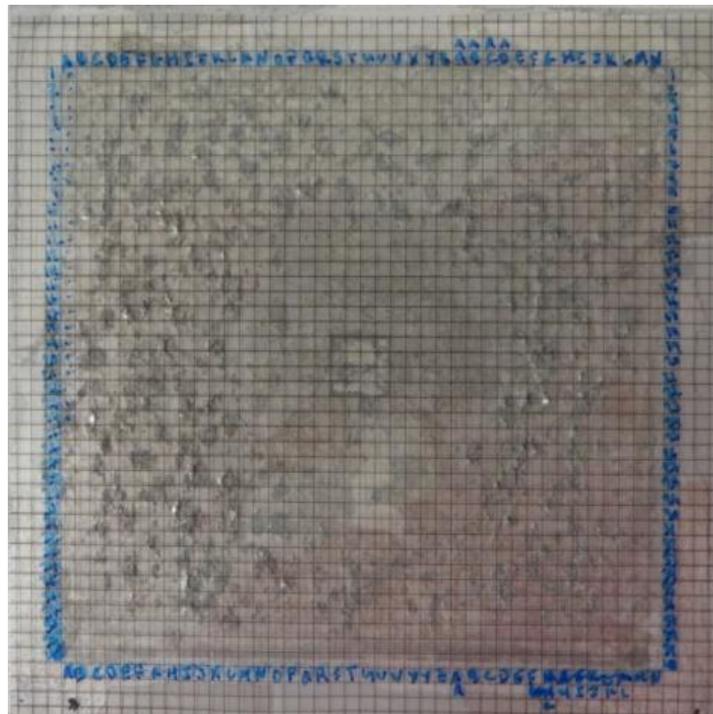
In an effort to quantify the severity and location of the corrosion damage relative to the clad spot, the machining method for determining pit depth described in ASTM G46: Standard Guide for Examination and Evaluation of Pitting Corrosion [29] was adapted to be used with corrosion that more closely resembles exfoliation. As shown in Figure 5.2, a 2.5 mm grid was applied to the corroded surface of the panel and the percent area of the panel surface affected by corrosion was visually estimated in each grid section.

Figure 5.2: Cleaned central clad spot panel with the application of a 2.5mm grid

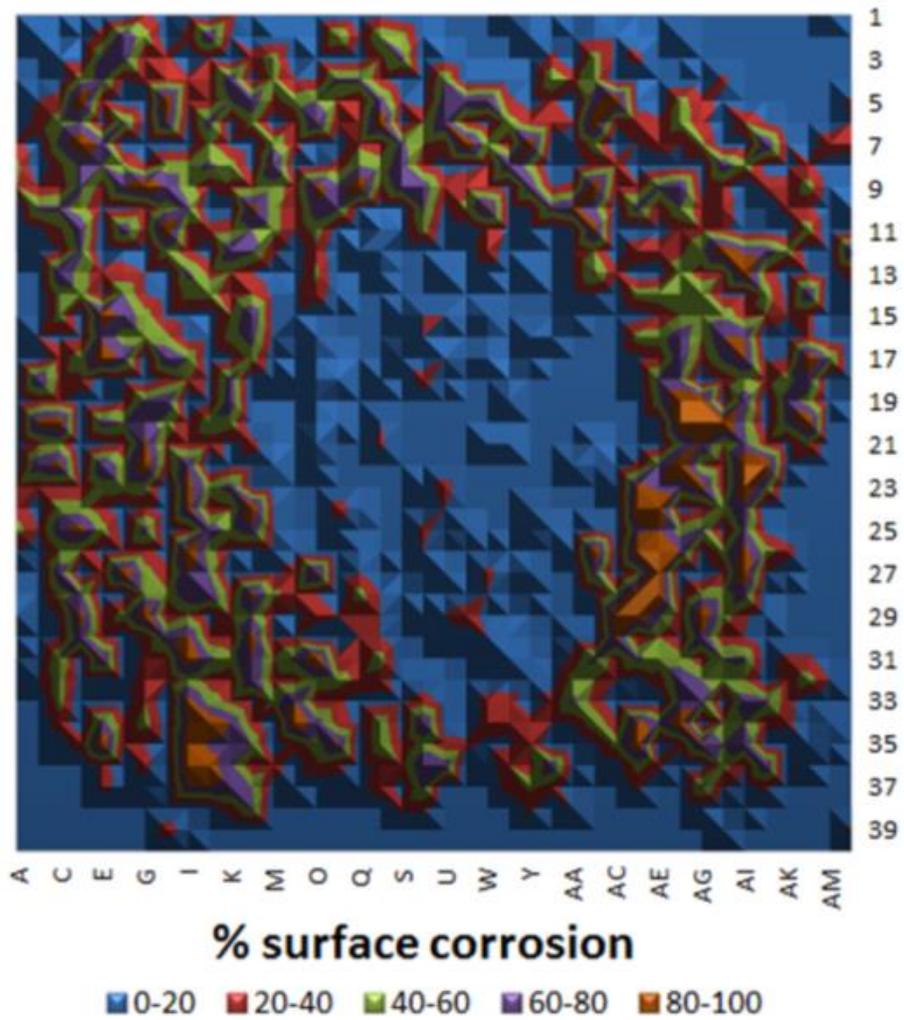
These values were then graphically represented in a surface plot, shown in Figure 5.3. This was done for two reasons. The first was to better visualize the extent of corrosion damage relative to the central clad spot. Using the surface plot, the area of the panel protected by the clad spot was estimated as a 3x3 cm square, shown in Figure 5.4. These dimensions were then used to produce the medium sized test panel with a clad spot pattern. It was estimated that a two dimensional array of 1 cm<sup>2</sup> clad spots spaced 2 cm from each other would be sufficient to protect the panel surface from corrosion after a 300 hour exposure in the acidic salt spray environment.

Figure 5.3: Surface plot of the 1x1 central clad spot panel (no milling), 24% of the surface exhibits signs of corrosion

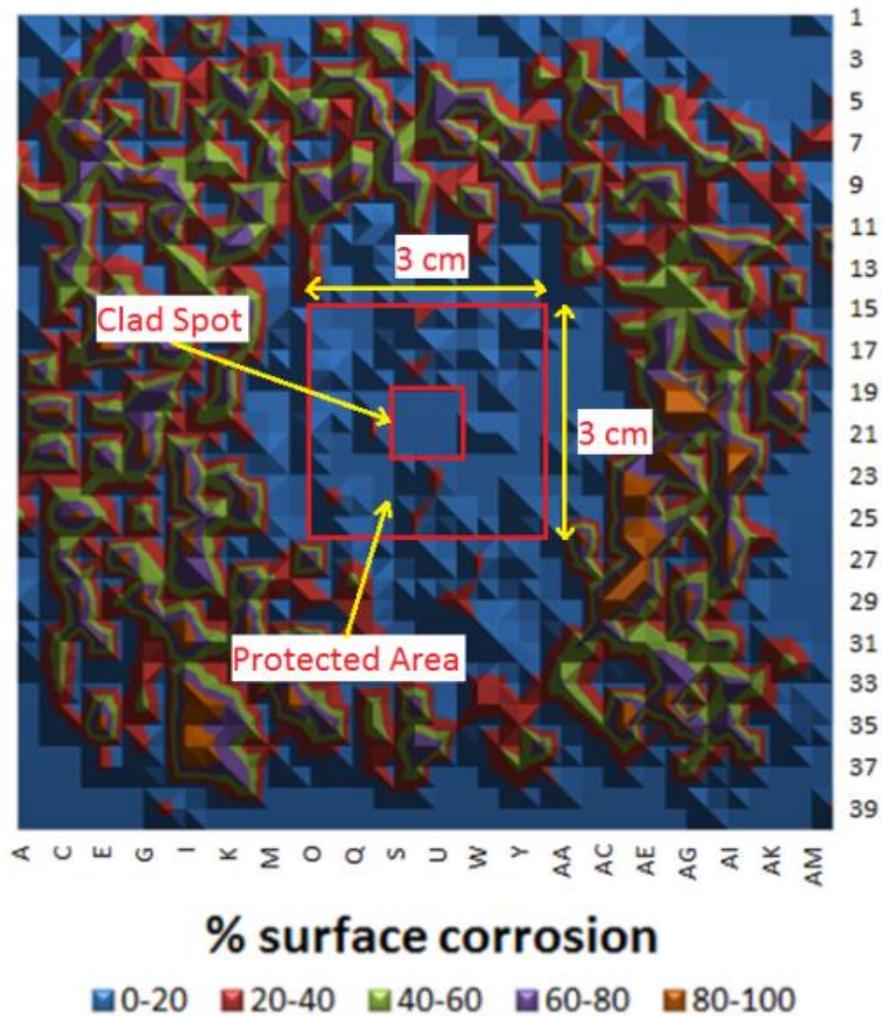
**Figure 5.4: Estimation of area protected by clad spot**

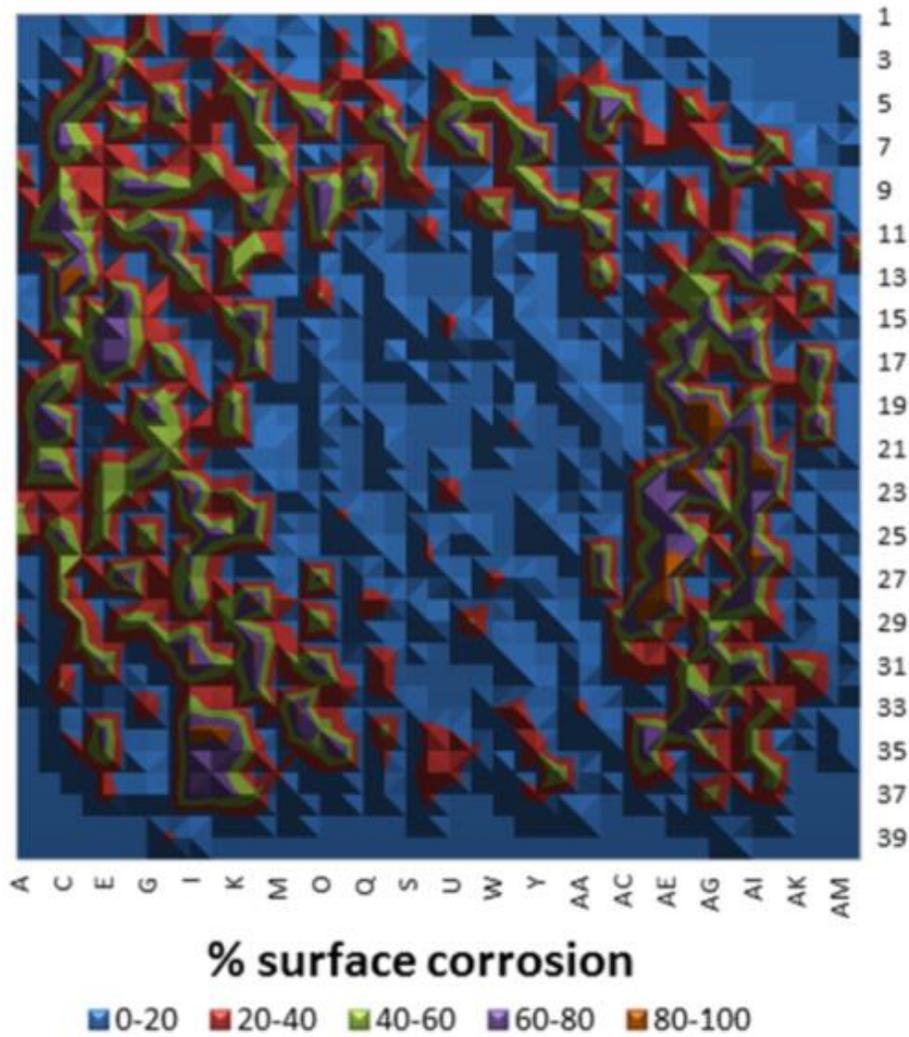
produced for each stage. In this way, the minimum corrosion depth and relative location to the clad spot could be determined. The results of the milling process for the central clad spot panel can be seen in Figures 5.5 and 5.6.

Figure 5.5: Surface plot of the central clad spot panel, 0.02 mm milled, 19% of the surface exhibits signs of corrosion

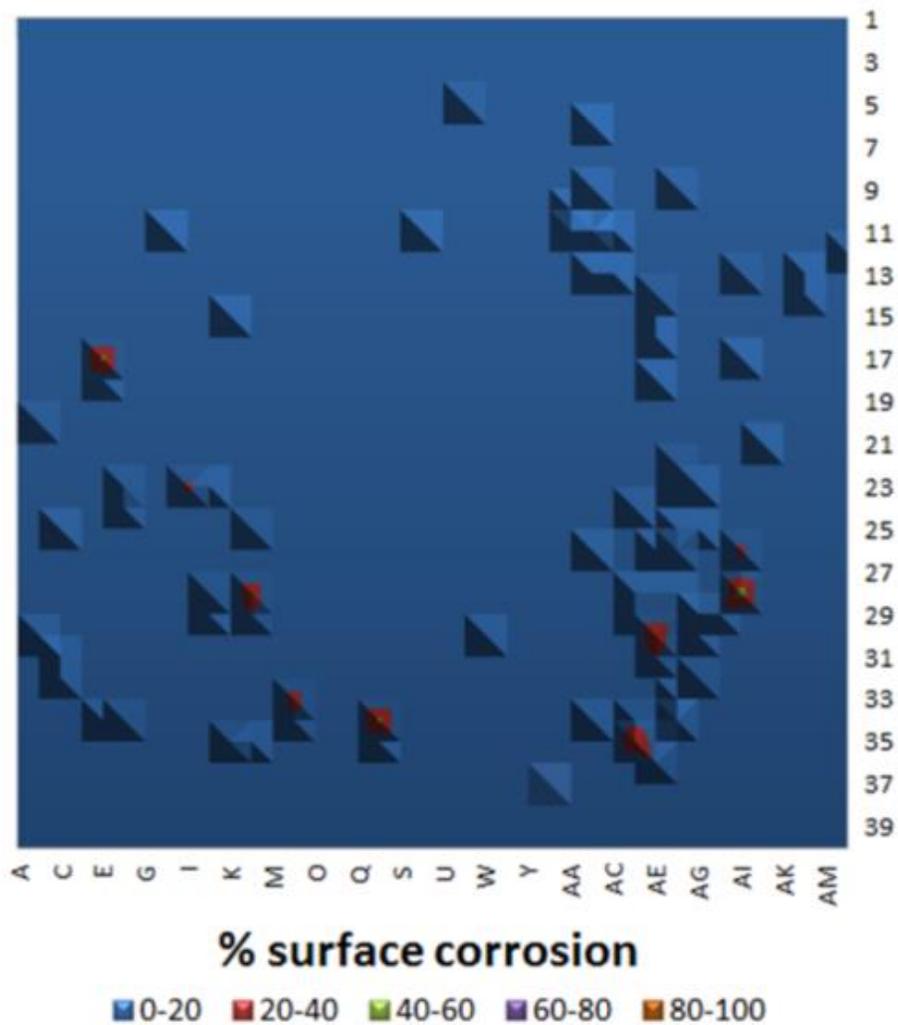
**Figure 5.6: Surface plot of the central clad spot panel, 0.17 mm milled. 0.6% of the surface exhibits signs of corrosion**

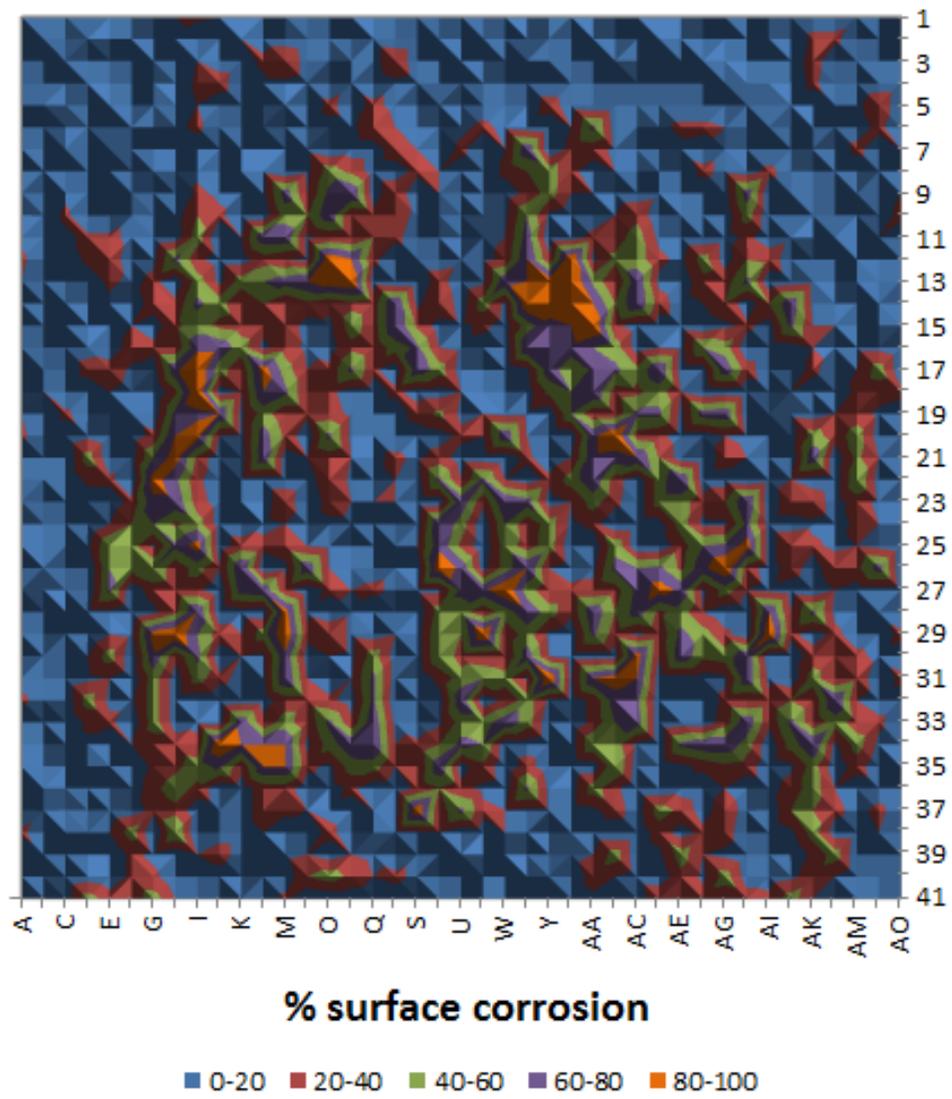
Figure 5.7: Surface plot of the 0.5 cm<sup>2</sup> central clad spot panel, no milling

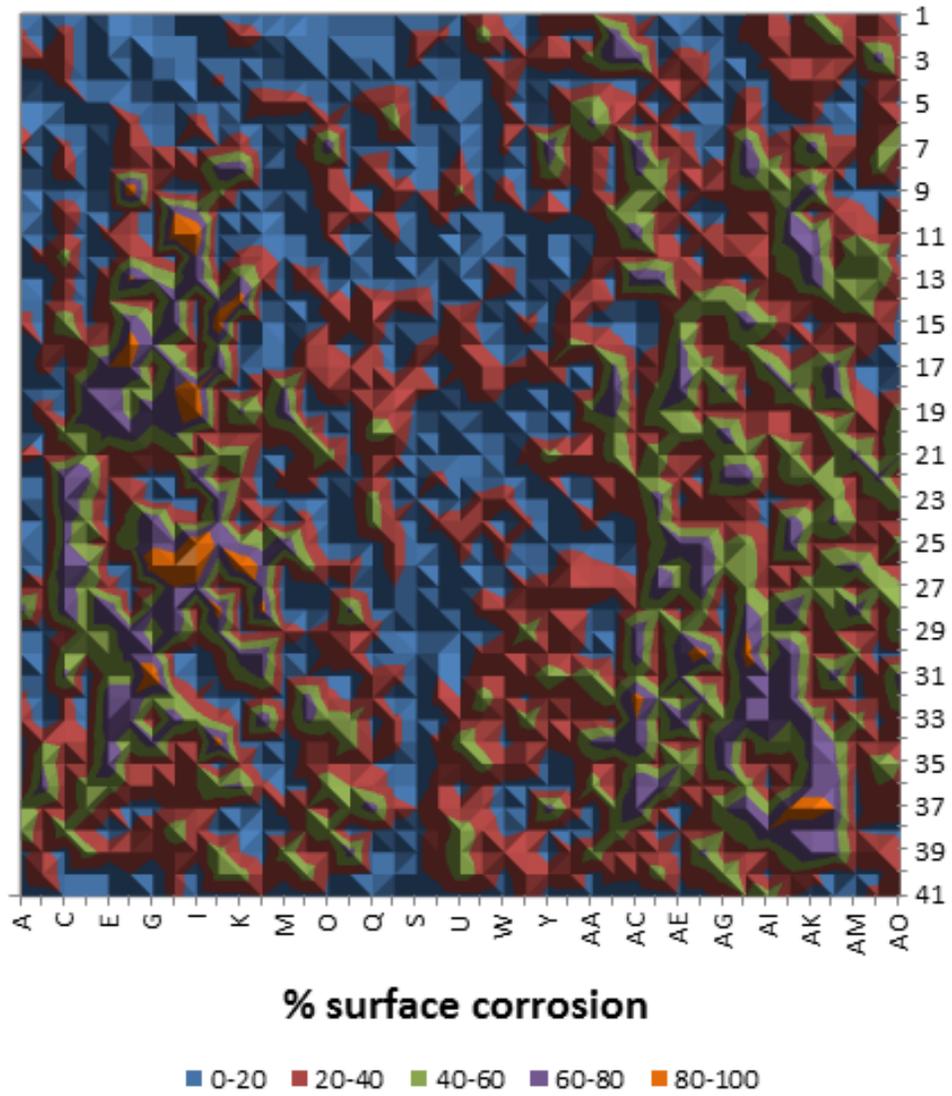
**Figure 5.8: Surface plot of the 1 cm<sup>2</sup> central clad spot panel, no milling**

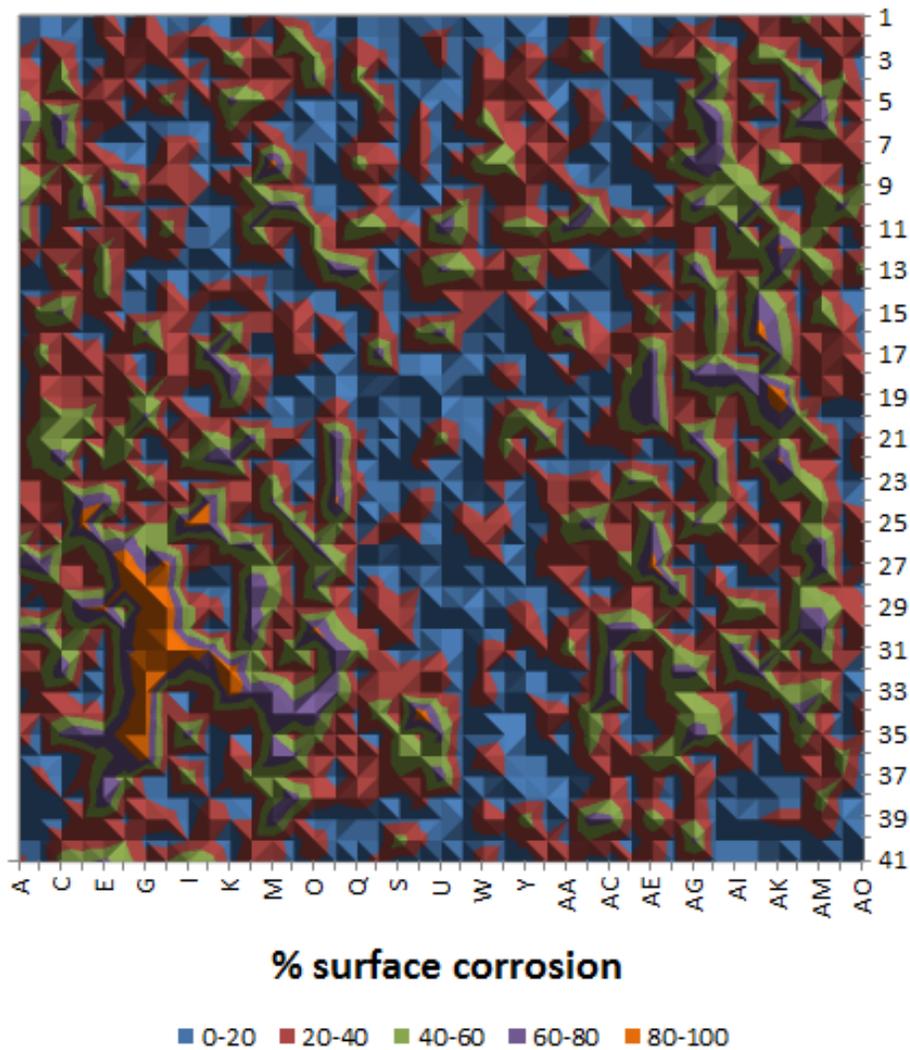
**Figure 5.9: Surface plot of the 2 cm<sup>2</sup> central clad spot panel, no milling**

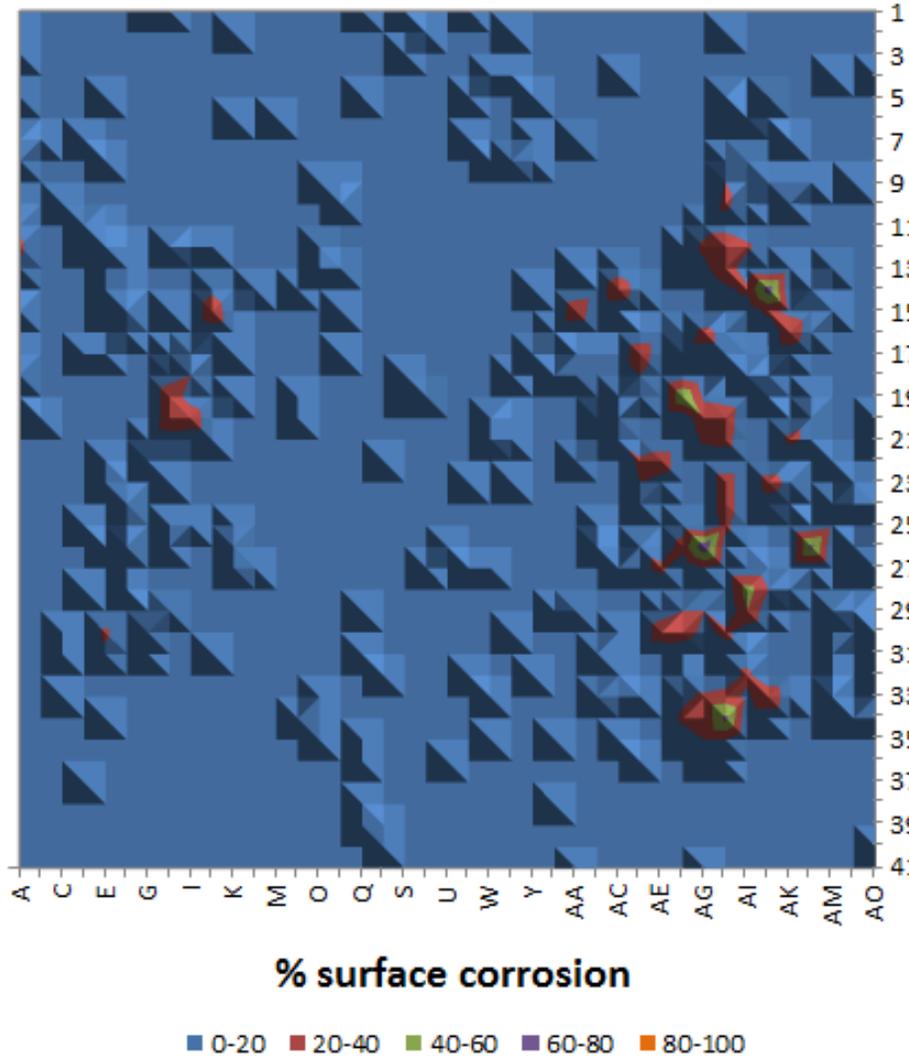
Figure 5.10: Surface plot of the 0.5 cm<sup>2</sup> central clad spot panel, 0.17 mm milled

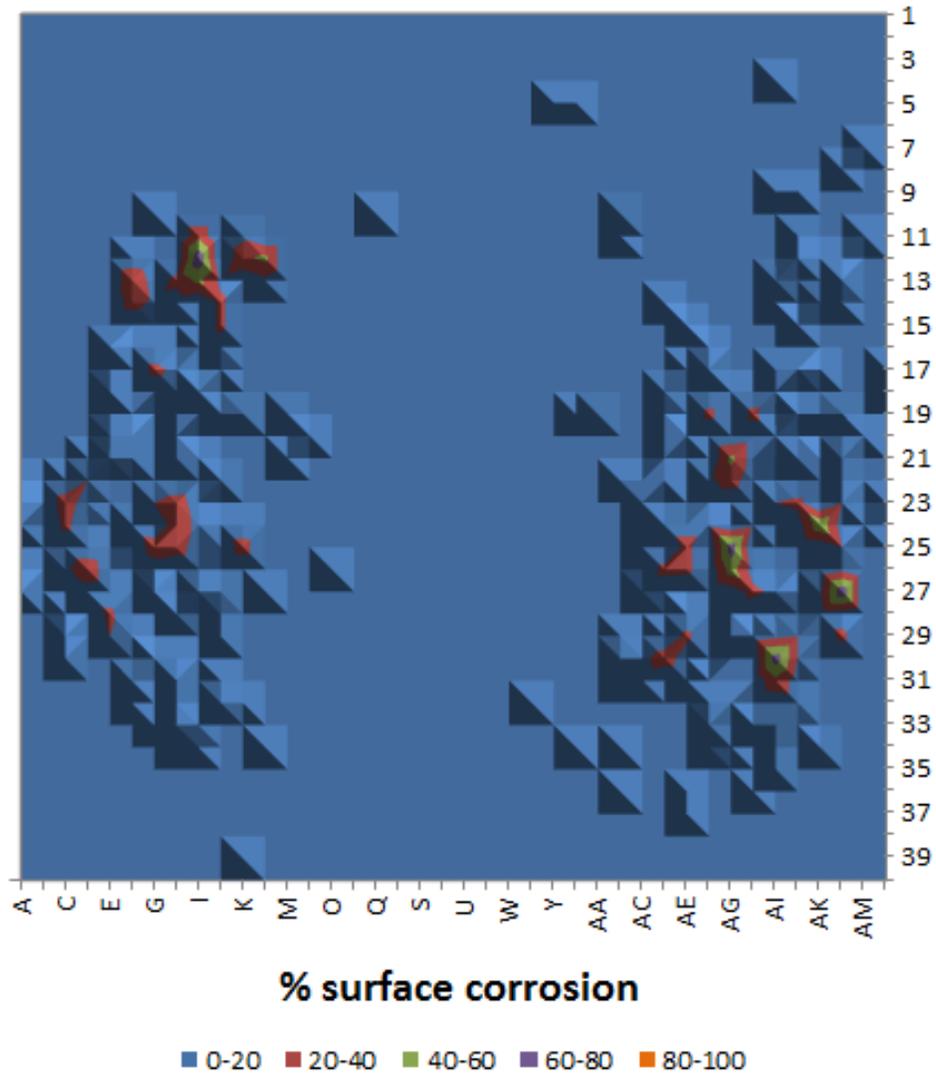
Figure 5.11: Surface plot of the 1 cm<sup>2</sup> central clad spot panel, 0.17 mm milled

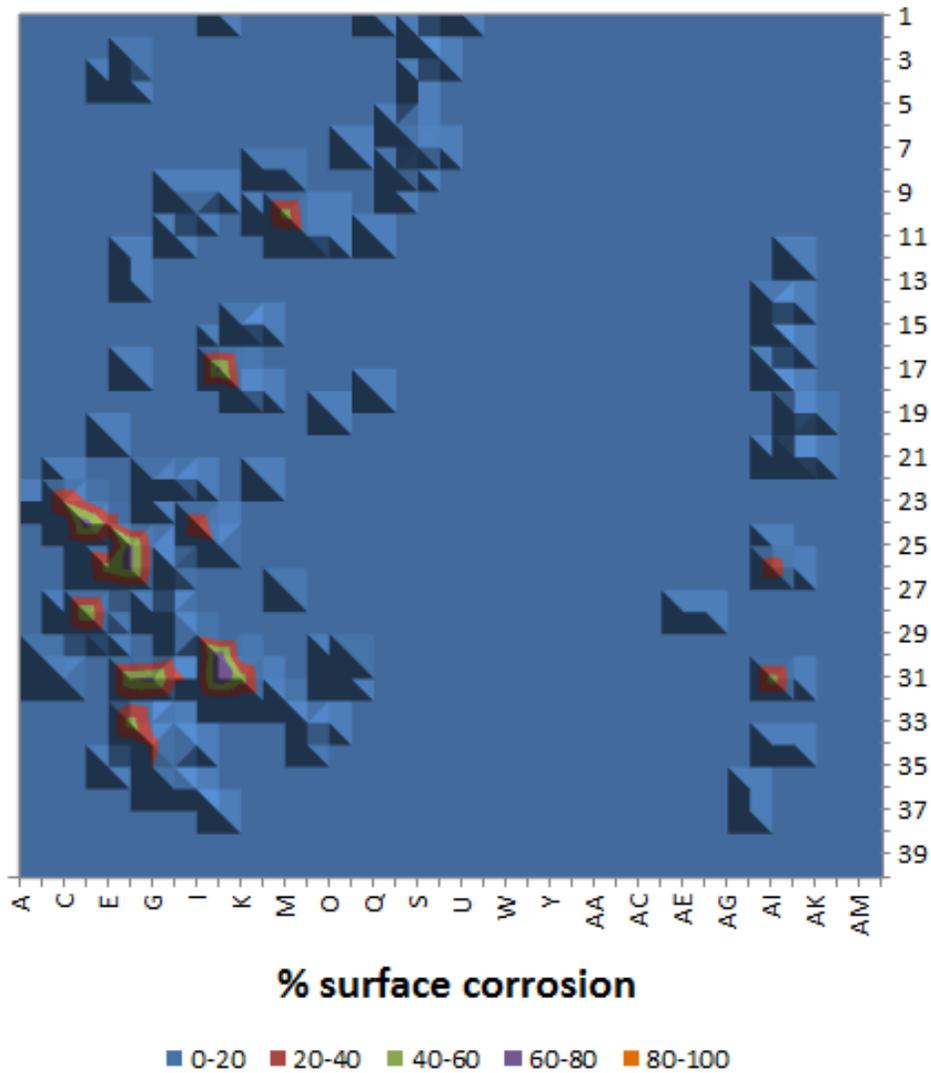
**Figure 5.12: Surface plot of the 2 cm<sup>2</sup> central clad spot panel, 0.17 mm milled**

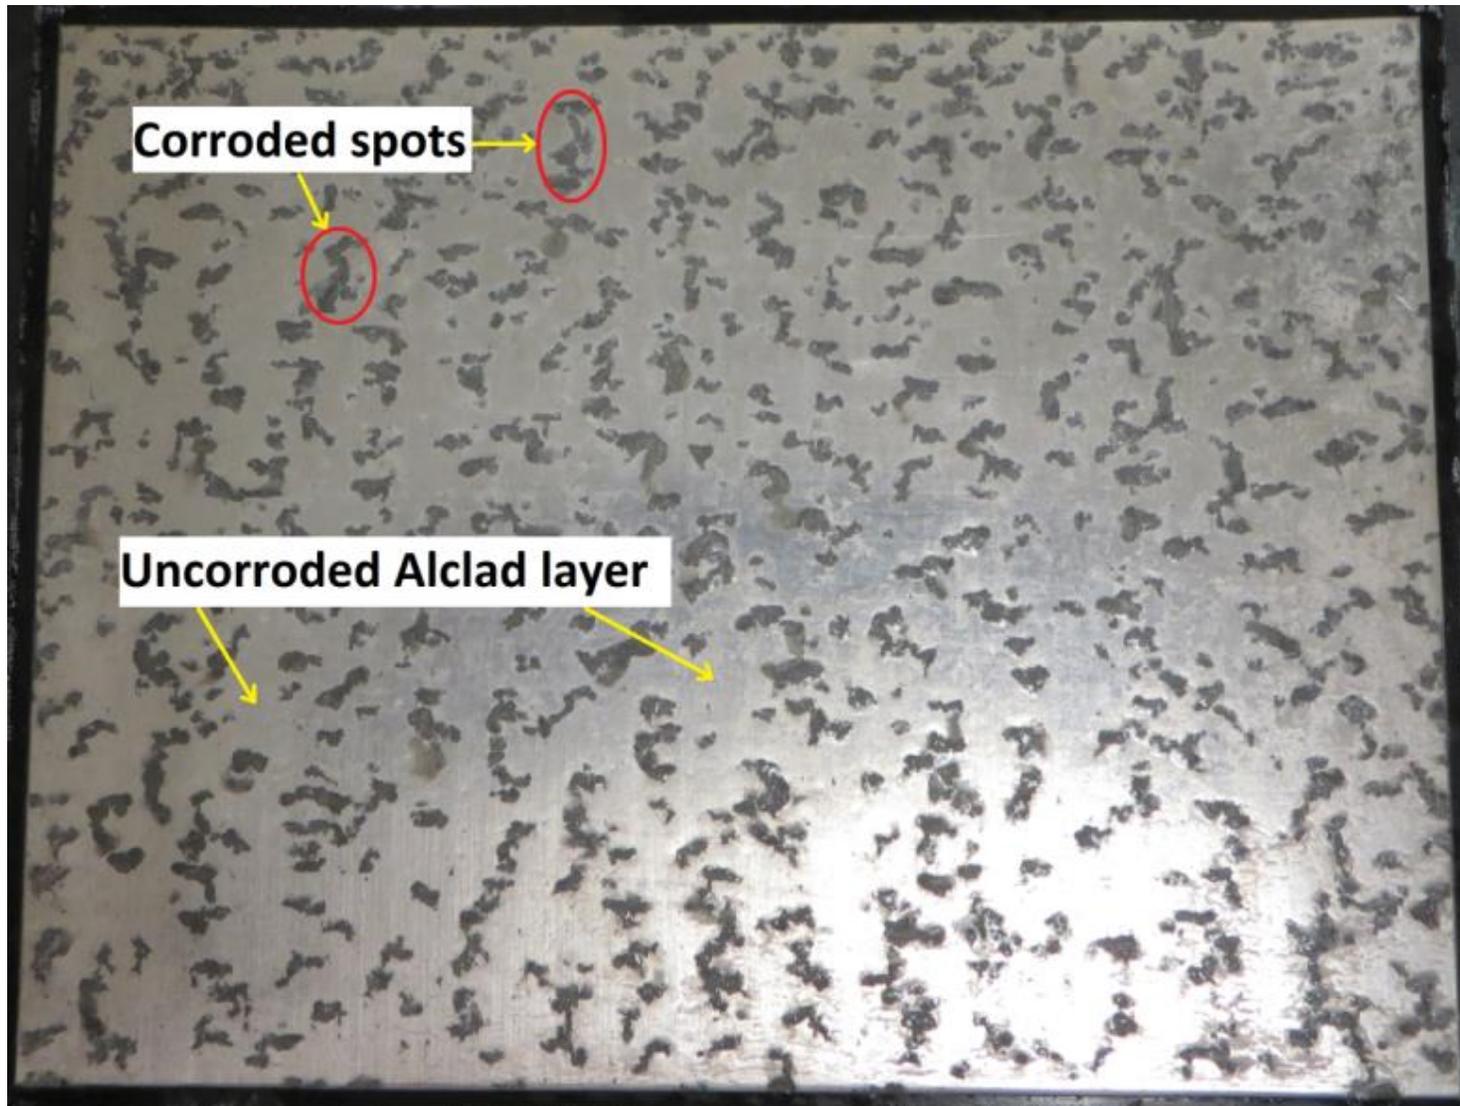
After removing the residual salt buildup on the clad medium sized panel with water and a stiff brush a fairly uniform distribution of large irregular shaped corrosion spots were exposed, this is shown in Figure 5.13. Upon closer inspection, small pits were also evident, distributed throughout the cladding layer. The depth of the observed corrosion was very shallow. From these observations, it can be inferred that in the acidic salt spray environment, pitting occurred and progressed in the cladding layer until reaching the core material. At this point, the pits stopped growing in depth because the Alclad layer is more electronegative than the core and acts as a sacrificial anode. Once the pit depth reached the aluminum core, the pits widened as the cladding layer continued to corrode preferentially relative to the core material. Multiple widening pits then connected to form the large irregular corrosion spots and continued to expand as the corrosion of the panel progressed. This corrosion behavior is what is expected and desired from aluminum protected by an Alclad layer. The cladding layer corrodes preferentially and the localized corrosion remains superficial, protecting the core material.

Figure 5.13: Fully clad test panel after corrosion exposure, before nitric acid cleaning, shallow corrosion spots are uniformly distributed over the panel surface

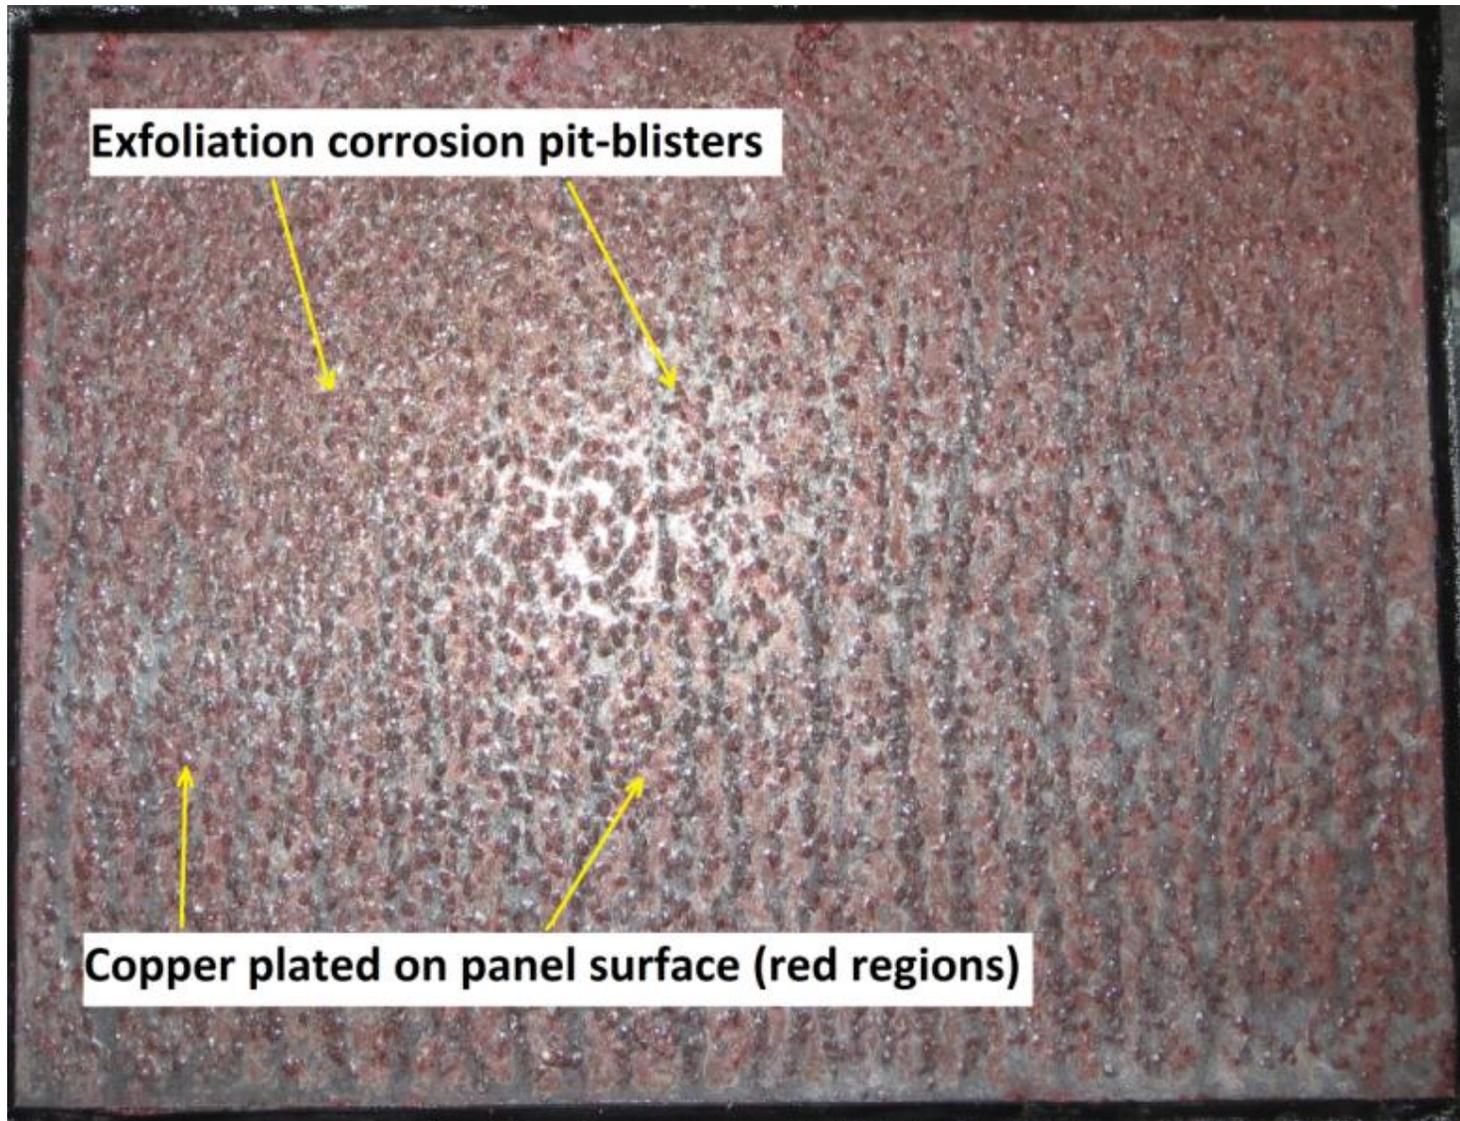
The red colored corrosion products observed over the majority of the corroded bare test panel is believed to be copper alloyed within the 7075 alloy that has dissolved into the corrosive electrolyte from a dealloying process and replate on the aluminum surface. This process is further discussed in Section 6.2.

Figure 5.14: Cladding removed test panel after corrosion exposure, before nitric acid cleaning, exfoliation corrosion is observed over the panel surface
