# **An Investigation of the Effectiveness of a Partial Cladding Pattern on Aluminum 7075 T651**

A thesis submitted to the  
School of Graduate Studies  
in partial fulfillment of the  
requirements for the degree of  
Masters of Engineering

Faculty of Engineering and Applied Science  
Memorial University of Newfoundland

January 2016

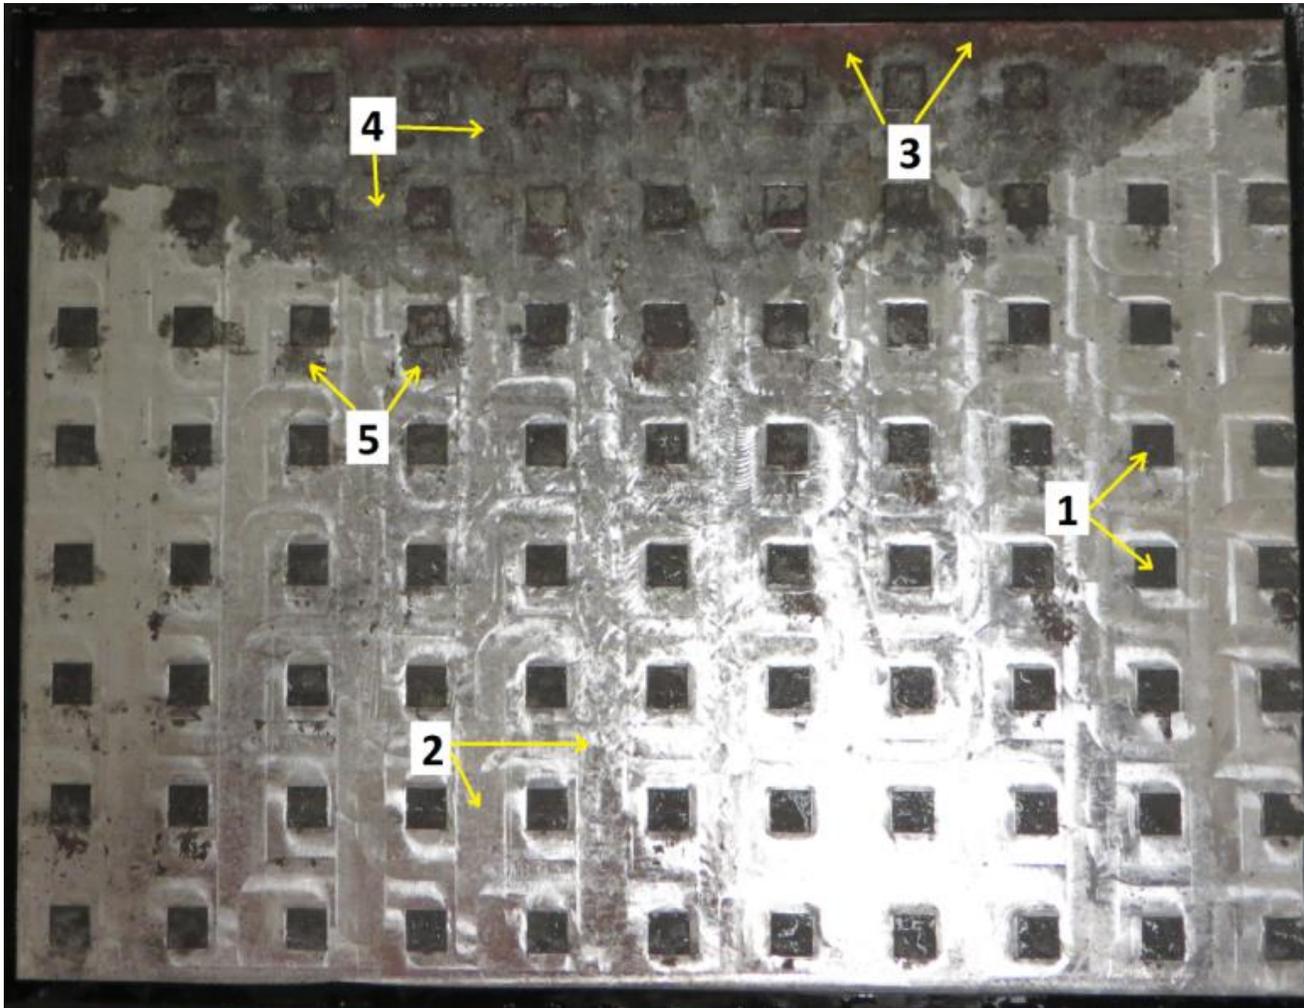
The residual salt buildup was removed from the spot clad panel in the same method described above. The corrosion observed on the surface of the spot clad panel was much less uniform than the fully clad and unprotected panels. In Figure 5.15, five distinct regions of corrosion behavior can be observed. (1) The surface of the clad spots experience general corrosion, depleting the sacrificial cladding layer while protecting the overall panel surface. (2) The majority of the panel surface was successfully protected by the partial cladding pattern. This is evident in the lower three quarters of the panel where the surface retained the shiny appearance and milling marks from the machining process. (3) On the upper edge of the panel there is a region of general corrosion with red coloring resembling what was observed on the unprotected test panel. Again, the explanation for this coloring is likely alloyed copper from the aluminum 7075 core deposited onto the panel surface from a dealloying process. The presence of the copper would have the opposite effect as the sacrificial cladding layer, creating a galvanic couple and aggravating corrosion. The effect of the copper is likely the cause of (4) the region of light general corrosion located between the red colored region and the shiny non-corroded region. Finally, (5) there are small patches of corrosion distributed throughout the non-corroded region of the panel. These patches are generally located adjacent to the clad spots. These patches of corrosion can possibly be explained by the acidic salt solution stagnating in the edges of the clad spots or within milling marks and leading to crevice corrosion.

Figure 5.15: Spot clad test panel after corrosion exposure, before nitric acid cleaning, five areas of corrosion behavior are observed: 1. Uniform corrosion on the clad spots 2. No corrosion over the majority of the panel surface 3. Light uniform corrosion with red coloring on the top edge of the panel 4. Light uniform corrosion between the red colored uniform corrosion and the non-corroded surfaces 5. Small patches of light uniform corrosion within the non-corroded area, usually adjacent and below the clad spots

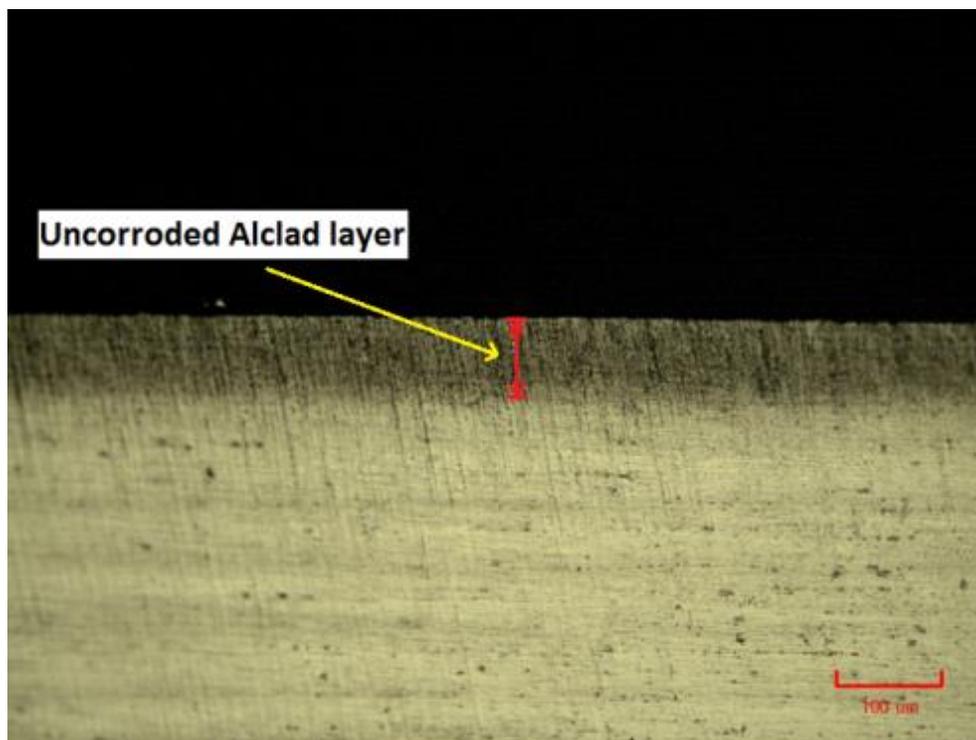
**Figure 5.16: Clad panel, region with no corrosion, 100x magnification**

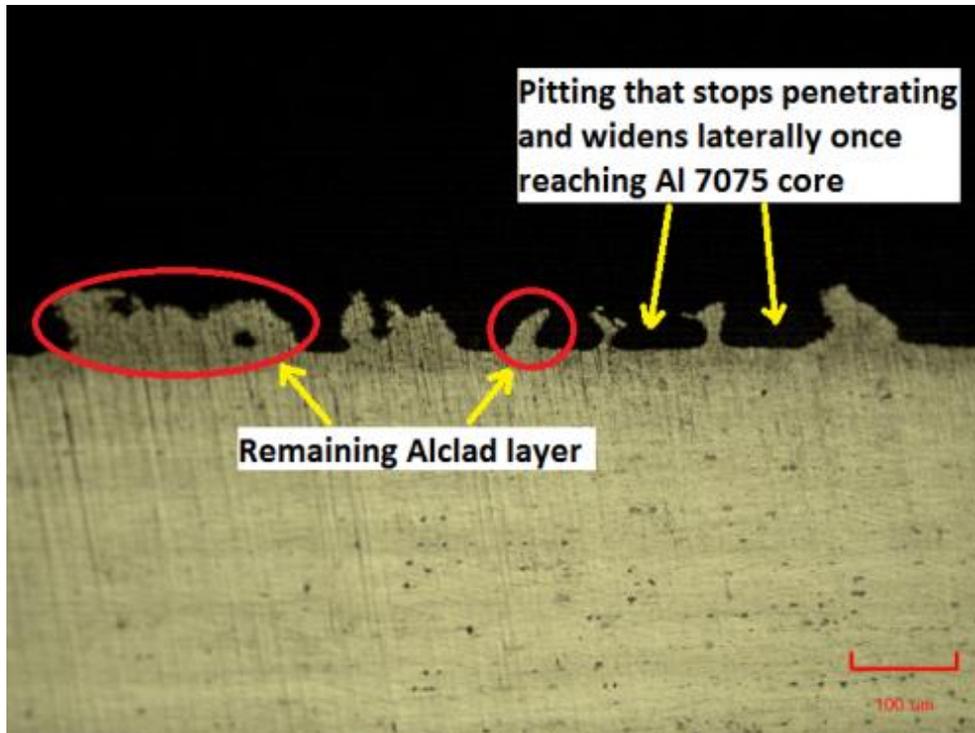
Figure 5.17 shows a cross-section of a corroded spot on the Alclad test panel. Dense pitting can be seen penetrating through the cladding layer up to the aluminum 7075 core. Once reaching the core, the pits progress laterally, widening the pit and merging with other pits, consuming the cladding layer. This corrosion behavior is what was expected from the Alclad 7075 alloy and represents the clad layer successfully protecting the core from corrosion damage.

**Figure 5.17: Clad panel, region with corrosion, 100x magnification**

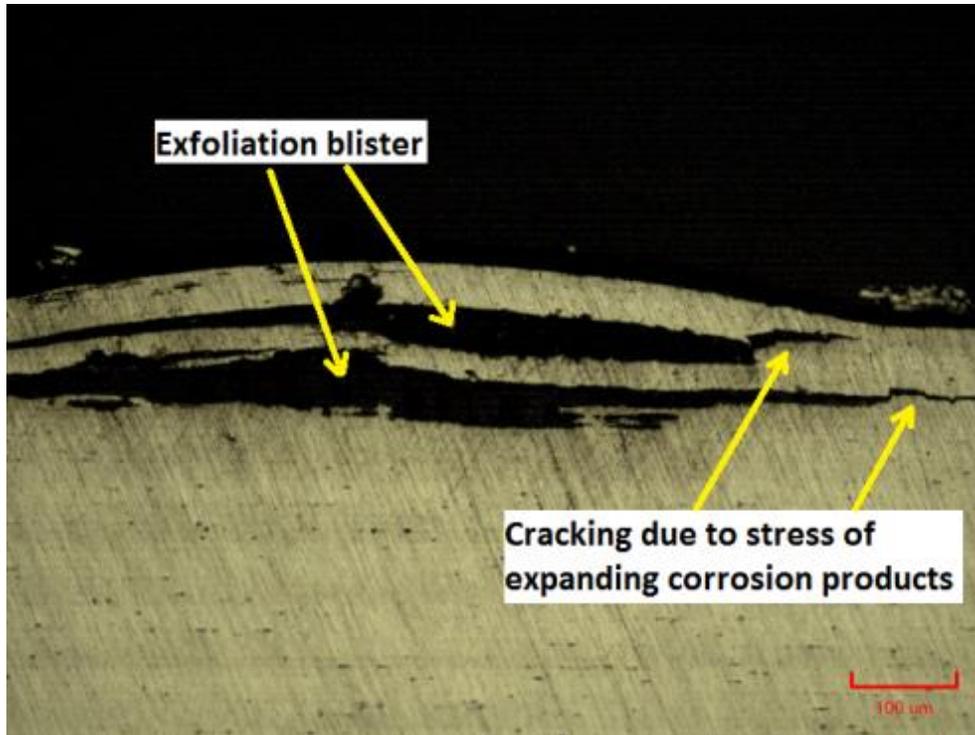
Figure 5.18: Unclad panel, exfoliation bulge, 100x magnification

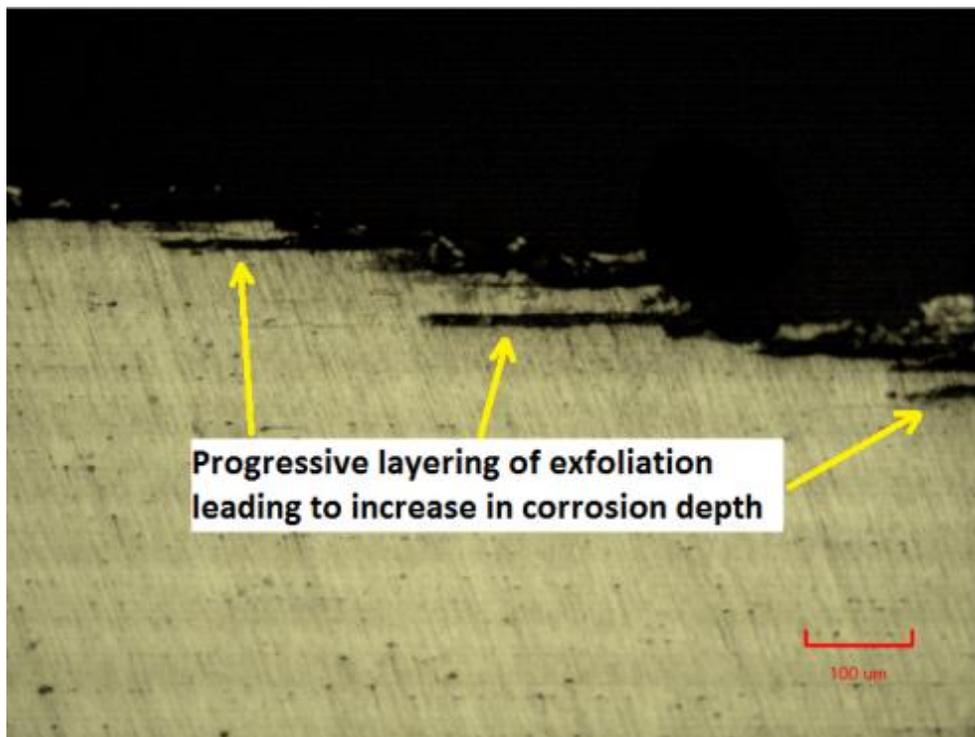
Figure 5.19: Unclad panel deep exfoliation damage, 100x magnification

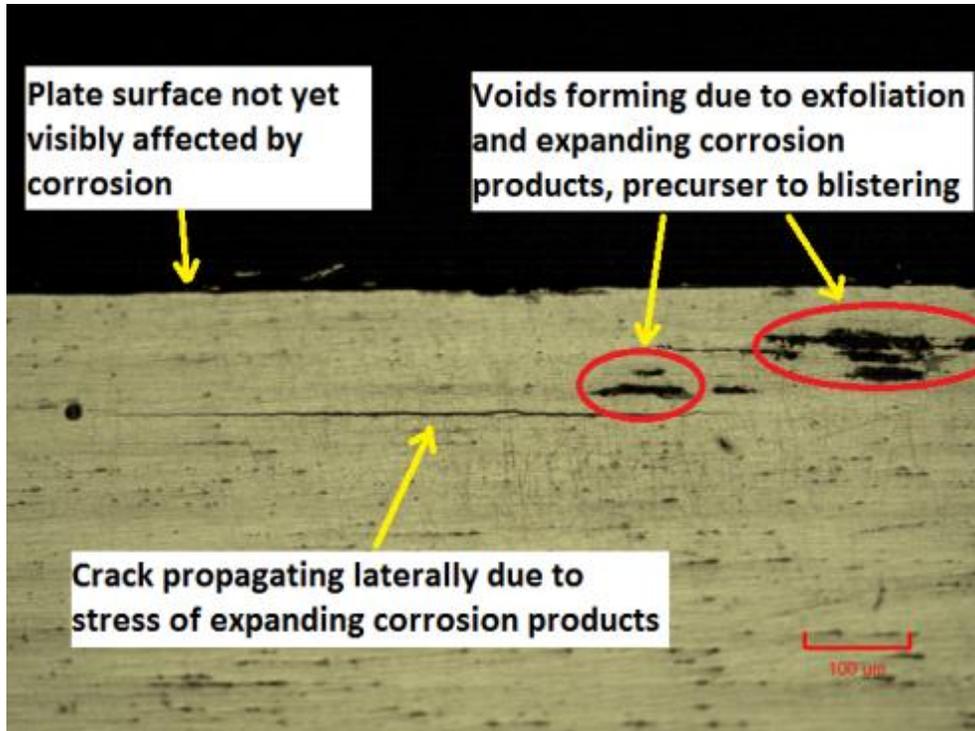
Figure 5.20: Unclad panel, crack propagation due to exfoliation, 100x magnification

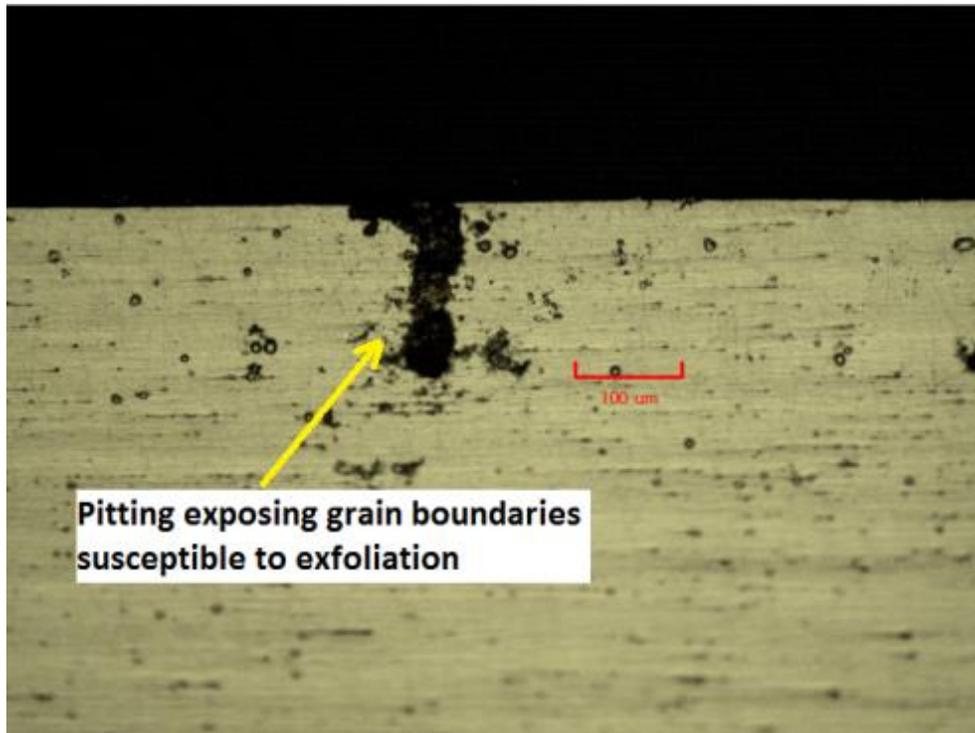
Figure 5.21 shows a well-defined pit in the aluminum plate. This was an example of obvious pitting observed in the analyzed cross-sections. The explanation for this may be that the corrosion initiated as well defined pits such as in Figure 5.21, but then propagated into exfoliation corrosion caused by intergranular attack of the large number of grain boundaries exposed by the pits. This process would eradicate the pit as exfoliation corrosion propagated radially.

Figure 5.21: Unclad panel, evidence of pitting, 100x magnification

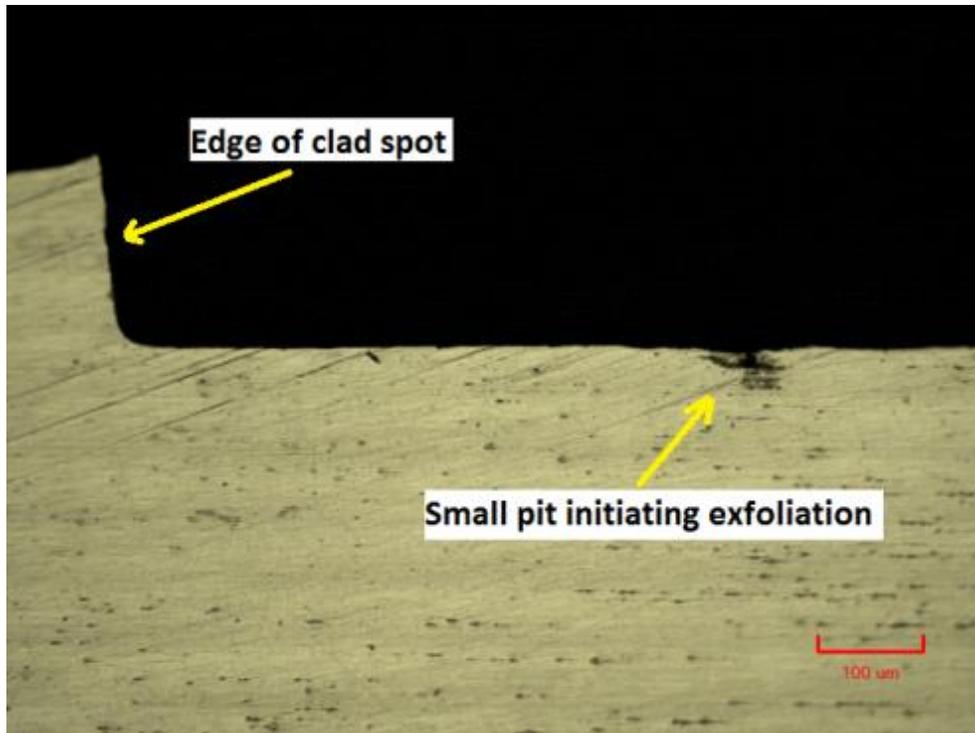
Figure 5.22: Spot clad panel, edge of clad spot with evidence of mild exfoliation

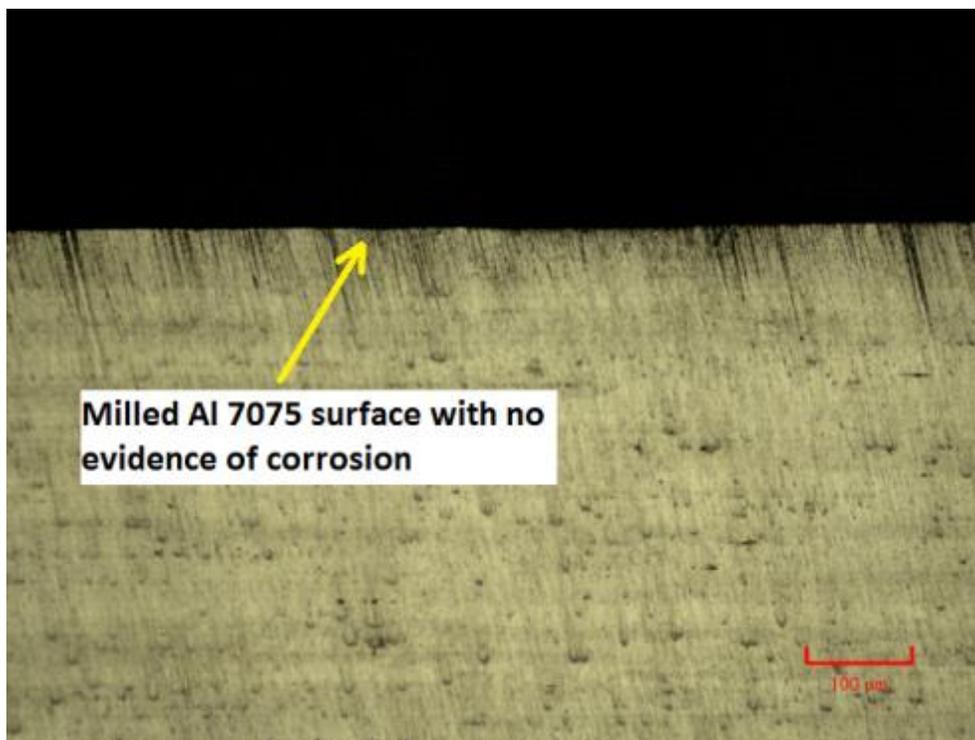
Figure 5.23 shows the typical surface not affected by corrosion observed over the majority of the partially clad test panel. No appreciable difference in surface appearance was observed between the surface affected by light general corrosion and the fully protected surface.

Figure 5.23: Spot clad panel, milled surface with no corrosion damage

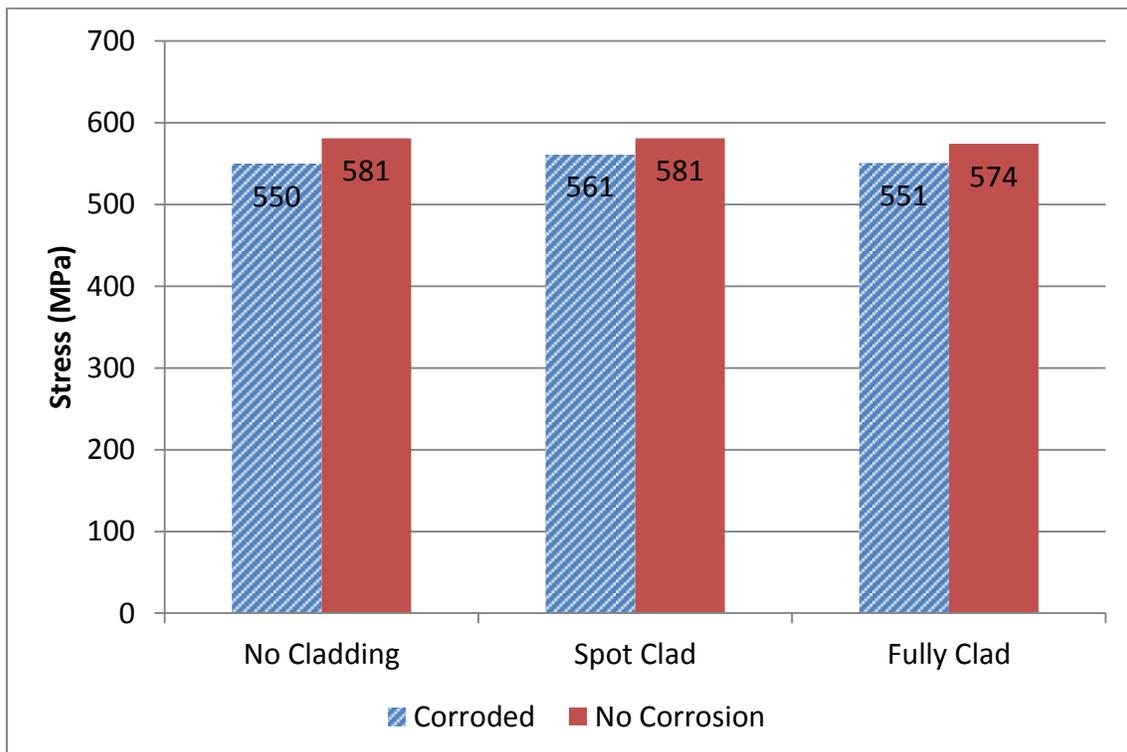
Tensile specimens were machined from the corroded medium sized panels and tested in accordance to ASTM B557 [27]. Non-corroded tensile specimens were produced and tested in the same fashion for comparison of tensile properties. The results of this comparison are summarised in Figures 5.24, 5.25, 5.26 and 5.27.

**Figure 5.24: Tensile strength summary**

This was followed by the fully clad test panel with a tensile strength percentage decrease of 4.0%. Finally, the cladding removed panel showed a percentage decrease in tensile strength of 5.3%. These values show that the fully clad and partially clad test panels were better protected from the corrosion environment when compared to the test panel with the cladding removed. These values are however more closely distributed than what would have been expected based on the corrosion observed on the test panel surfaces. It was expected that the unprotected test panel would have performed considerably worse than the two protected panels. This is an indication that the exfoliation corrosion damage observed on the test panel with the cladding removed was superficial when compared to the overall plate thickness of 6.35 mm.

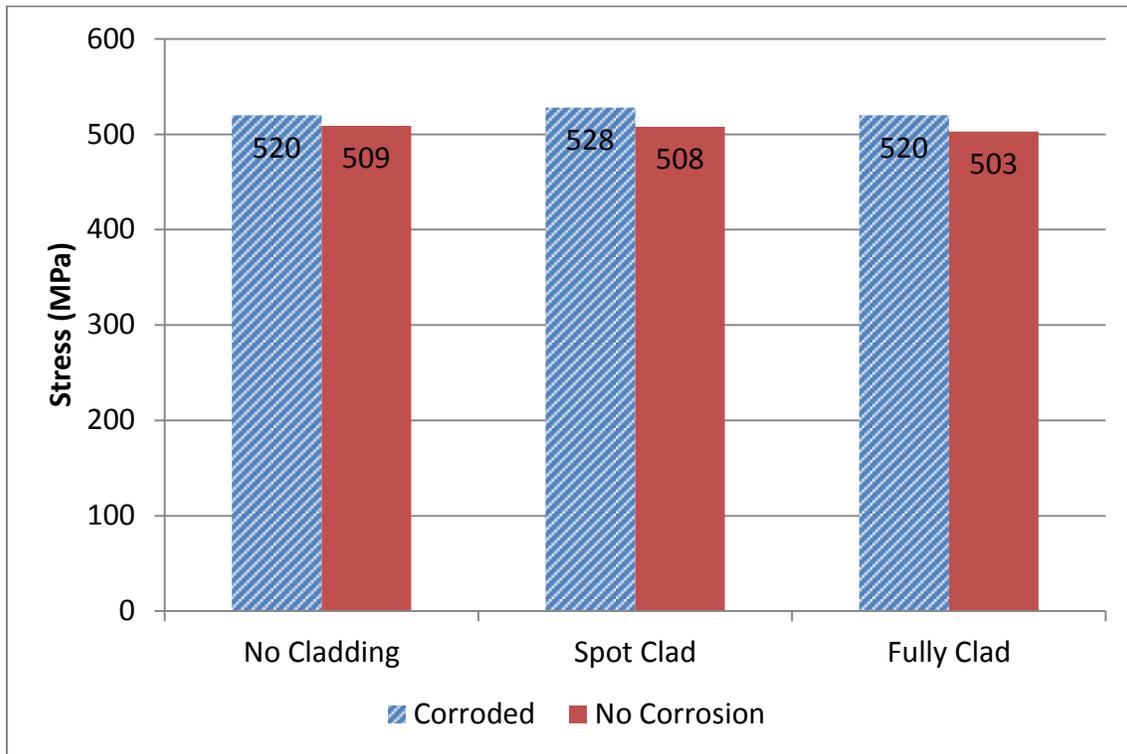
**Figure 5.25: Yield strength summary**

The yield strength of the three test panels each increased after exposure to the corrosion environment. The spot clad, fully clad and cladding removed test specimens showed a percent increase in yield strength of 3.9%, 3.4% and 2.2% respectively. This trend is not easily explained, as it is expected the yield strength would decrease with corrosion exposure.

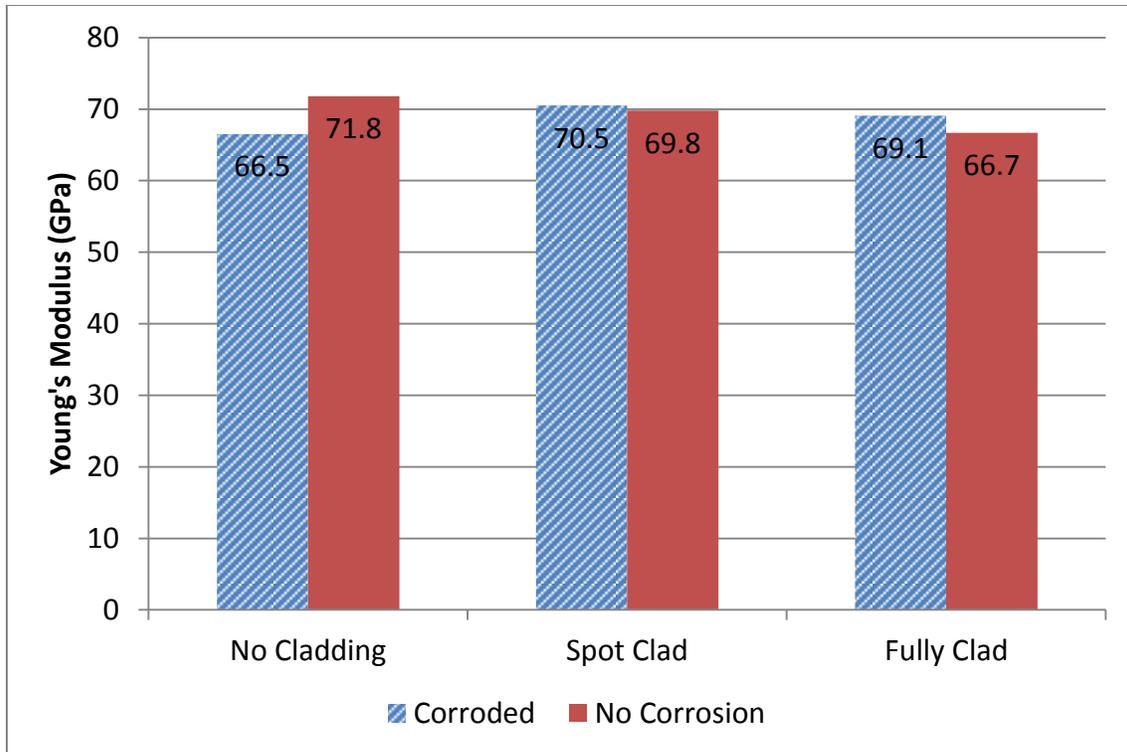
**Figure 5.26: Young’s modulus summary**

The Young’s modulus of the spot and fully clad test panels appeared to increase after corrosion exposure while it decreased for the panel with the cladding removed. The percentage increase in Young’s modulus for the spot clad and fully clad test panels was 1.0% and 3.6% respectively. The percentage decrease in Young’s modulus for the unprotected panel was 7.4%. The decrease in Young’s modulus observed for the cladding removed panel when compared to the smaller increases for the spot clad and fully clad panels implies that the cladding removed panel was influenced to a greater extent by the corrosion environment.

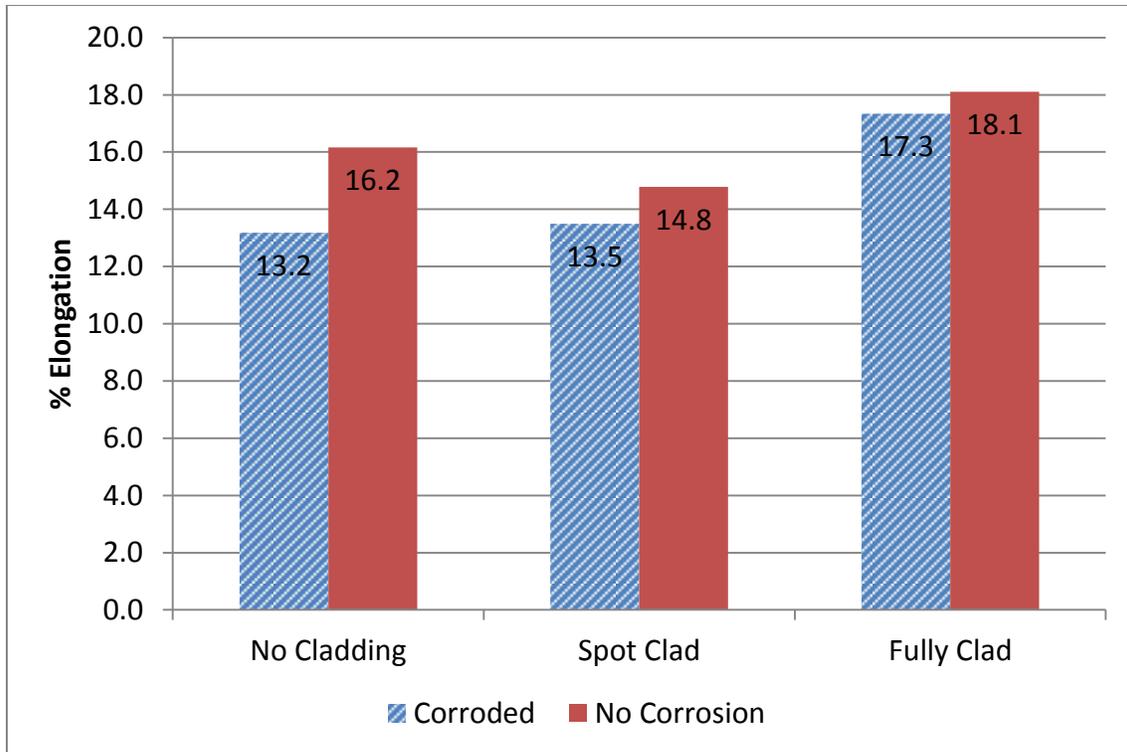
**Figure 5.27: % Elongation summary**

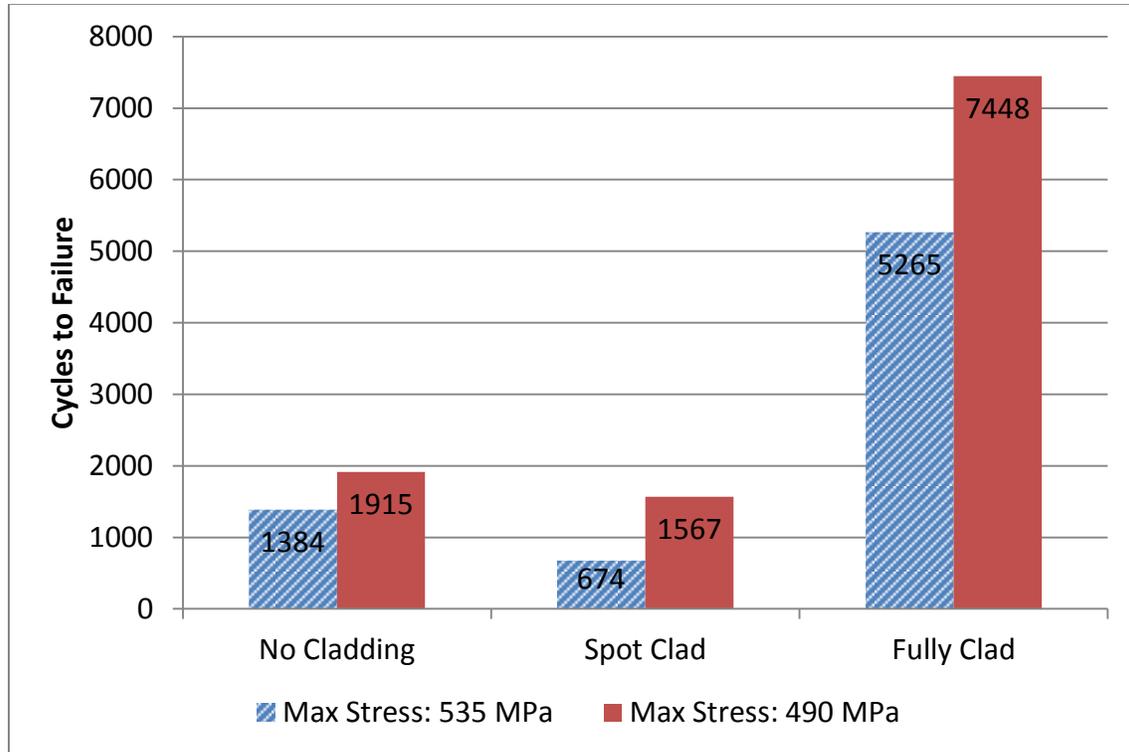
**Figure 5.28: Corroded sample fatigue test summary (R=0.1)**

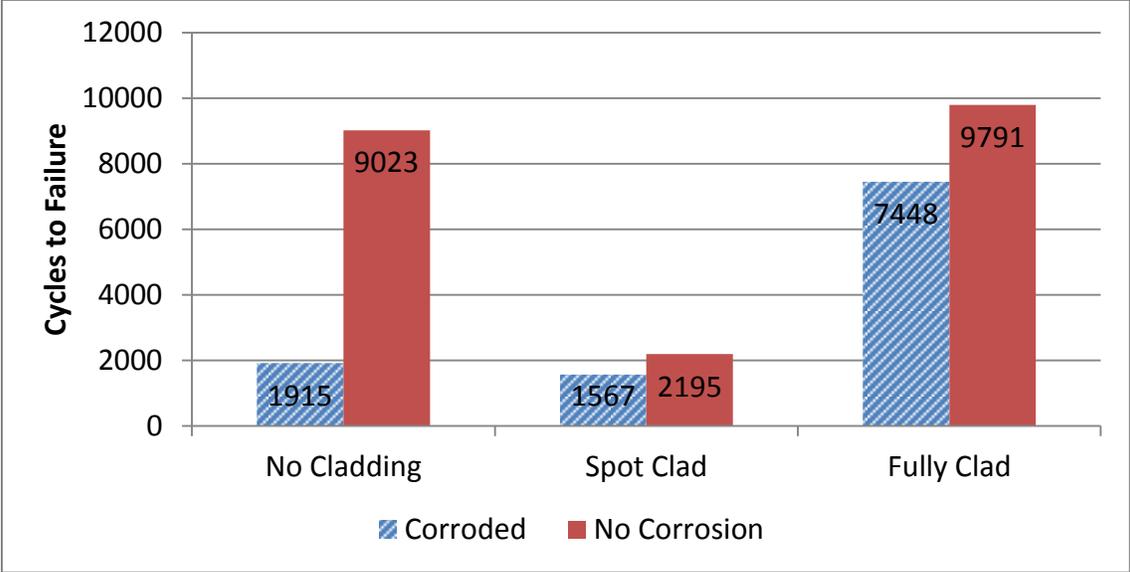
Figure 5.29: Corroded vs no corrosion fatigue test summary (R=0.1, max stress = 490 MPa)

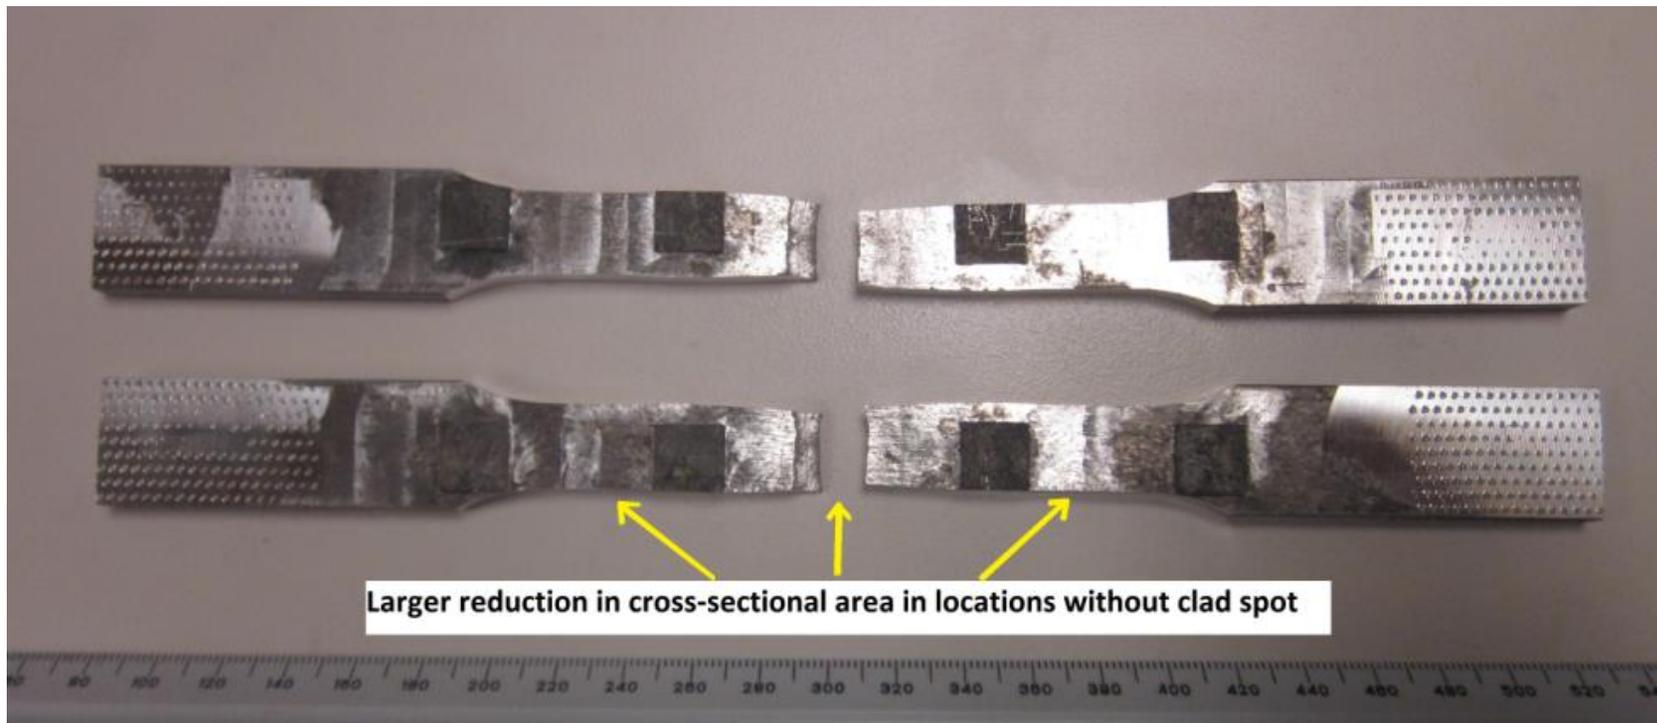
Figure 6.1: Partially clad tensile test specimens showing necking limited to areas without clad spot

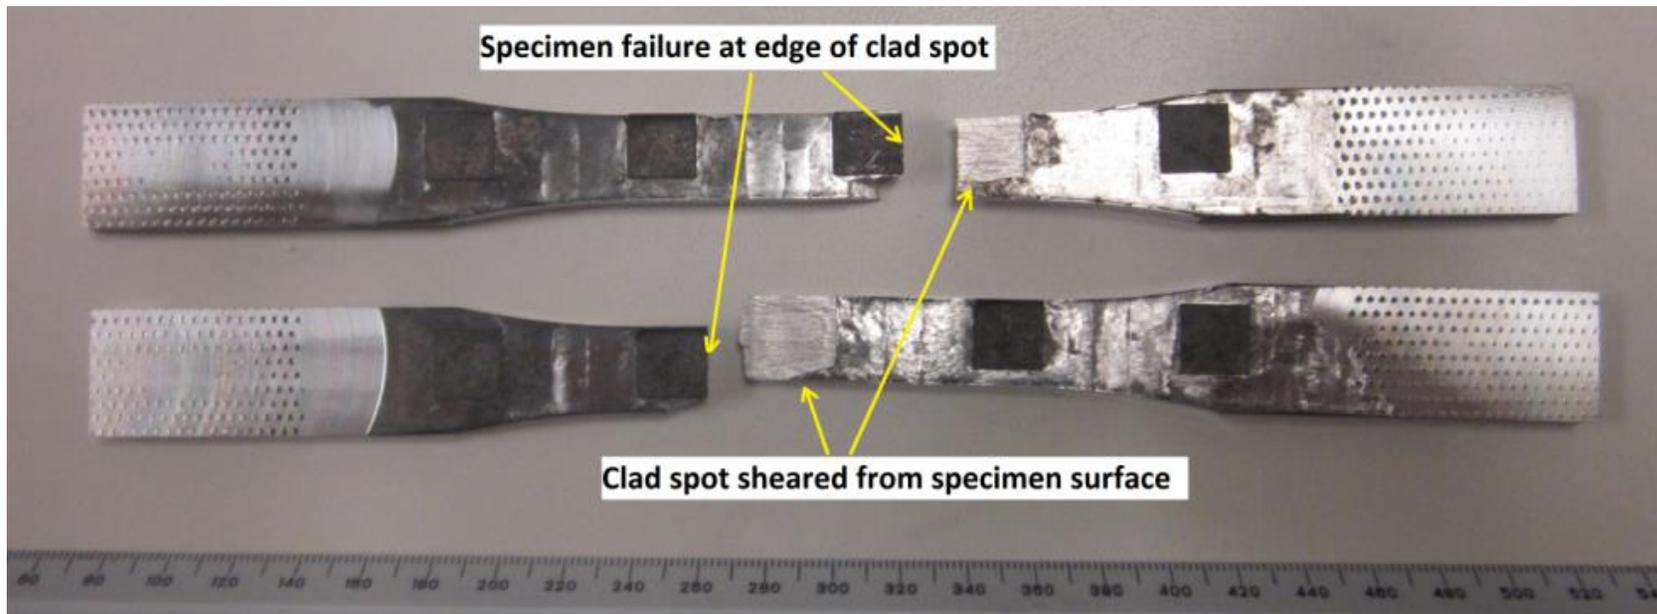
Figure 6.2: Partially clad fatigue test specimens shown to fail at sheared clad spot edge

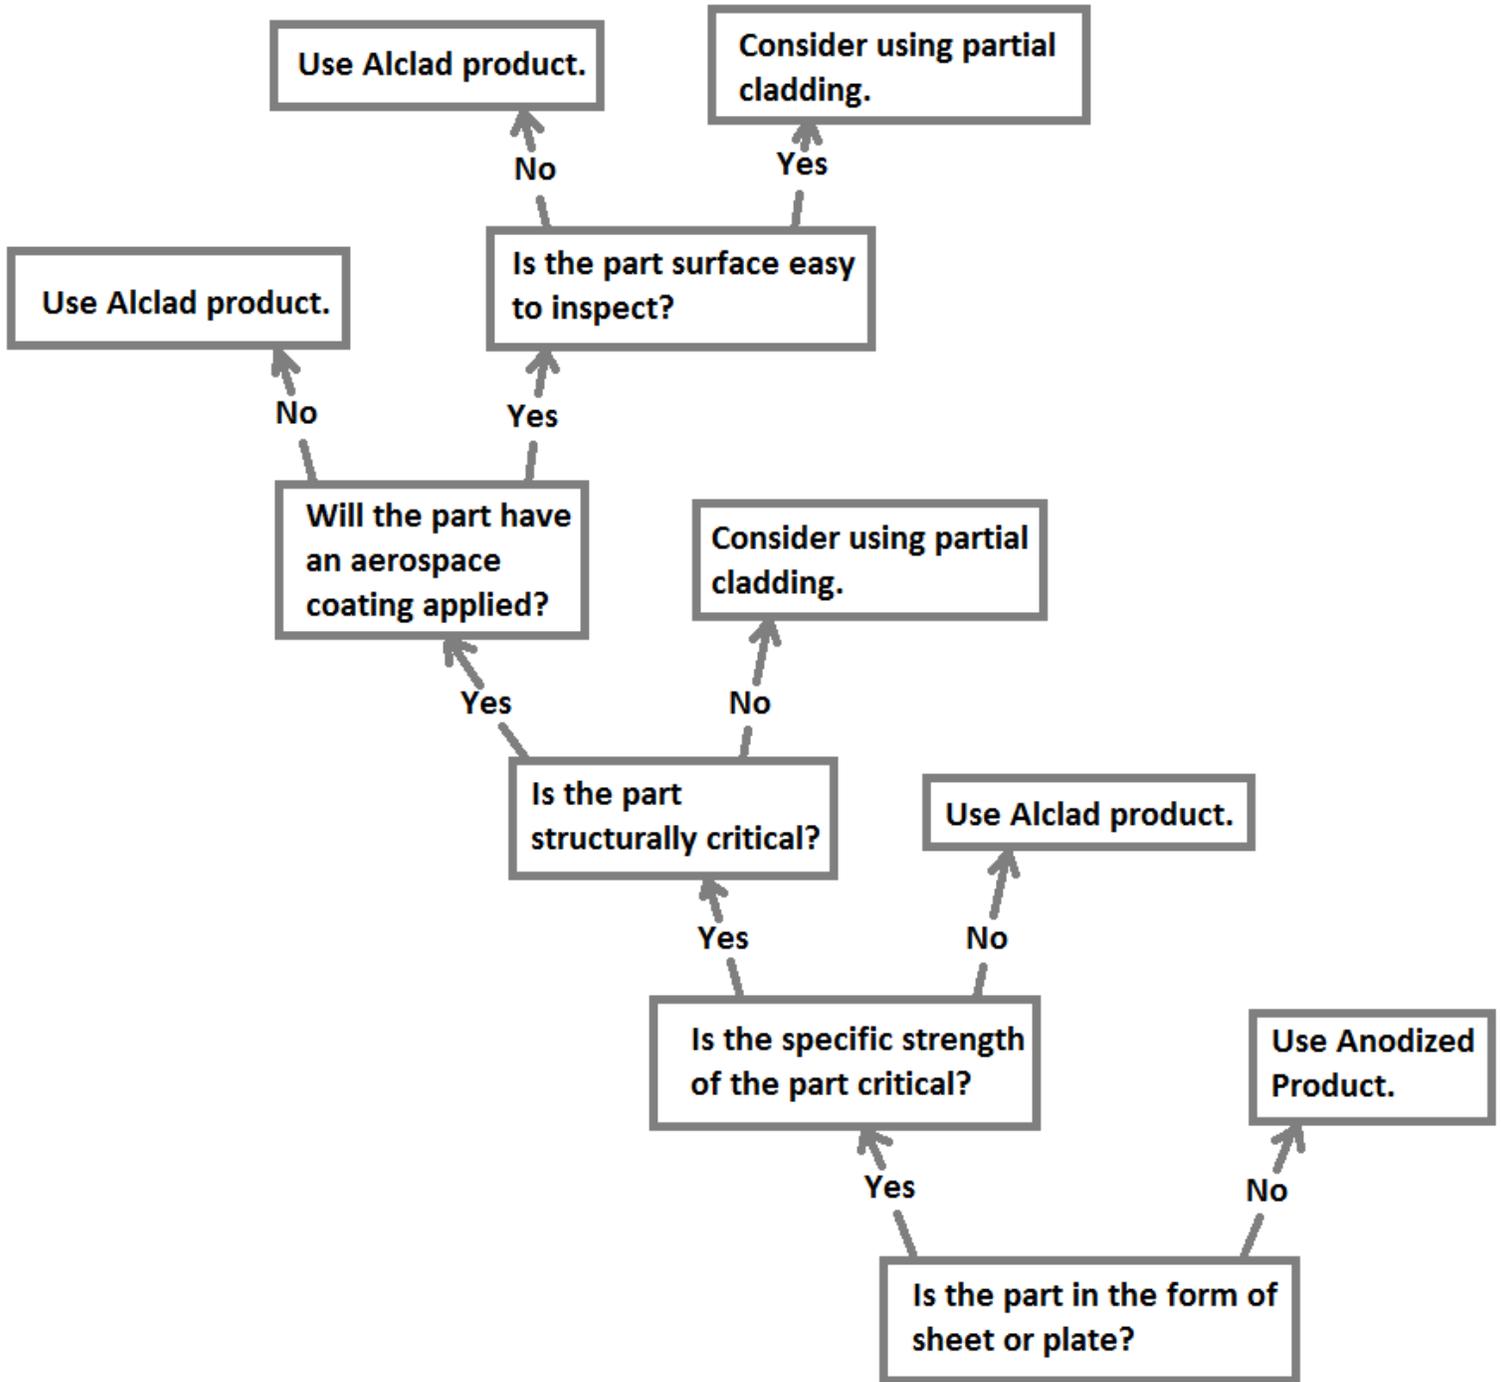
Figure 6.3: Decision tree for the selection of partial cladding in the aerospace industry

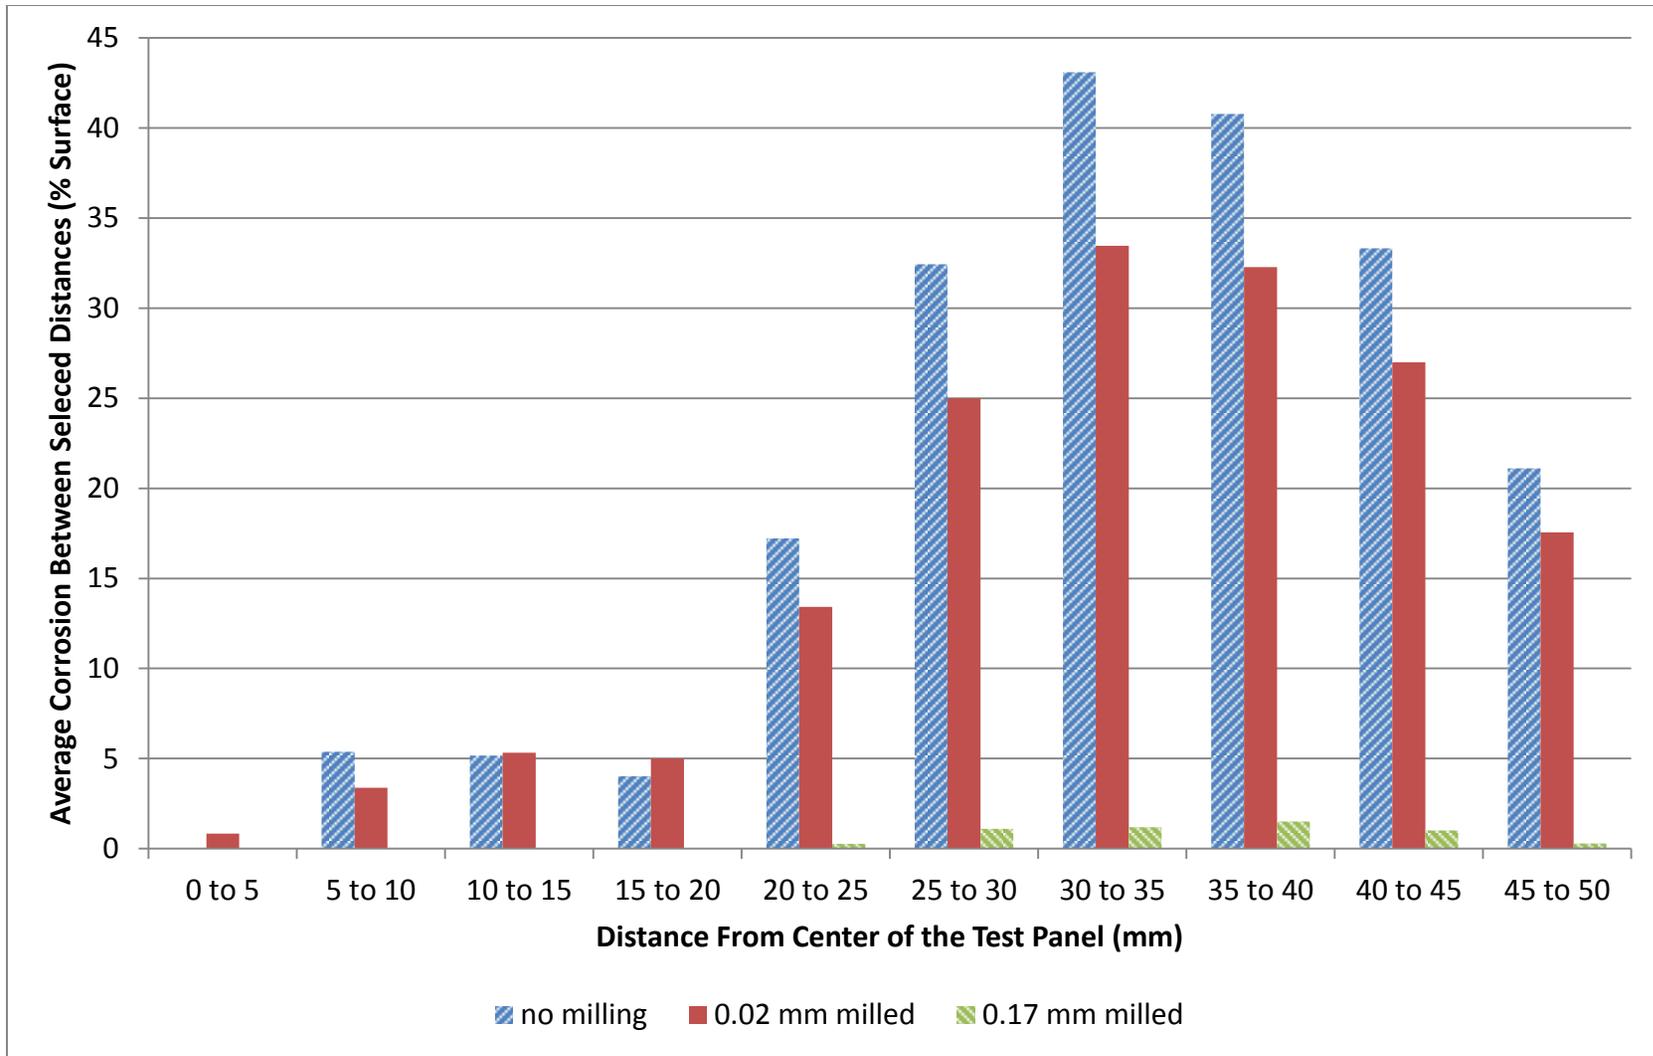
Figure 6.4: Average percentage of corrosion damage observed on the surface of regions defined by rings emanating from the center of the initial 1 cm<sup>2</sup> central clad spot test panel, three milled depths are shown representing the minimum corrosion penetration

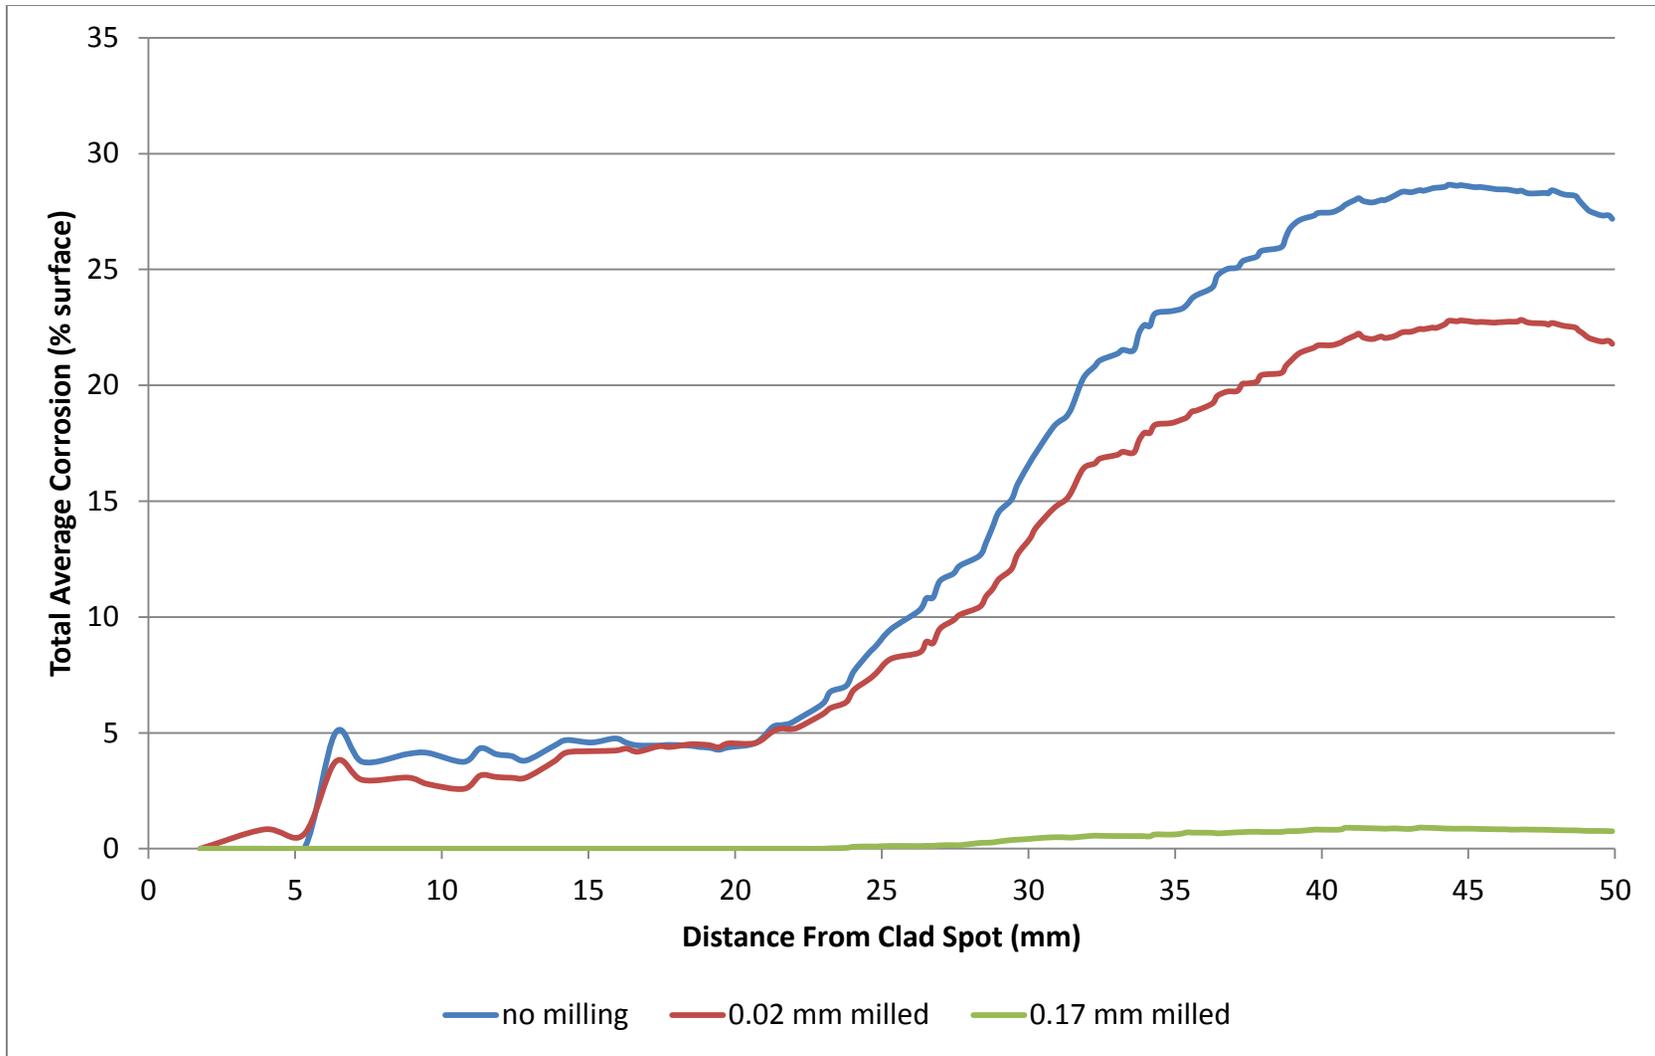
Figure 6.5: Cumulative average percentage of corrosion damaged observed on the surface of an increasing circular area having a radius defined by the distance from the center of the initial 1 cm<sup>2</sup> central clad spot test panel, three milled depths are shown representing the minimum corrosion penetration
