# **An Investigation of the Effectiveness of a Partial Cladding Pattern on Aluminum 7075 T651**

A thesis submitted to the  
School of Graduate Studies  
in partial fulfillment of the  
requirements for the degree of  
Masters of Engineering

Faculty of Engineering and Applied Science  
Memorial University of Newfoundland

January 2016

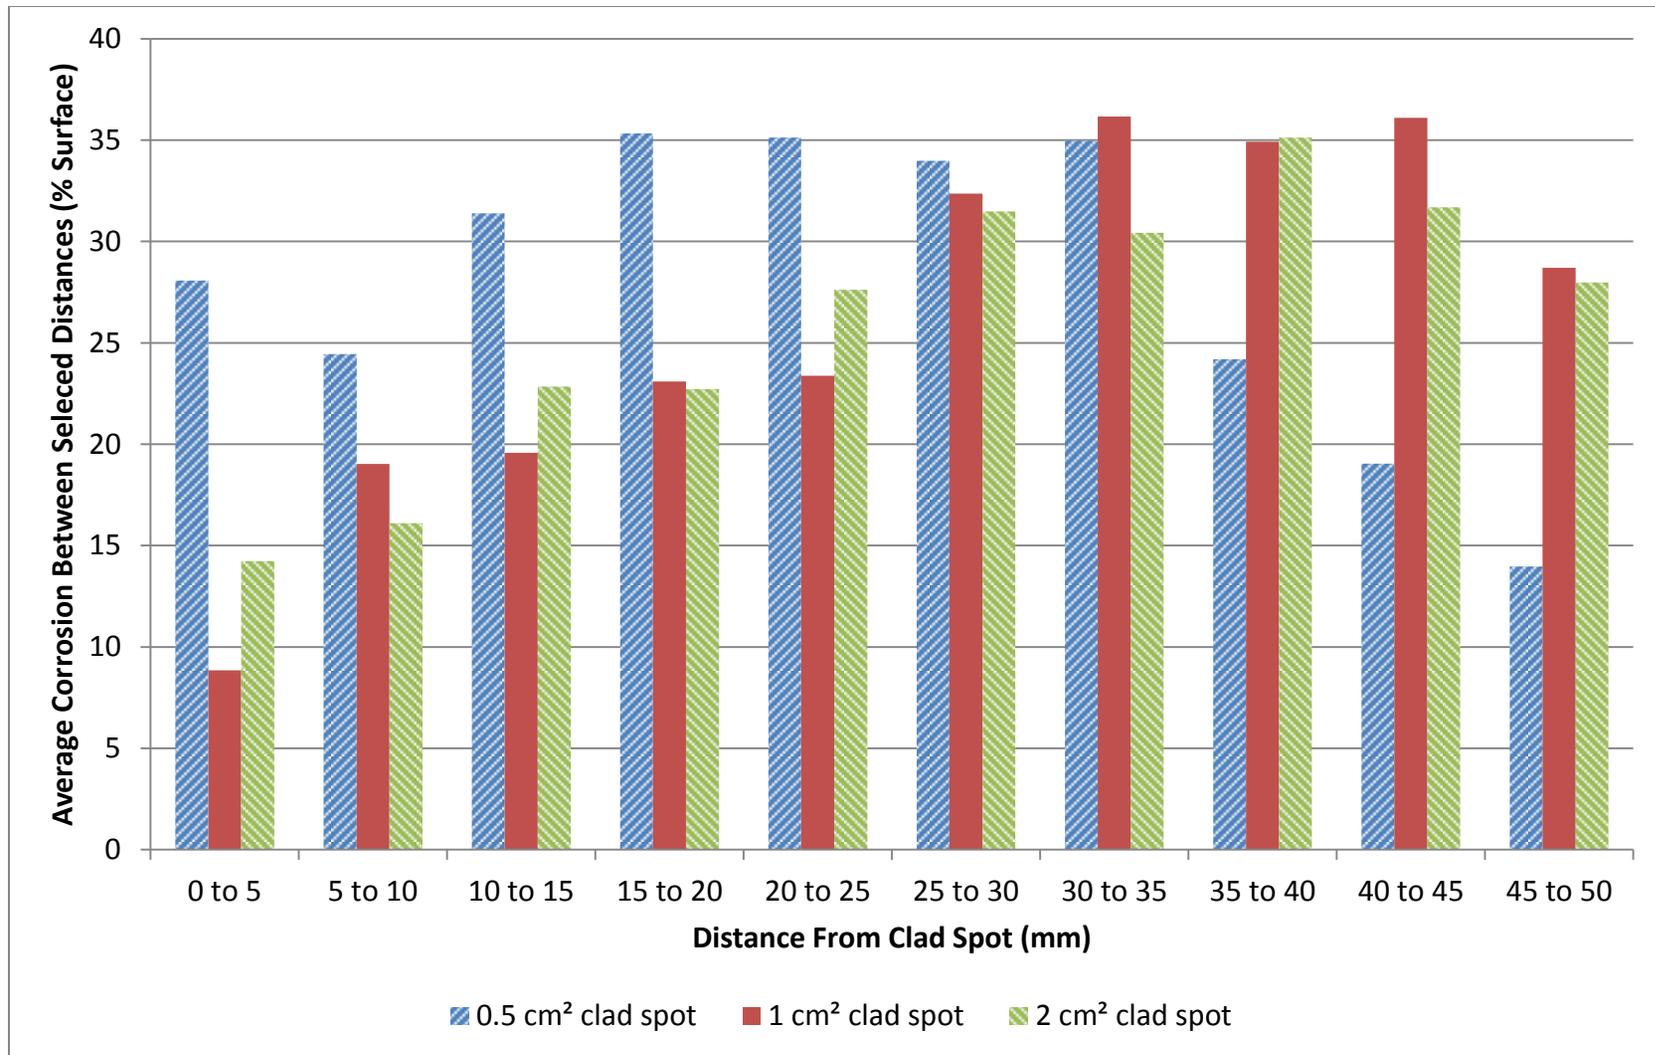
Figure 6.6: Average percentage of corrosion damage observed on the surface of regions defined by rings emanating from the center of the second set of central clad spot test panels (0.5 cm<sup>2</sup>, 1 cm<sup>2</sup> and 2 cm<sup>2</sup>), milling marks remain, no milling after corrosion exposure

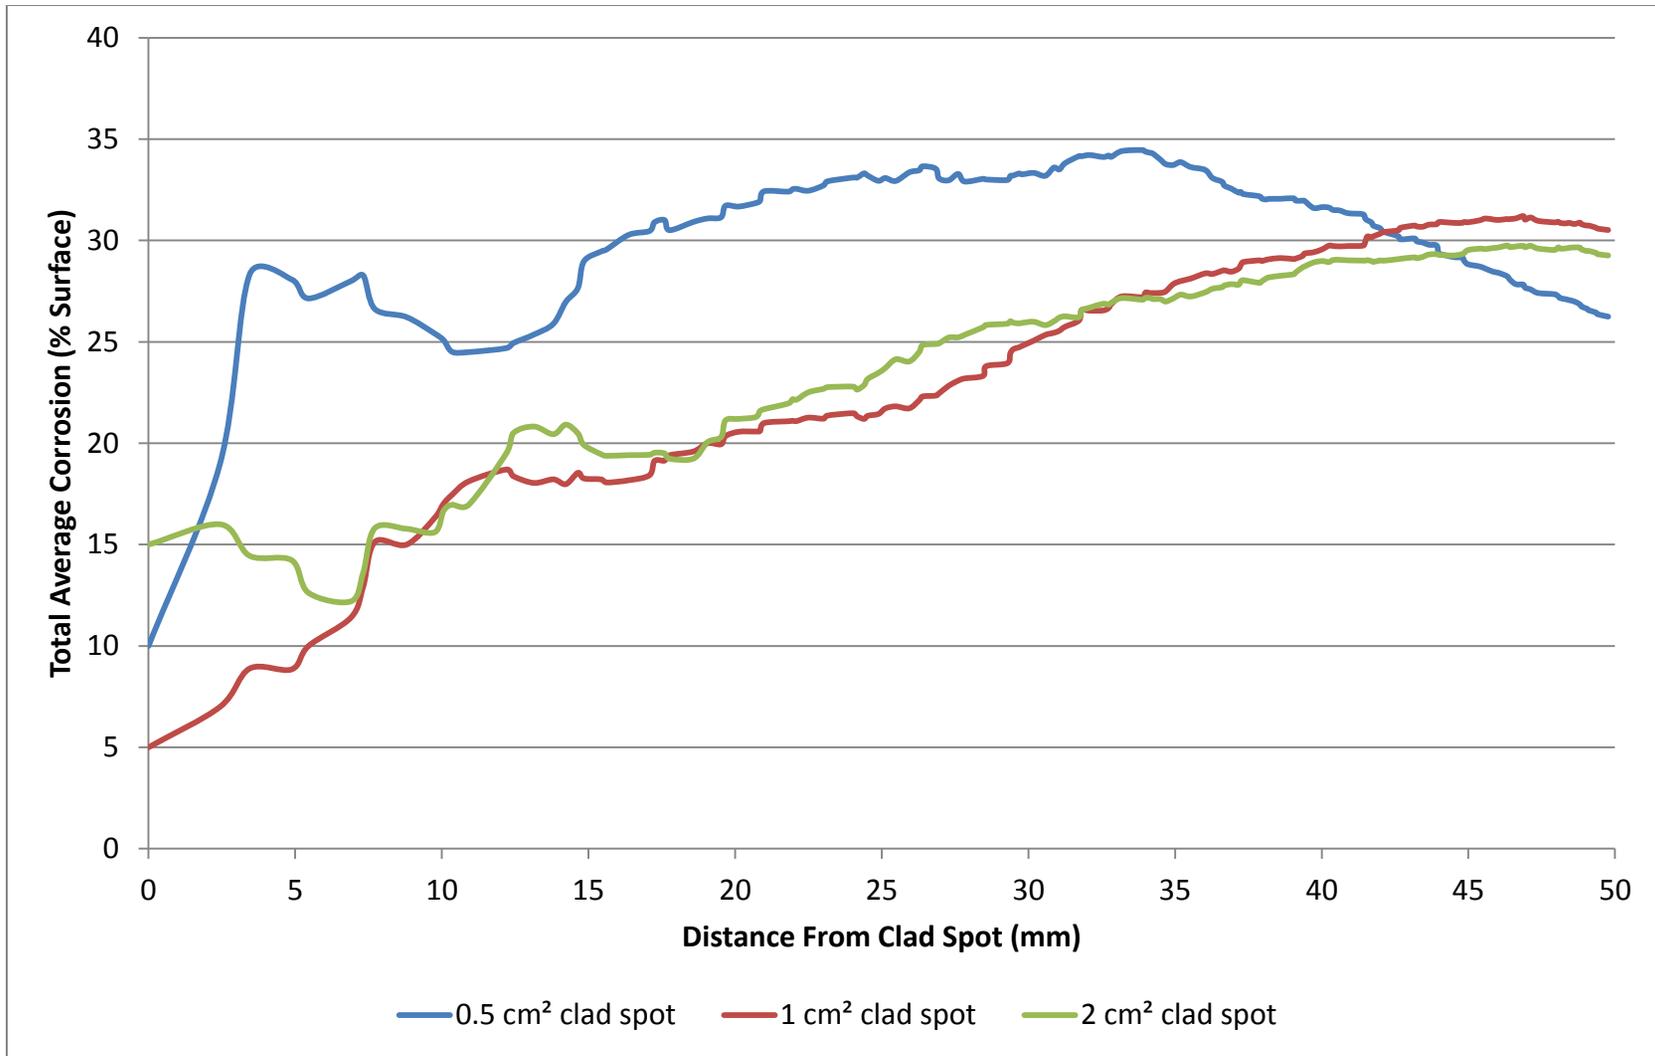
**Figure 6.7: Cumulative average percentage of corrosion damaged observed on the surface of an increasing circular area having a radius defined by the distance from the center of the second set of central clad spot test panels (0.5 cm<sup>2</sup>, 1 cm<sup>2</sup> and 2 cm<sup>2</sup>) milling marks remain, no milling after corrosion exposure**

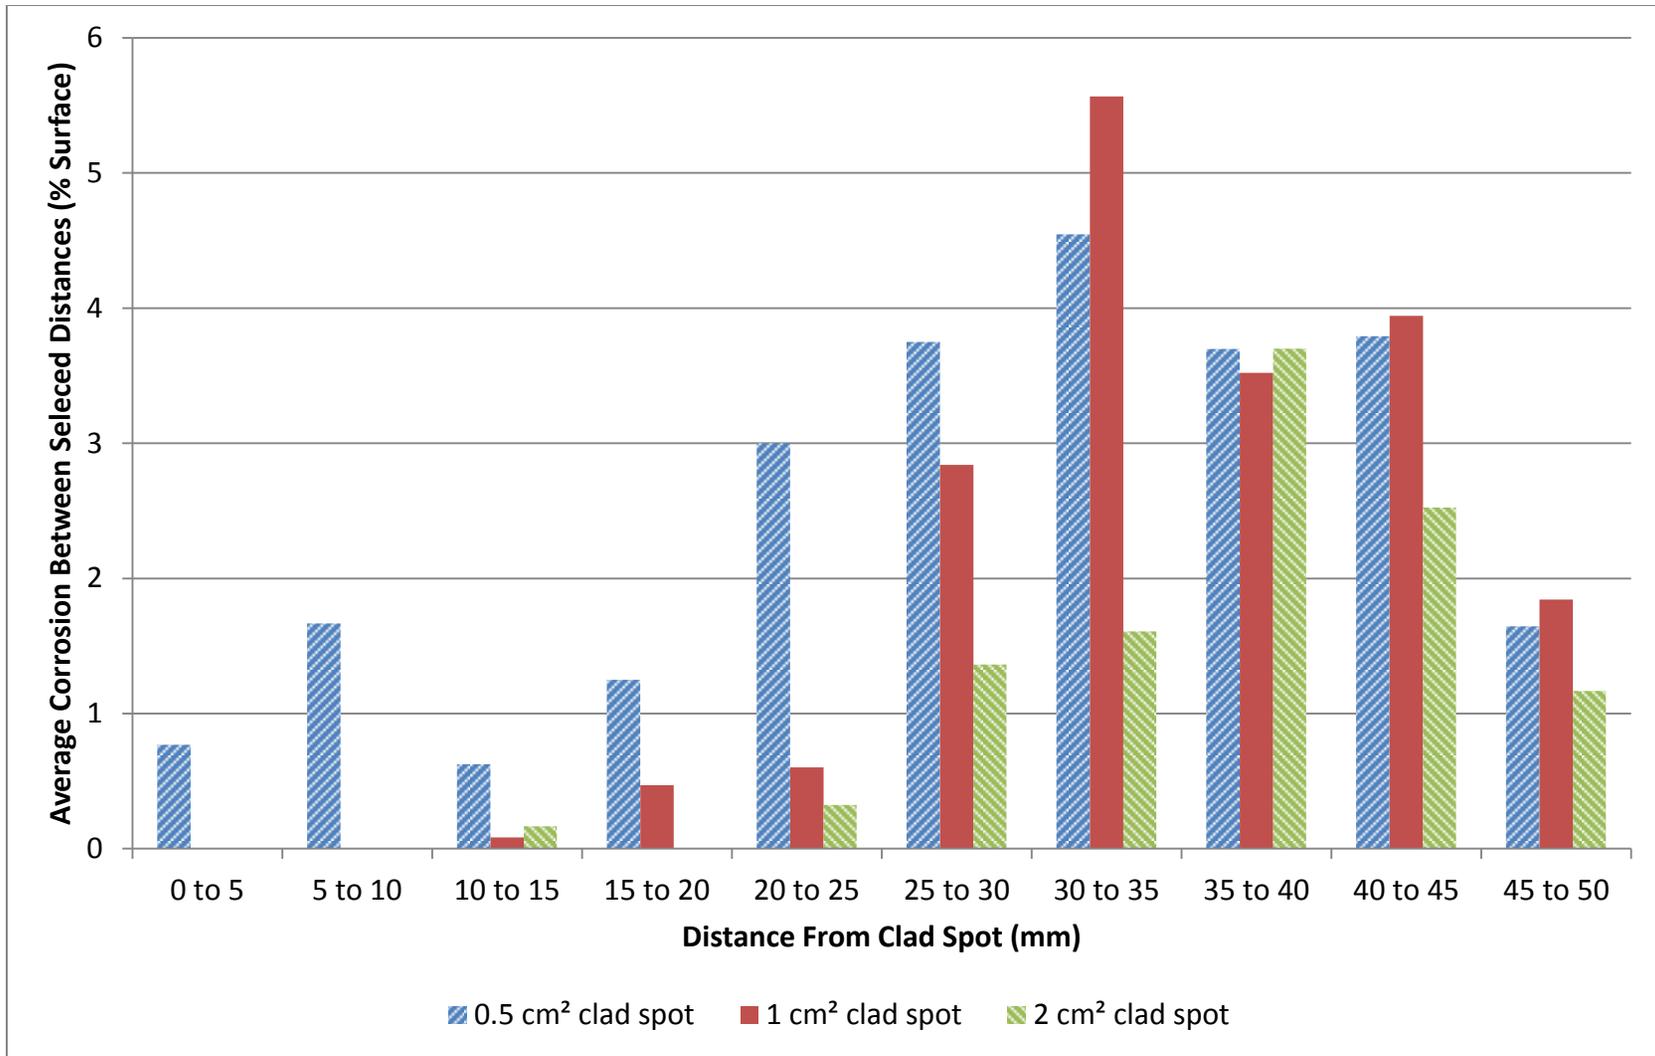
Figure 6.8: Average percentage of corrosion damage observed on the surface of regions defined by rings emanating from the center of the second set of central clad spot test panels (0.5 cm<sup>2</sup>, 1 cm<sup>2</sup> and 2 cm<sup>2</sup>), milling marks remain, the surfaces were milled to a depth of approximately 0.17 mm after corrosion exposure

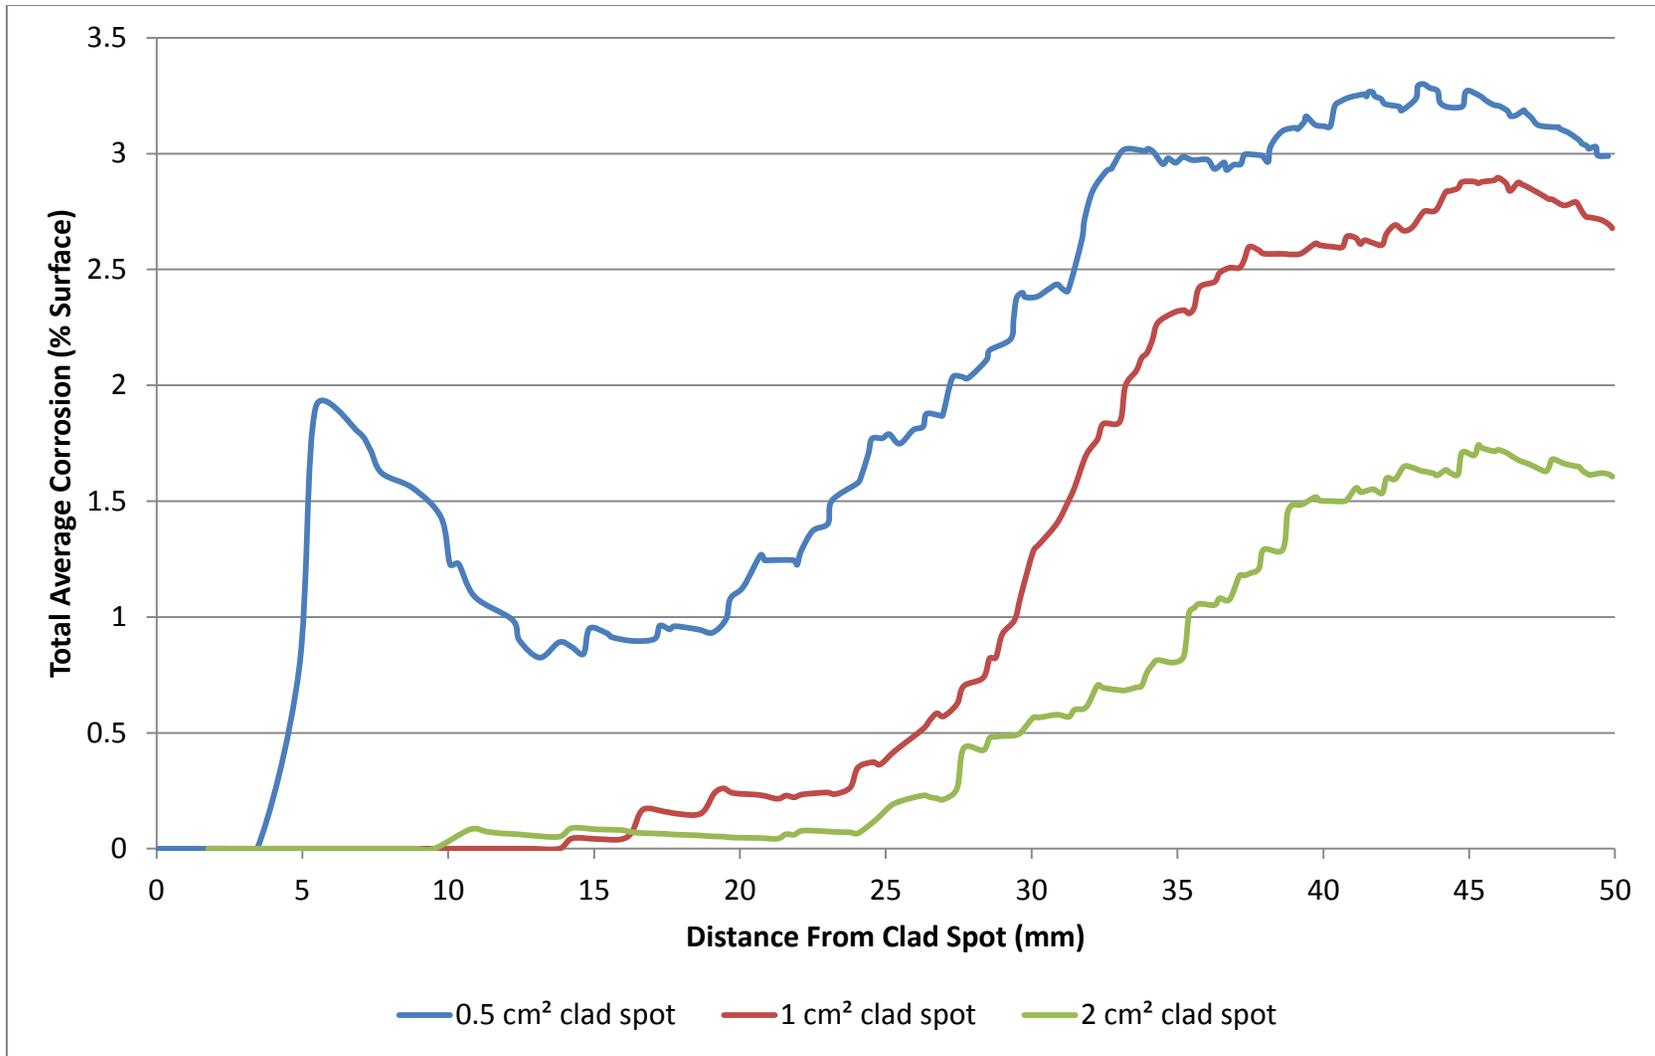
**Figure 6.9: Cumulative average percentage of corrosion damaged observed on the surface of an increasing circular area having a radius defined by the distance from the center of the second set of central clad spot test panels (0.5 cm<sup>2</sup>, 1 cm<sup>2</sup> and 2 cm<sup>2</sup>), milling marks remain, the surfaces were milled to a depth of approximately 0.17 mm after corrosion exposure**

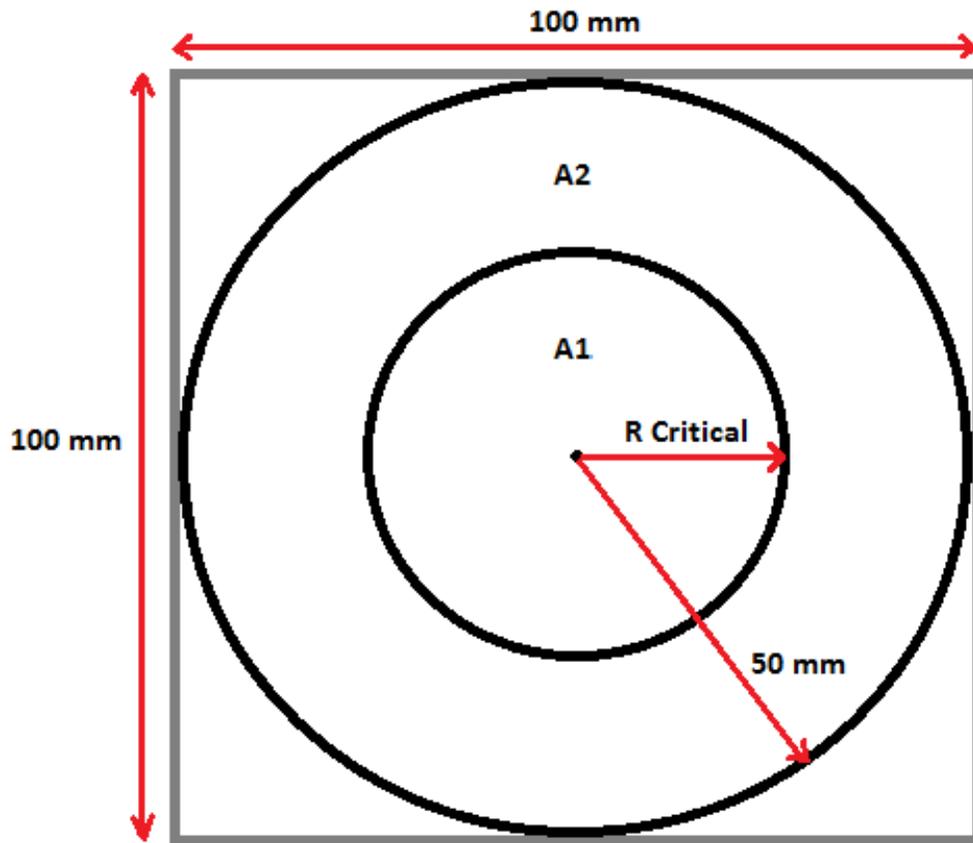
**Figure 6.10: Diagram showing the areas A1 and A2 used to determine the critical radius of each of the single clad spot test panels**

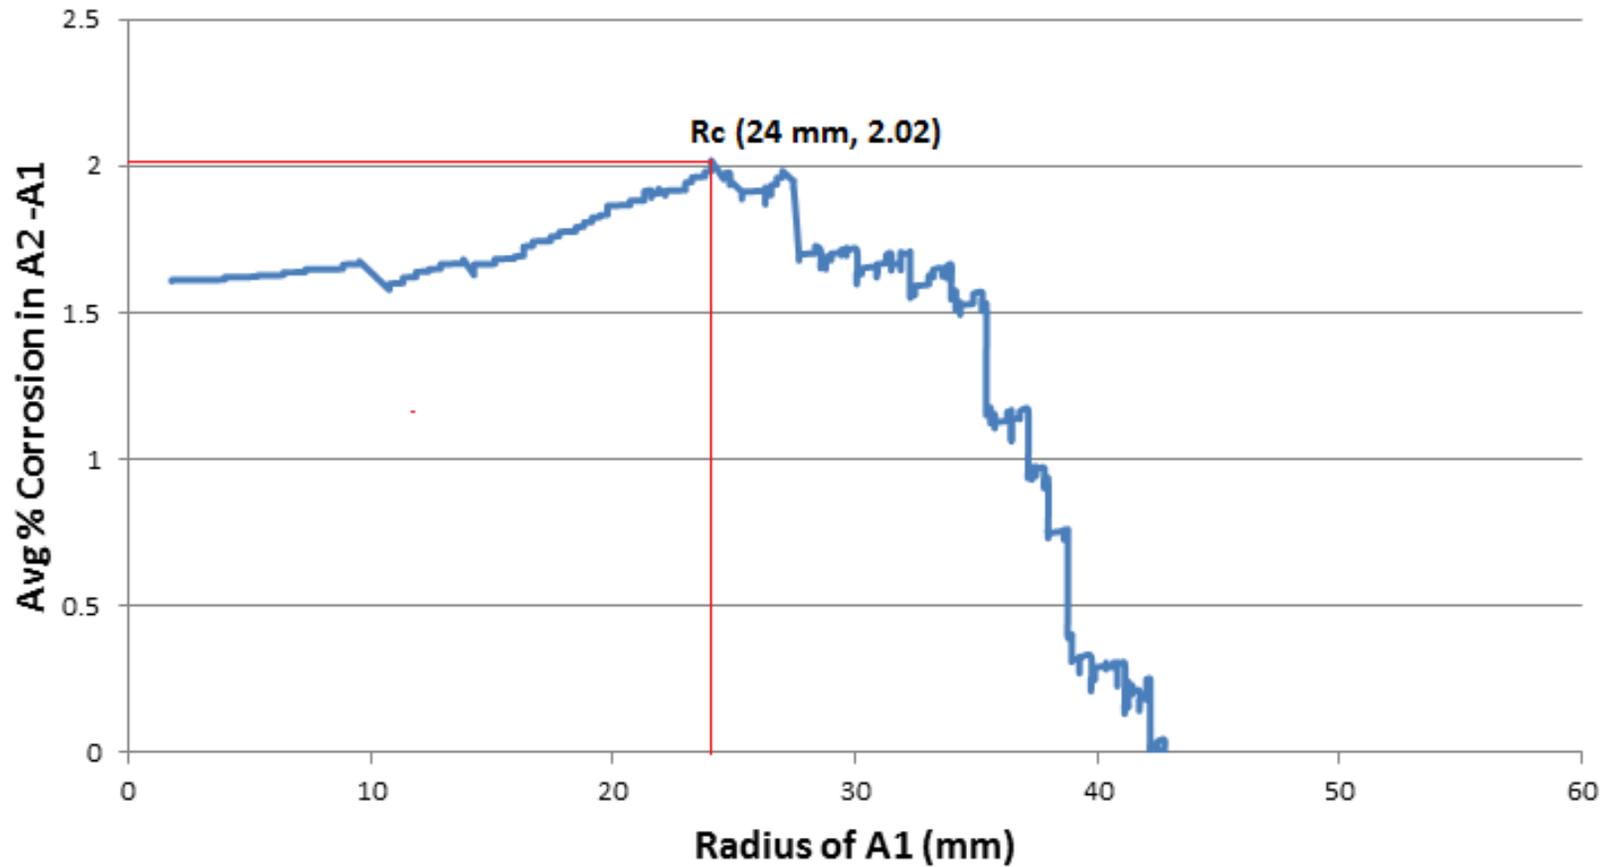
Figure 6.11: Critical radius graph for the 2 cm<sup>2</sup> central clad spot panel after 0.17 mm milled from the surface, indicated point is the critical radius determined by the radius of A1 where the difference in percent surface corrosion between A2 and A1 is at a maximum

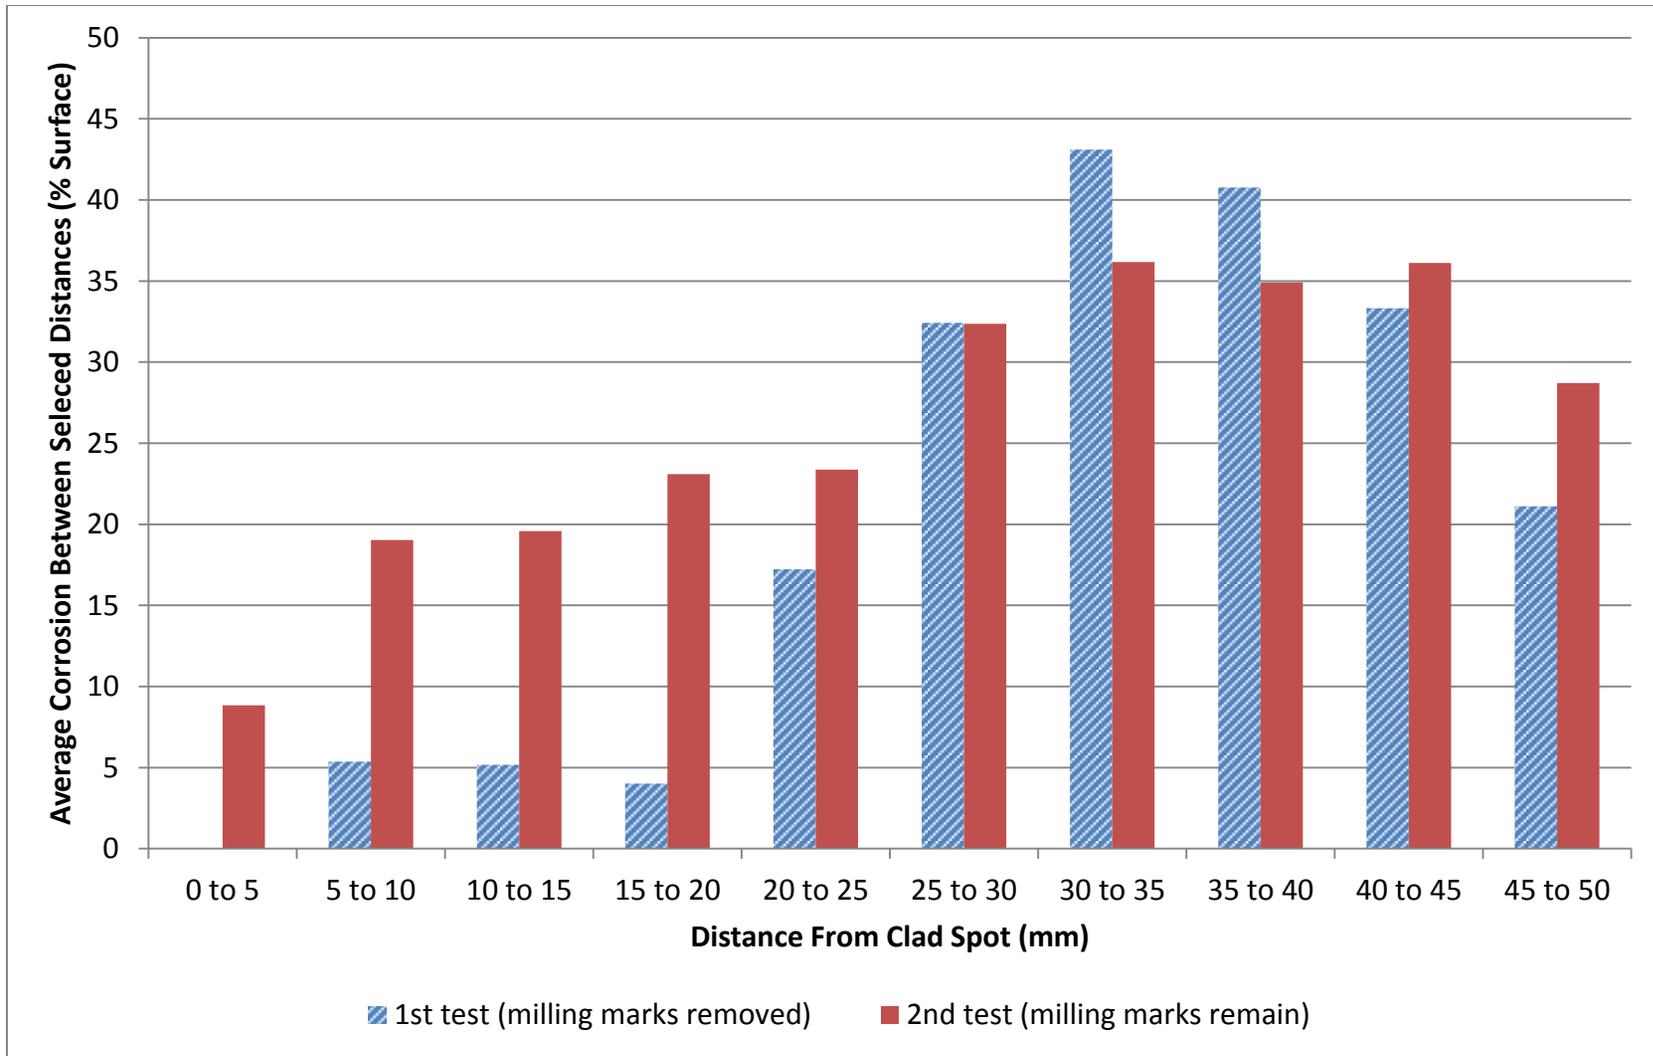
Figure 7.1: Average percentage of corrosion damage observed on the surface of regions defined by rings emanating from the center of the initial and second 1 cm<sup>2</sup> central clad spot test panels, no milling was applied to the surfaces

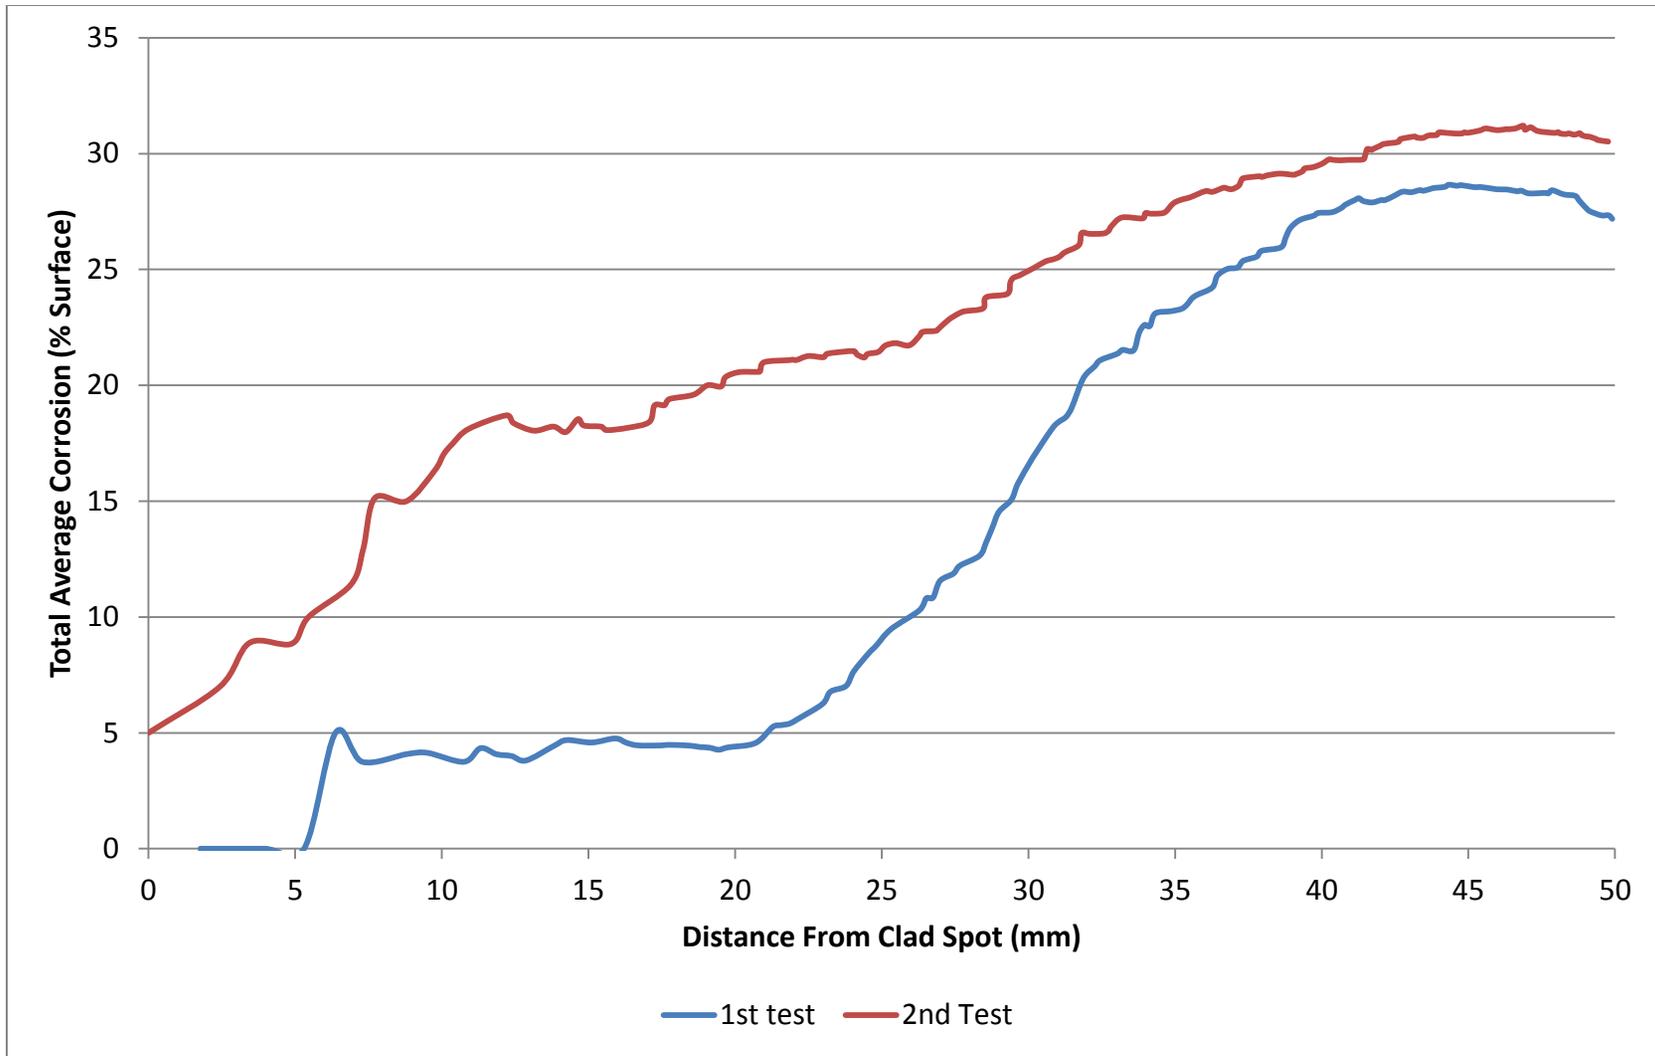
Figure 7.2: Cumulative average percentage of corrosion damaged observed on the surface of an increasing circular area having a radius defined by the distance from the center of the initial and second 1 cm<sup>2</sup> central clad spot test panels, no milling was applied to the surfaces

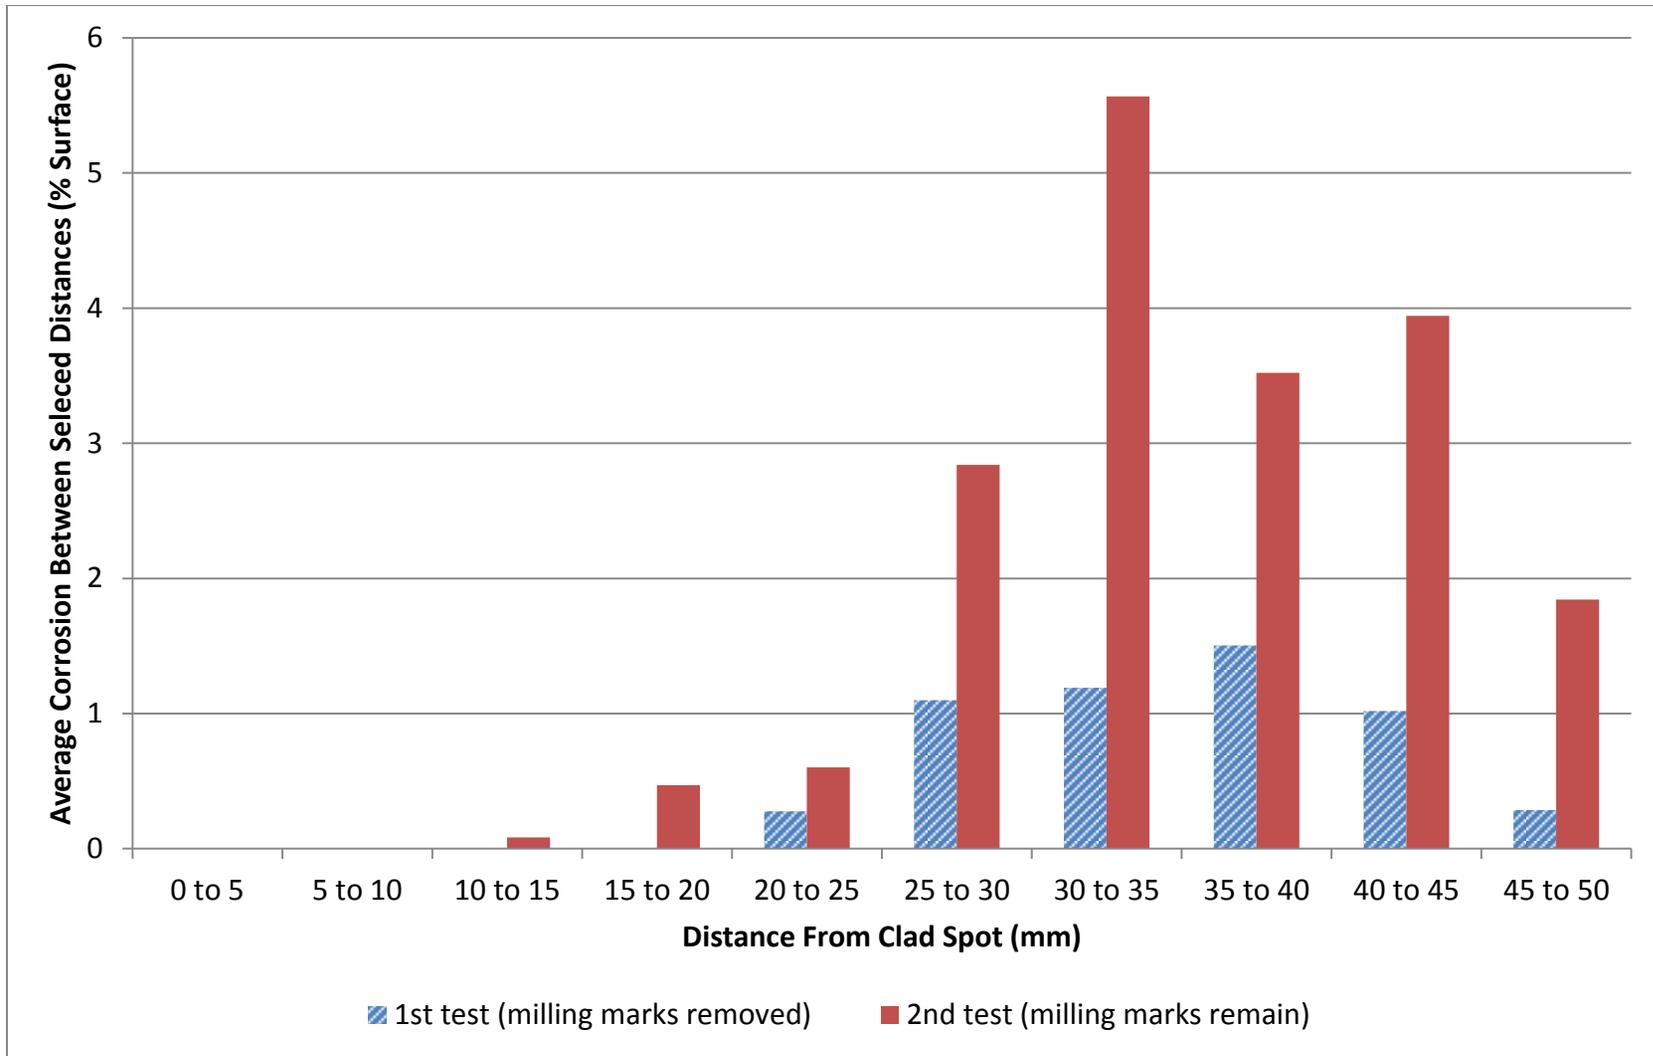
Figure 7.3: Average percentage of corrosion damage observed on the surface of regions defined by rings emanating from the center of the initial and second 1 cm<sup>2</sup> central clad spot test panels, the surface was milled to a depth of approximately 0.17 mm after corrosion exposure

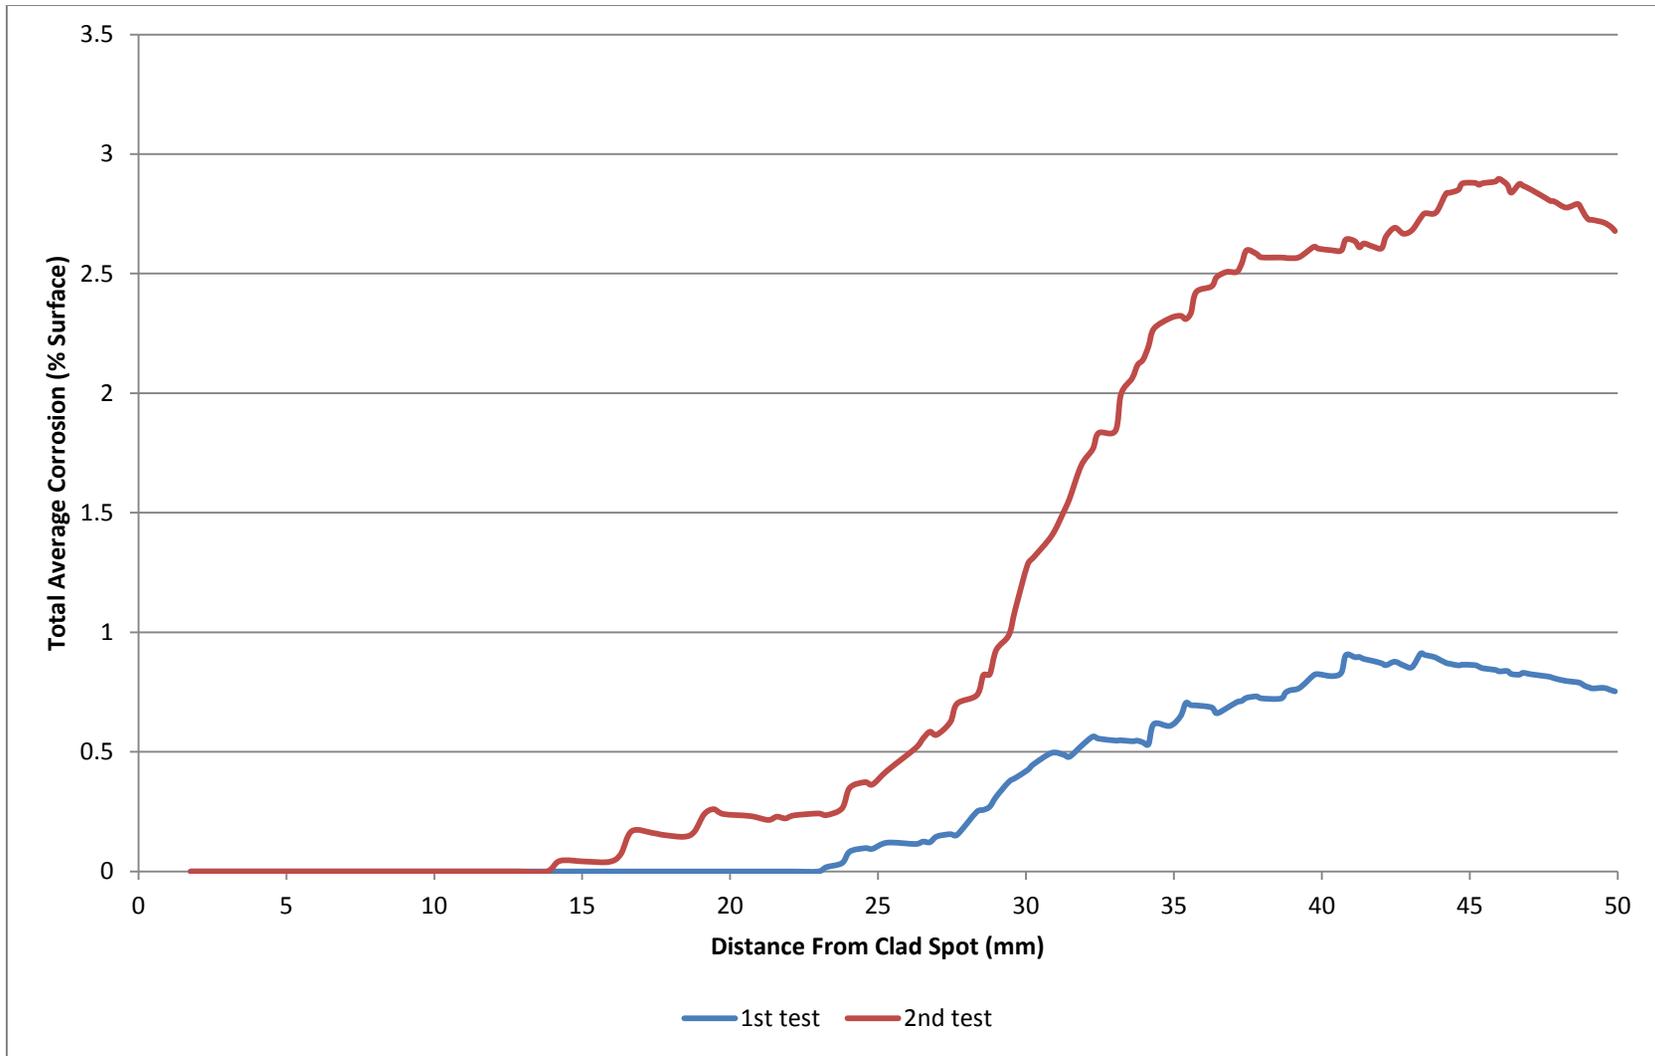
**Figure 7.4: Cumulative average percentage of corrosion damaged observed on the surface of an increasing circular area having a radius defined by the distance from the center of the initial and second 1 cm<sup>2</sup> central clad spot test panels, the surface was milled to a depth of approximately 0.17 mm after corrosion exposure**

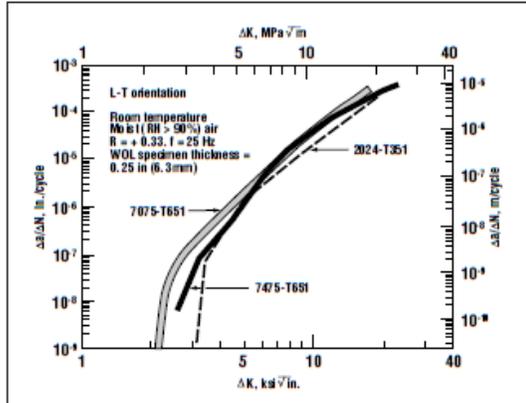
Fatigue crack growth behavior under spectrum loading is becoming increasingly important in the selection of alloys for fatigue critical aircraft structures. Various high strength aerospace alloys are compared for life prediction in flight hours using two types of fatigue spectrums; a wing root application (tension dominated), and a horizontal tail application (tension-compression).
