A SEVENTEENTH-CENTURY HOUSE AT FERRYLAND,  
NEWFOUNDLAND (CgAf-2, AREA B)

DOUGLAS A. NIXON

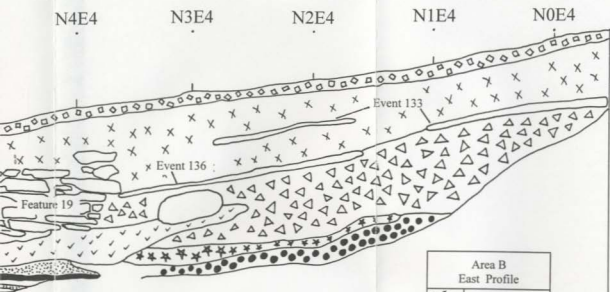
Area B Profile at East 4,  
facing east.

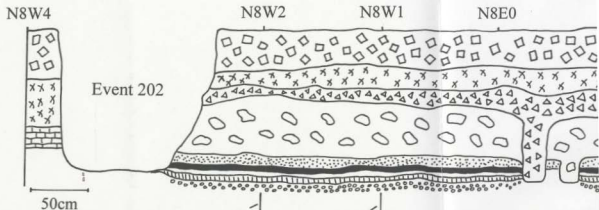
Figure 4.3. Area B Profile at North 8, facing north.

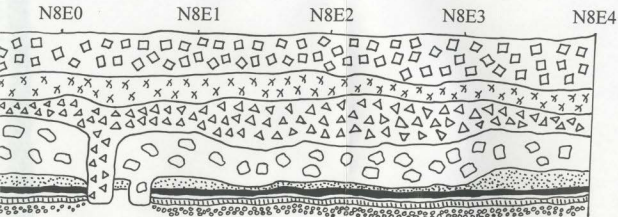
Area B Profile at North 8,  
facing north.

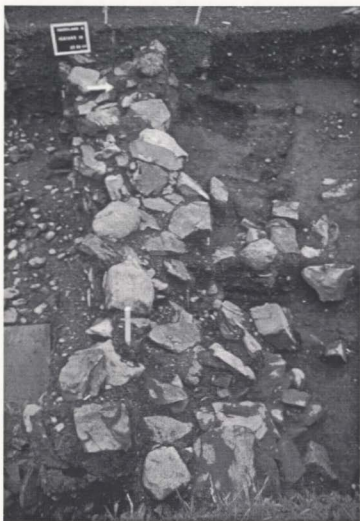
Figure 4.7. Feature 19, partially excavated, facing east.

Event 183 was a narrow band of sterile yellow clay found in the eastern profile of Area B. It ran underneath Feature 19 and measured roughly 3 m (9 ft. 11 in.) in length. Within the limits of the house it was overlain by Event 145 and covered Event 188. This event is similar to Event 142 and likely represents a fill deposit laid down in order to level the southern footings of the house prior to its construction.

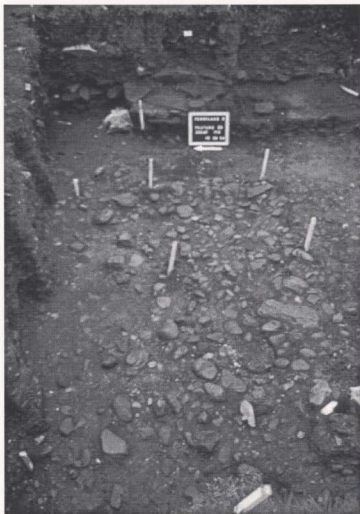
Figure 4.8. Feature 33, partially excavated, in background. Feature 35, upper right, Feature 34 in foreground, facing east.

Feature 33 was a collection of flat stones with a quantity of associated charcoal, with no evidence of burning, located in the northeastern corner of Area B (Figure 4.8). This feature occurred in Events 143 and 145 and was later fully excavated to reveal a collapsed stone chimney and hearth.

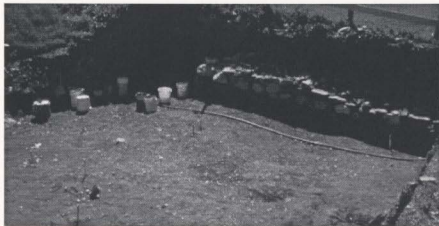
Figure 4.10. Wall Segment 15 at right, facing southwest.

Wall Segment 15 was a carefully constructed dry-laid stone footing that supported the west end of the house (Figure 4.10). Running north-south this feature measured approximately 4.9 m (16 ft.) in length, averaged 50 cm (1 ft. 7 in.) in width, and 55-65 cm (1 ft. 9 in.- 2 ft. 1 in.) in thickness. A scatter of rocks and cobbles to the west of its

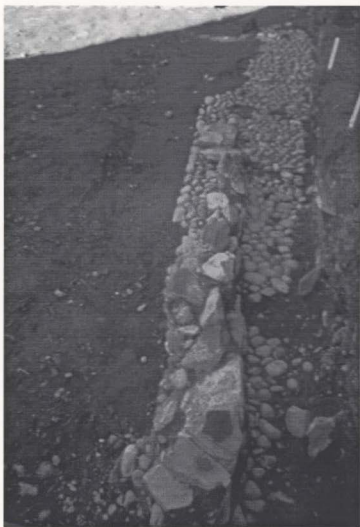
Figure 4.11. Wall Segment 17 overlying Feature 56, the cobblestone road, in foreground, facing west.

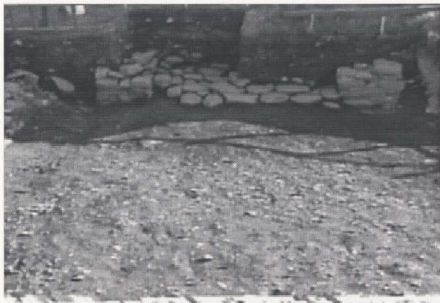
Figure 4.12. Wall Segment 18 encompassing Feature 33, the hearth, in background, facing east.

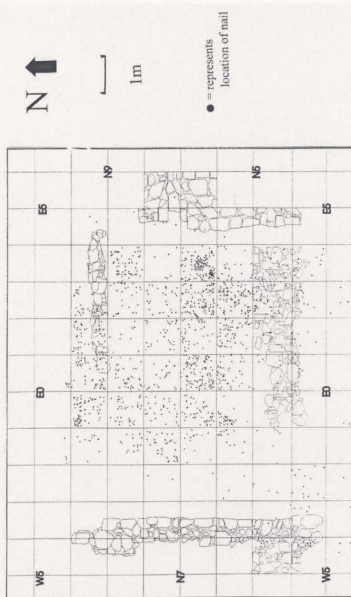
Figure 5.2. Distribution of iron nails in the occupation levels of the House at Area B, Events 143 and 145.

First, the excavation of the house at Area B has revealed a relatively large amount of disturbance in its western end by the construction of a more recent waterline. Figures 5.2. to 5.5 portray the distribution of iron nails and ceramics within the house, as well as their virtual absence from the location of the waterline at the "low" end. This indicates that activities which might have taken place there cannot be readily identified and that, as a result, the portrayal of indoor activities cannot avoid being incomplete. At the same time, however, the distribution of ceramics vessel fragments within the house, based on their categorization by use or function (Section 6.2), shows no clear concentration of any one particular activity in any specific part of the house. This suggests that the ground floor of the house was not purposefully separated, but instead served more likely as a general area for a variety of activities. Such a pattern of use was not uncommon in the 17th-century homes of those of lesser means in England (Brunskill 1997:88) or Ireland (Blades 1981:52), as well as among many settlers of the Chesapeake (Horn 1988:317; Carson et al. 1981) and New England (Hawke 1988:52; Cummings 1979:22). Moreover, the physical subdivision of what was a relatively small house (15-x-30-ft.) by the insertion of a partition or cross-passage would have resulted in a certain reduction of useful floor space.

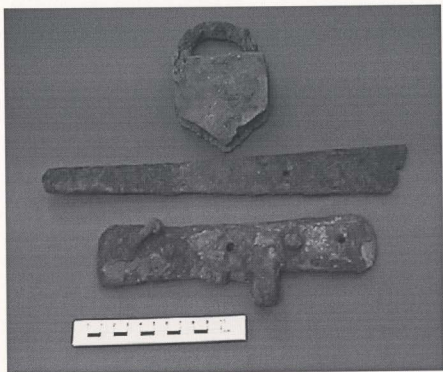
Figure 7.7. Iron Artifacts: Padlock and Hinges. Padlock, Event 143, 112111, top. Hinge, Event 145, 109614, centre. Hinge, Event 145, 142744, bottom.

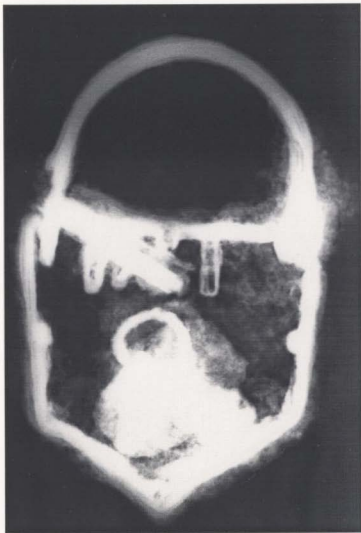
Figure 7.9. X-radiograph of iron padlock interior (112111). Image not to scale.
