# **Multi-Edge Disc Cutters Wear and Damage Evaluation**

**Master of Engineering**

Faculty of Engineering and Applied Sciences  
Memorial University of Newfoundland

This research is focused on wear and damage measurements of large-diameter disc cutters and drilling tools used for a mining operation at Baie Verte, north of Newfoundland, Canada. The field data compiled for wear and damage of the large diameter drilling disc cutters showed that the two methods (damaged score count and wear measurement) used to determine disc cutter wear give complimentary results. The objective for carrying out this project was met, although it is important to note that future research to carry out an expansive evaluation of wear and damage of the large diameter drilling cutters and drilling tools needs to be done as several drilling parameters influence the degree of wear and damage experienced by the disc cutters and drilling tools.

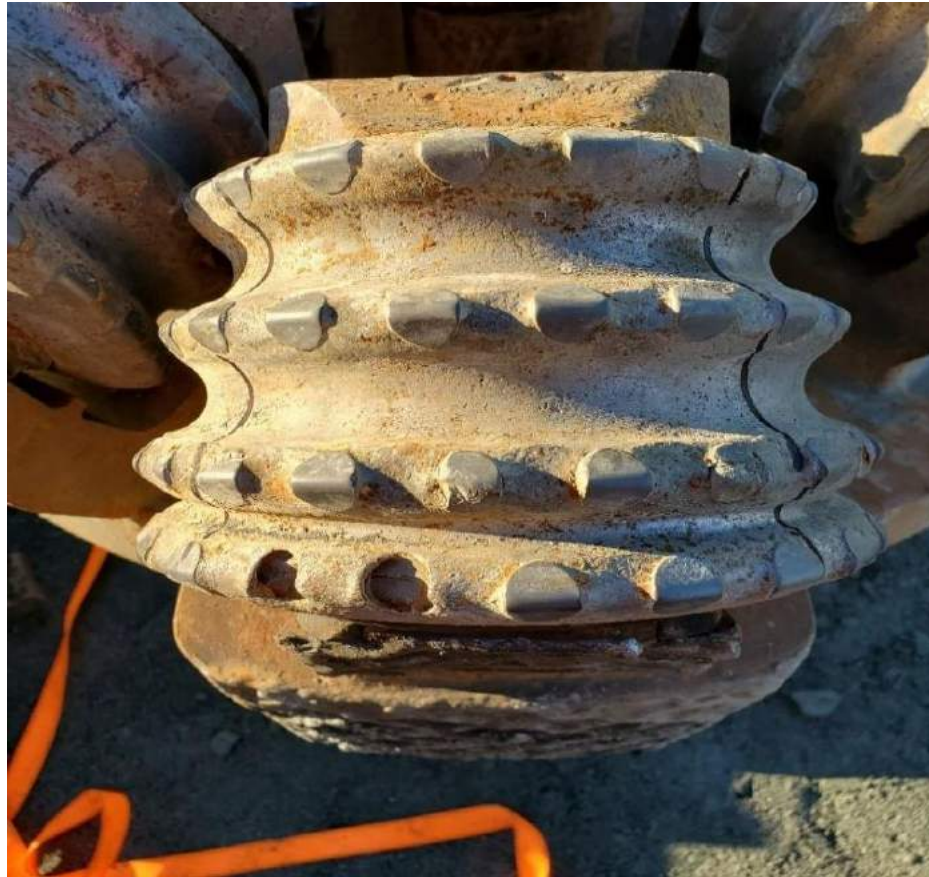
Figure 3-1. Damaged multi-edge disc cutters (Novamera Inc., 2022).

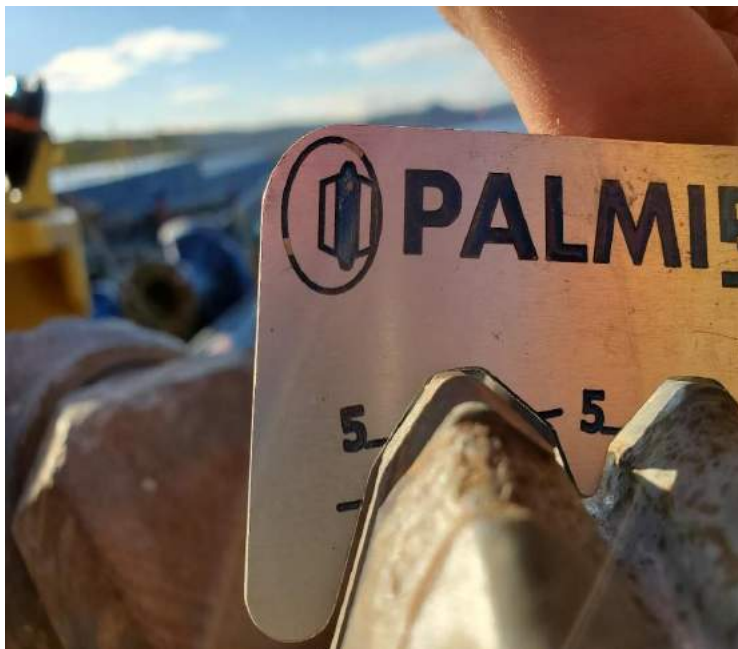
Figure 3-2. Image of Wear Gage used on the field. (Tytler et. al., 2022)

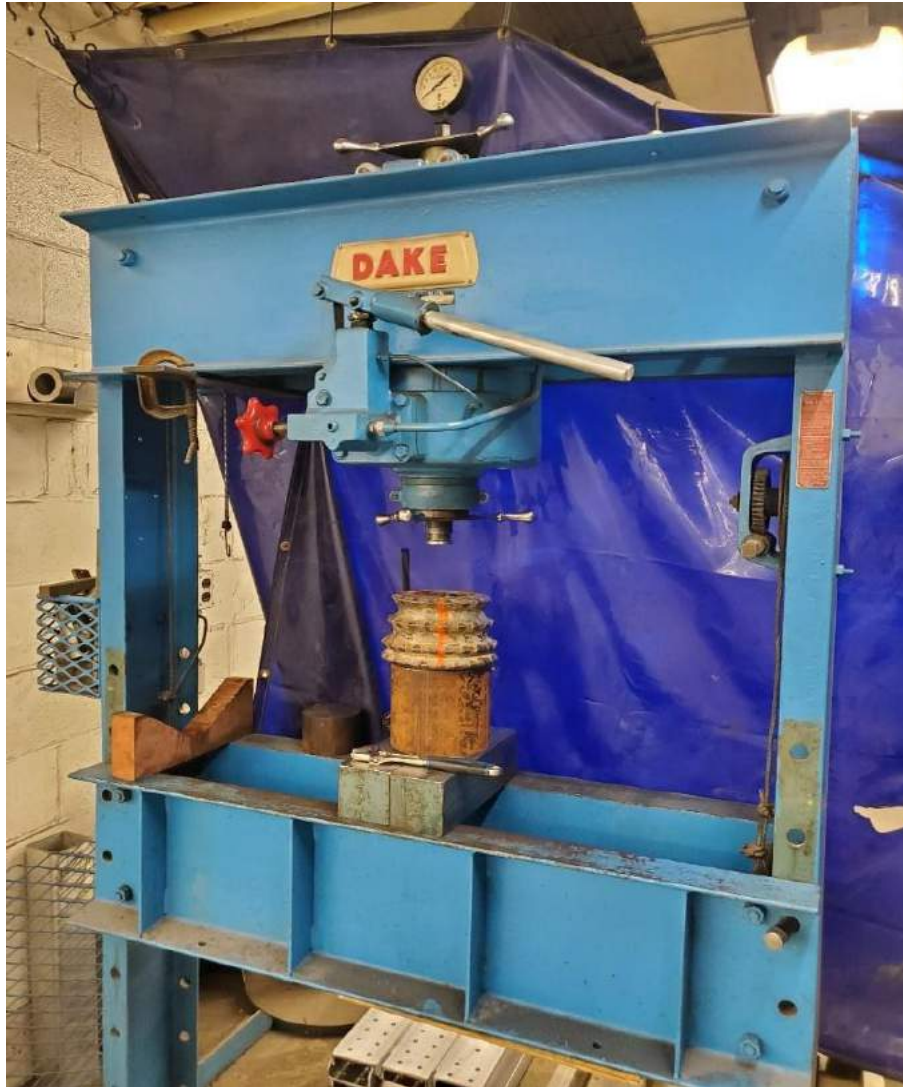
Figure 3-4. Image of a Mechanical Servo-Press.

The mechanical servo press has a simple driving chain without a flywheel, clutch, or brake, which are necessary for a conventional mechanical press. As a result, maintenance is made easier for the servo press because all press motions, such as starting, changing velocity, and stopping, are handled solely by the servo motor. Figure 3-4 shows an image of a mechanical servo press, which outperforms the long-used hydraulic servo press in terms of productivity, product precision, and machine dependability without the noise of a hydraulic pump or convoluted piping. Flexible sliding movement is the servo press's key characteristic. The mechanical servo-drive press combines mechanical press speed, accuracy, and dependability with the flexibility of a hydraulic press (unlimited slide

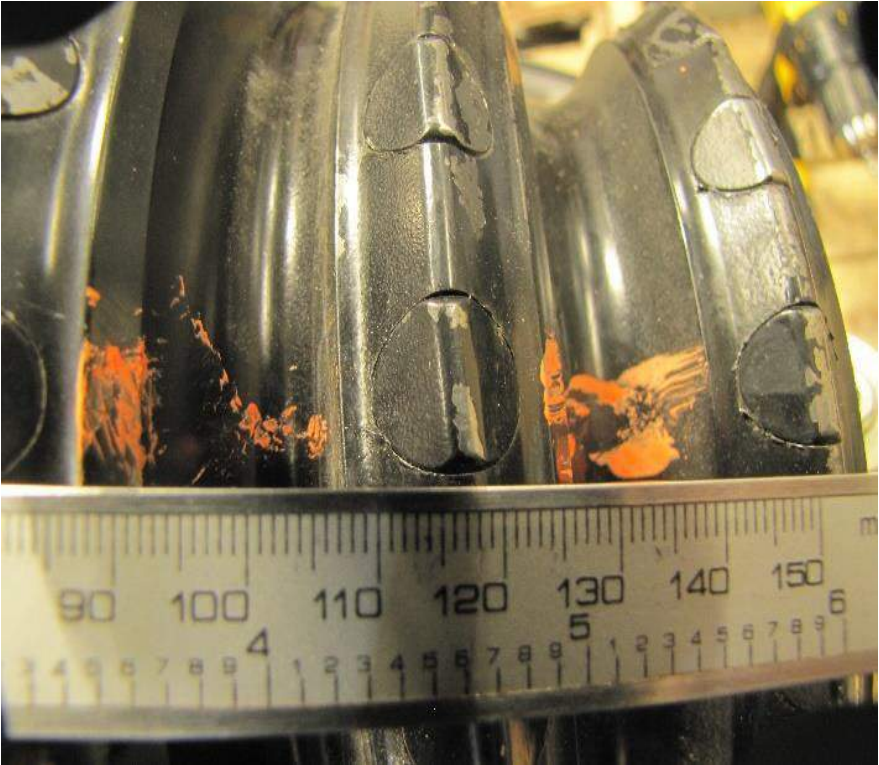
Figure 4-1. Diagram of a Scaled Set of Multi-Edge Disc Cutters.

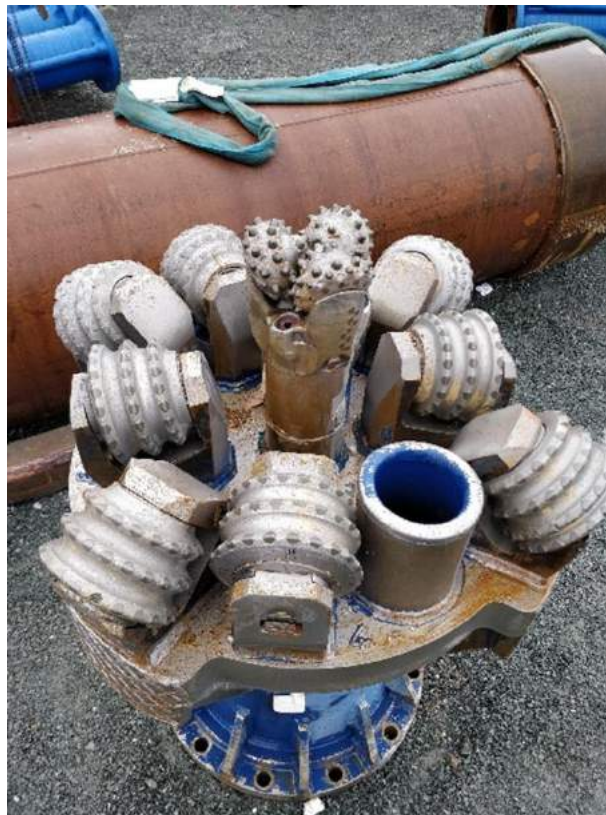
Figure 4-2. A diagrammatic representation of a large-diameter disc cutter. (Novamera Inc., 2022).

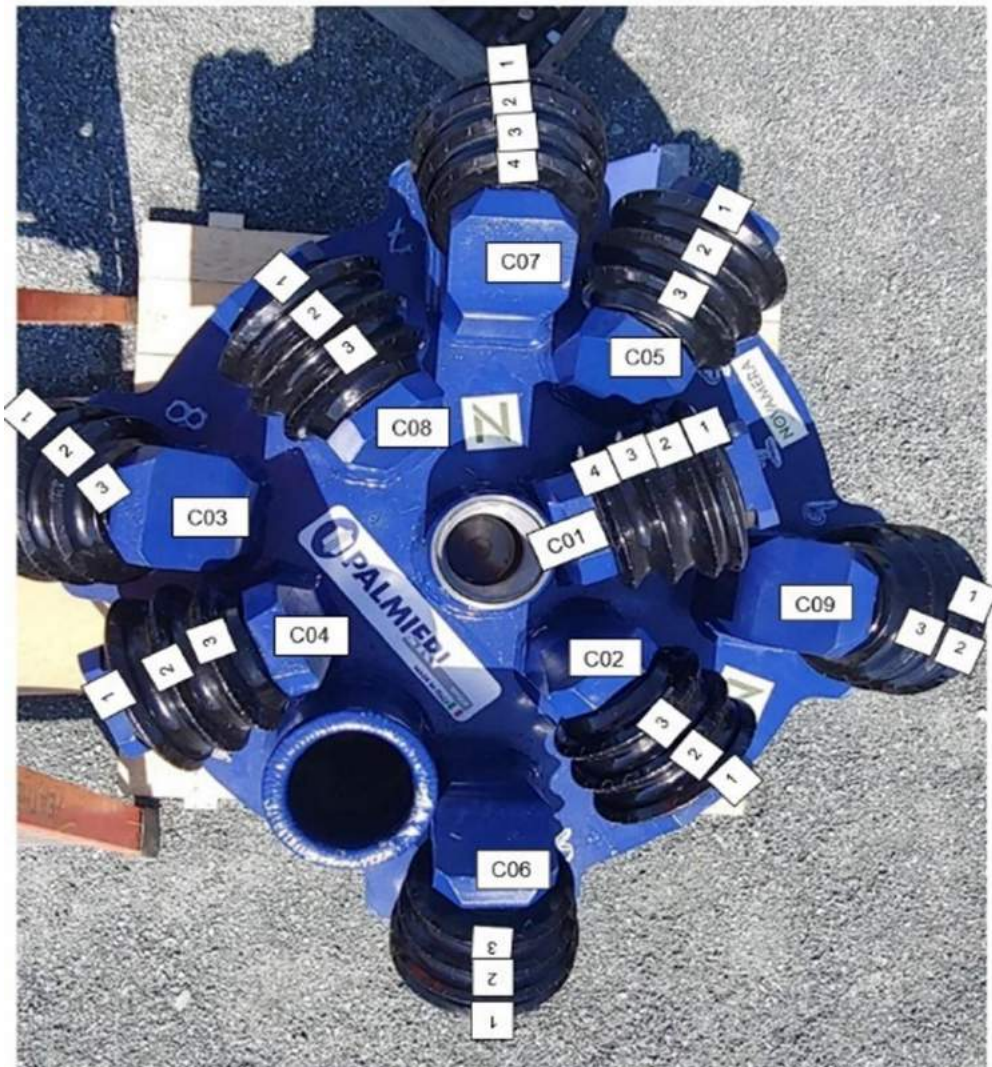
Figure 4-4. Diagram of a fully labeled cutter head.

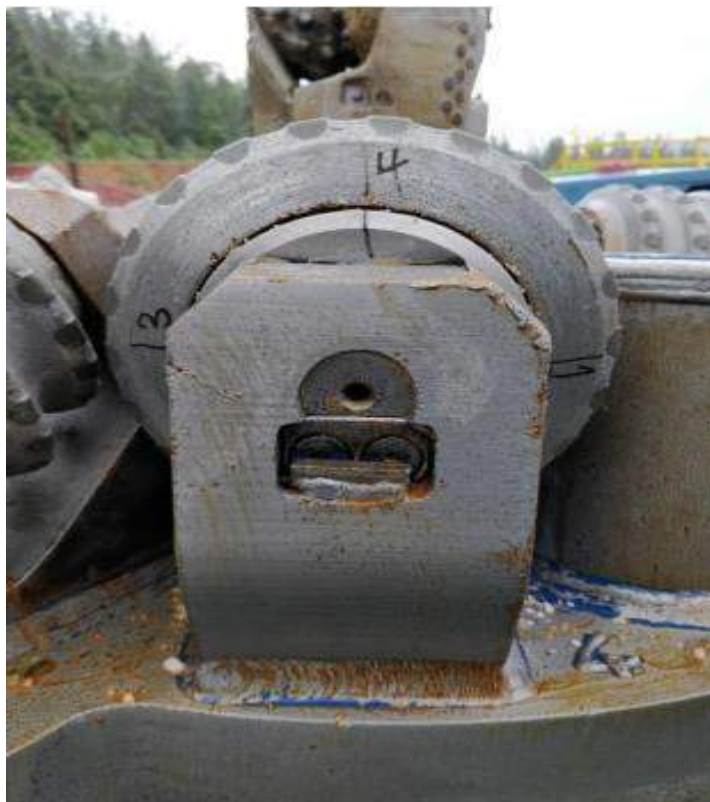
Draw lines 1, 2, 3, and 4 on the side of the outermost disc for each disc cutter, with one line on the cutter's base. The angles between the first, second, third, and fourth marks should be around 90 degrees. As indicated in Figure 4-5, the lines should then be extended so that they cross the top of the cutter. The function of the pen marker is to split the cutter into four zones, making it easier to tally the number of damaged inserts. The marks serve as a guide for estimating wear. Figure 4-6 shows how the disc cutter is divided into four zones to serve as a reference for the wear estimation.

Figure 4-5. Diagram showing disc cutter divided into zones.

- Extend the lines from each zone, from the side of the disc and across the top of the cutter as shown in Figure 4-5.
- For each zone, count the number of damaged inserts on each disc, such as (1-2) and (2-3). Photograph the current zone's cutter in addition to counting and documenting the number. The following is a recommended SOP: Figure 4-6 shows how to photograph the cutter number and the number (1-4) on the side of the cutter. Take a photo of each disc on the cutter after that (3 or 4, depending on the number of discs for the certain cutter). By ranking the photographs in order of file name or time, it is straightforward to sort them and discover the damaged insert of the source cutter and disc in this pattern.

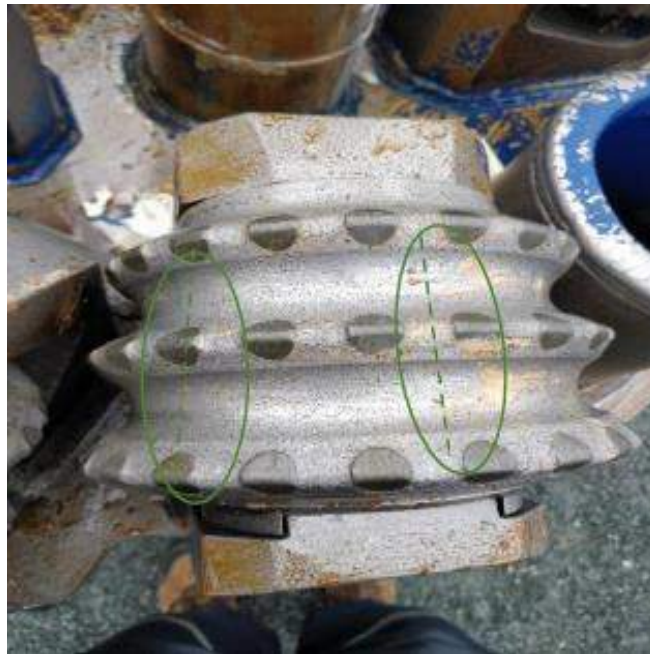
Figure 4-6. Diagram showing extended lines across the top of the cutter.

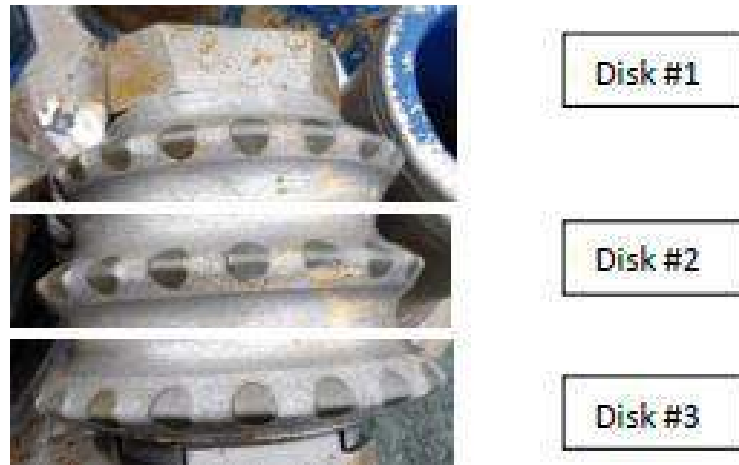
Figure 4-7. Diagram of multi-edge disc cutter.

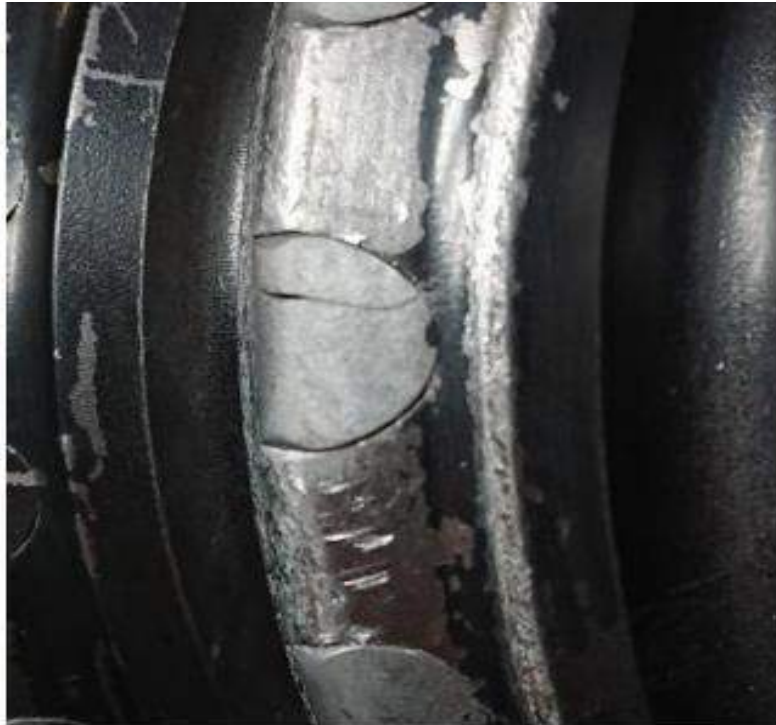
Figure 4-8. Diagram of a fractured insert.

- The damage score for each cutter is then calculated by adding the damage scores of the discs. The score of the cutters with four discs (cutter nos. 1, 6, and 7) is calibrated against the score of the cutters with three discs by multiplying their score by  $3/4$ . The total number of damaged inserts and the damage score are then summarized and compared in another sheet. Figure 4-8, and, Figure 4-9, depicts diagrams of fractured and chipped inserts respectively.

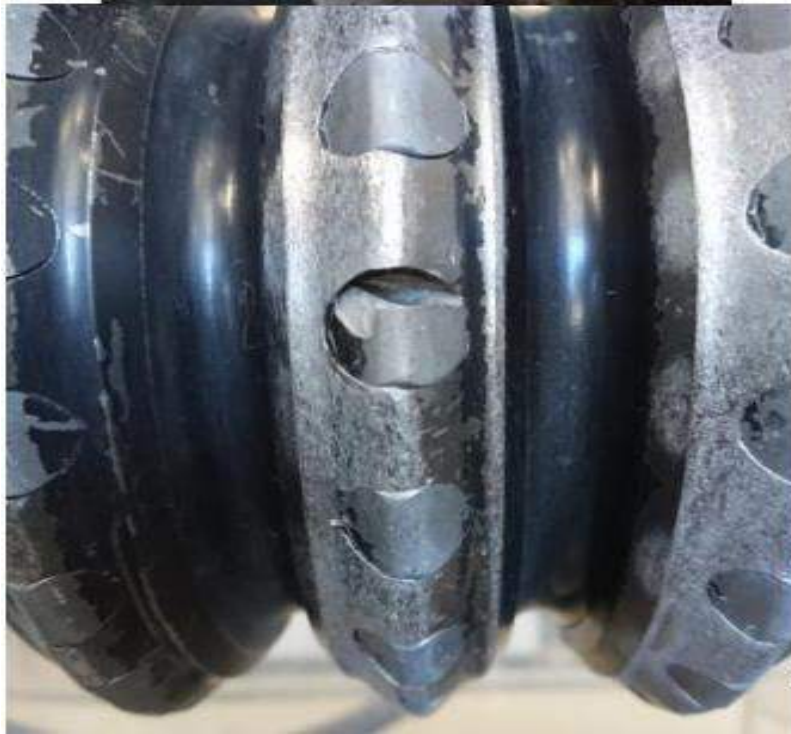
Figure 4-9. Diagram of a chipped insert.

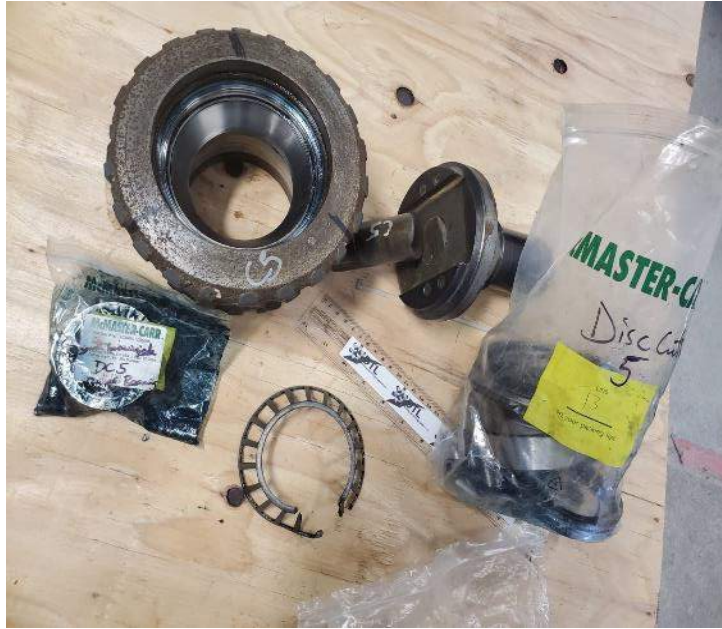
- ✓ The small bearing side:
  - ✓ Seal – free of nicks, burrs, scratches, and lapped surfaces isn't damaged, and the O-ring is in good condition.
  - ✓ Small bearing cup - observed scratches and heat marks. The damaged area where foreign material wore through.
  - ✓ The tapered roller bearing is damaged, the O-ring is in okay condition.
  - ✓ Bearing retainer – damaged.

Figure 5-1. Disassembled disc cutter parts.

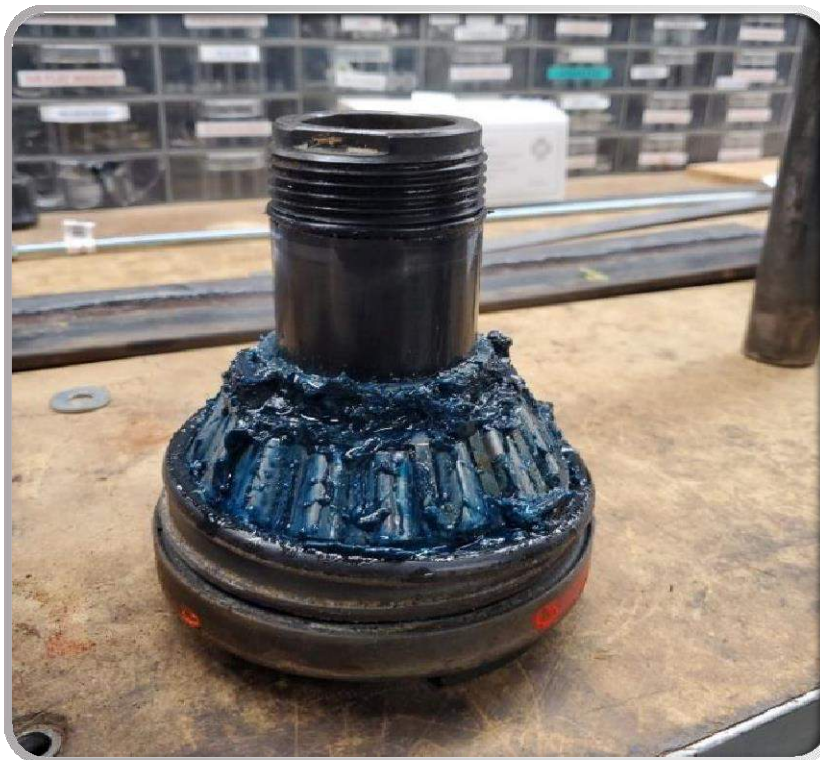
- ✓ The big bearing side:
  - ✓ Seal – free of nicks, burrs, scratches, lapped surfaces aren't damaged, and the O-ring is in good condition. Figure 5-2 depicts the image of the disc cutter roller bearing.

Figure 5-2. Image showing roller bearing.

- ✓ Big bearing cup – all in good condition.
- ✓ Tapered roller bearings are okay, O-ring is in okay condition.
- ✓ Bearing retainer – in good condition.
- ✓ Shaft: was observed to be in good condition for most cutters except for cutter 4 with a fractured shaft pin and cutter 5 with a broken shaft pin, half stuck in bearing retainer.
- ✓ Dirty grease was found in cutter 7 and a broken shaft pin in cutter 5. Figure 5-3 shows the comparison between dirty grease and clean grease.

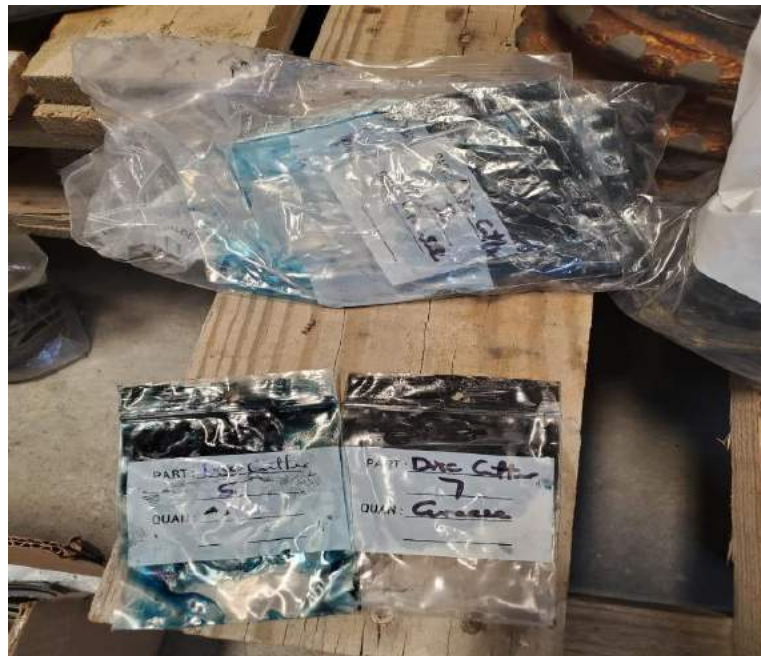
Figure 5-3. Image showing dirty grease vs clean grease.

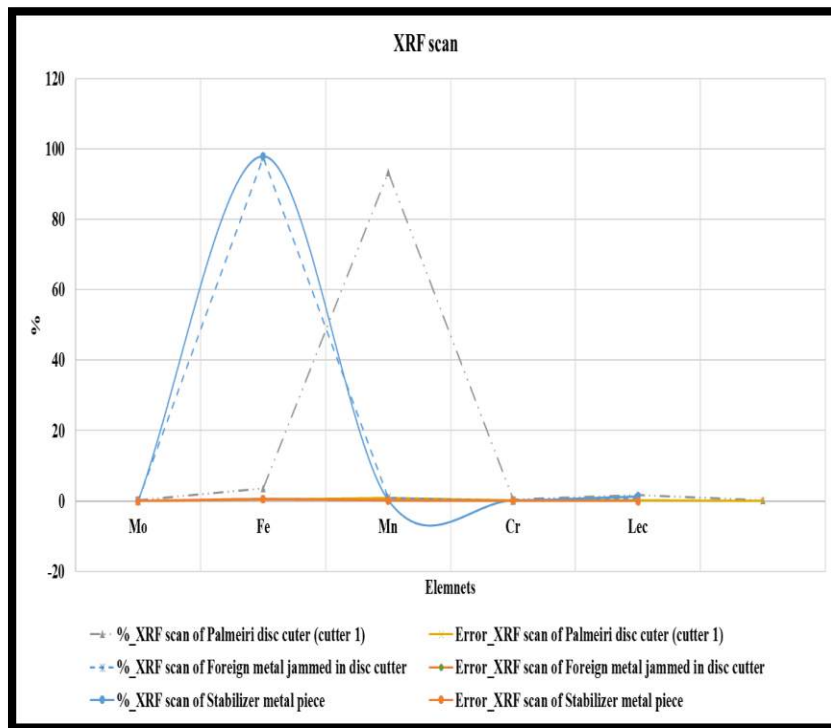
The results from the scan show that the foreign metal that got stuck in the cutter head, thereby leading to a non-penetrating time during the mining operation has an identical material composition to the stabilizer wear plate. From further investigation, a working theory was deducted, and it was determined that there was a likely spike in torque during drilling which led to the failure of one of the stabilizers downhole. The stabilizer wear plate gave way and got stuck between disc cutters thereby preventing them from rotating and in the long run brought to a halt the drilling operation. Figure 5-5 shows a plot of the foreign metal matching the stabilizer wear plate.

Figure 5-5. Plots of XRF scans of Palmieri disc cutter, foreign metal, and stabilizer wear plate.

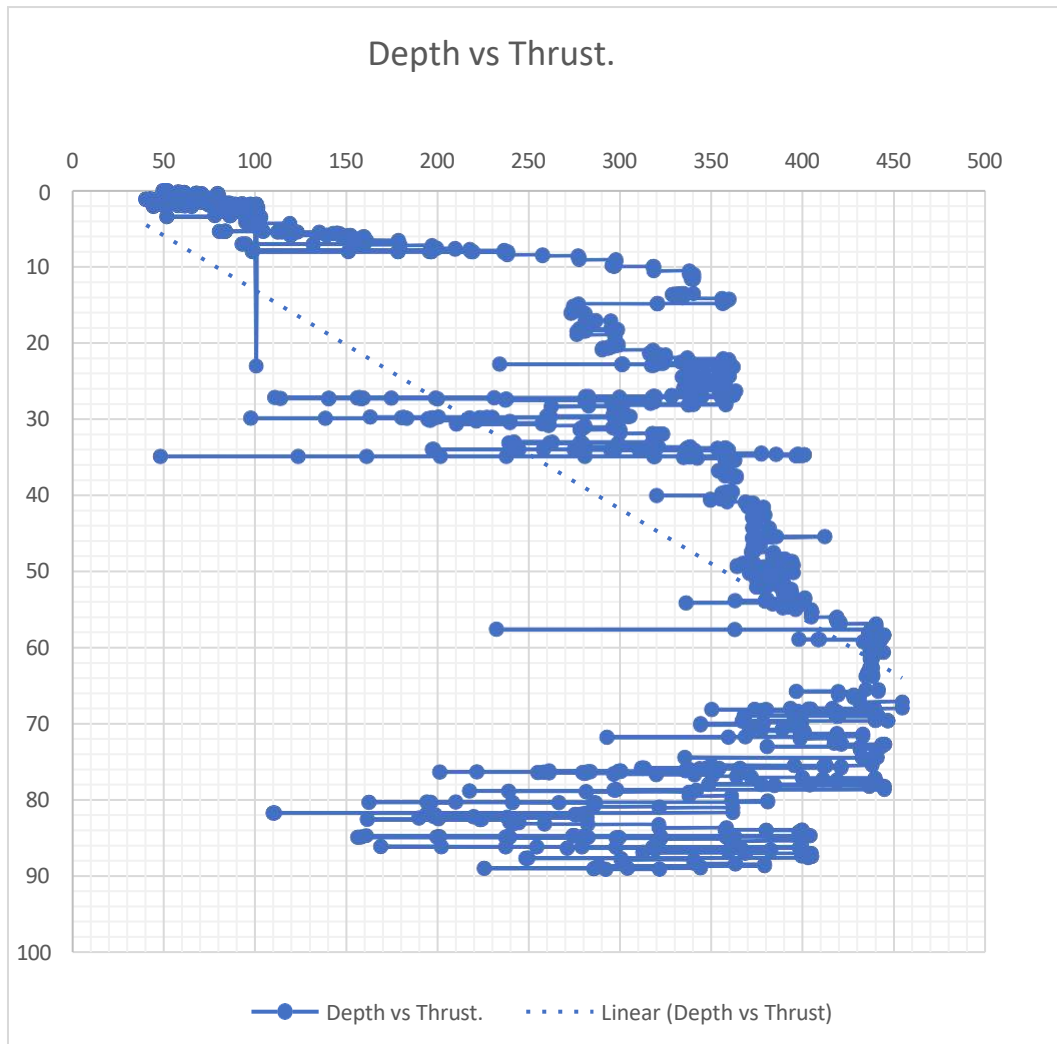
Figure 6-1. Plot of Depth against Thrust.

Up until a maximum of 22rpm, the rotational speed gradually rose. The initial applied thrust also increased gradually as drilling continued. Figure 6-1 shows a plot of depth against the applied thrust. The string weight and skin friction had an effect on the bit's effective weight on the bit when it was applied to the rock surface at the bottom of the hole. The hole tortuosity and roughness are caused by skin friction. The skin friction is calculated as a percentage of the normal forces perpendicular to the hole's axis. The skin friction is calculated as a percentage of the normal forces perpendicular to the hole's axis. The calculated coefficient of static friction ( $\mu$ ) is 1.13 based on the results of the free stroke test performed during the FFT1.

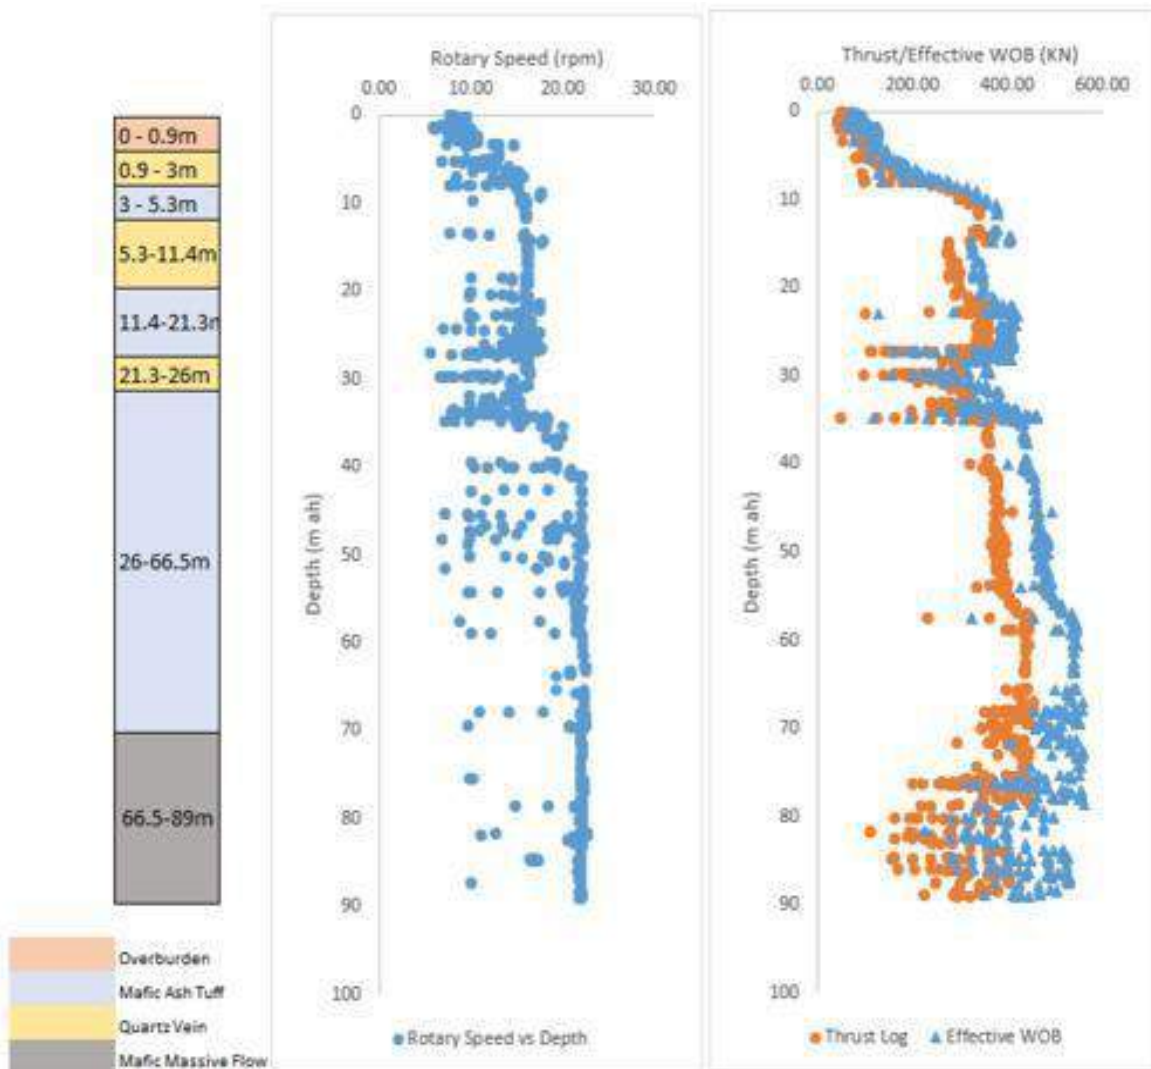
Figure 6-2. Plots of input drilling parameters (Q4 2022, DTL report).

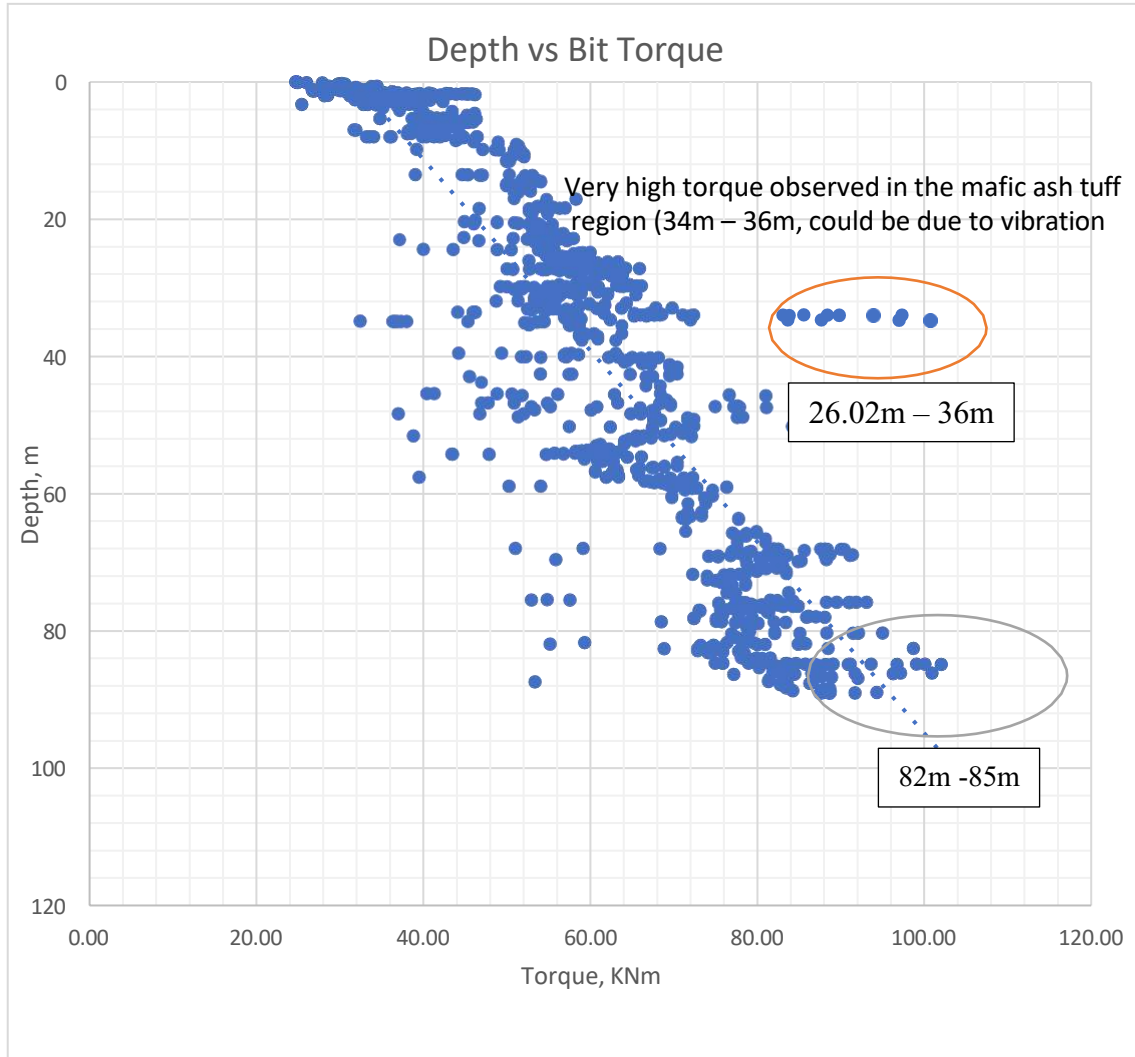
Figure 6-3. Plot of Depth against Torque.

Reaction torque ( $T_r$ ) is subtracted from the total recorded torque to get the torque on the bit ( $T_b$ ) ( $T$ ). Off-bottom testing, also known as free stroke tests, was conducted during the FFT1 to create the reaction torque model. Two models were created to compute the response of torque as shown in equations 6-3 and 6-4 (De Moura, 2021). Figure 6-3 shows a plot of depth against torque.

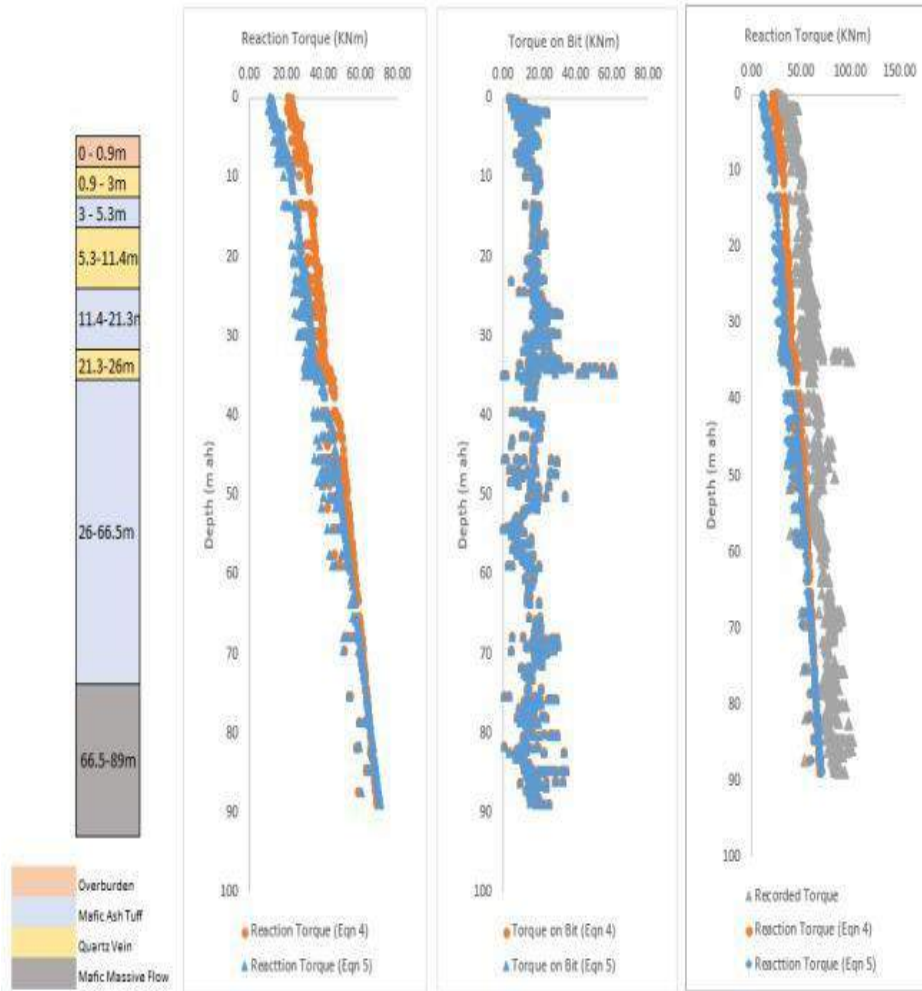
Figure 6-4. Torque log data (Q4 2022, DTL report).

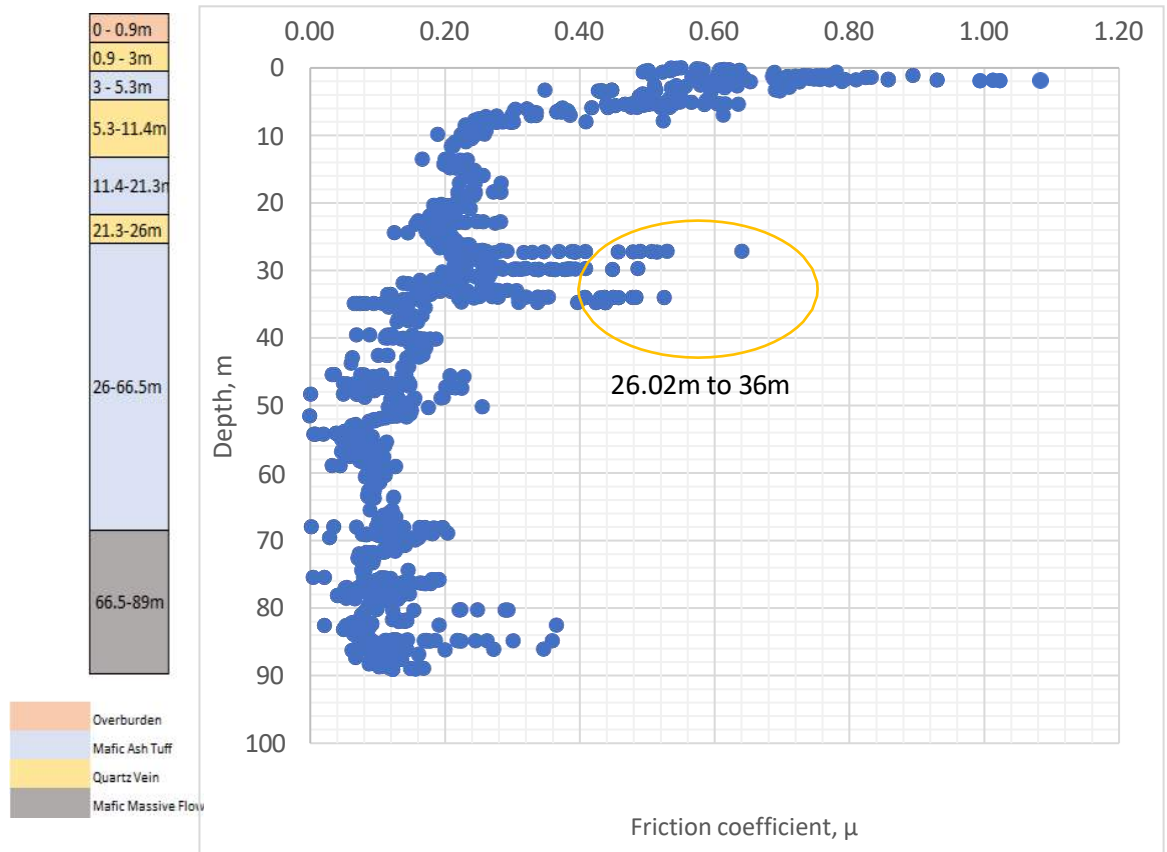
From Figure 6-5, it can be observed that there is a variation in the friction coefficient in the mafic ash tuff region, across hole depths 26.02m to 36m, this could have led to the observed anomalous increase in torque in relation to the effective weight on bit applied by the disc cutters, and hence, damage to the bearing of the disc cutters.

Figure 6-5. The plot of depth against friction coefficient.

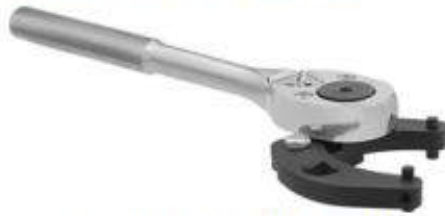
Shown with Ratchet Wrench (Not Included)

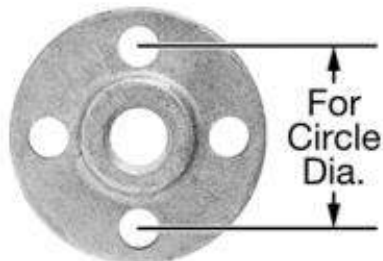
Wrench Style	Spanner
Spanner Wrench Style	Pin
Spanner Wrench Type	Adjustable
Square Drive Size	1/2"
For Circle Diameter	1"-3 3/4"
Pin Diameter (Pin Length )	7/32" Dia. x 1/4" Dia. (3/16" Lg. x 3/16" Lg.)
Pin Shape	Round
Overall Length	3 1/2"
Material	Steel
Finish	Black Oxide
For Use With	Rings, Flanges, and Collars
Individual/Set	Individual
RoHS	Not Compliant
REACH	Not Compliant
DFARS	Specialty Metals COTS-Exempt
Country of Origin	United States
USMCA Qualifying	No
Schedule B	820412.0000
ECCN	EAR99
Related Product	<a href="#">Replacement Pins</a>

Use your ratchet wrench as a handle. Reverse the pins to fit different hole sizes on the face of collars, bearings, and other machine tool components. Wrenches are hinged to fit a range of diameters.

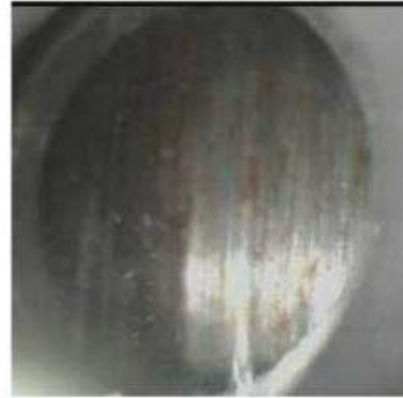
XL3-90638

Reading No 2016  
 Mode General Metals  
 Time 2022-03-29 13:15  
 Duration 1.03  
 Units %  
 Sigma Value 2  
 Sequence Final  
 Alloy1 LA-3310 : 1.12  
 Alloy2 Ni-Hard 1 : 1.55  
 Flags  
 SAMPLE  
 HEAT  
 LOT  
 BATCH  
 MISC  
 NOTE  
 User Login User

%	±	Error
Sb	< LOD	:	0.110
Sn	< LOD	:	0.111
Cd	< LOD	:	0.073
Pd	< LOD	:	0.065
Ag	< LOD	:	0.131
Ru	< LOD	:	0.024
Mo	0.319	±	0.035
Nb	< LOD	:	0.011
Zr	< LOD	:	0.010
Bi	< LOD	:	0.079
Pb	< LOD	:	0.052
Se	< LOD	:	0.016
Au	< LOD	:	0.002
W	< LOD	:	0.294
Zn	< LOD	:	0.192
Cu	< LOD	:	0.296
Ni	3.612	±	0.486
Co	< LOD	:	1.324
Fe	93.402	±	0.866
Mn	0.438	±	0.201
Cr	1.745	±	0.182
V	< LOD	:	0.154
Ti	< LOD	:	0.378
Al	< LOD	:	80.000
LEC	0.295	±	0.011
