**Mapping Areas of Interest for Coastal Enhancement related to
Capelin Spawning in Conception Bay, Newfoundland and Labrador**

**Master of Science,
Geography Department, Faculty of Humanities and Social Sciences**

Memorial University of Newfoundland

October 2023

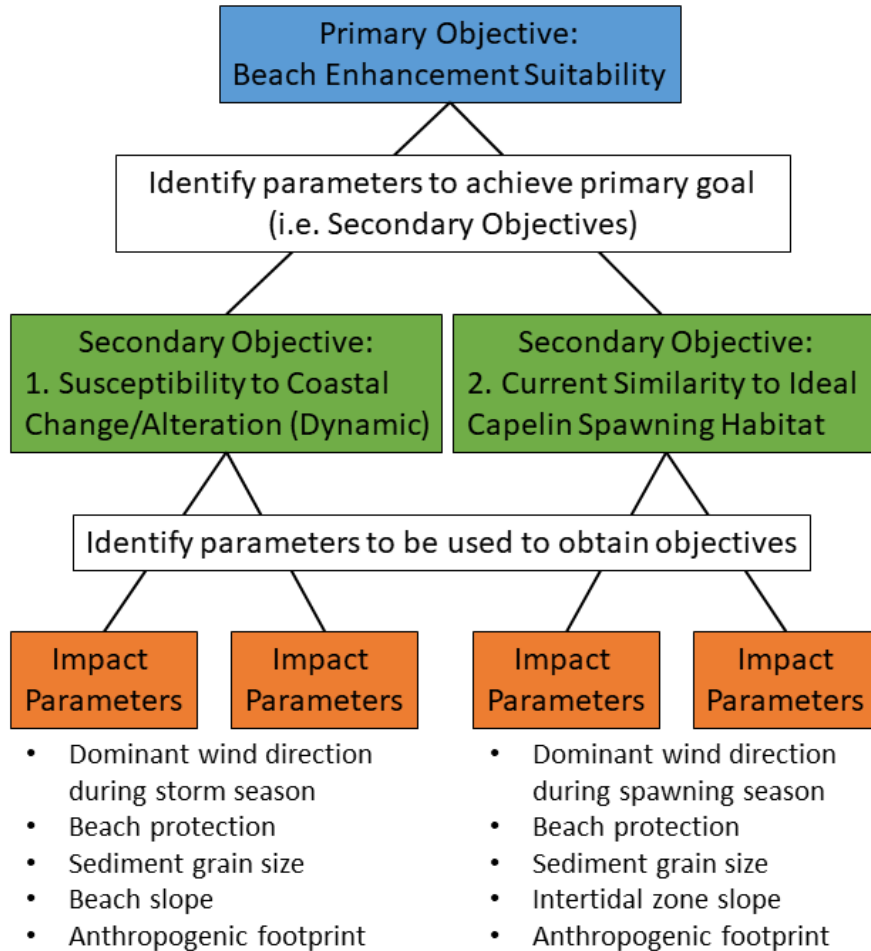
Figure 2.4: General MCDA prioritization approach

the changes observed at each site to favour sites that are less dynamic in terms of sediment movement.

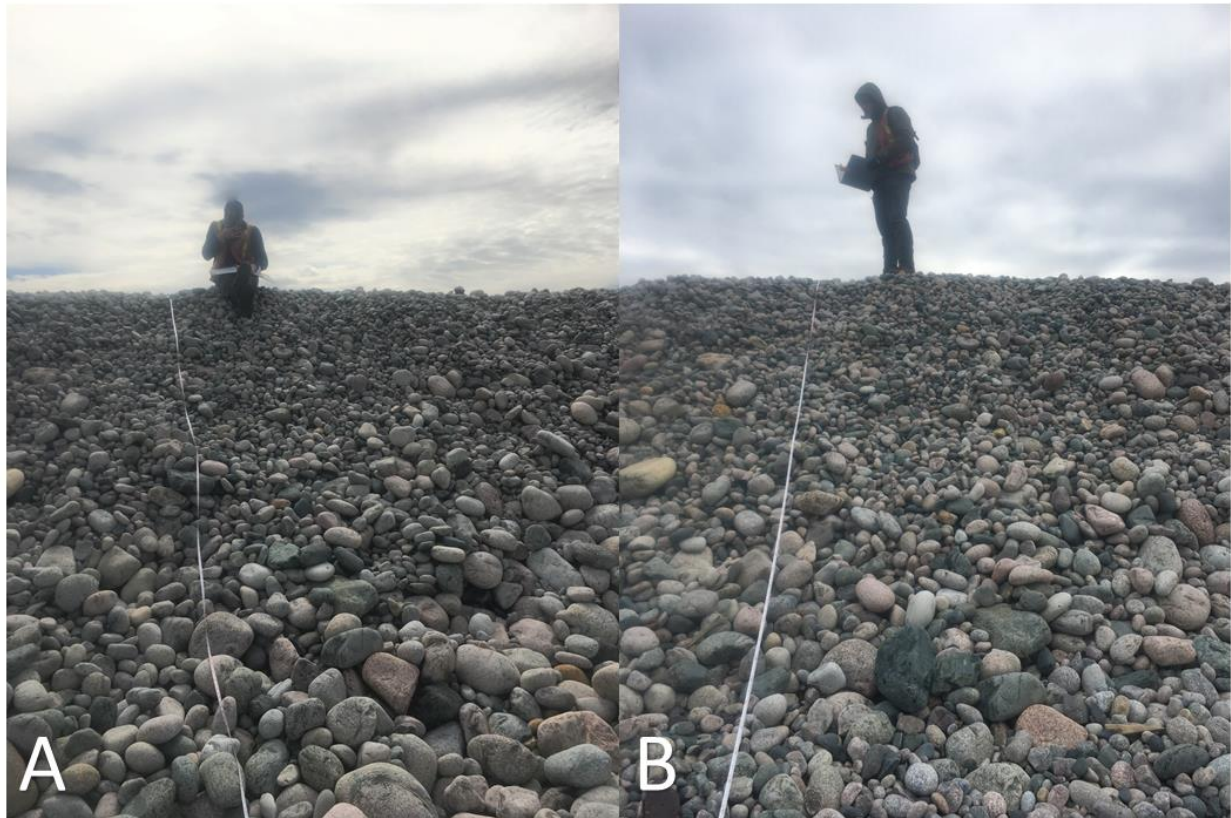
Figure 3.4: Furthest backshore slope for T3-T4, central beach. (A) 11 September 2019 and (B) 15 November 2019.

slope. The cobble zone at the base of the backshore's steepest slope transitions to ~70% coarse pebbles towards the crest (Figure 3.4).

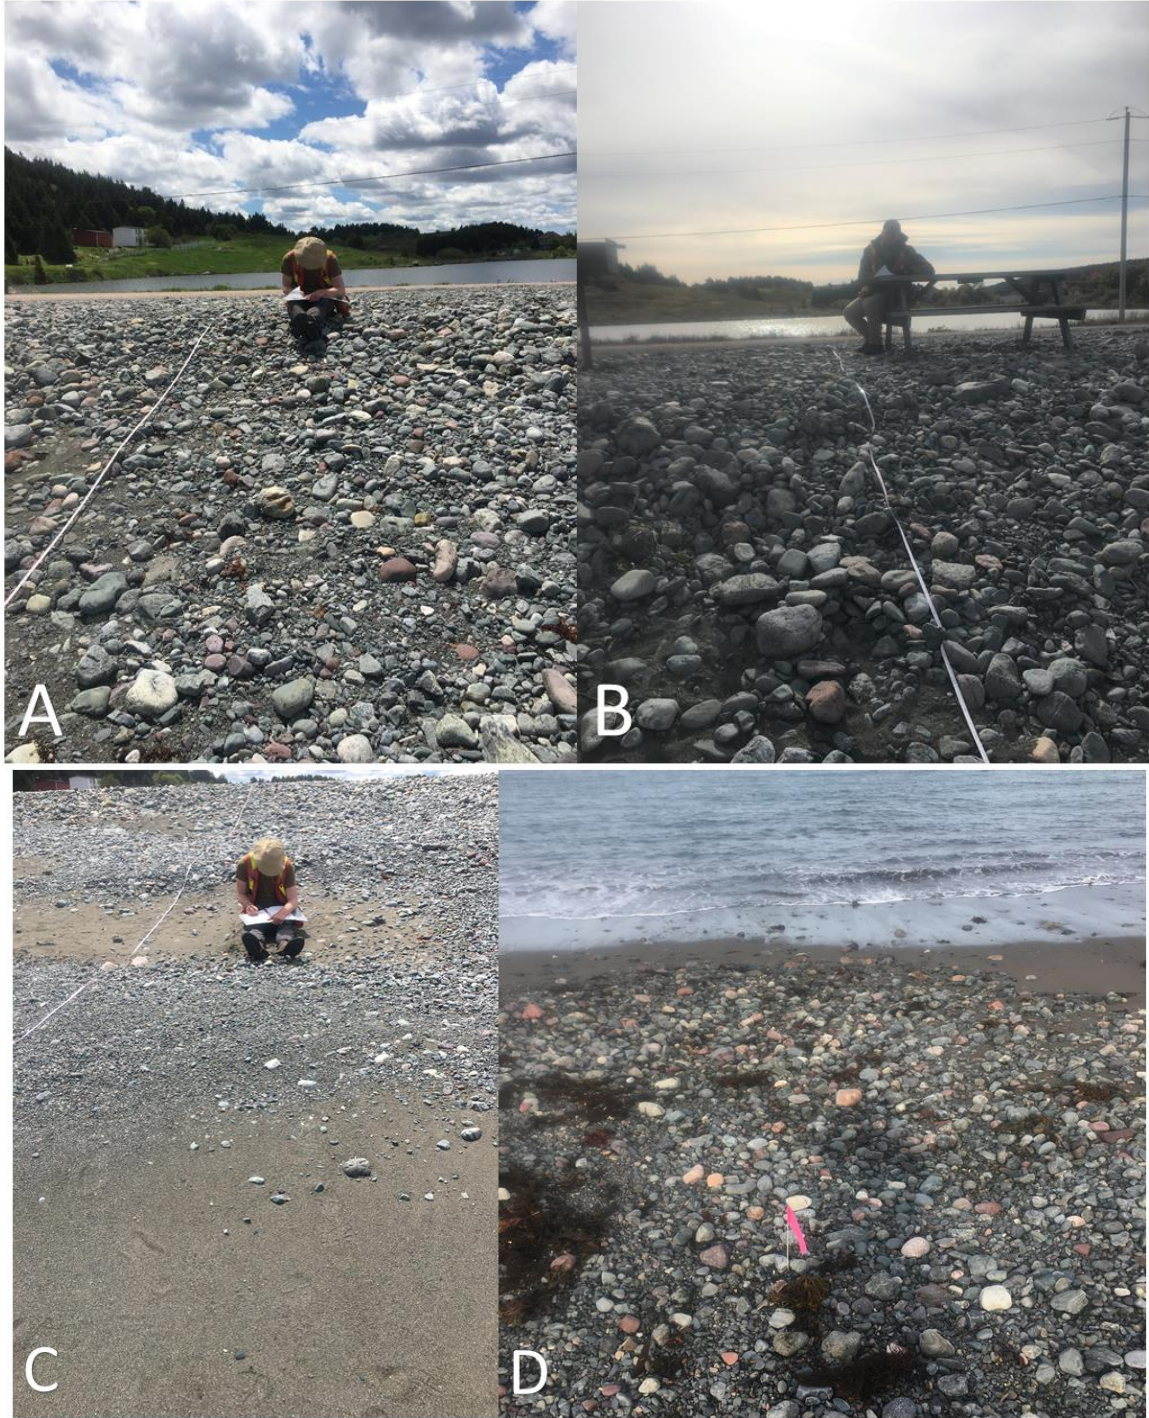
Figure 3.10: Central transect, T3-T4, for Chapel's Cove Beach. (A) & (B) Lead up to mechanical flatten part of the backshore on 19 June 2019 and 17 October 2019, respectively. (C) Alternating sand pebble patches on 19 June 2019. (D) Intertidal zone ~1 hour before a 0 m low tide.

transition begins to a 60/40% cobble-pebble split that continues for 3 m. The remainder of the beach is mechanically flattened, with 80% pebbles and other clasts distributed from sand to fine cobbles (Figure 3.10). In October, the swash zone's directly landward was a 1 m width of >90% sand along the transect. Landward for 2-3 m, this shifted to a 60/40% pebble-cobble mix. Landward of that zone is a >90% pebble zone extending to 10 m from the shoreline, where a patch of 80% sand with pebbles and cobbles was recorded. The landward zone showed the same texture as in June (Figure 3.10).

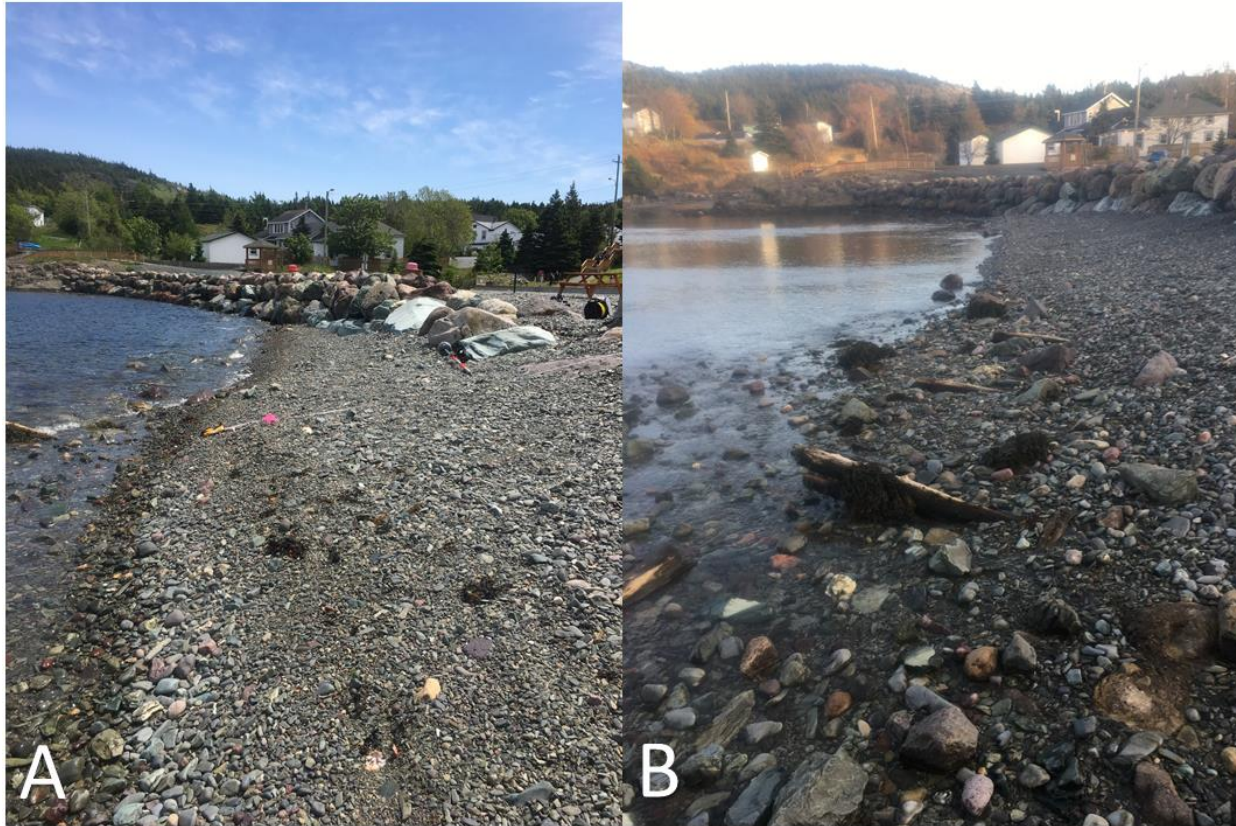
Figure 3.16: Primary beach, west, in Harbour main looking east from the freshwater outflow. (A) 27 June 2019. (B) The base of the wooden structure, 12 November 2019.

The third transect was placed on the western side of the main beach, T5-T6 (Figure 3.12, Figure 3.15, & Figure 3.16), directly adjacent to the freshwater outflow. This part of the beach has a nearly continuous intact rock wall about 75 m in length. The western end had some structural failure. The freshwater outflow is connected to the ocean directly at the west end of the rock wall. This area contained the greatest amount of exposed gravel in front of the rock wall at approximately 15 m width, but the gravel beach's width in front of the rock wall tapers away to 0 m eastward (Figure 3.15 & Figure 3.16). The eastern part of the rock wall had no intertidal zone, as the low tide shoreline was in contact with the rock wall. During both visits, a small part of the upper intertidal area bordering the swash zone included higher proportions of cobbles and fine boulders. These were concentrated in the vicinity of the base frame remain of a wooden structure (Figure 3.16).

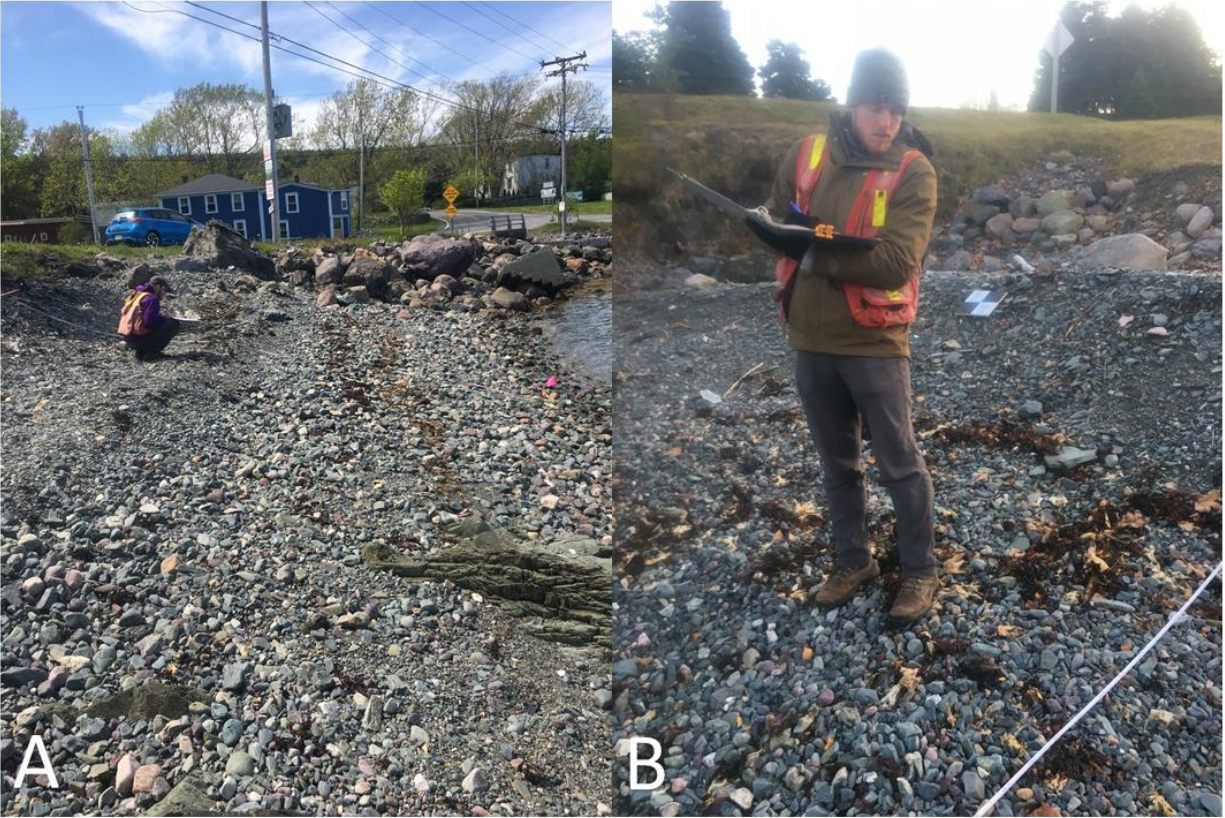
Figure 3.18: Secondary beach in Harbour Main. (A) Eastside of the beach looking westward at transect T7-T8 on 27 June 2019. (B) Taken from transect line T7-T8 looking south on 12 November 2019.

In June, the zone closest to the low tide shoreline was dominated by 80% finer cobbles, with pebbles covering the remainder. Around the midpoint of the beach's width, the texture transitions into an 80% pebble-dominated area with isolated cobbles. The beach gravel is replaced by soil, vegetation, and construction grade gravels in the Conception Bay Highway 15 m from the low tide shoreline. Coarse cobbles and boulders have been placed at this boundary to protect the road by slowing further erosion, but some of the soil has collapsed upon the clasts. In November, the intertidal zone directly adjacent to the low tide shoreline textural dominance contained pebbles, finer than June, with a 60/40% ratio with fine cobbles. Landward within a ~3 m wide zone, a transition to ~90% pebbles occurs, extending to the limit of the beach gravel (Figure 3.18).

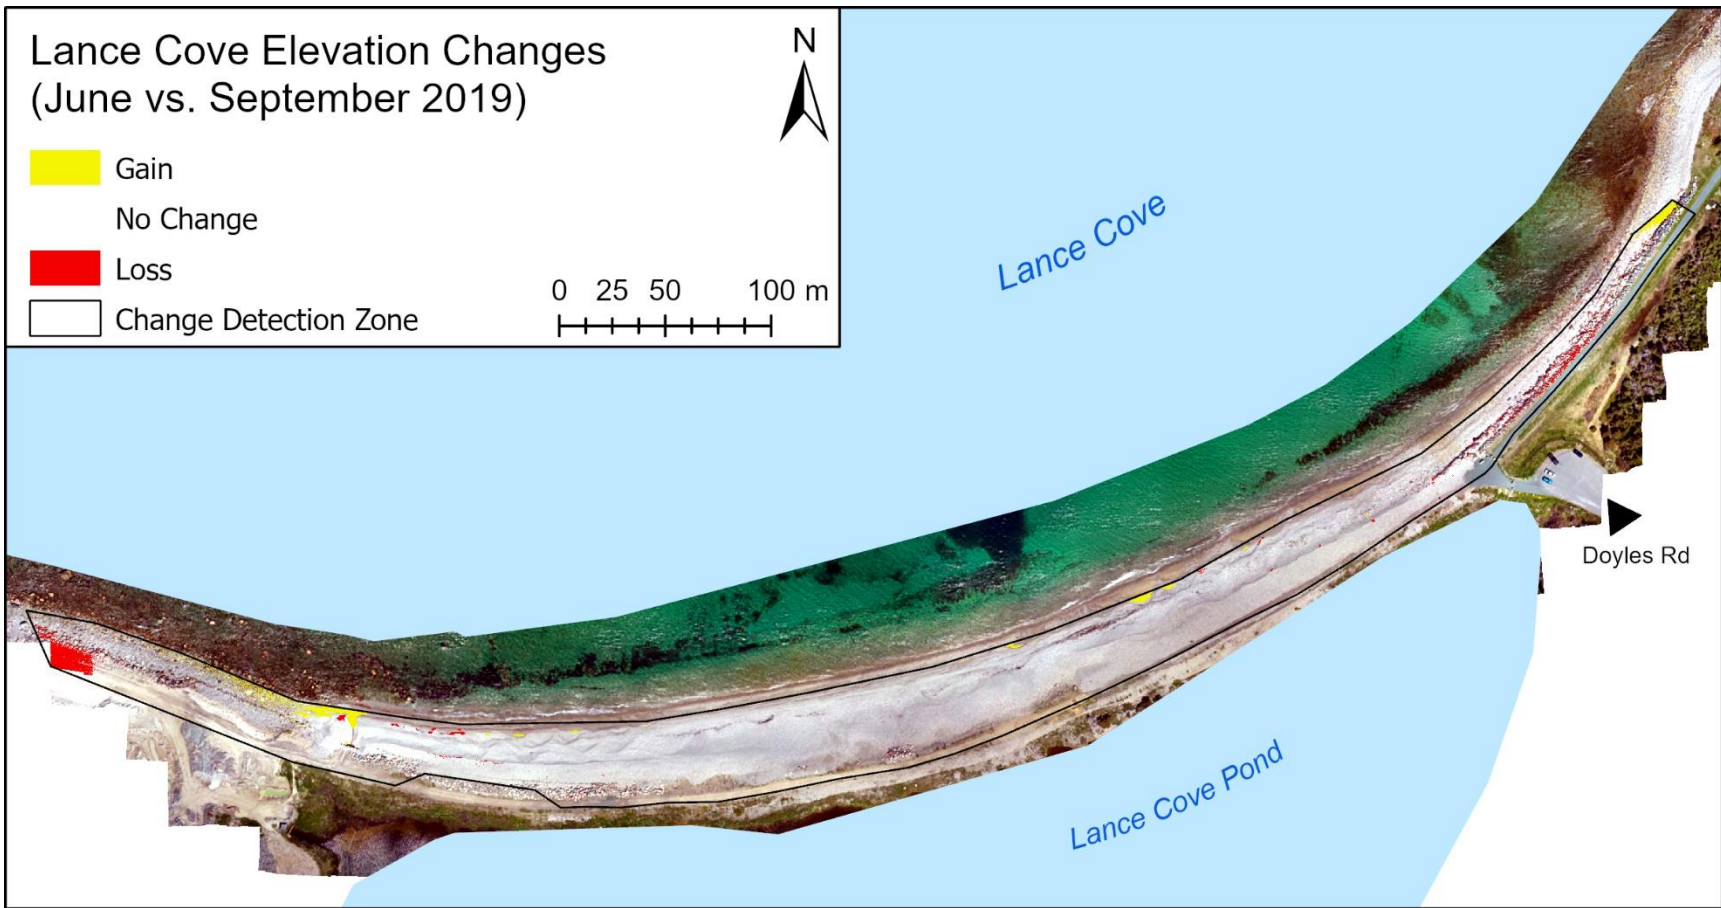
Figure 3.19: DSM differences for Lance Cove between June 2019 and September 2019.

The elevation change for June vs. September ranged from 1.9 m maximum gain to 2.2 m maximum loss. However, the mean change was a 1 cm gain, with a 4 cm standard deviation. High elevation changes are rare, located around larger boulders and the rock walls and possibly resulting from slight shifts in georeferenced between survey dates. In zones with exposed cobbles and finer clasts, few monitored changes were noted. Some small patches of elevation gain along the beach's intertidal zone and some patches of elevation loss were observed. For all parts of the beach,

Both Lance Cove and Chapel's Cove show a sediment reworking pattern mainly restricted to a distance of ~20 m inland from mean low tide (Figure 3.19 & Figure 3.32). The limited changes indicated at Lance Cove between June and mid-September (summer) were restricted to ~10 m inland of mean low tide (Figure 3.19, Figure 3.20, Figure 3.21, & Figure 3.22). The limited change at Lance Cove during the 2019 summer is likely associated with the unusually calm conditions. Environment Canada recorded only five days between the end of June and mid-September 2019 where winds in St. John's were in excess of 40 km/h, and only one of those days had winds reaching 50 km/h. A typical summer has an average of approximately five days of >50 km/h winds (Environment Canada, 2020). Even in the intertidal zone, the limited elevation changes at Lance Cove indicate that the southwesterly dominant wind direction may not have produced enough wave action that could rework sediment and benefit capelin spawning.

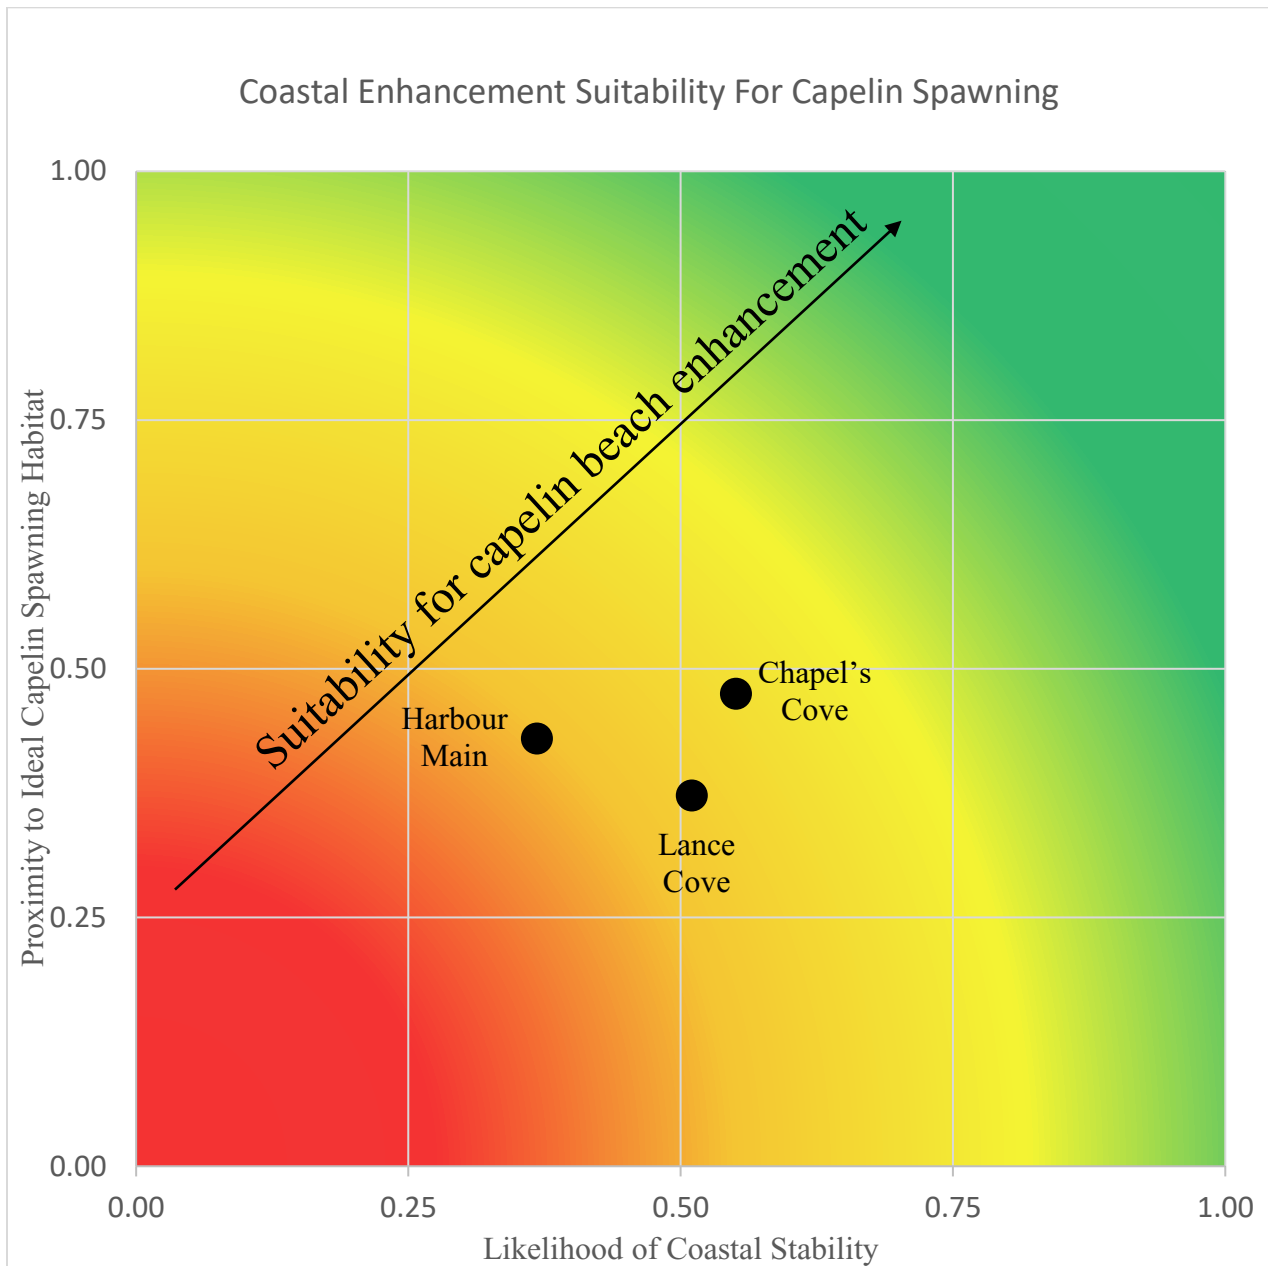
Figure 3.33: Enhancement suitability placement chart for capelin spawning beaches in Newfoundland and Labrador. Arbitrary coloring red to green associated to less ideal to more ideal respectively.

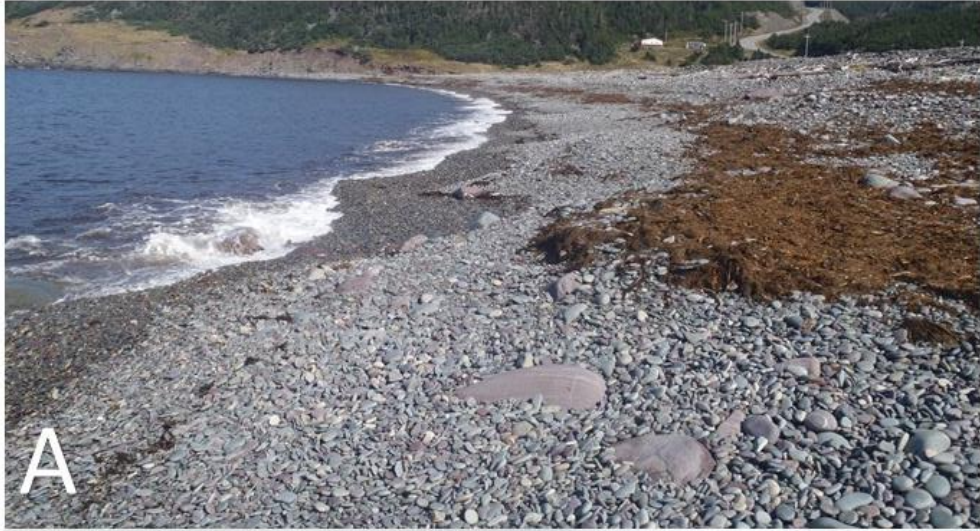
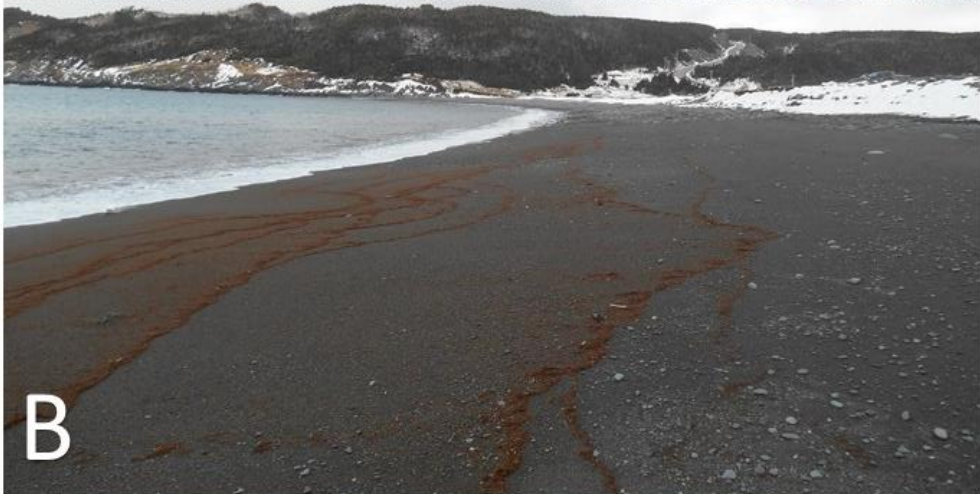
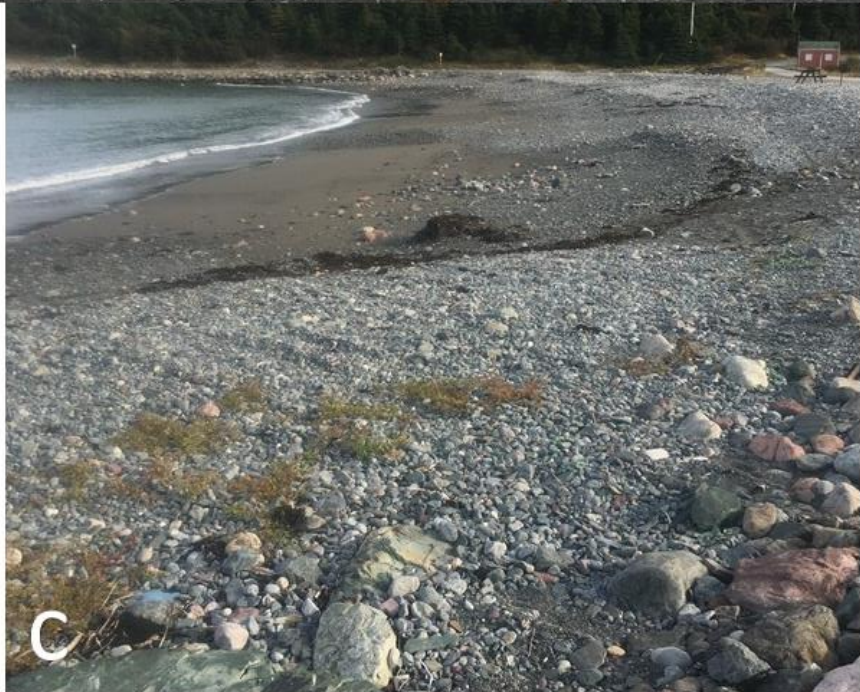
Figure 4.2: (A) Ship Cove Beach pre-enhancement, pebble to cobble sediment, photo orientation North – September 2011 (Photo Credit: Melanie Irvine); (B) Ship Cove post enhancement, granule to fine pebble sediment, photo orientation North – Feb. 2018 (Photo Credit: Victoria Neville), (C) Chapel's Cove, sand patches in the intertidal zone and pebble to cobble sediment, photo orientation Southeast - October 2019. Chapel's Cove (C) and Ship Cove, before enhancement (A) both, outside of the sand patches at Chapel's Cove, have a similar pebble to cobble texture and cusping features. A proposed enhancement for Chapel's Cove would fall in line with Ship Cove post enhancements (B), where the beach is a well-mixed granule-small pebble texture.
