**Geophysical Investigation of Coastal Roads Vulnerable to Erosion, Bay Bulls,
Newfoundland and Labrador**

Master of Science (Geophysics)

Memorial University of Newfoundland

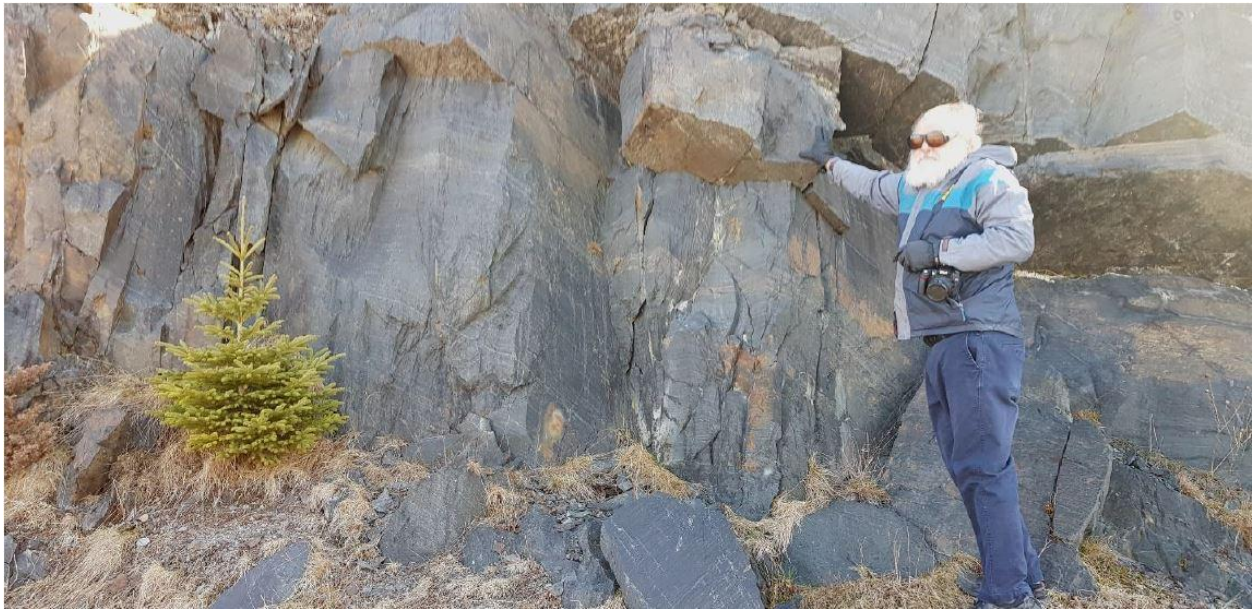
Figure 1-9) Bedrock outcrop of Gibbet Hill Formation (363280 mE, 5241880 mN). Professor Norm Catto for scale.

As the thick sedimentary package of Gibbet Hill rocks bent, the layers separated along bedding planes (as required by geometry), often at contacts between layers with different grain sizes (Figure 1-9 and Figure 1-10). These contacts may be the locations of small amounts of shale or other weak minerals, in thin layers. These bedding parallel fractures thus have their origin in the tectonic forces which caused the syncline to form. Other fractures, at high angles to the bedding planes, may be related to bending forces near hinges (limits of elasticity) or to decompression.

The layering and primary fracture planes in the bedrock dip to the north (Appendix A). This implies that overland and groundwater flow in the overlying Quaternary sediments is more effective than flow through the bedrock. Water seeping into these fractures, on the other hand, might enhance bedrock fracturing by frost wedging. Grass and tree roots within fractures (Figure 1-9, Figure A 3 to Figure A 9) would also promote break-up of rocky slopes. Slabs of rock spalled off the rock face may be observed at the bottom of outcrops (e.g. Figure 1-9), as can slickensides connected with their detachment.

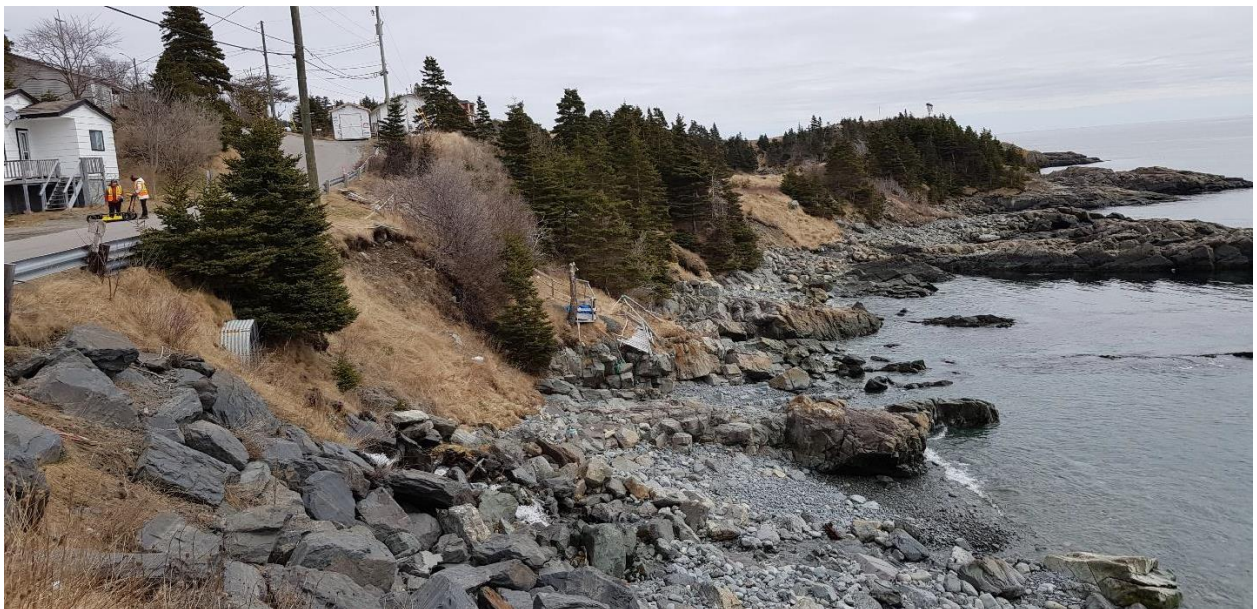
Figure 2-3) View of the beach at the Bread and Cheese site, looking east. Rip-rap and the bay end of the culvert are seen to the left. (1 April 2021).

Figure 2-3 depicts the pocket beach at the Bread and Cheese site. Rip rap and the bay end of the culvert is seen to the left.

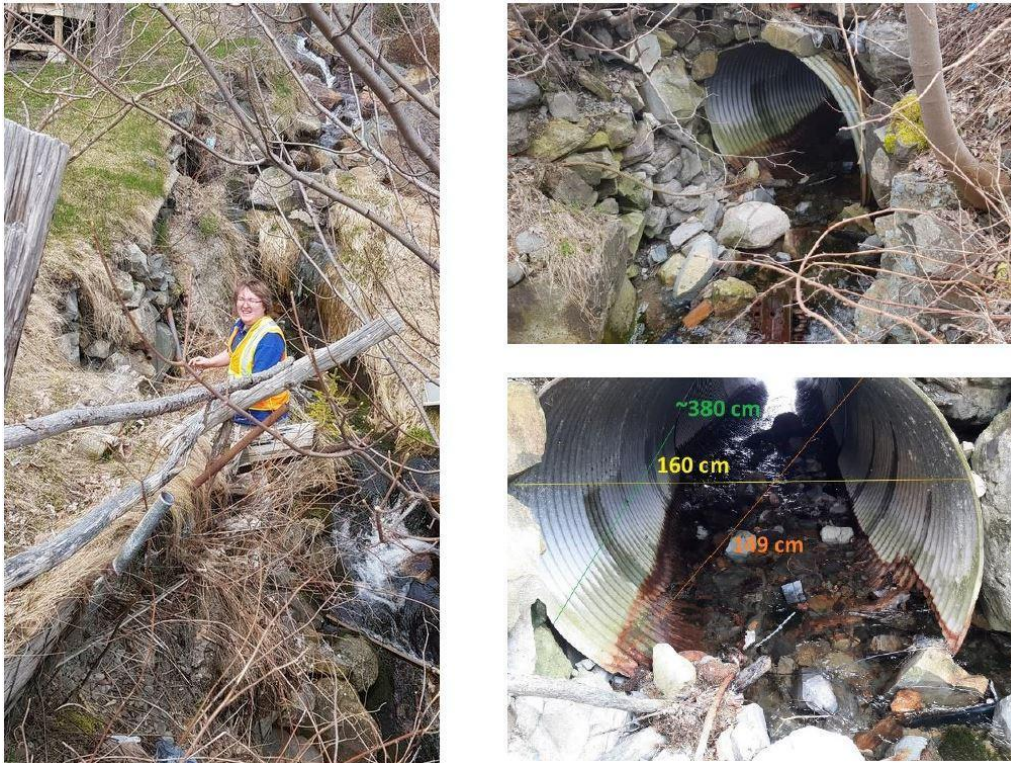
Figure 2-4) Left: The boulder-strewn creek north of the Bread and Cheese culvert. Photo taken from the road, looking north. Right: The north end of the culvert, taken from the west bank of the creek (top), and from the creek bed looking south (bottom). (22 April 2021)

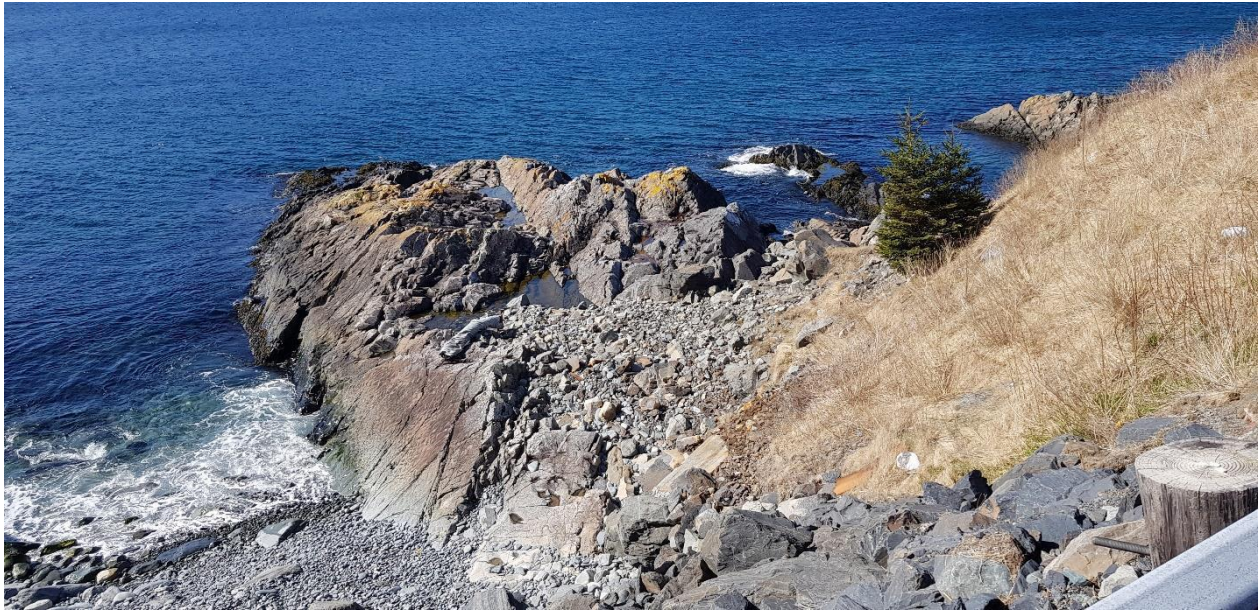
Figure 2-8) Western headland of pocket beach at Bread and Cheese site. Photo taken from Gunridge Road, about 10 m east of Figure 2-7, facing southwest.

The variation in the shapes of the pebbles on the beach and nearby headland (Figure 2-7 and Figure 2-8) indicate that wave action is commonly restricted to the near shoreline, except during storms. Such storms would play a role in erosion of the bluff (Figure 2-11 and Figure 2-12). Overland water is likely to be the main factor leading to instability of the surficial vegetated diamicton veneer and road material: recently (in late 2022 or early 2023), a new guardrail was constructed inside an older one (Figure 2-13) which had been carried bay-ward with creeping motion of surficial materials. To protect the road section nearest to shore, it would likely be necessary to armour the rest of the pocket beach.

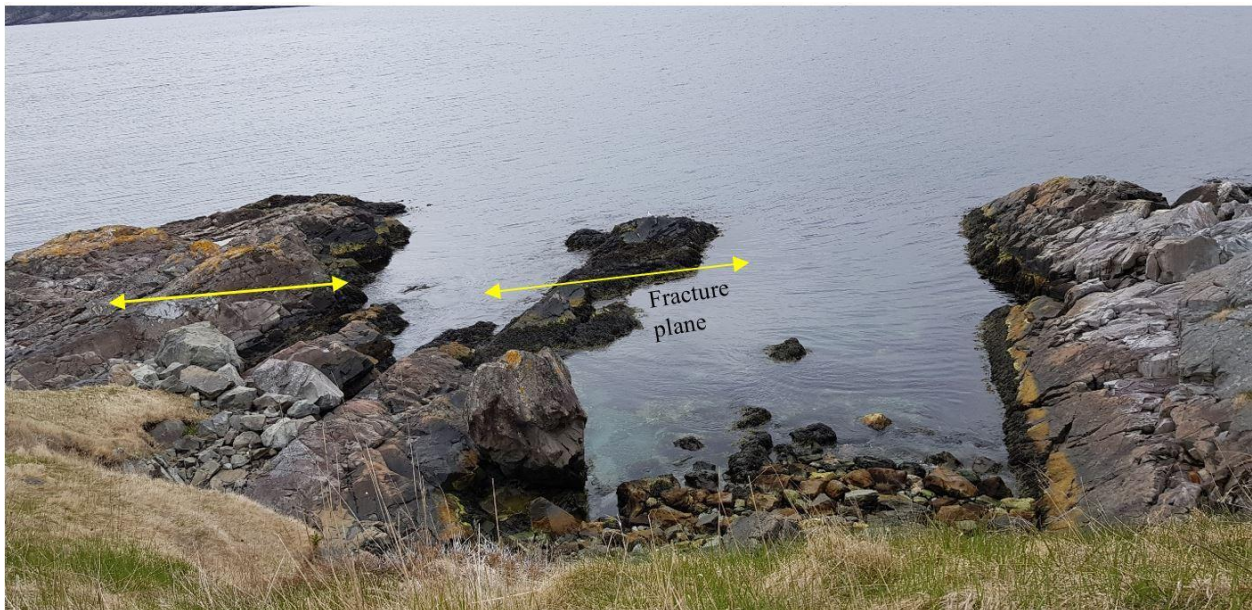
Figure 2-10) Photo of rocky headlands to the west of the pocket beach. Taken from Gunridge Road about 25 m west of Figure 2-7, facing southwest. Yellow arrows represent the orientation of fractured plane.

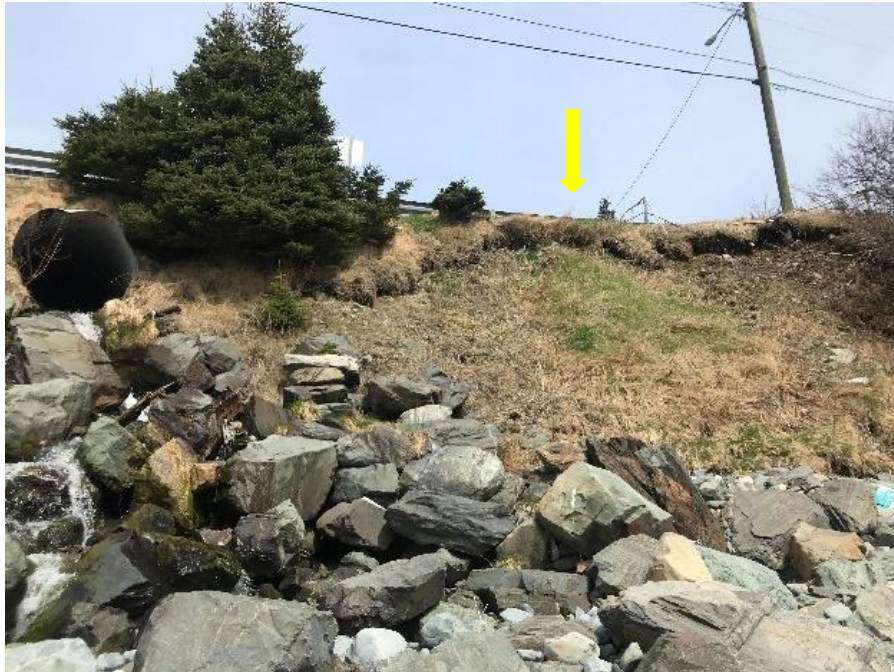
Figure 2-11) Lack of coherence in the Quaternary cover is depicted, as shown by the yellow arrow. The culvert opening appears on the left. Left and bottom: boulders (rip rap) have been brought there to stabilize the road. Photo taken from the beach, facing northeast.

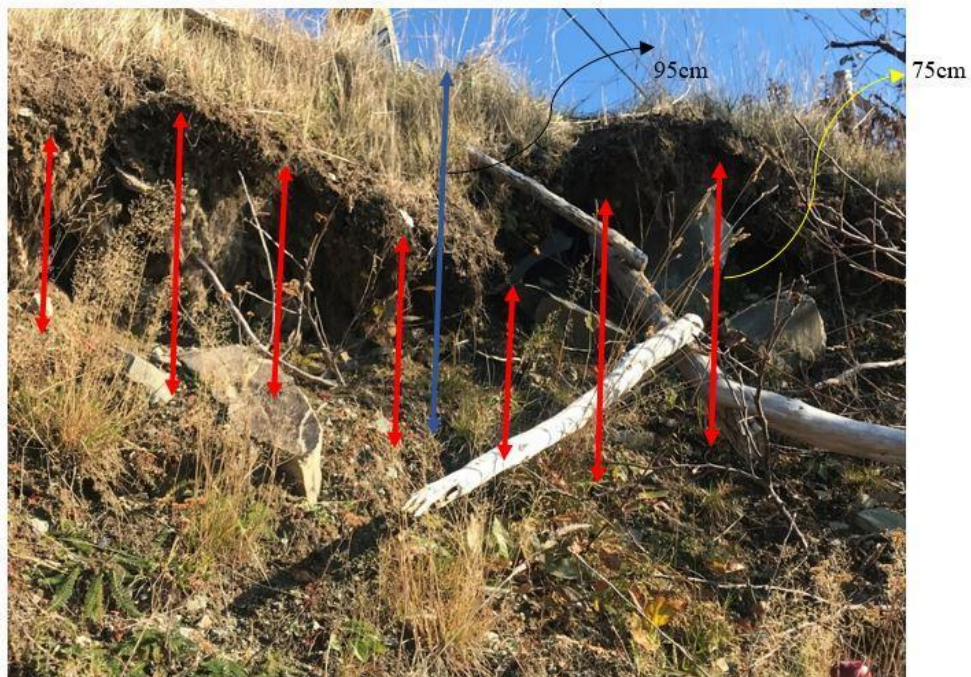
Figure 2-12) An expanded view of separations shown in Figure 2-11. Average amount of separation was 50 cm and the distance from the top of the bank was roughly 95cm.

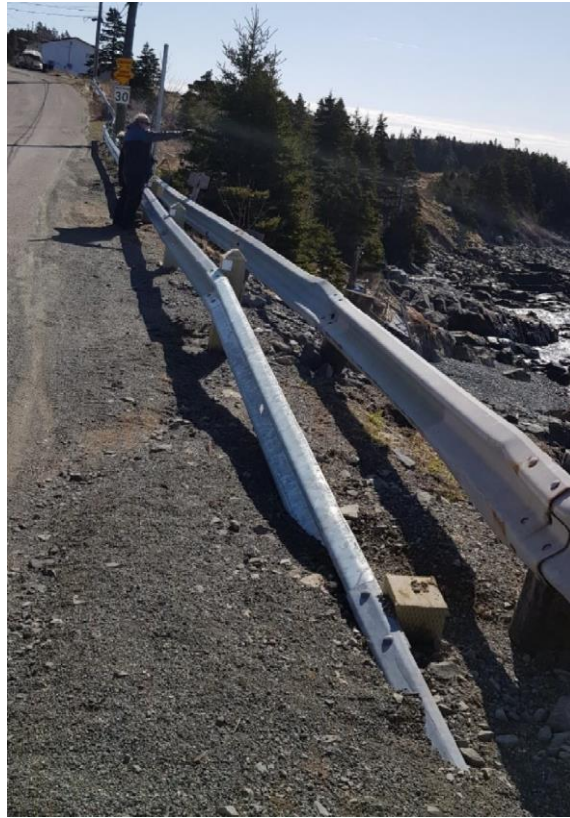
Figure 2-13) New railing constructed inside older railing. Looking east, Bread & Cheese, 21 April 2022.

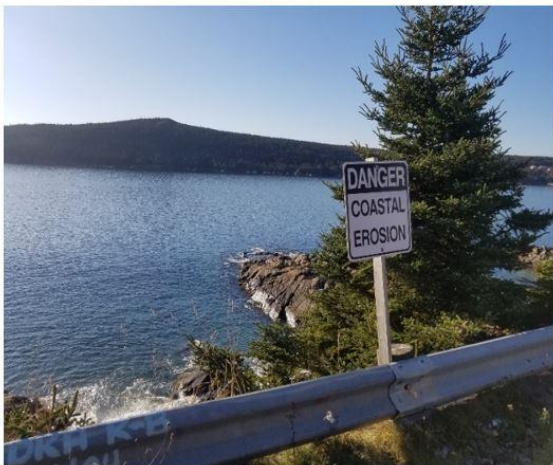
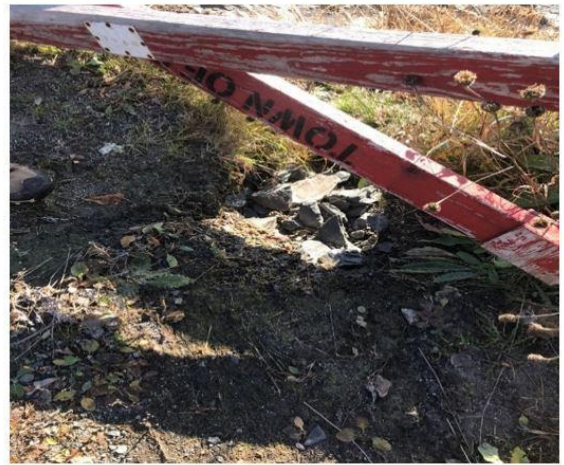
Figure 2-14) Clifftop erosion because of surface water and danger sign at the cliff top above the eroded area.

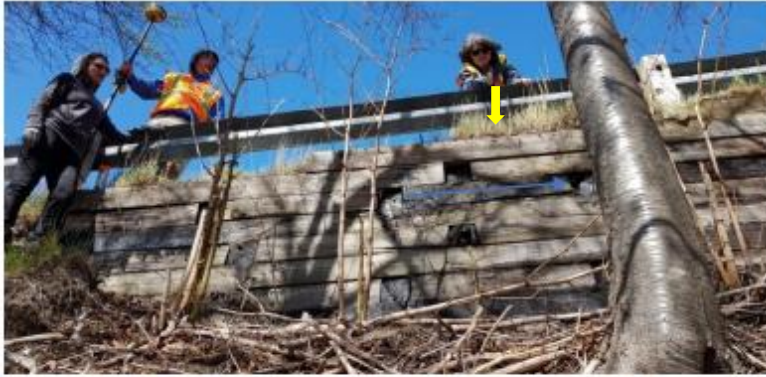
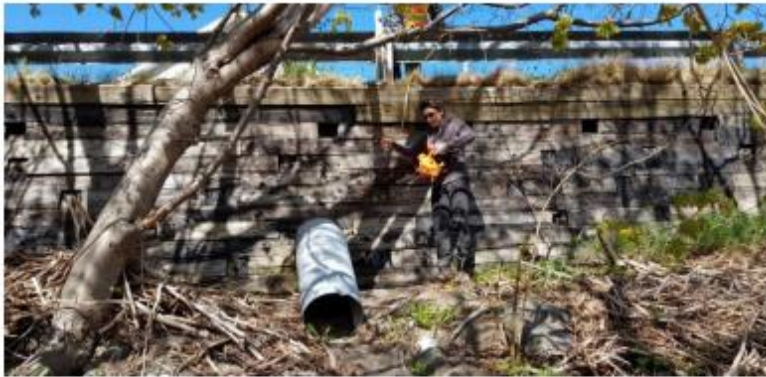
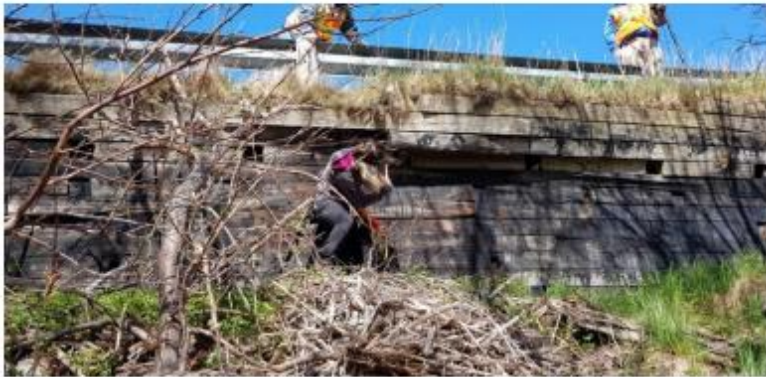
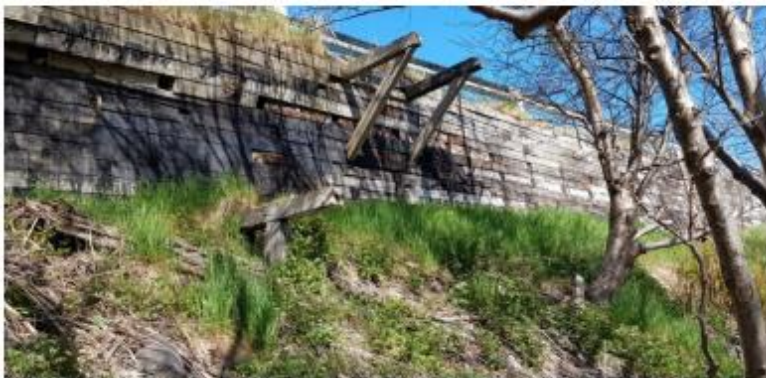
Figure 2-16) Wooden retaining wall at the Cliff site. Photographed from the steep slope southwest of Northside Road.

a) NW end of wall, from 0 to ~4.5 m. Field assistant Ms Hicks is indicating a distance of 3m from the first guard rail post (yellow arrow).

b) Wall near culvert 1. NW to SE. Photo ~7.4 m wide, centred ~16 m from NW end of wall.

c) Wall, centred ~24 m from NW end of wall.

d) Wall, centred ~ 30 m from the NW end of wall

Past about 40 m (to the SW), it appears that the wall slopes inward, as it was probably first constructed. Over the first 10 m, however, the wall is approximately vertical, and over a section from 10 to 30 m the top few beams are dislocated outward, as seen in Figure 2-16 c and Figure 2-16 d and Figure 2-17. This is presumably due to the creeping motion of material under the road surface. Note, from Figure 2-17, that one of the boards under Culvert 1 is also displaced. To the

The Cliff site underwent road widening in the 1960's with the construction of a wooden retaining wall, which is now displaced outward in some locations due to subsurface movement (Figure 2-17). This shift is evident in the shape of the wall and of the road surface (Figure 2-16 and Figure 5-10). Observations of longitudinal cracks in the pavement (Figure 2-25) were further signs of subsurface creepage. GPR survey data (Figure 5-16 and Figure 5-18) reveal the locations bedrock, road fill, and the beams extending from the wall under the road. This is useful information for planning the eventual replacement of the retaining wall, as there are no records of its construction.

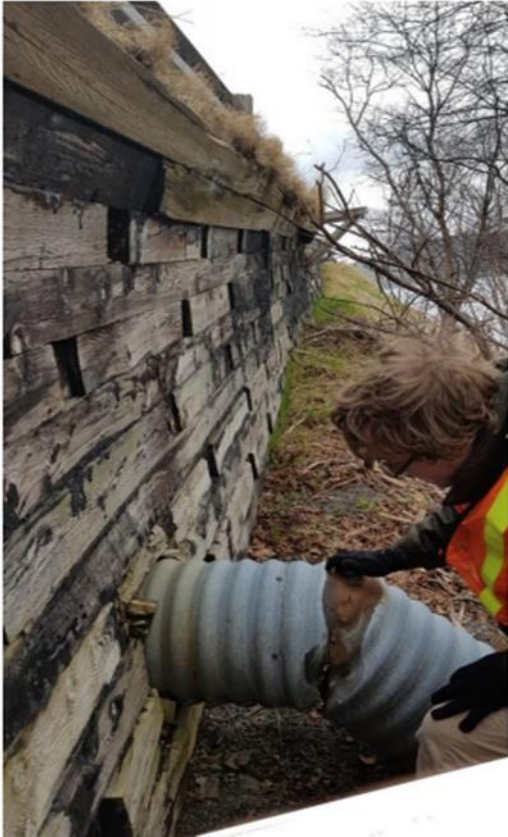
Figure 2-17) side view of the wall near culvert 1.

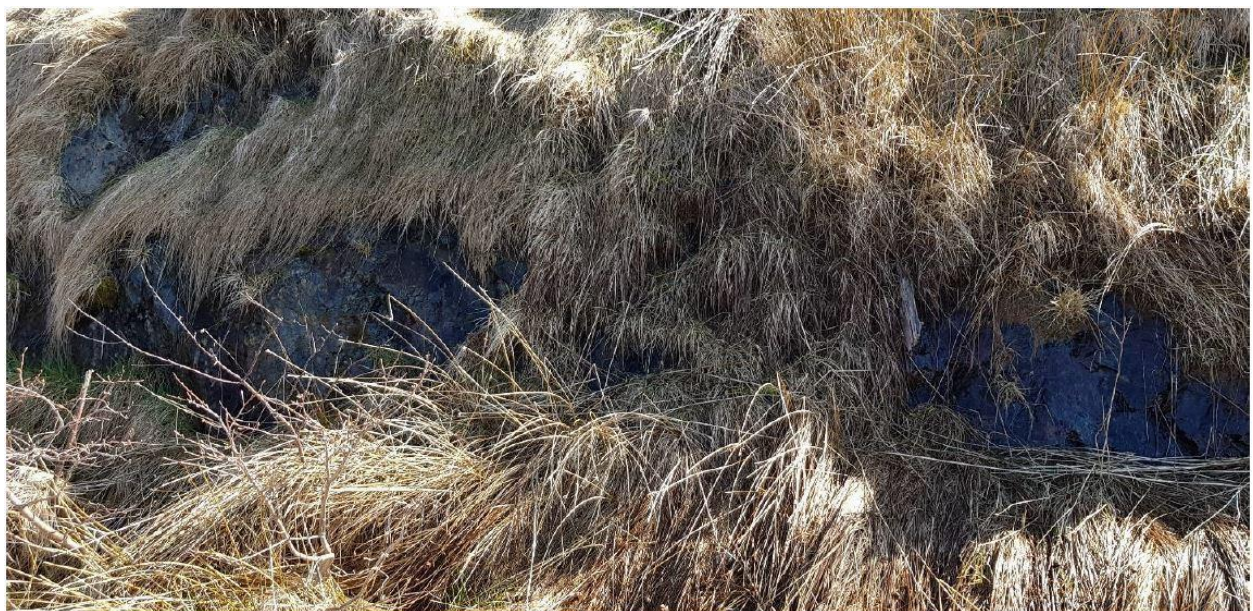
Figure 2-21) Bedrock showing underneath vegetative cover on the slope above Northside Road, Cliff site, a few metres southeast of the deck shown in Figure 2-20.

A few 10s of meters east of the locations in Figure 2-21, it can be seen that the till has accumulated behind a power pole (Figure 2-22), as this obstacle is impeding the downward motion of the near surface sediments. Trees also act as obstacles, as seen Figure 2-23. In addition to the surficial downslope movement, some bedrock has detached, and boulders have descended. Such

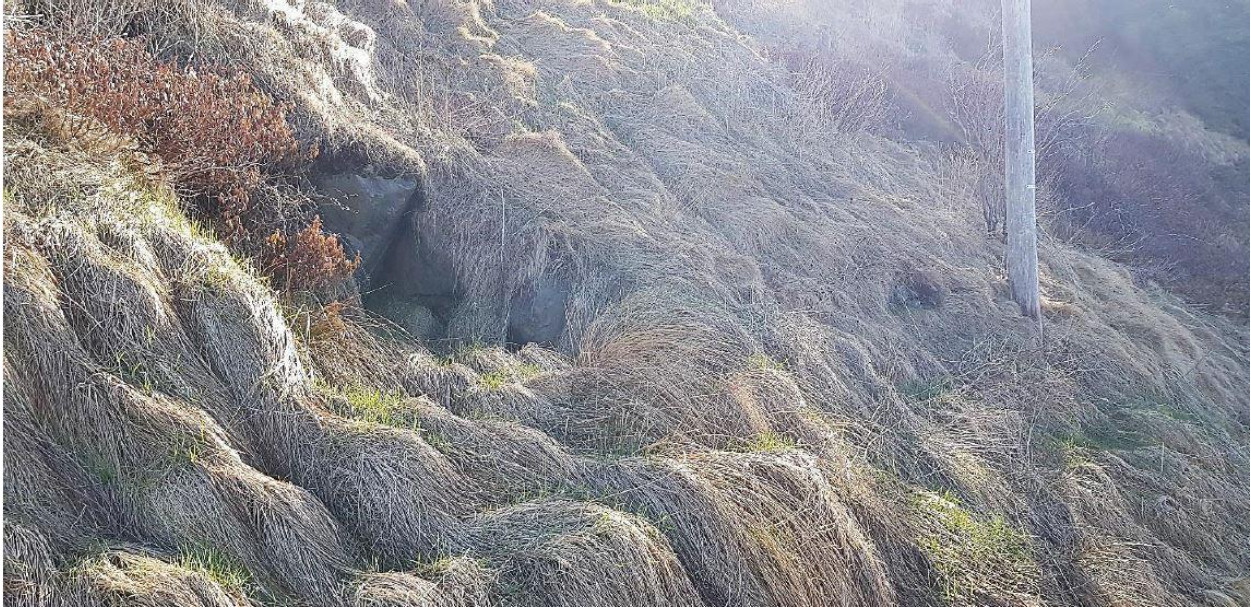
Figure 2-22) Creeping of surficial turf, with some accumulation behind the street light pole seen on the right in Figure 2-20. Some boulders are seen within the grassy slope.

boulders are shown in Figure 2-22 and Figure 2-24. Note that their angular shape indicates that they have not moved far. Bedrock is exposed next to the path of flowing water in Figure 2-24.

The importance of upland water flow in this area can be observed in sites such as (Figure 2-24). The weight of water and its effect on diminishing internal cohesiveness of Quaternary glacial derived cover undoubtedly contribute to its creeping downslope movement (Figure 2-22). Groundwater infiltrating underneath the road may jeopardise the road, causing lengthwise fractures, as seen in Figure 2-25.

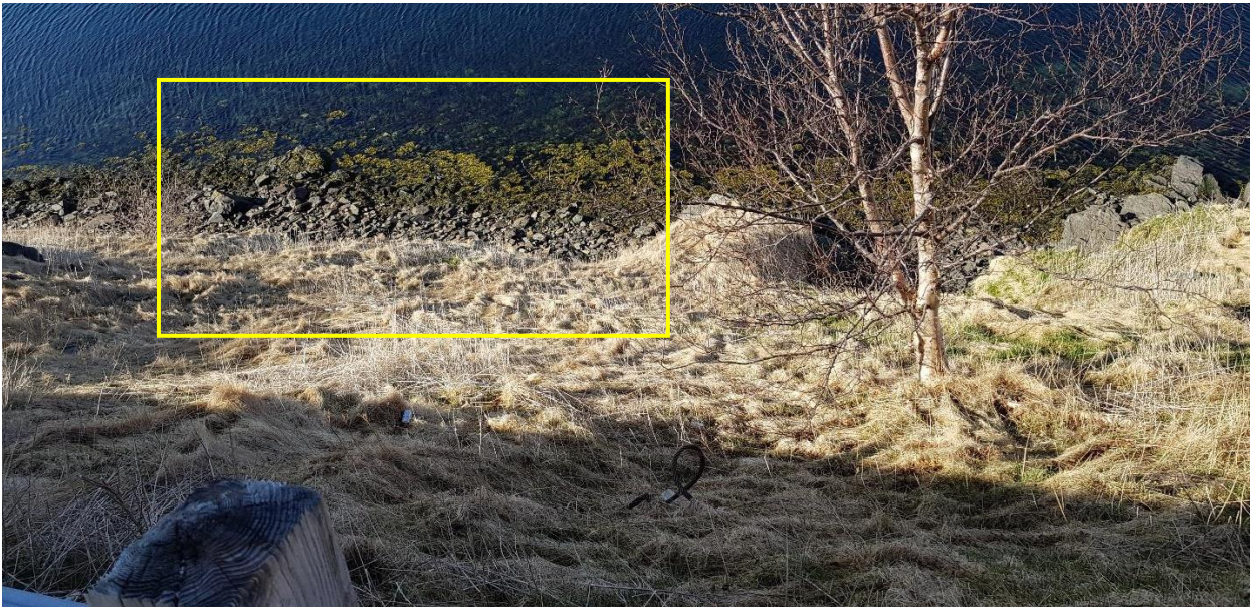
Figure 2-23) Looking downslope (to the southwest) from the edge of Northside Road at ~ UTM 362205 E, 5241945 N. 21 April 2022. Yellow rectangle indicates area of Figure 2-25.

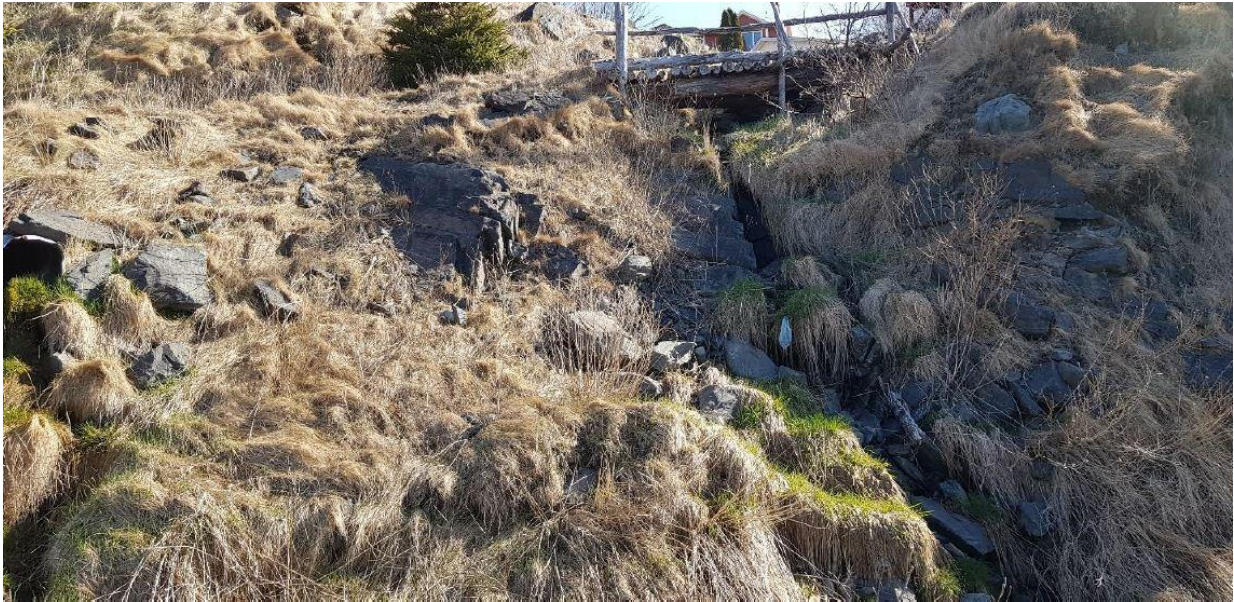
Figure 2-24) Vegetated sediment containing many angular boulders, near a fourth culvert to the southeast of the survey area (~ UTM 363300 E, 5241850 N). 21 April 2022.

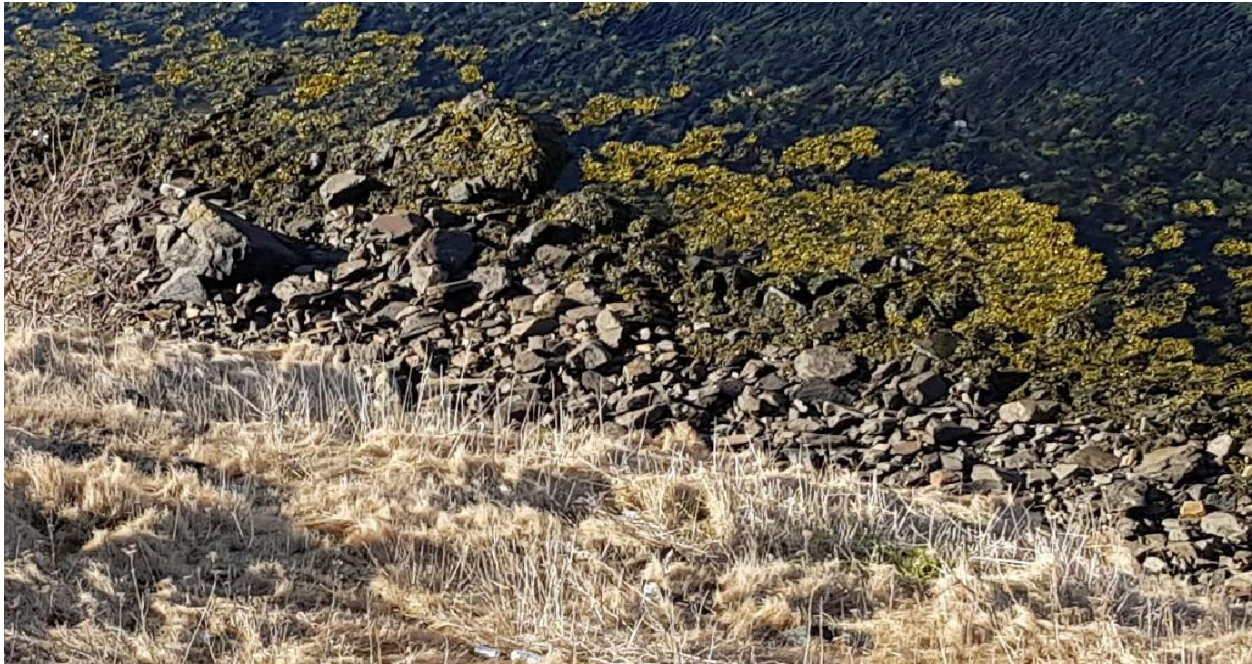
Figure 2-26) Shoreline below the Cliff site. Close-up of region shown in Figure 2-22.

Changes in the geomorphology of the Cliffs site are mainly due to terrestrial processes, as wave-action has little effect. This was likely the case even before the dock was built. Winds here come mainly from the northeast, so this side of the bay, overlooked by a steep slope, is particularly sheltered. The relative unimportance of wave action can be seen on the shoreline (Figure 2-26). The rocks here are angular and poorly sorted, with no apparent gradation in size closer to the shore and no sign of shingling. Some rocks are lying at steep angles to each other. Wave action on shale debris would be expected to result in rounded, disc-shaped pebbles. The appearance of seaweed at the water line is another indication of how relatively undisturbed by wave action the shoreline is in this location.

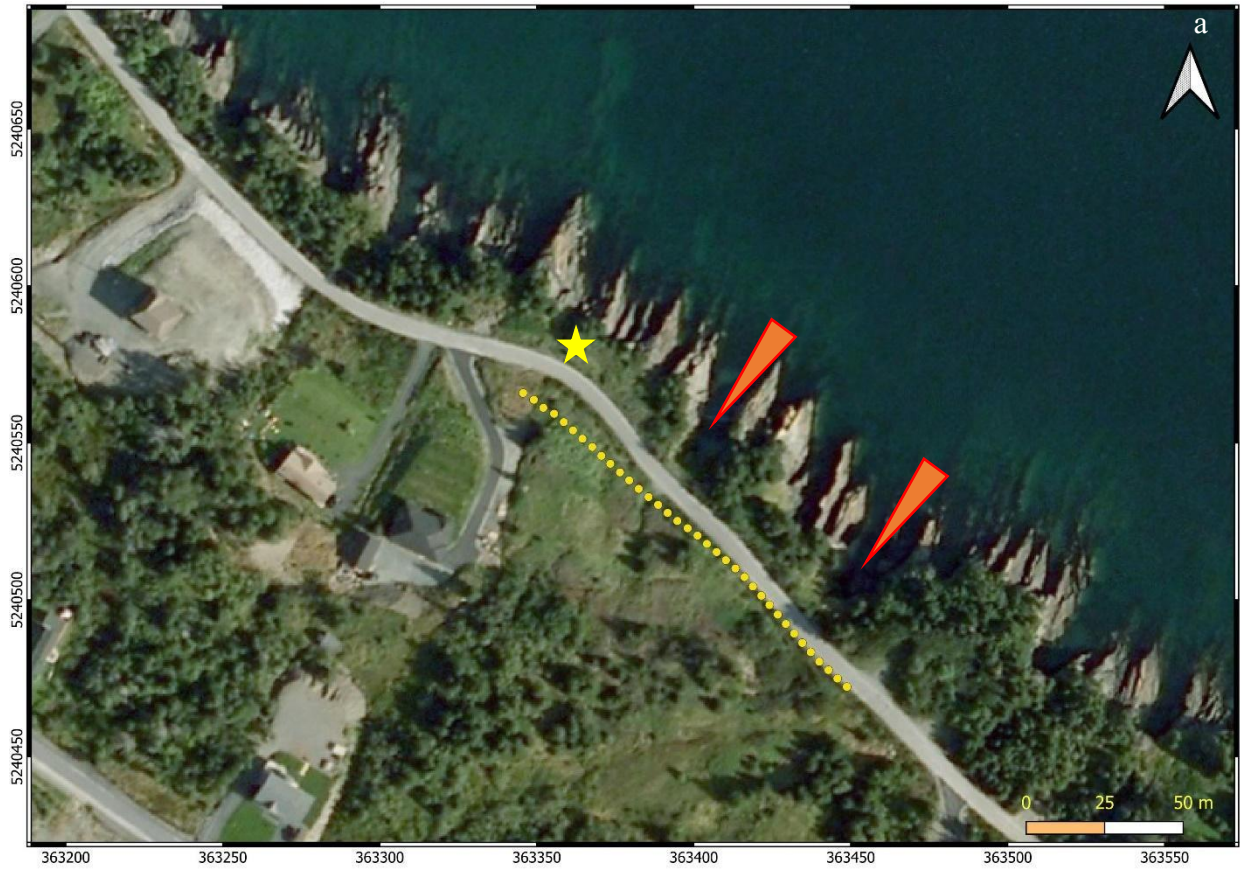
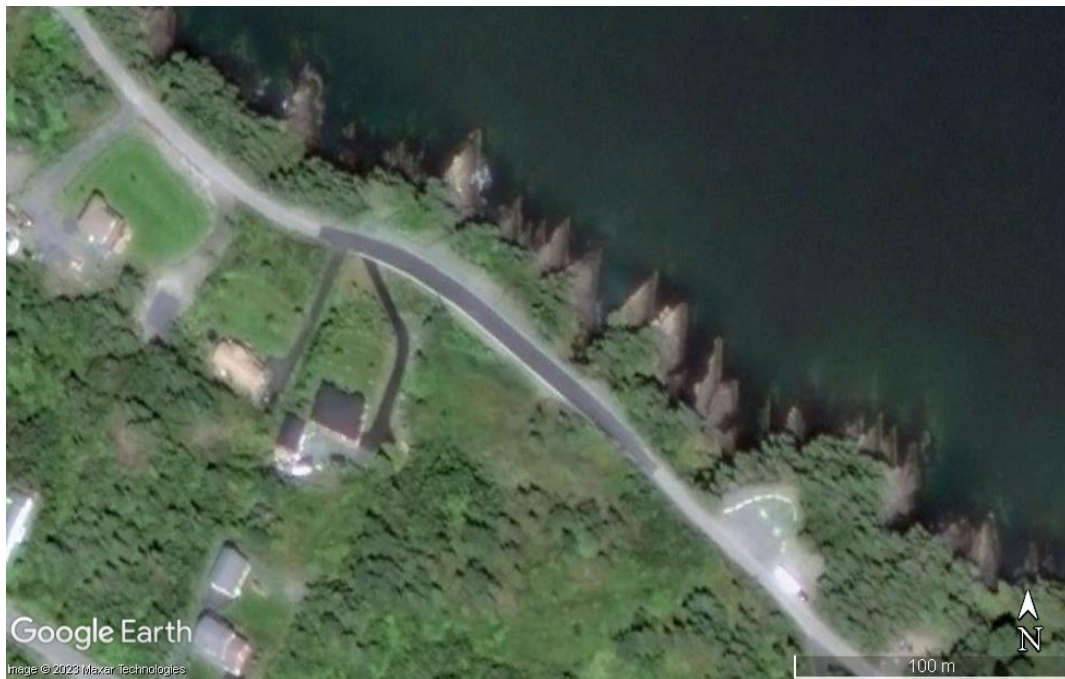
Figure 2-27) a) Air photo of the Quays site, taken before the relocation of the road in 2014. The orange arrows indicate the inlets. Yellow dots indicate the location of the southwest edge of the new road. The star is the location of Stone's Gulch. b) Lower resolution Google Earth image of the same region, after the relocation of the road. Image date 8/2014.

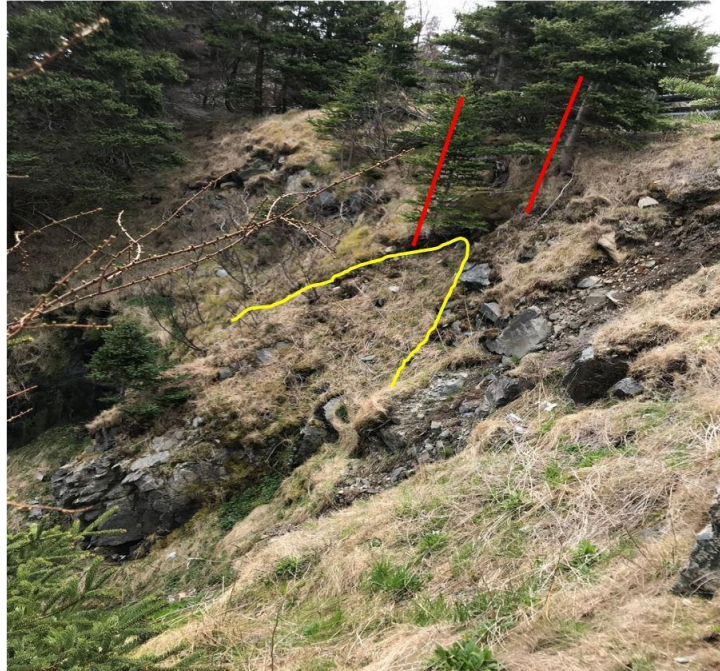
Figure 2-32) The yellow curve shows the soil creeping area (failure of soil cohesion), and the red line depicts that the tree is not straight yet. (Quays site, first eastern inlet.)

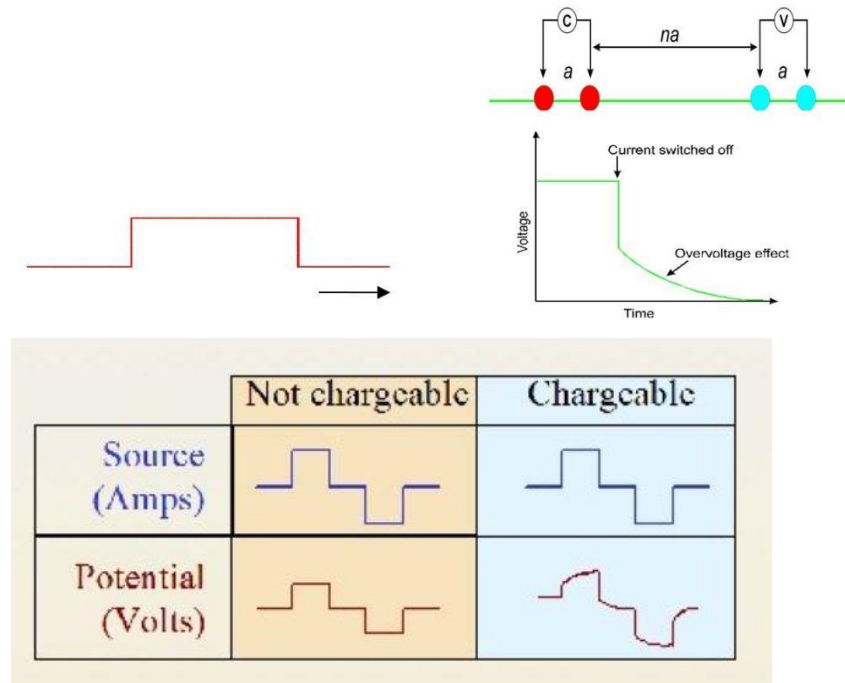
Figure 3-10) Demonstration of an induced polarization measurement using a standard arrangement of direct current four-electrode resistivity (Telford et al., 1996).

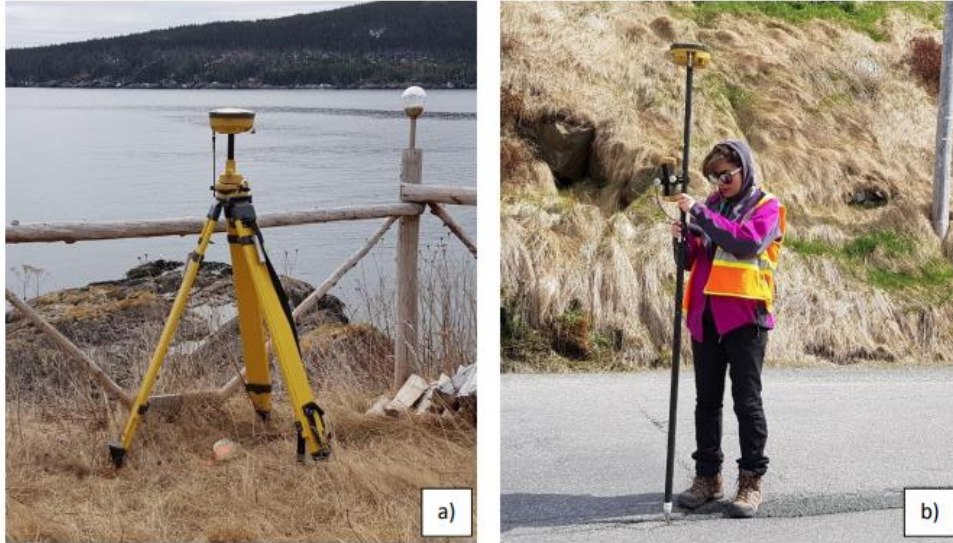
Figure 3-31) a) RTK base receiver on a tripod. Bread and Cheese site, April 1, 2021. b) RTK rover receiver on staff. Operator Marzieh Arshian. The Cliff site, April 26, 2021.

RTK surveys were carried out using a Topcon Hiper V system (Figure 3-31). At the three sites, detailed RTK location and elevation surveys were conducted over the GPR grids and along the DCR lines. At the start of each survey, the RTK base was set up near the survey area: at the Bread and Cheese site, on the headland east of the pocket beach; at the Cliff site, in a driveway to the east of the road; at the Quays, in a school-bus turn-around location at the south-eastern end of the site.

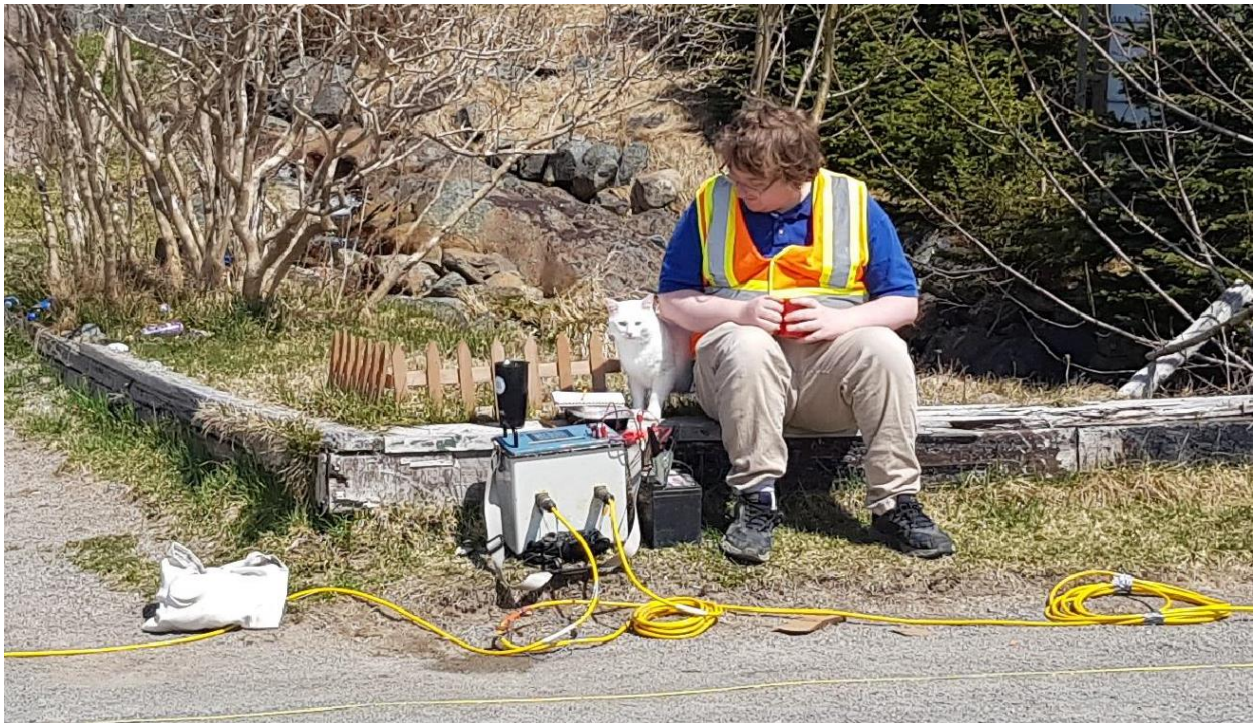
Figure 4-2) Illustrates the programmable Iris Instruments Syscal Junior DCR unit used to collect data in Bay Bulls. The control and storage unit was located in the middle of the spread.

Two 120 m long multi-core cables connect to the control box. Each cable can connect to twelve ~30 cm long stainless-steel electrodes at a maximum of 10 m spacing. For the present study, a 12 V external battery was utilized to boost the current. Saltwater was poured over each electrode to improve electrical contact with the ground. In order to increase the length of the survey, the first half of the spread (12 electrodes) was shifted forward to guarantee considerable data overlap (Figure 4-1). The control and storage unit was located in the middle of the spread (Figure 4-2), electrodes were hammered into the ground at 4 m intervals in a straight line (Figure 4-3), and once all the electrodes were connected to the cable 'take outs', the readings were taken, using four electrodes at a time, according to a pre-set sequence.

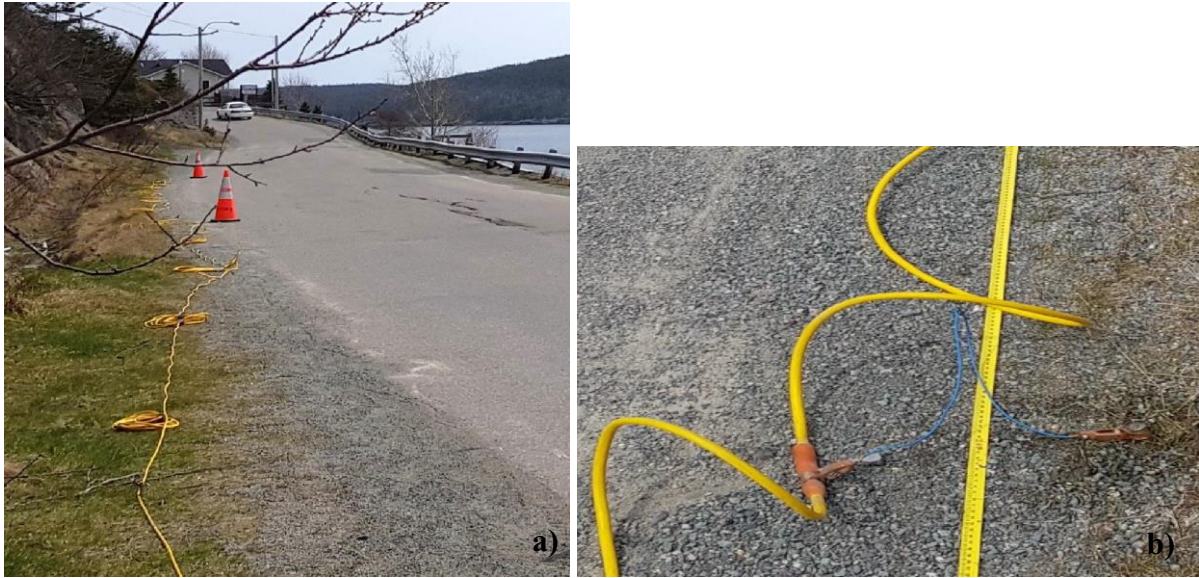
Figure 4-3) a) DCR multicore cable spread out along the road side. b) DCR multicore cable showing take out (orange) and a blue wire with bulldog clips each end, connecting callout to the top of a steel electrode (white arrow) hammered into the ground. The Cliff site, 26 April 2021.

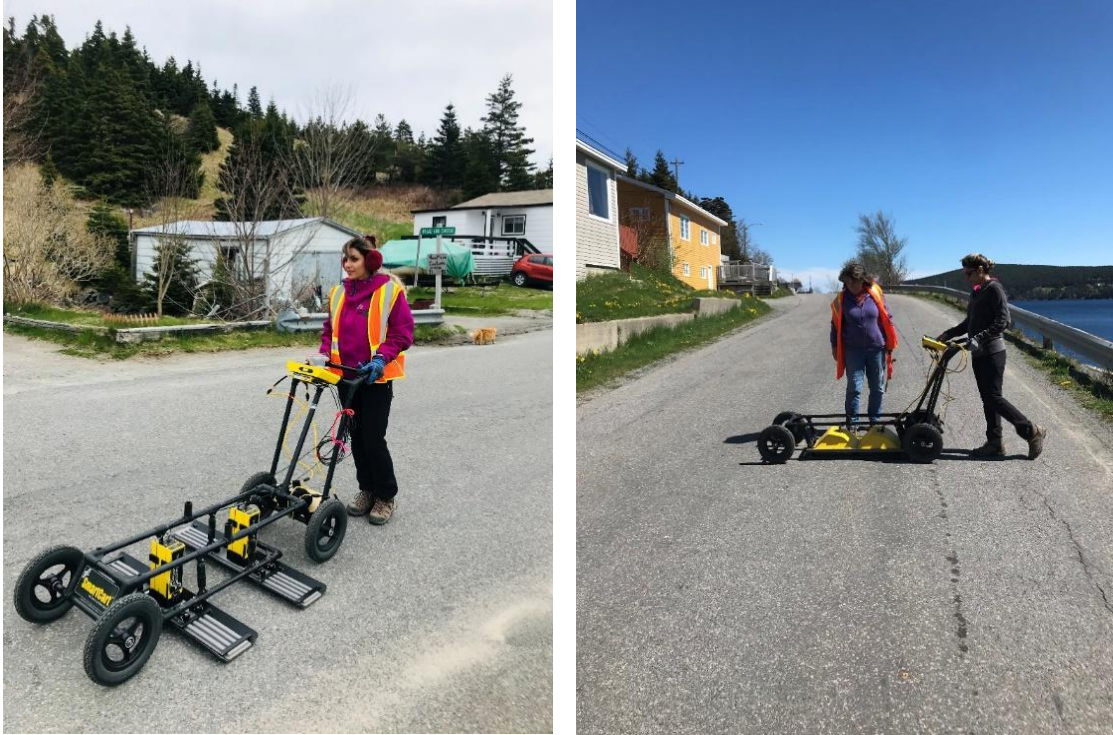
Figure 4-5) Sensors & Software EKKO Pulse Pro GPR with (a) 100 and (b) 250 MHz antennas. Operated by Marzieh Arshian. The two yellow mounds in (b) are shields covering the transmitter (back) and receiver (front) antennas. A skid plate separates the antennas from the road.

GPR surveys were conducted over the study area using a Sensors and Software pulse EKKO PRO GPR, mounted on a Smart Cart. The system, with 100 and 250 MHz antennas, as shown in Figure 4-5.

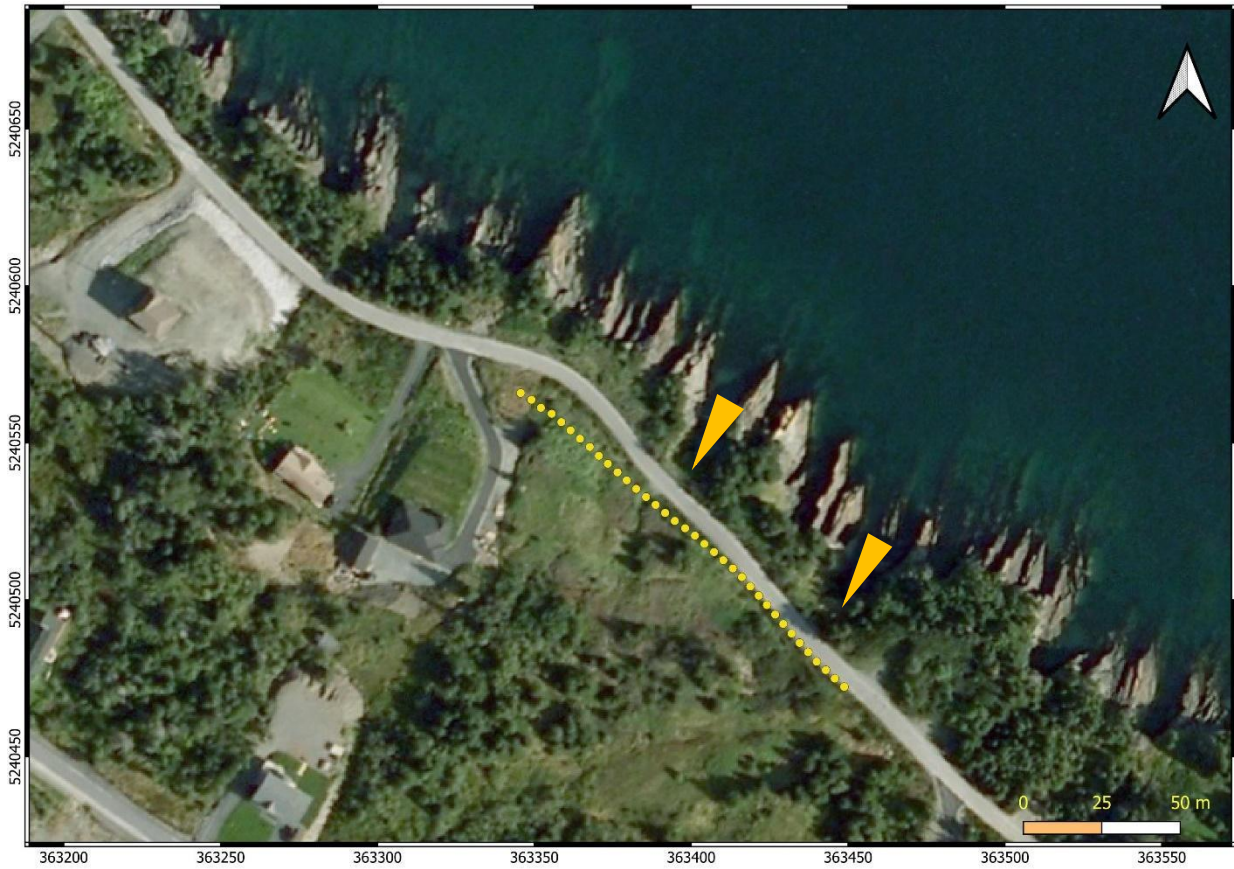
Figure 4-10) Top: Air photo of the Quays, from 2011 before the road was relocated. Yellow points illustrate the location of electrodes in DCR survey, along the existing road. Yellow arrows depict the location of concerning inlets. Bottom: Graph including electrode location of DCR surveys, RTK and, the culvert at the Quays site, May 18, 2021.

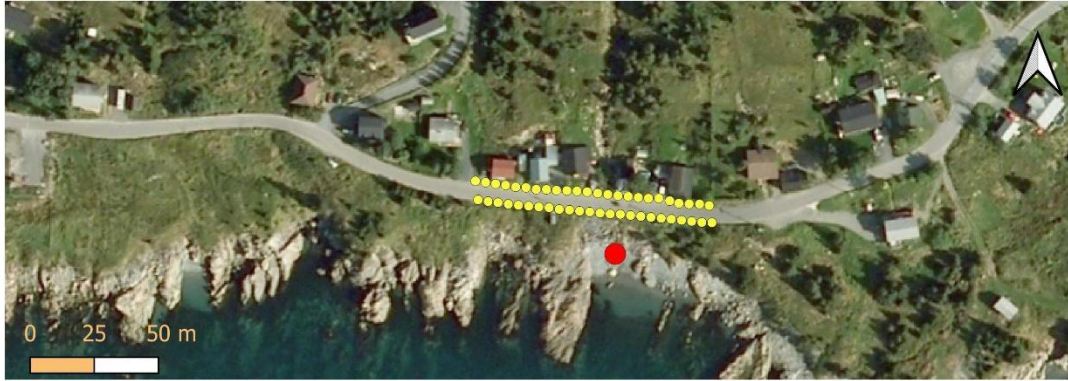
Figure 6-1) Illustration of the correlation of the geophysical results at Bread and Cheese. Note the different vertical exaggerations in the separate profiles.

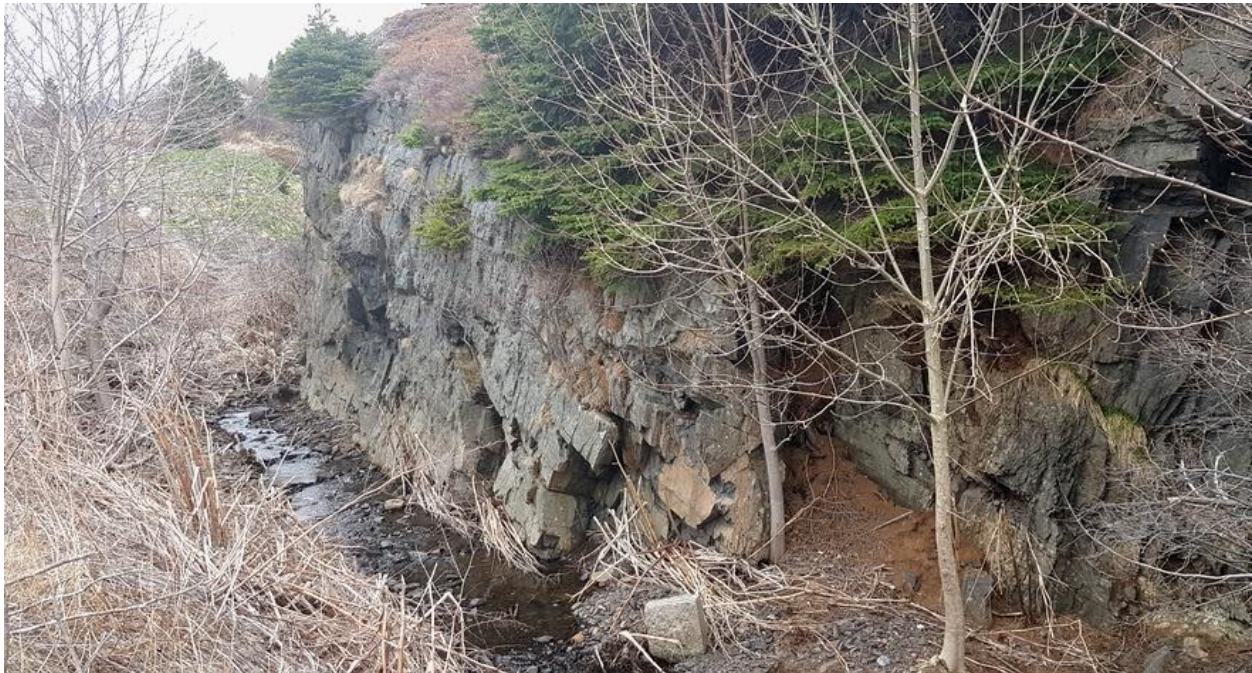
Figure A 3) Location 1. Outcrop E of creek, NE of marine terminal. View to north. Renew's Head Fm, St John's Group.
