**Geophysical Investigation of Coastal Roads Vulnerable to Erosion, Bay Bulls,
Newfoundland and Labrador**

Master of Science (Geophysics)

Memorial University of Newfoundland

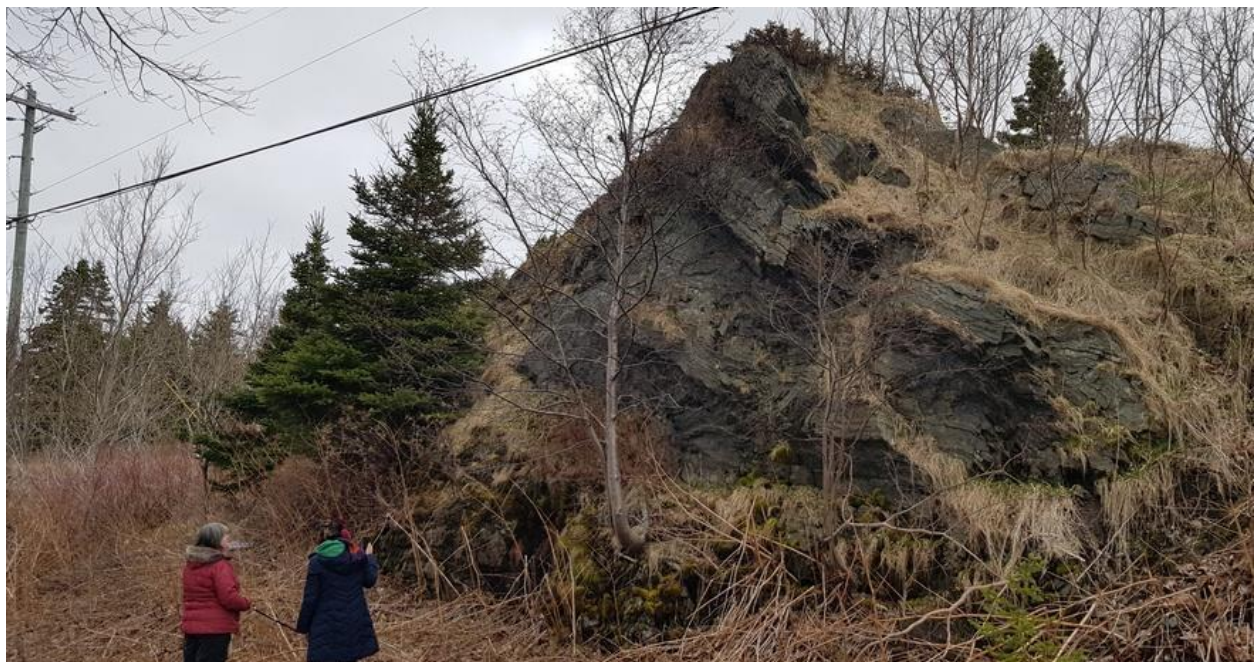
Figure A 5) Location 2. View to north. Outcrop of dark, shale-rich Renew's Head Fm, St John's Group.

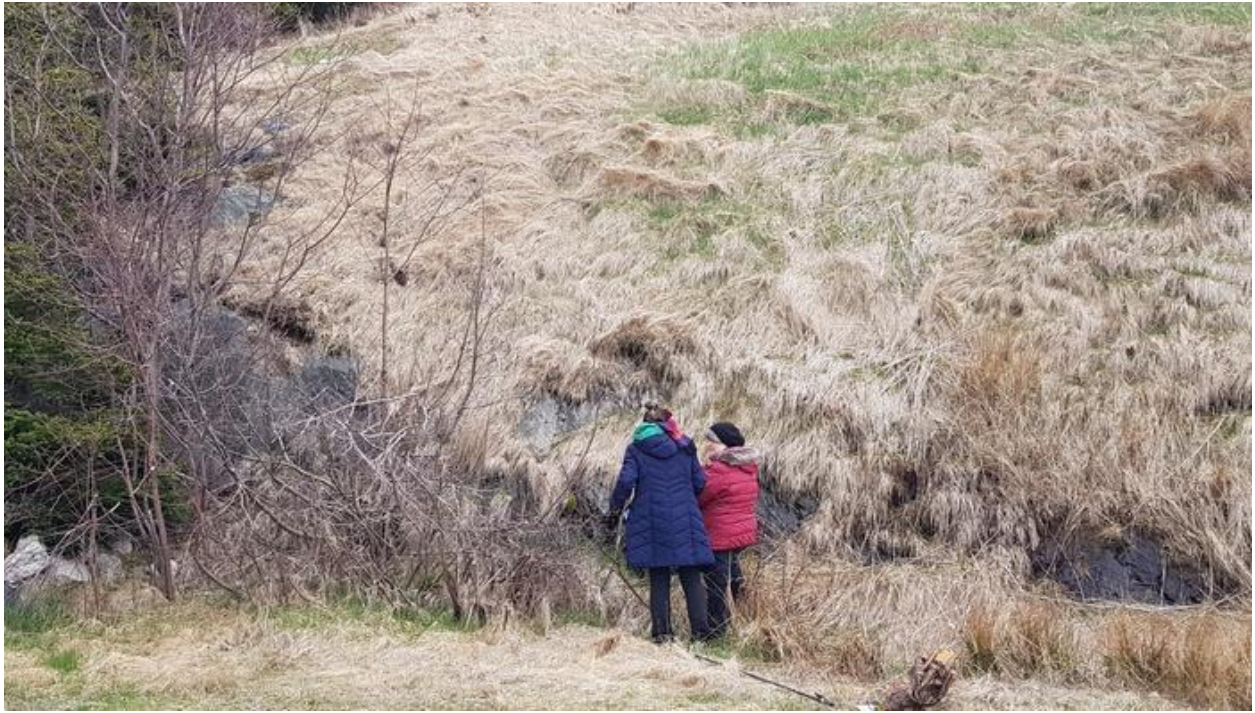
Figure A 6) Location 3. Outcrop at base of grassy slope, NE side of road. Dark, shale-rich Renew's Head Fm, St John's Group.

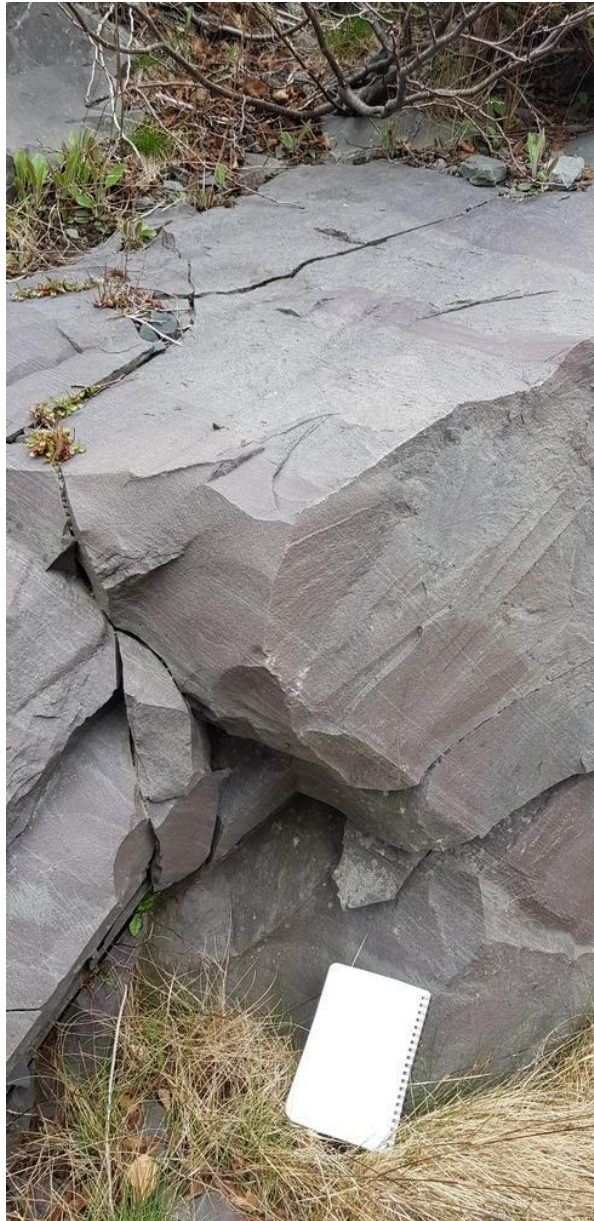
Figure A 11) Location 7. Close-up of outcrop, illustrating concoidal fractures.
