**A PRACTICAL MODEL FOR MICROBIALLY INFLUENCED CORROSION  
RISK ASSESSMENT**

**Master of Engineering**

Memorial University of Newfoundland

May 2024

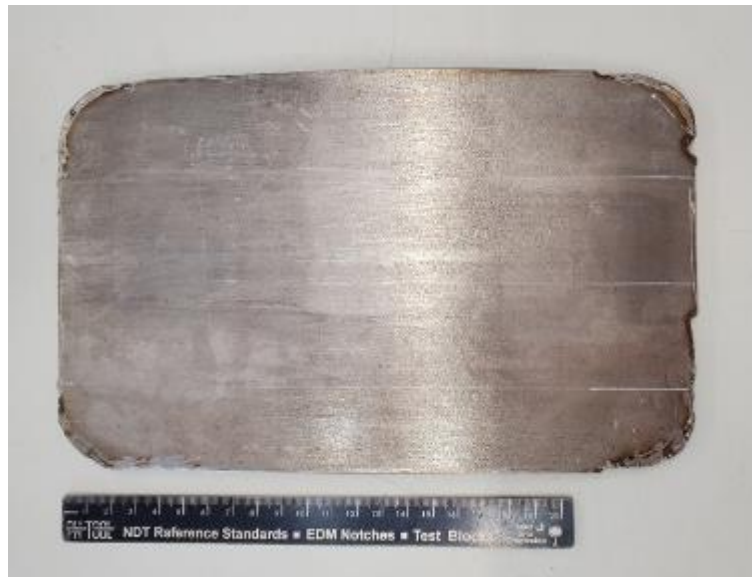
*Figure 4 A section of a MIC damaged pressure vessel plate seen from the outside surface is used for the case study.*

The plate has three pits that were detected via NDT, these are labelled as pits 1, 2, and 3. Prior to the removal of the plate, pit 3 had been excavated to a depth of about 2mm and it resulted in an oval gouge with axis lengths of approximately 10mm by 12mm.

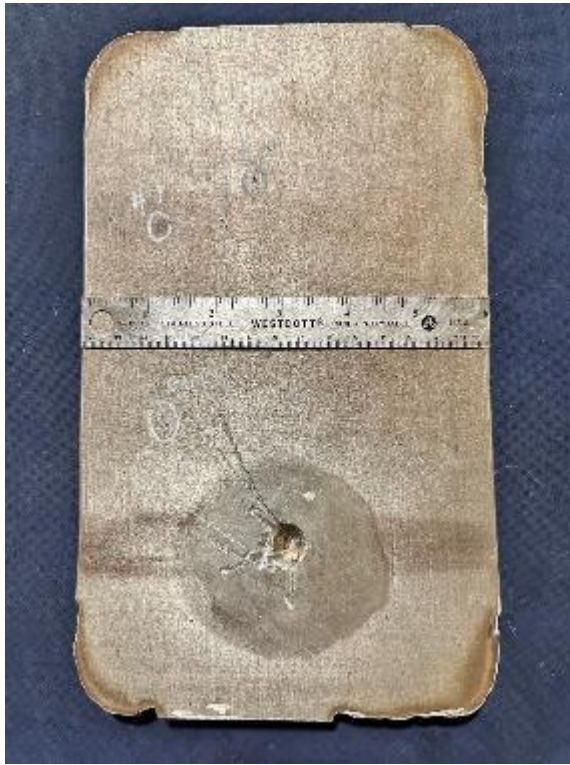
*Figure 5 Visual examination of the internal surface of the test plate. Pits 1 and 2 are highlighted pit 3 is the large pit in the bottom centre of the plate.*

Prior to the volumetric inspection, a visual examination of the test plate was performed to help support the interpretation of the NDT. The visual inspection identified three distinct pits and one area where pits were initiated. Pits 1, and 2 and the initiating pits (identified early) were labelled on the test plate. As shown in Figure 5 pits 1, 2, and 3 could be seen visually. Pit 3 had a length of approximately 15 mm, a width of approximately 12 mm, and an approximate depth of 2mm measured using a pit gauge.

The size and depths of pits 1 and 2 could not be measured as their diameters were too small to measure accurately without the use of magnification.

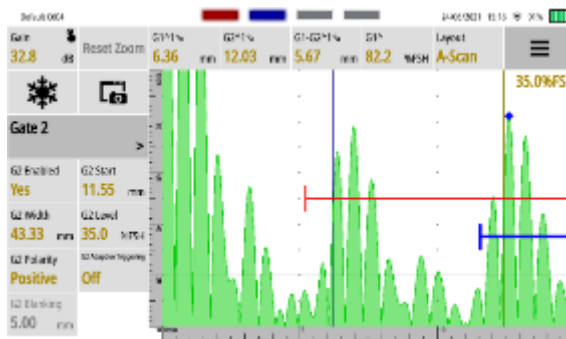
Figure 8 Back wall echo (BWE) set at 80% full-screen height.

In trial #1, the plate was scanned with a gain set to 80% full-screen height (FSH), see Figure 8. As can be seen in Figure 9, there was very little sound loss between the first and second back wall. There was no discernable indication from MIC at all, no reduction in the back wall because the probe diameter is very large compared to MIC.

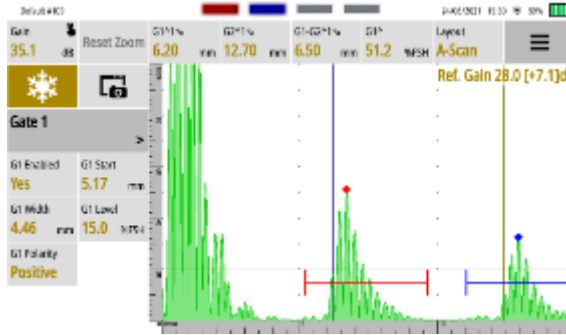
Figure 10 MIC pit response with an additional 7.1 dB to the reference gain. The first and second BWE are the red and blue dots respectively.

it could easily be mistaken for noise. For all intents and purposes, the MIC could not be detected. The best estimate at the pit depth based on the signal response was 1.1mm.

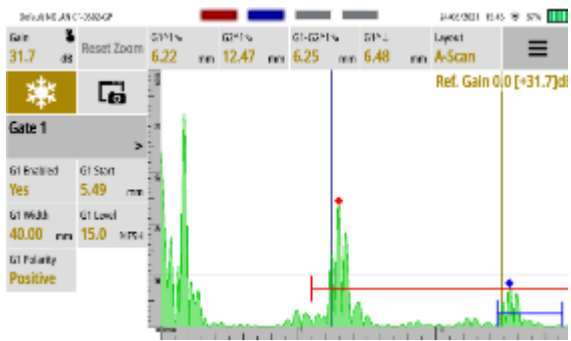
Figure 13 MIC response with a BWE set at 80% FSH. Pitting is visible in the front of the signals at low amplitude.

Figure 12 is the signal response from calibration. Figure 13 shows the signal response from the MIC pit. The drop in sound level can be seen just before the first and second BWE. The signal is at a relatively low amplitude. The pit depth was measured at 1.3mm.

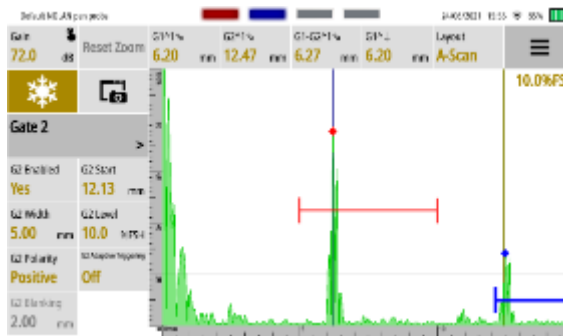
Figure 14 Signal response with a BWE set at 80% FSH.

Like trial 3, Figure 14 shows the signal of the uncorroded material. Figure 15 shows the signal response at pit 3. Using the smaller diameter, higher frequency probe, the signal generated by the MIC pit is easily detected. Unlike trial #3, the signal overshadows the BWE. The pit depth was measured at 1.6mm.

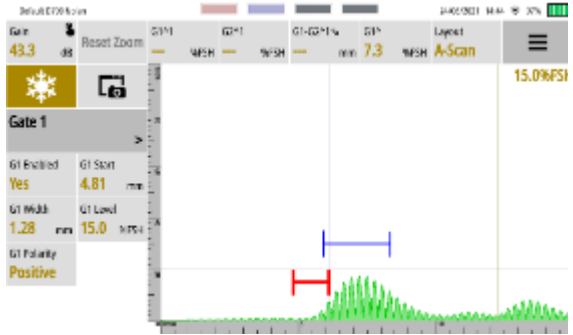
Figure 17 Signal response at MIC pit. No reflection with a reduction of second BWE.

this probe response to the MIC is attenuation of the signal, see Figure 17. The resulting signal shown in Figure 18 allowed the pit to be measured at 1.12 mm.

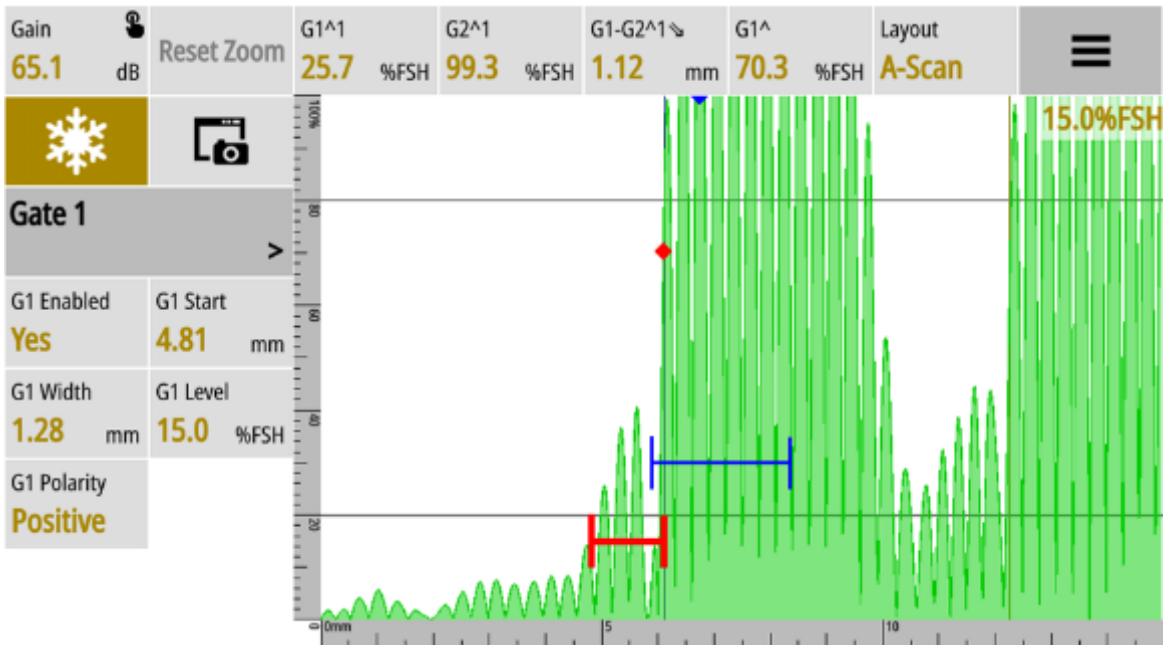
Figure 18 MIC pit response compared to noise at 10%.

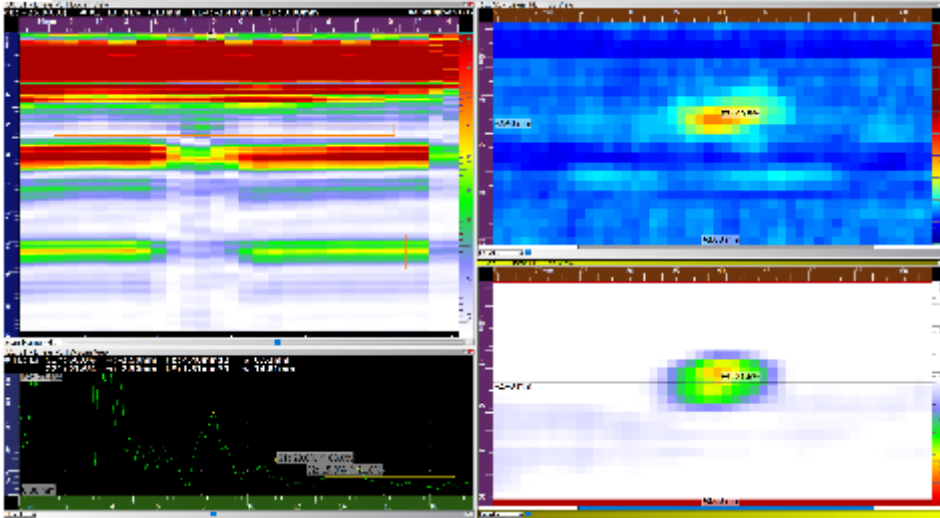
Figure 21 Trial #6 - A 2.25 MHz PAUT probe with a 1 mm pitch.

Figure 21 to Figure 24, inclusive show the PAUT signal responses caused by pit 3. The various screenshots demonstrate an improved resolution of the pit with a higher frequency and smaller pitch in the probe.

Regardless of the PAUT probe used the results provide a better understanding of the pit damage and size. It was noted in trial #6 that the lower frequency 2.25 MHz probe had an extended dead zone at the entry surface as seen by the red banding before the first back wall echo. As such, accurate through-wall sizing was not possible. In trial #7, there is a smaller dead zone and an improved signal-to-noise ratio providing a much clearer

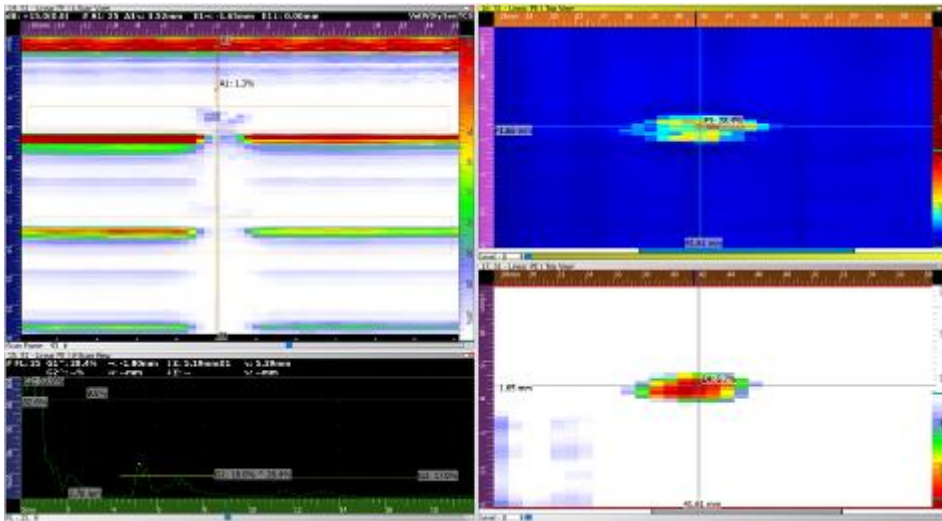
Figure 23 Trial #8 - A 10 MHz PAUT probe with a 0.3 mm pitch.

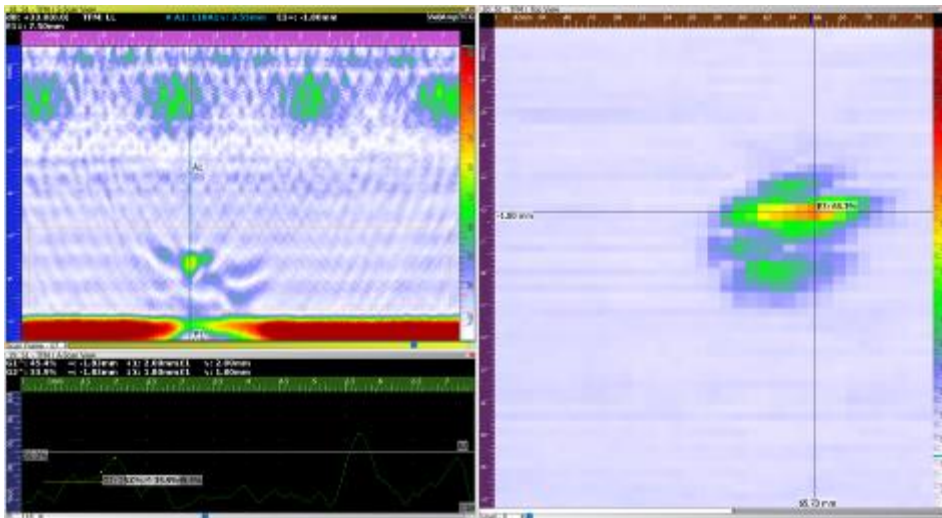
Figure 24 Trial #9 - A 5 MHz PAUT probe with a 0.6 mm pitch using the Time Focus Method (TFM).

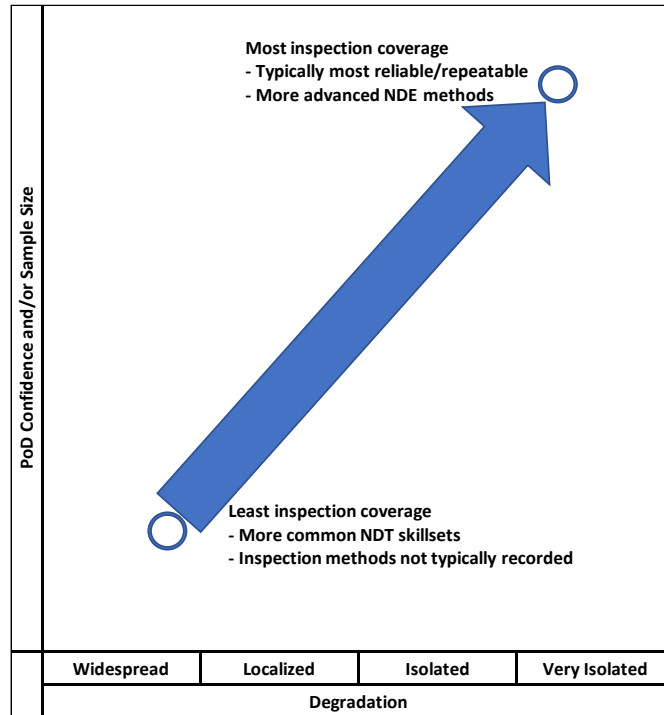
Figure 26 A sketch of POD Confidence versus degradation based on the inspection of the MIC plate sample.

NDE/NDT methods and corrosion type based on this case study is shown in Figure 26. It is recognized that there are techniques to approximate the depth of a defect using RT using density; however, the results would be subjective. So, any data obtained would not likely be used in fitness for service calculations.

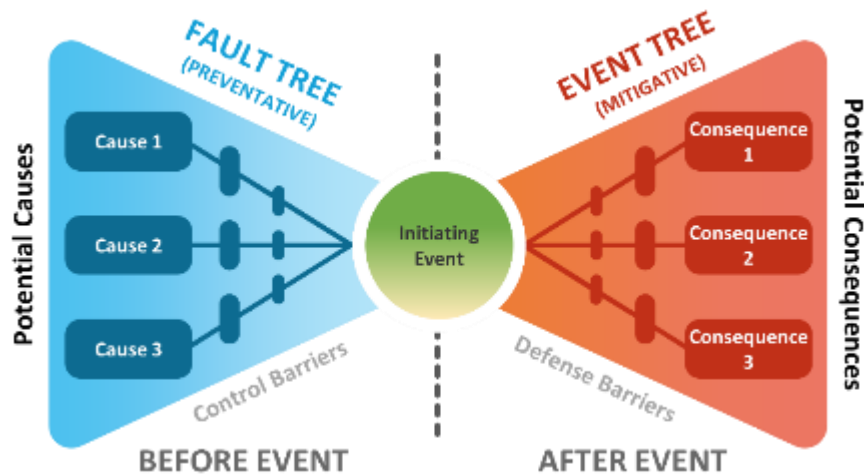
Figure 27 An overview of a bow tie, showing the fault tree on the left and the event tree on the right.

Figure 27 illustrates the proposed bowtie.

The left side of a bow tie considers preventative measures leading to an undesired event and is the focus of FTA. The right side of a bow tie focuses on the mitigative measures that lead to multiple consequences, after the initiating event and represents the ETA.

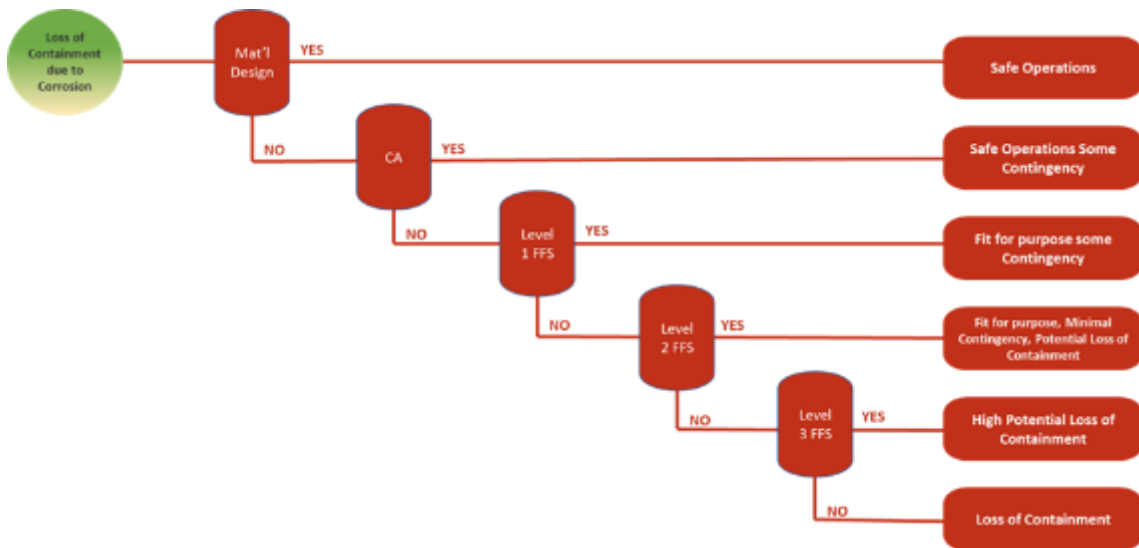
Figure 29 A fitness for service event tree.

If one applies this sequence to an event tree, then the potential consequences are shown in Figure 29. If corrosion occurs, the material selection has failed. There is still a barrier of a corrosion allowance, which presuming is greater than 0, ensures that there should be no issues related to safe operations.

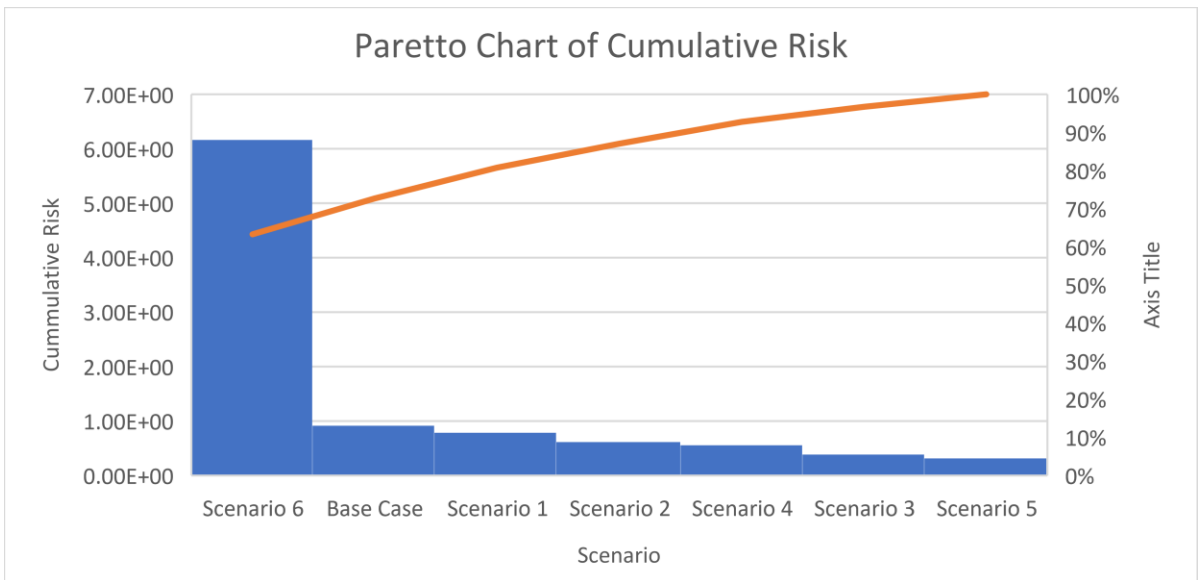
Figure 33 A Pareto chart showing the cumulative risk profiles.

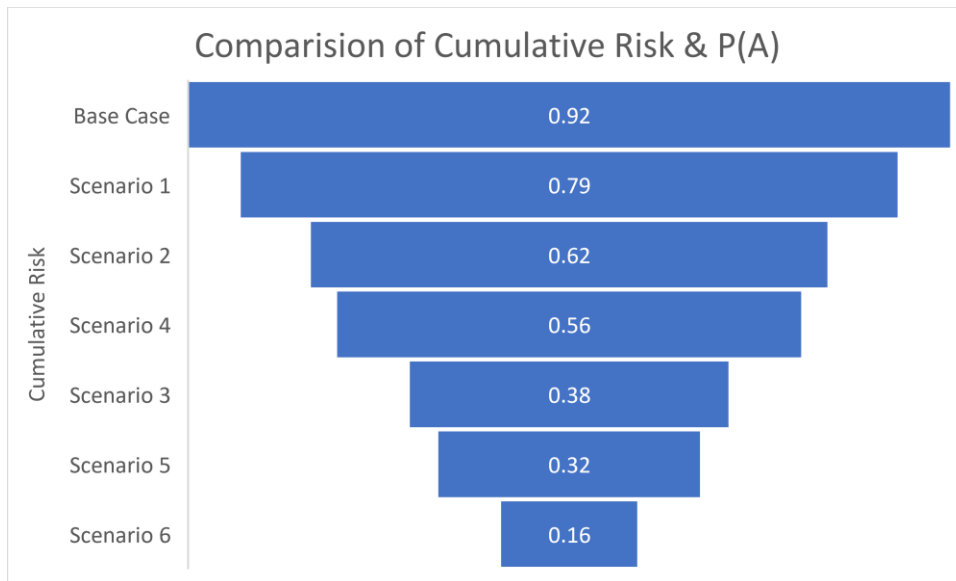
Figure 34 A comparison of the cumulative risk and the resulting probability of loss of containment due to corrosion.

The results of the Monte Carlo simulations on the bow tie demonstrate that the basic activities bolstered using additional integrity surveillance tools such as chemical, process and MMM methods will reduce the risks potentially caused by corrosion.
