THE RELATIVE SEVERITY OF NATURAL AND
SYNTHETIC SEAWATERS ON FATIGUE CRACK
GROWTH IN CATHODICALLY PROTECTED STEEL

A Thesis submitted to the School of Graduate
Studies in partial fulfillment of the
requirements for the degree of
Master of Engineering

Faculty of Engineering and Applied Science
Memorial University of Newfoundland
February 1988

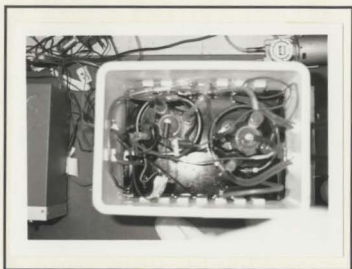
Figure 17. Ice-chest with cover removed, showing electrochemical cells..

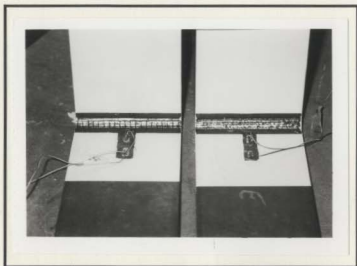
Figure 31. Preparation of welded T-plates.

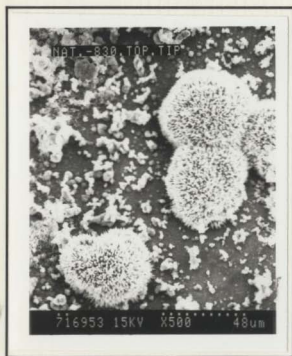
ELEMENT	WT%
Na	3.32
Mg	6.64
Ca	19.10
Mn	1.06
Fe	65.90
Cl	0.85
S	0.73
Sr	2.40

Figure 36. SEM analysis of calcareous deposits near tip of artificial crevice polarized to -830 mV (SCE) in 5°C natural seawater.

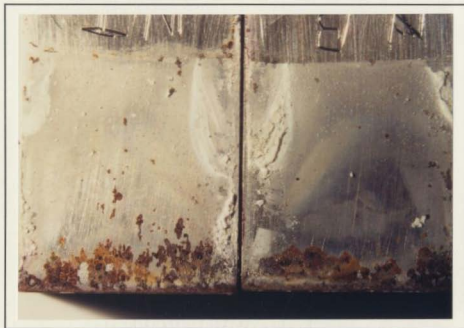
Figure 37. Crevice surfaces after polarization to -900 mV (SCE) for 500 hours in 5°C natural seawater (X6.3).

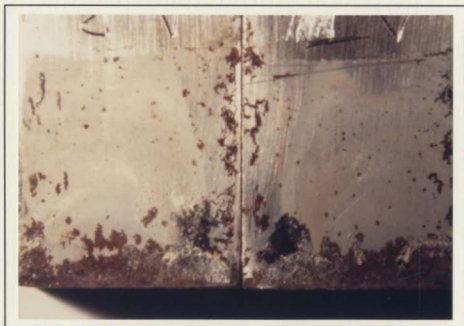
Figure 38. Crevice surfaces after polarization to -900 mV (SCE) for 500 hours in 5°C synthetic seawater (X6.3).

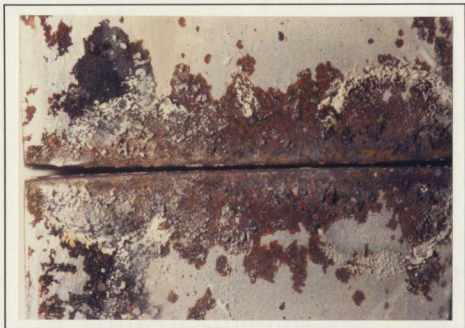
Figure 43. Crevice surfaces near mouth of specimen polarized to -900 mV (SCE) for 500 hours in 5°C synthetic seawater, before removal of deposits (X6.3).

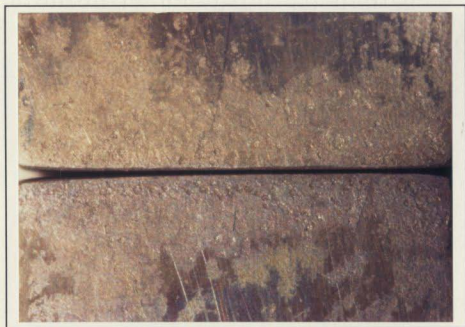
Figure 44. Crevice surfaces near mouth of specimen polarized to -900 mV (SCE) for 500 hours in 5°C synthetic seawater, after removal of deposits (X6.3).

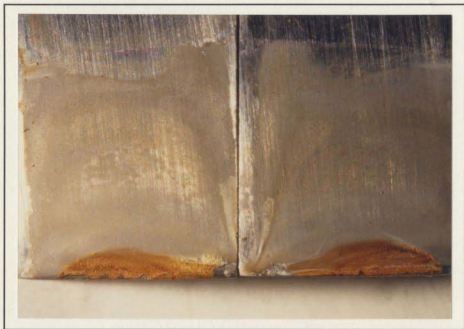
Figure 45. Crevice surfaces after polarization to -830 mV (SCE) for 500 hours in 22°C synthetic seawater (X6.3).

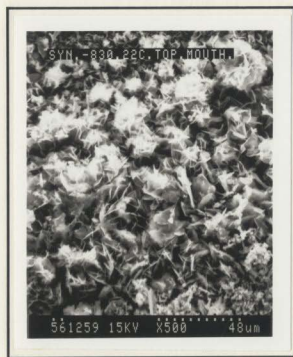
ELEMENT	WT%
Na	3.06
Mg	5.42
Ca	0.13
Mn	0.20
Fe	84.88
Cl	0.64
S	3.63
Sr	2.05

Figure 48. SEM analysis of calcareous deposits near mouth (top surface) of artificial crevice polarized to -830 mV (SCE) in 22°C synthetic seawater.

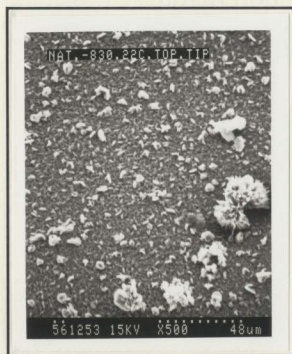
ELEMENT	WT%
Na	2.11
Mg	72.67
Ca	0.97
Mn	0.46
Fe	18.96
Cl	0.92
S	1.13
Sr	2.78

Figure 51. SEM analysis of calcareous deposits near tip of artificial crevice polarized to -830 mV (SCE) in 22°C natural seawater.

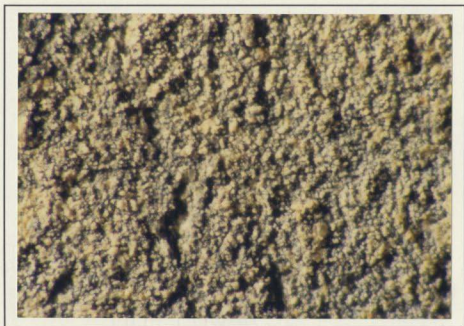
Figure 56. Calcareous deposits on fracture surface of CT specimen tested at -830 mV (SCE) in 22°C natural seawater (X100)

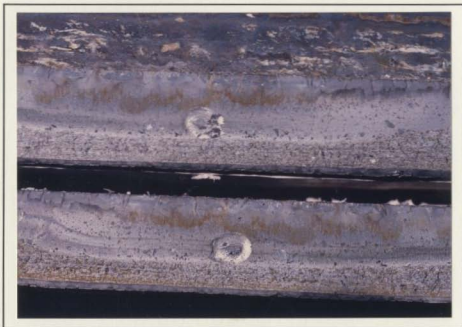
Figure 62. Fracture surface of a welded T-plate specimen tested in 5°C natural seawater (NATURAL#2).

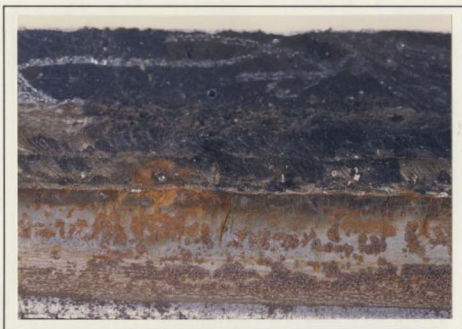
Figure 63. Fracture surface of a welded T-plate specimen tested in 5°C synthetic seawater (SYNTHETIC#1).
