USE OF ALTERNATING CURRENT FIELD MEASUREMENT
(ACFM) TECHNIQUE FOR SIZING INTERNAL SURFACE
DEFECTS ON THIN-WALLED AUSTENITIC
STAINLESS STEEL PIPES

WING HENDROPRASETYO AKBAR PUTRA

On the Hibernia platform, stainless steel piping systems that are used to transport freshwater or seawater are sometimes attacked by localised corrosion processes near welds.

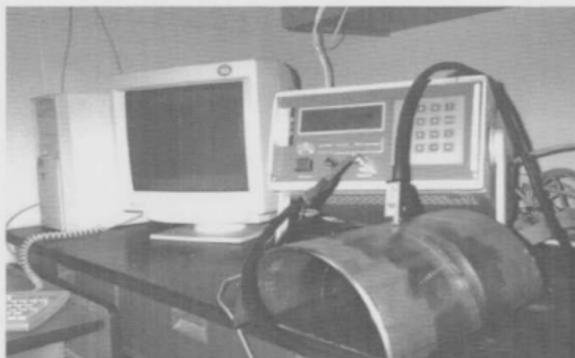
Figure 3.3. The U9b ACFM crack microgauge connected to the external computer.

A Pentium 150, 32 MB RAM external computer was used to control the instrument during the experiments. TSC's QFM version 2 software was installed on the computer for monitoring and graphing data obtained from the ACFM probe. The computer allows the data to be stored thus improving auditability and allowing off-line reanalysis or year-n-year comparison of defect size. Figure 3.3 shows the U9b ACFM crack microgauge connected to the external computer.
