# COASTAL GEOMORPHOLOGY, PROCESSES AND EROSION AT THE TOURIST DESTINATION OF FERRYLAND, NEWFOUNDLAND AND LABRADOR

A thesis submitted to the

**Master of Science**

April 2016

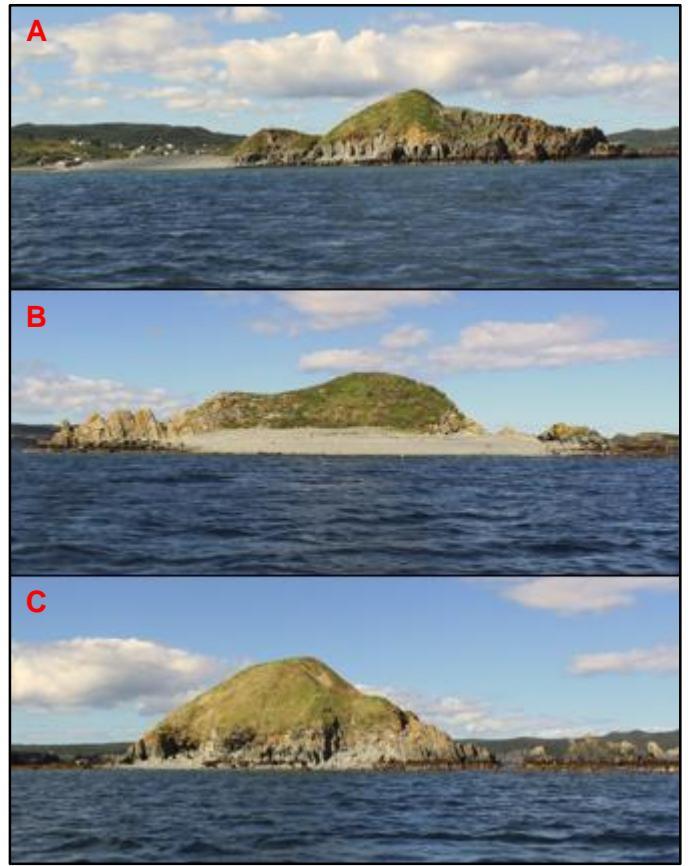
Figure 4.3. Islands on the sill. A: Wrens Island with associated cobble barrier. B: Costellos Island with associated cobble barrier. C: Ship Island with the remnants of a cobble barrier. Bois Island is discussed separately.

The northeastern sides of the islands consists of steep rocky cliffs that transition to eroded jagged bedrock and eroded angular blocks forming small rock platforms at msl. The seaward edge of these platforms consists of jagged and eroded rocky cliffs that drop off steeply into deeper water. Differential erosion is prevalent with numerous examples of less erosion-resistant stratigraphic beds eroded from between more erosion-resistant beds. Joints and fractures are prevalent indicating weathering and erosion caused by freeze-thaw cycles where the expansion of joints and fractures results in the release of angular blocks. The majority of this eroded material is transported towards and into the harbour by large waves and currents from a north-easterly direction.

The southern sides of Wrens Island and Costellos Island (Figure 4.2) consist mostly of multiple berm barriers of pebble, cobble and boulder clasts. Waves were observed breaking on the N-NE side and refracting around the islands to travel shore-parallel to these barriers. Examination of the till cap and eroded rock reveal that large waves break around and, at times, over these islands to further denude the till veneer cap and remove and erode blocks of sedimentary rock from the north side to the south side. During site investigations in September and October 2014, the steeply dipping sedimentary stratigraphy was denuded except for the remnants of the till cap on the N-NE side with numerous open joints and fractures susceptible to frost action. Large angular pieces of bedrock with a maximum observed size of 0.8 m wide and 0.3 m thick were observed in various positions on and around the islands, including on the barrier surface on the south side. The presence of angular blocks in-situ, around the edges of the cliffs, and on the barriers indicates transport by large waves. Evidence of wave and current transport is seen where large blocks (0.4 m x 0.3 m) have been deposited on the barriers, separated from the source rock. Underwater

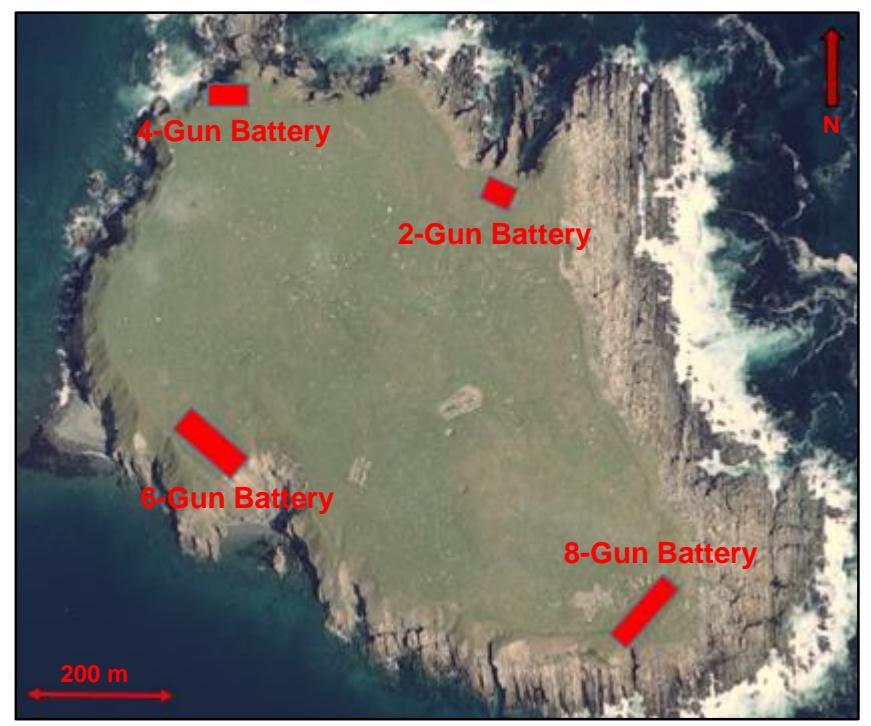
Figure 4.4. Gun Batteries on Bois Island. North is up. (Adapted from Newfoundland and Labrador Government, Aerial Photograph 95044-10).

The island shows multiple signs of bedrock weathering and erosion. Till veneer erosion is prevalent on most bluffs. Freeze-thaw heave in the rocky cliffs (joints, fractures, and bedding plains) and on the till cliffs is the dominant cause of erosion, followed by transport via rainfall and gravity. Large waves and currents transport all but the largest pieces away from the base of the rocky cliffs. Residents described an event similar to a combined debris avalanche and block slide in 2012 on the western till slope approximately 30 metres above msl (Figure 4.5A). From site observation, this slope failure was caused by a combination of cliff erosion and debris slide. Figure 4.5B shows a similar example directly east of the 4-Gun Battery (Figure 4.4).

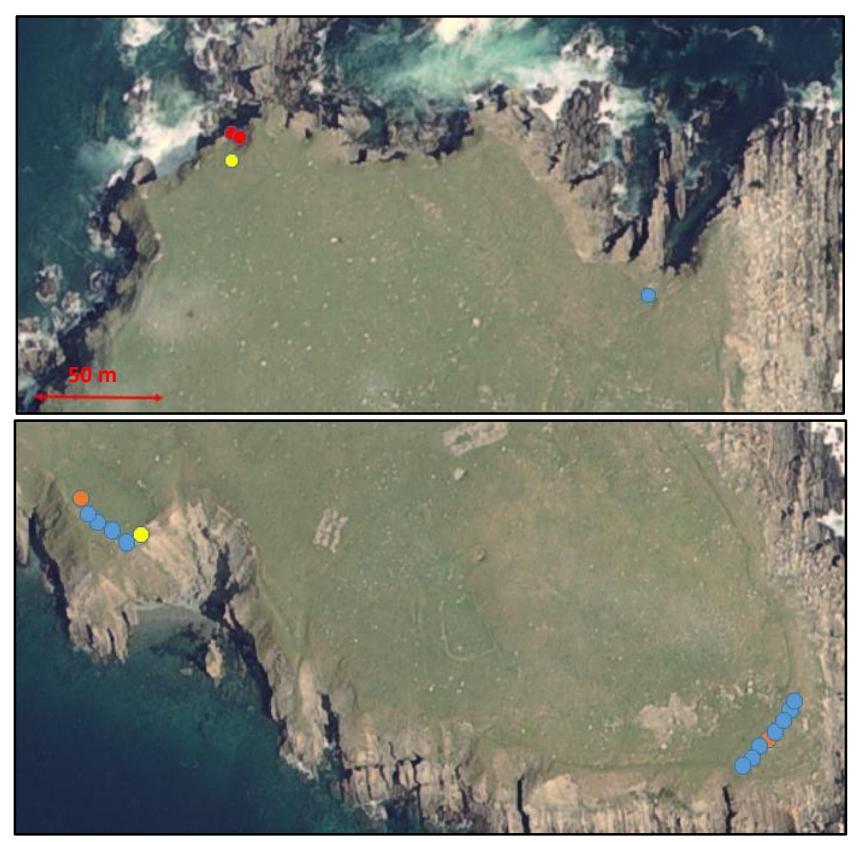
Photographs taken of the island and information from residents indicated that some of the ordnance from the batteries was at risk of being eroded. Other pieces had been displaced and have fallen to the rocky shoreline of the island. A site visit on June 5, 2015 revealed the location of four gun batteries, 17 ordnance pieces and two potential locations. Table 4.1 shows locations for the ordnance. Figure 4.4 shows the main gun batteries on the island and Figure 4.6 shows the location of each ordnance piece found during a site visit on June 5, 2015.

Figure 4.6. Locations of ordnance. North is at the top. Blue indicates some nearby erosion and in-situ, orange indicates possible location (visually undetected), yellow indicates at risk via erosion, and red indicates eroded and displaced (Adapted from Newfoundland and Labrador Government, Aerial Photograph 95044-10).

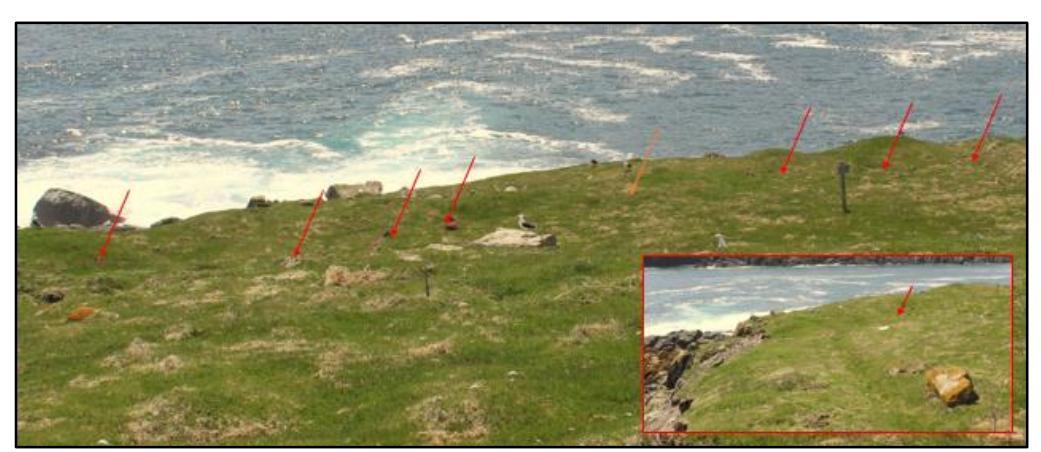
Figure 4.8. Location of ordnance at the 8-Gun Battery. The orange arrow near middle indicates the possible location of the undetected ordnance at this site located by ground thumping and compass needle movements. Inset shows eroding till cliff along the SE flank of this site – red arrow showing one of the ordnance locations. Photo taken from N 47° 1.566', 52° 51.751' looking SE.

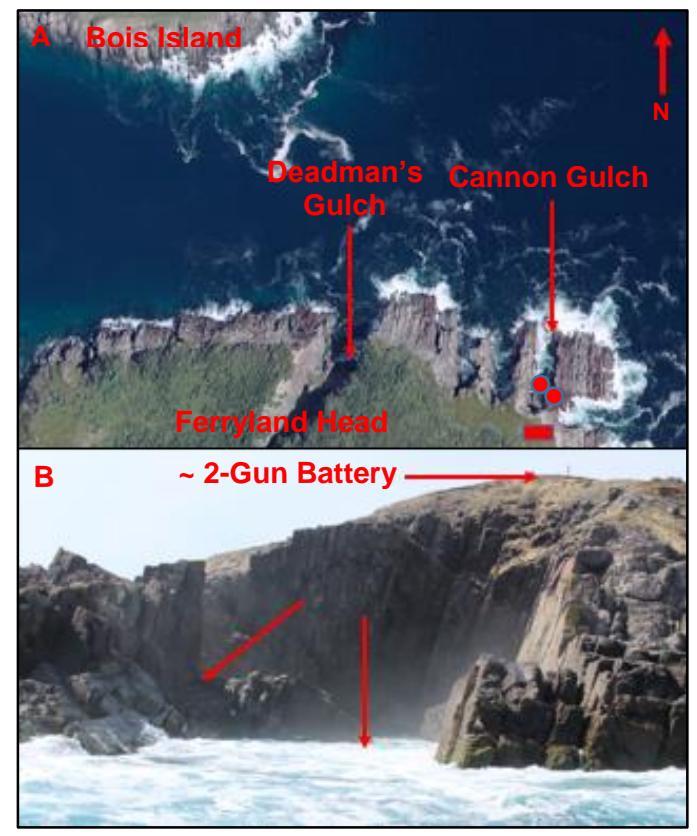
According to local knowledge and site observation, a 2-Gun Battery (est. 1700s) existed on the north shore of Ferryland Head on a former till cliff that has been eroded (Figure 4.11A). According to fish harvesters and residents, the ordnance pieces have been eroded from the battery and are now separated, with one submerged in seawater and visible at low water during calm conditions, and the other perched on a rock ledge concealed from seaview by an outcrop. The ordnance pieces are larger (greater than 6 inch inside diameter – assumed Demi Cannons) than are the pieces on Bois Island. The ordnance pieces are significant due to their larger size and undocumented location. Several site visits were attempted, but the sea state and lack of landing spots in the narrow gulch prevented shore access or underwater camera deployment. The site is significant due to the possible presence of ordnance and may contain new information regarding military history.

Figure 4.11. 2-Gun Battery at Ferryland Head. North is up in **A**. **A:** Location of 2-Gun Battery (red rectangle) and eroded ordnance pieces (red dots) (Newfoundland and Labrador Government, Aerial Photograph 95044-10). **B:** approximate location of ordnance pieces (red Arrows).

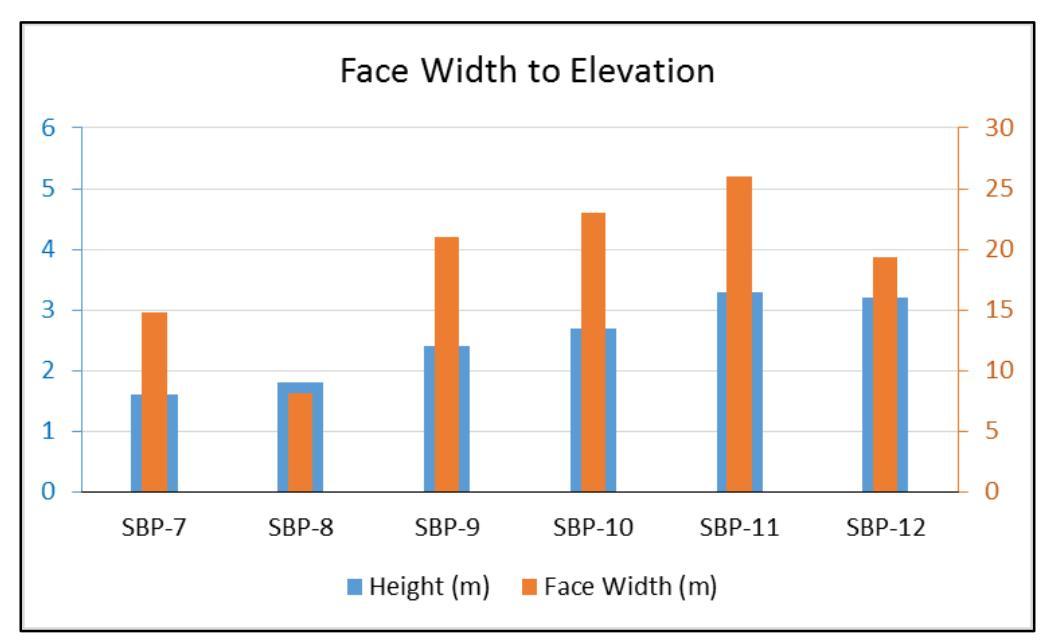
Increased longshore current on the barrier face and toe-of-slope transports available materials to the west, as seen in the barrier face heights in Figure 4.13. This is also seen in the clast arrangement in profiles (Figure 4.14) where a boulder fabric on the eastern extent of the barrier (SBP8) transitions to a cobble assortment with transient berms (SBP-11 to SBP-12). The cobble location indicates dominant wave transport from east to west with

Figure 4.13. Sandy Cove barrier face width to barrier elevation comparison.

The barrier increases in elevation from SBP-7 to SBP-11 with a slight drop at SBP-12. The barrier face width also generally increases from SBP-7 to SBP-11 with a decrease at SBP-12. The lesser barrier elevation and face width at SBP-8 is due to the proximity of a transition from a boulder barrier to a sand and pebble barrier face – sand and pebbles have been deposited west of SBP-8. The lower barrier elevation and narrower face width at SBP-12 is a result of dominant E-W longshore current and sediment transport over the low rocky shore protrusion on the west end of the barrier. Sediment is trapped against the eastern edge of this protrusion. Once the trap is filled, any excess is transported over the protrusion to the west. This barrier was observed over 40 times, and the sediment pattern represents the dominant wave approach and sediment transport for this barrier. As such, the pattern indicates that waves and sediment transport during the time of this study has remained with little change in height to face width in the transects along the barrier. This indicates that waves refracting around Ferryland Head consistently approach the barrier in a similar way with every wave and surge event. Cobbles and pebbles are transported across the boulder fabric and toward the west end. Clasts here are reworked from these waves and smaller waves from the N-NE. This pattern also aligns with local accounts and observations of wave approach.

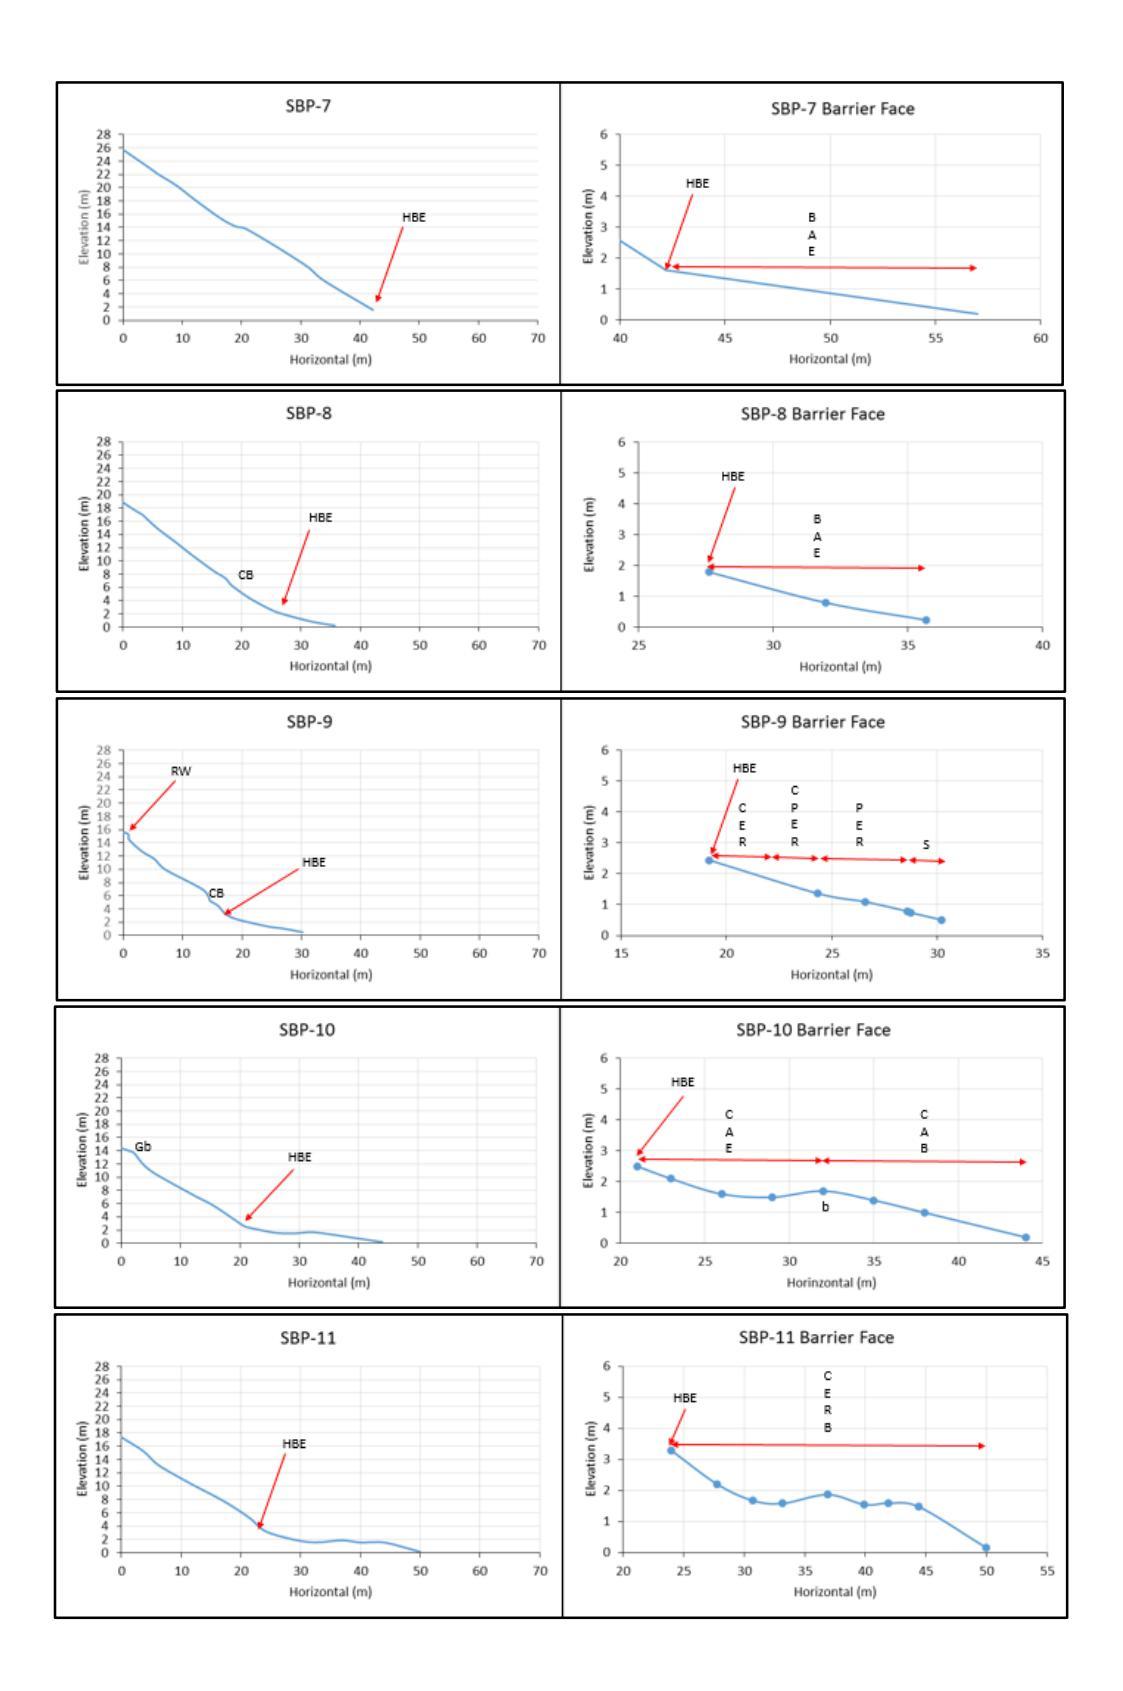
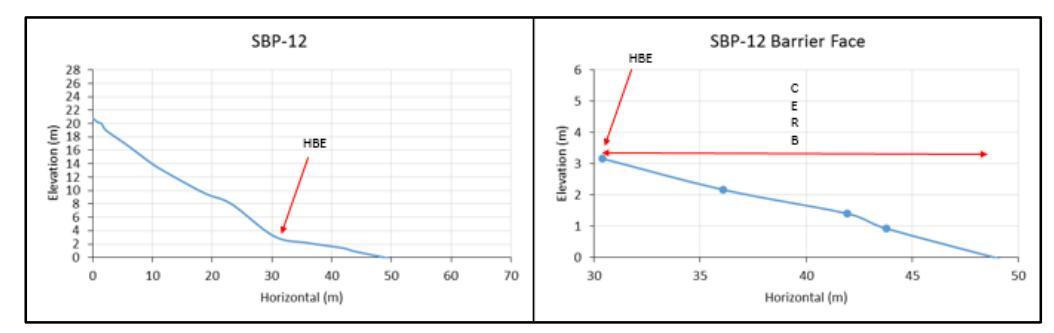
Figure 4.14. Six Slope-Barrier Profiles on the Sandy Cove System. HBE in SBP-7 is at large boulder barrier not accessible to waves. HBE is Highest Barrier Elevation during survey. SBP-10 is cut off at HBE due to RTK receiver reception.

SBP-7 consists of a grass-covered slope from 25.7 m to a sharply eroded turf edge at 8.1 m. From here to 1.5 m is an exposed till slope. From 1.5 m to water level at approximately 0.2 m consists of angular and equantic boulder fabric. This section was not surveyed due to slippery footing, but is indicated as a straight line to water level (0.3 m) at an estimated horizontal distance from HBE. The grass-covered slope shows signs of slumping. The turf edge to the HBE is exposed due to wave undercutting.

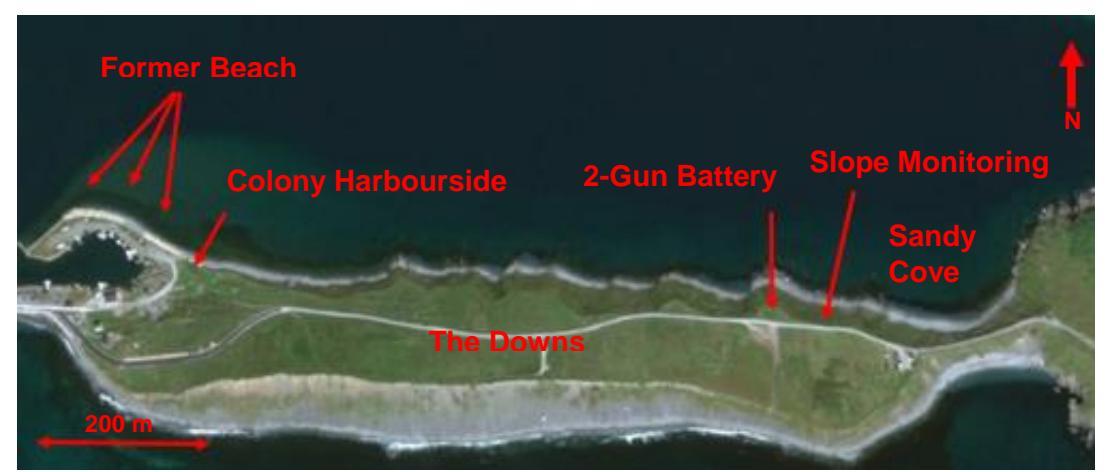
The north side of The Downs consists of a rocky shoreline with pocket beaches (average length ~50 m) from the western extent of Sandy Cove barrier to the Colony of Avalon site at the harbourside (Figure 4.17). Most of the toe-of-slope where the grassy slope meets the bedrock shows signs of wave and surge impact via undercutting. Differential erosion reveals the dominant east-west influence of larger waves and currents entering from The Narrows. The upper to mid slopes indicate creep movement with sporadic linear, partially grass-covered openings at normal to oblique angles to the bluff edge. Several places along the slope also show signs of rotational movement. Six monitoring slope nails and a top-of-slope/edge-of-road transect were established in a section of slope west of the gun battery to monitor slope movement, including the edge of the road (Figure 4.17). This section of road is at risk for failure due to improper water drainage, slope movement, and motor vehicle loading. Routine tape measure checks on these slope nails revealed no slope movement during the study period.

Figure 4.17. The Downs North. Differential erosion is evident from the sediment deposition to the east (right) of shore-normal outcrops. This is further evidence of dominant wave approach from the east and associated sediment transport. The slope monitoring site near the gun battery is shown. (Google Earth).

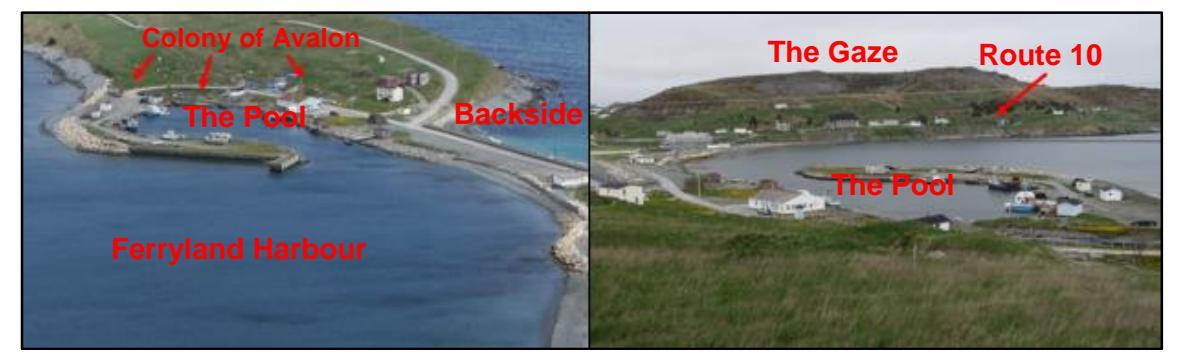
The Pool is a shallow (< 4 m) bulb-shaped basin semi-enclosed by a fortified curved spit. The spit material consists of marine sediments, and multiple areas of artificial infills of varying thicknesses taken from nearby sources (e.g. quarry, barriers, till bluffs) (Figure 4.19).

Figure 4.19. The Pool. Left: is the western aspect taken from The Gaze in 2014. **Right:** is the Eastern aspect taken from The Downs.

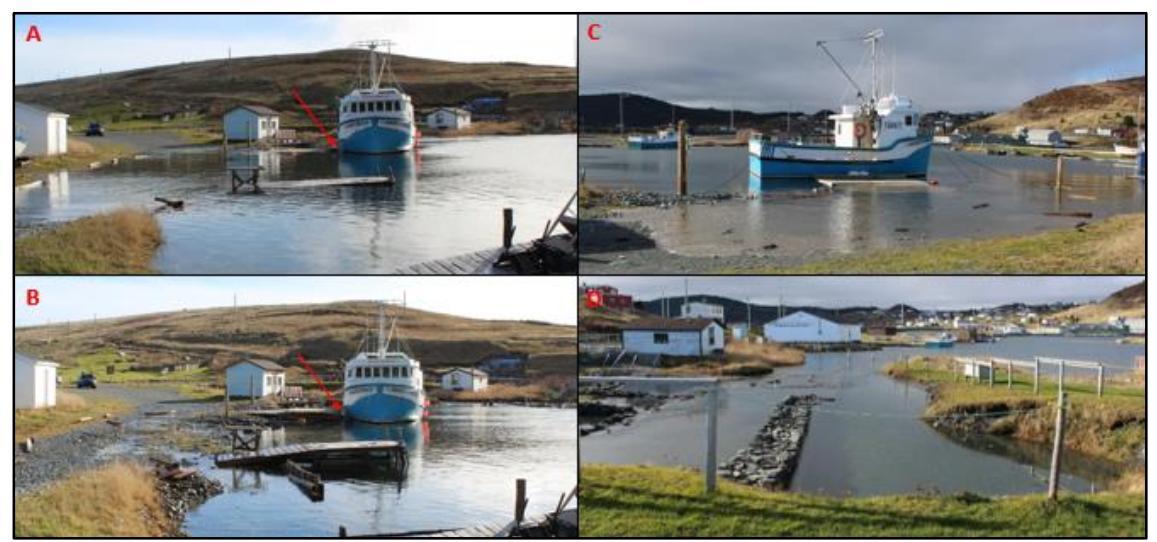
Figure 4.20. A, B, and C show one period of an oscillation (~0.5 m) at The Pool on November 24, 2014 (there were more than 5 periods during this event). Photographs were taken at 12:51 (A), 12:53 (B), and 12:55 (C, D) respectively. C shows sediment laden water and floating debris at the end of the period. D, taken at the same time as C (secondary remote camera) shows flooding of the Lower Colony site. Water level in A, C, and D is approximately 2 m above the quays. The red arrows indicate the position of FLEWWL-1.

During this event, fine sediment was transported in the current. Larger sand- to cobble-sized fill materials were observed tumbling into the deeper water. Debris (round sticks in the water in 4.20A and D) from damaged shoreline supports was also moved and, in one case, a piece of a piling from a damaged seawall made impact with a smaller motor vessel on the opposite side of The Pool. Local knowledge indicate that past water level has risen above the floor of the white shed on many occasions (left in Figure 4.20A and C).

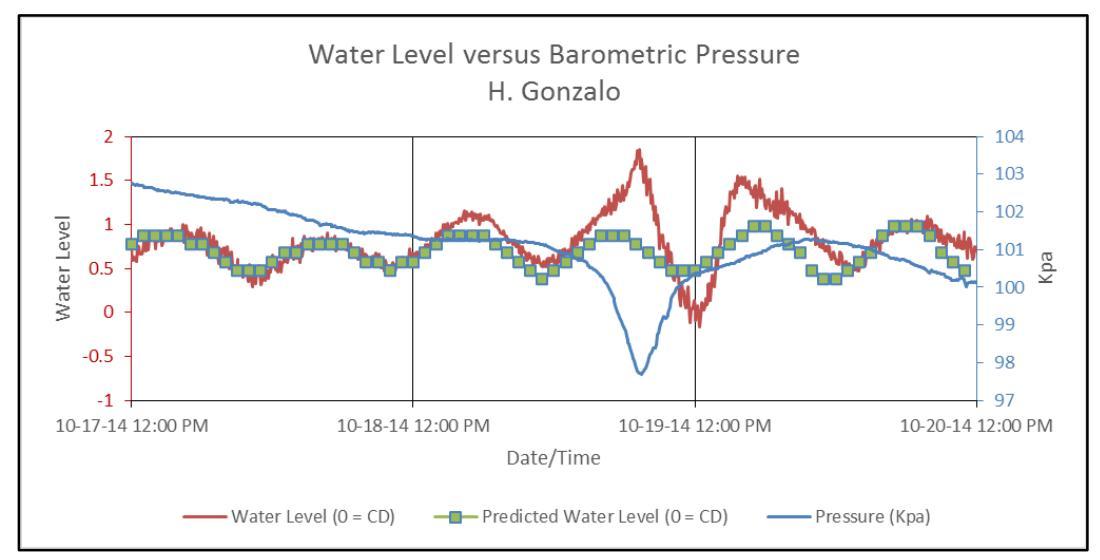
Figure 4.21. Water level changes during the passage of Hurricane Gonzalo.

Figure 4.21 shows many oscillations in The Pool as shown by very sharp rises and falls in water levels over short time periods. Barometric pressure dropped gradually and then sharply during the overnight into the early morning of October 19<sup>th</sup>. The evening of the 18<sup>th</sup> shows a rise in tide (predicted and measured) slightly prior to the normal wave cycle. The seawater at this point was under the influence of surge being pushed ahead of

The example and observation provided for Figure 4.21 and 4.22 indicate that surge and oscillations cause erosion on the shoreline of The Pool. Figure 4.23 and Figure 4.24 show numerous oscillations that may also contribute to erosion at the shoreline. There is a wealth of local knowledge regarding similar events.

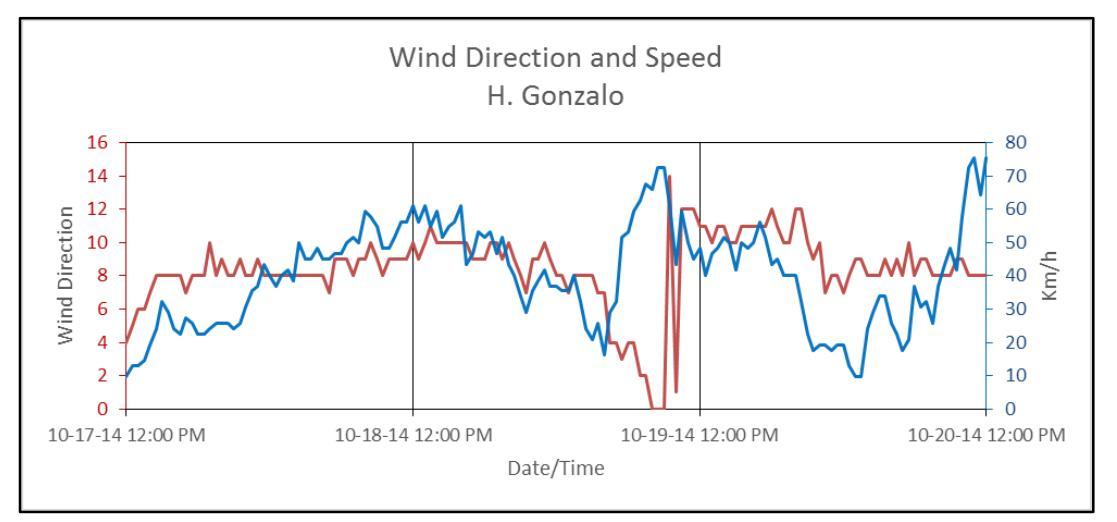
Figure 4.22. Wind speed and direction before, during and after Hurricane Gonzalo. Wind direction interpretation: N = 0, NNE = 1, NE = 2, ENE = 3, E = 4, ESE = 5, SE = 6, SSE = 7, S = 8, SSW = 9, SW = 10, WSW = 11, W = 12, WNW = 13, NW = 14, NNW = 15.

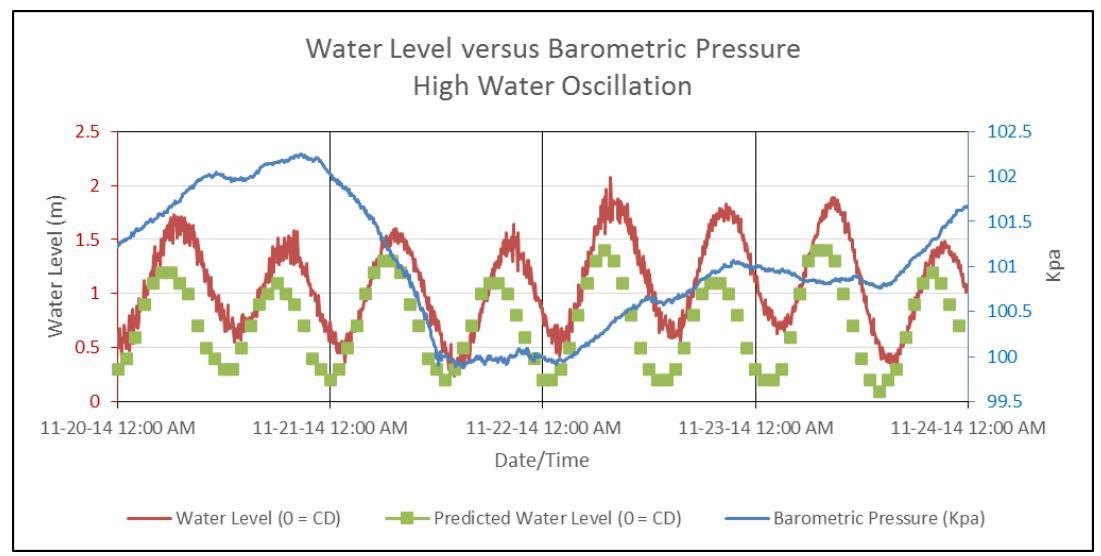
Figure 4.23. Highest recorded water level in datalogger deployment history (September 13, 2014 to May 31, 2015).

Figure 4.23 shows a number of features including higher than normal high tides and higher than normal low tides, numerous oscillations, a sharp drop in barometric pressure, and a long period oscillation with an amplitude of up to 0.8 m. The accentuated high high water seems to coincide with the low pressure over the area. However, the wind speed was fairly light and from the southwesterly direction, blowing offshore (Figure 4.24). The cause

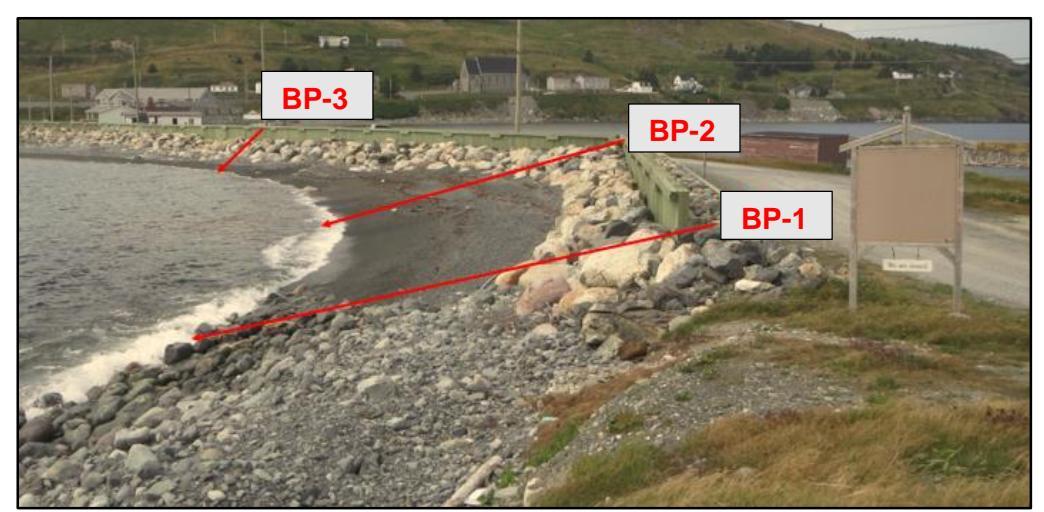
Figure 5.11. BP-1 to BP-3. Post survey completion – arrows for location and direction only. BP extend further to the right and follow actual elevation. Note coarse sand, armour stone, breakwater, cribbing and road.

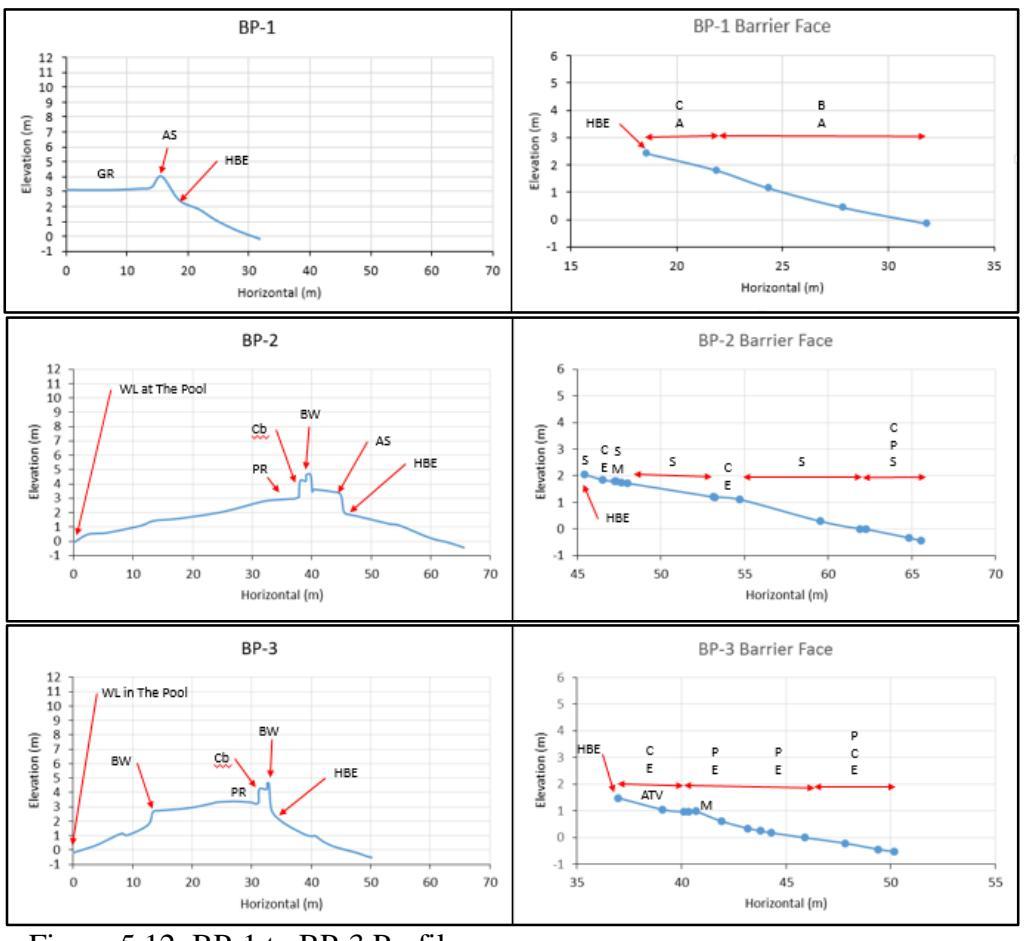
Figure 5.12. BP-1 to BP-3 Profiles.

BP-1 begins on a 255 mm nail near a utility pole between the gravel road and the Breen residence. From HBE, there are two sediment types; angular and equantic cobbles and angular and equantic boulders to water level at -0.3 m. The profile is straight with accumulated cobbles in the upper third of the profile that have been transported from the toe-of-slope of The Downs during high water and waves events.

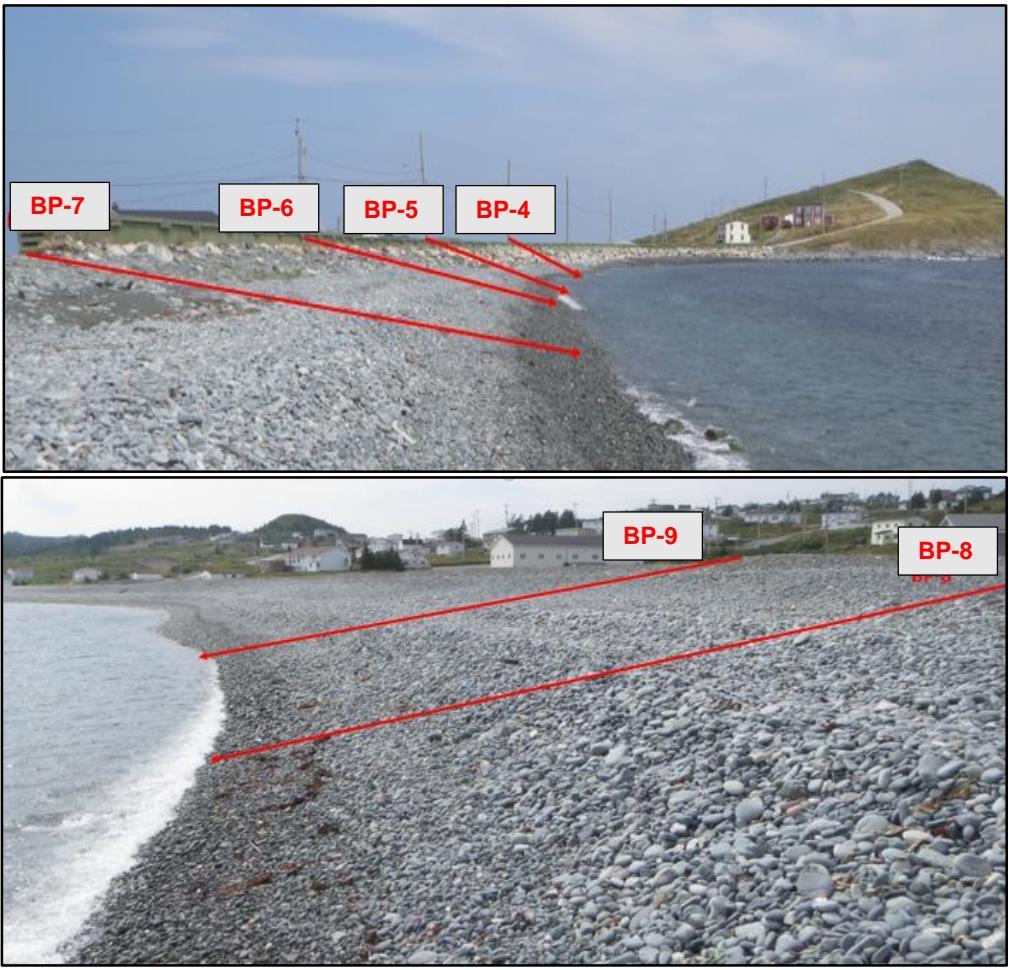
Figure 5.13. Approximate locations of BP-4 to BP-9. The dark coloration nearshore of BP-4 and BP-5 show the marine organics of the shoal related to Mad Rocks Sill. The cuspate feature in the intertidal zone south of BP-9 indicates the division of the northern and southern sections of nearshore currents and geomorphic factors. BP-10 is directly south of this cuspate point (below).

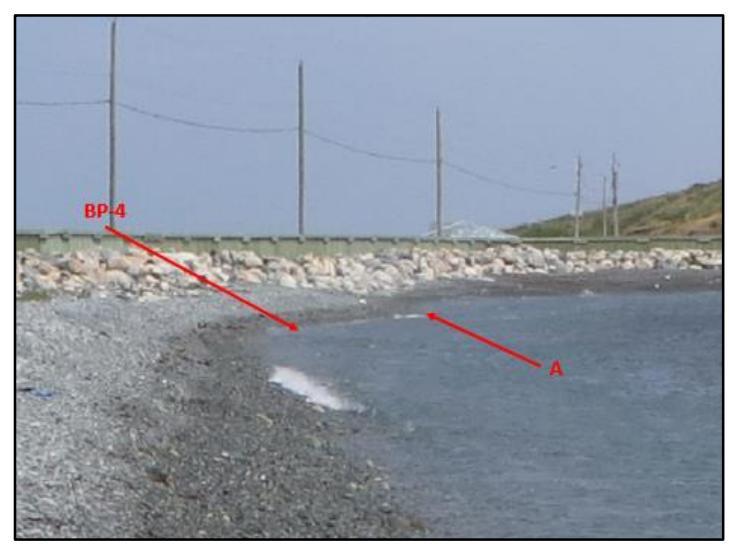
The bathymetry off the beach step of the section between BP-4 to BP-9 consists of the transition of Mad Rocks Sill into deeper water further south. Figure 5.14 shows a small accretionary spit that develops during minor to moderate wave action into BP-1 to BP-3. This spit is eroded during moderate to high wave action due to stronger westerly longshore currents that transport sediments further SW. A spit also occurs further SW near BP-5 and BP-6. The bathymetric drop off the beach step between BP-8 to BP-9 is steeper than BP-4 to BP-7 and is evident in the unstable beach step that is usually at the critical angle of repose. The profiles for this segment are contained in Figure 5.15.

Figure 5.14. Transient cuspate spit (A) that marks the average westward edge of cobbles that transition to coarse sand further west towards The Downs.

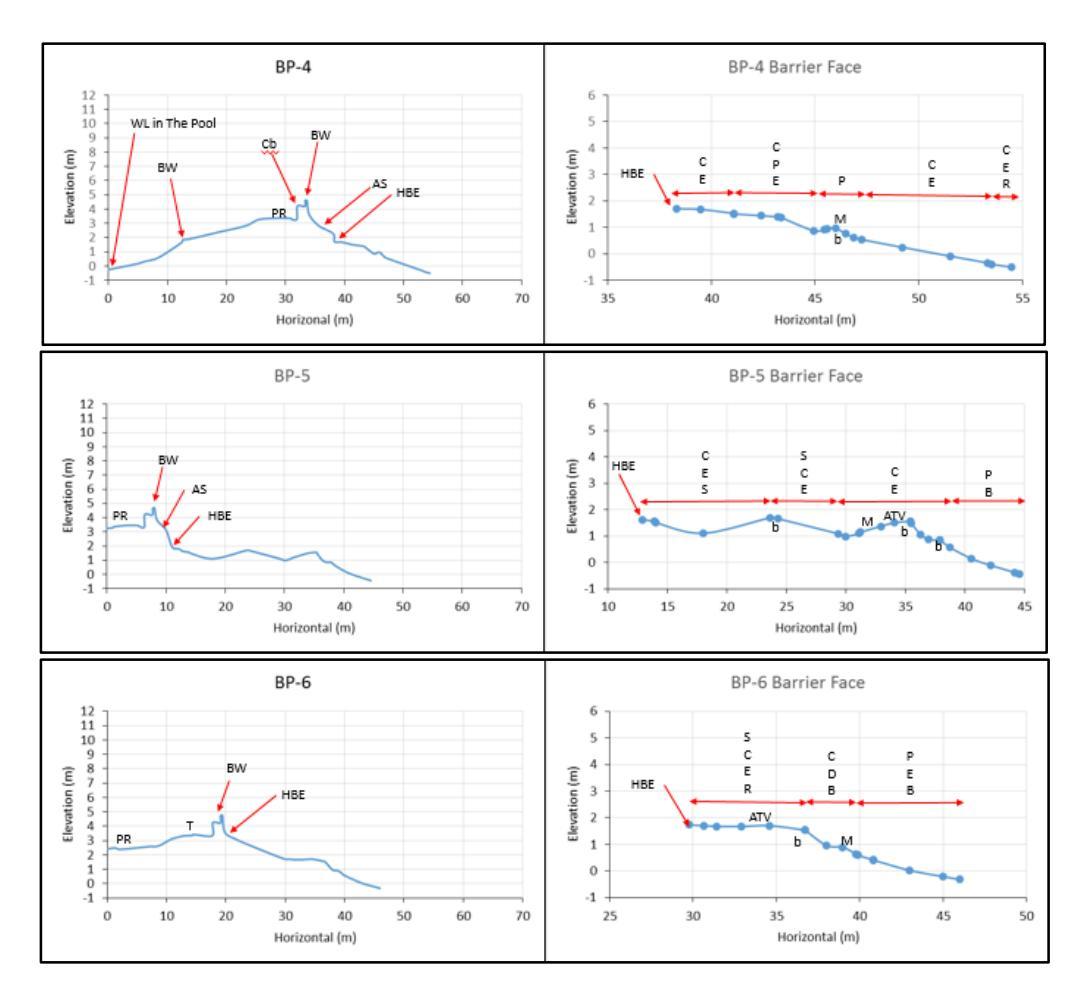
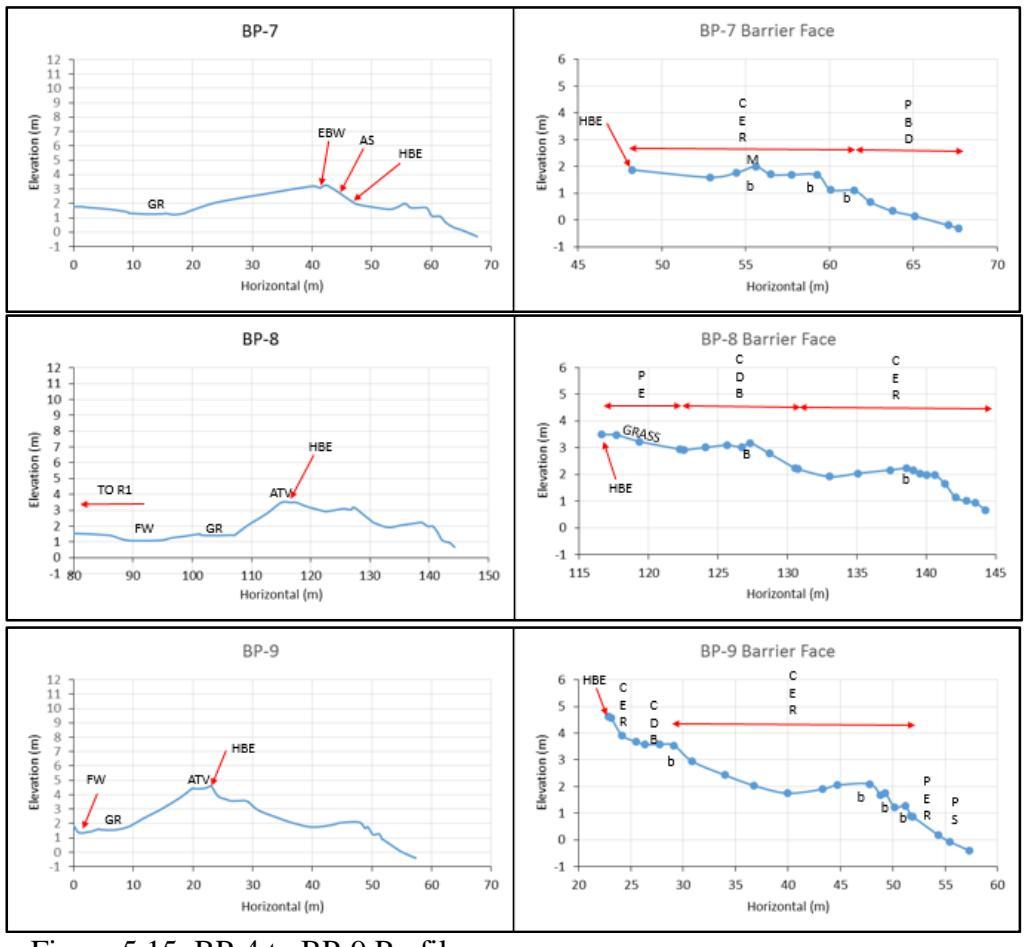
Figure 5.15. BP-4 to BP-9 Profiles.

BP-4 begins at -0.3 m at the water level in The Pool. From here it rises over sand and cobbles to the base of a dilapidated breakwater at 1.65 m. The top of the breakwater is at 1.9 m. From the breakwater to the paved road surface at 3.2 m consists of compacted fill exhibiting drainage cuts from overtopping of the main breakwater. The right figure begins at HBE and consists of five sediment types: equantic cobbles, cobbles and equantic pebbles, a berm of pebbles covered with marine organics, equantic cobbles, and equantic and roller cobbles to water level at -0.5 m. BP-4 is near the transition point from the coarse sand of BP-1 to BP-3 to the remainder of Ferryland Beach. BP-5 begins on a 255 mm nail at 3.2 m near the eastern end of the fence on the roadside of the Herb Williams property fence. From here, it crosses the road at 3.4 m and then extends over compacted fill material to the cribbing. There are four sediment types and two berms seaward of HBE, shown in the right figure. Equantic cobbles and sand transition into sand and equantic cobbles to form the first berm. Equantic cobbles form the second berm followed by mixed shaped pebbles with partially buried equantic and angular boulders (< 0.5 m diameter) and angular armour stone (> 0.5 m diameter) on the berm face to the water level at -0.4 m. Boulders and armour stone are partially buried along the water line and are visible into the nearshore.

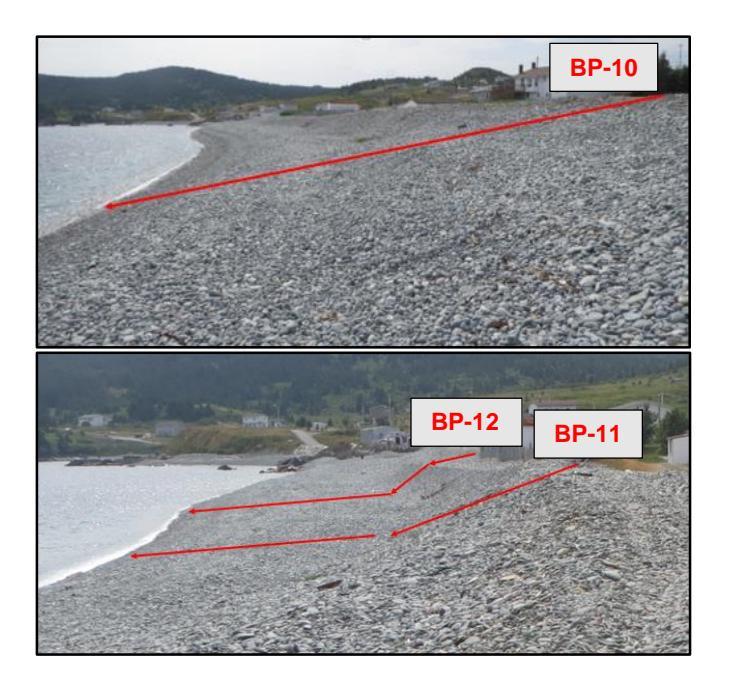
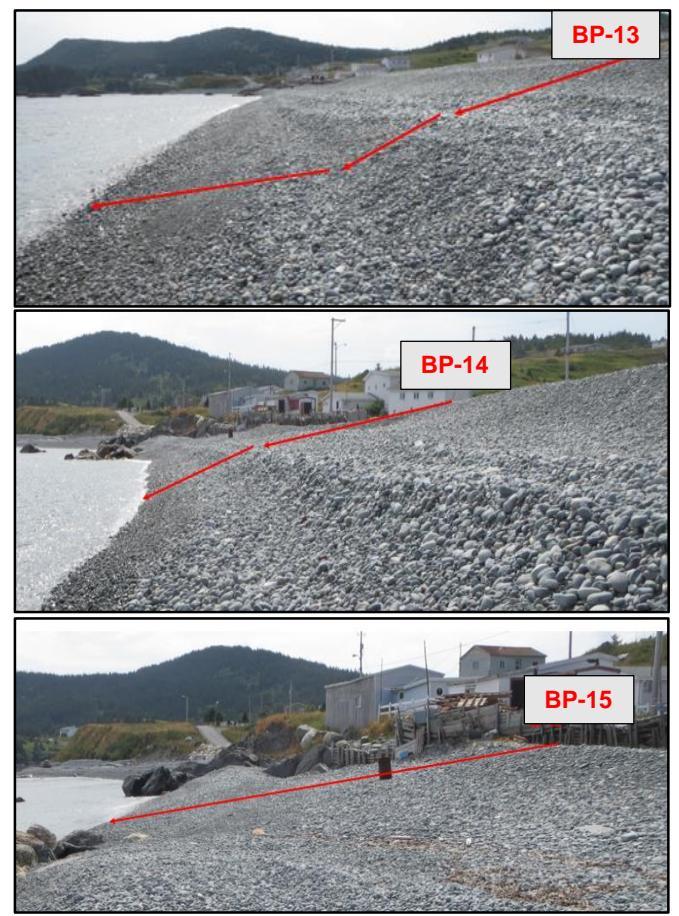
BP-10 to BP-15 (Figure 5.16) are delineated into a segment based on easterly exposure and influence of Crow Island, shore-normal activity, nearshore bathymetry, berm formation, and barrier impacts due to anthropogenic activities. The segment consists mostly of cobbles with an accentuated storm berm between BP-11 and BP-12, major anthropogenic influences in the southern section, and multiple berms. Cusp formation is similar to the previous segment. However, the cusps are at times slightly oblique to the SE.

Figure 5.16. Approximate locations of BP-10 to 15.

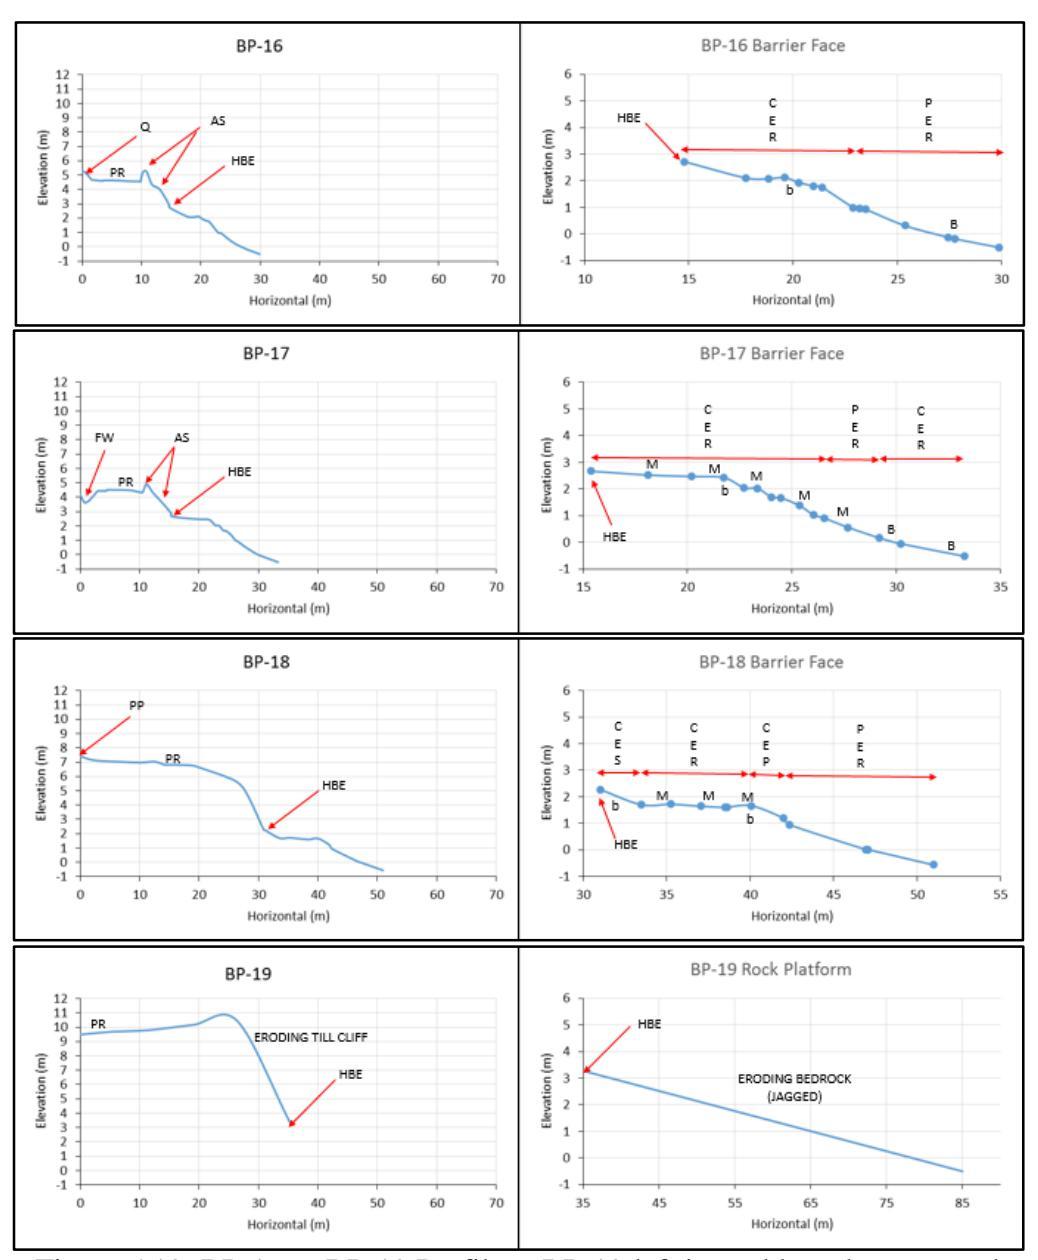
Figure 5.19. BP-16 to BP-19 Profiles. BP-19 left is could not be surveyed due to unsafe surfaces of the bedrock shore face. It is included to show the near even slope from HBE to the water line. Slope and distance were calculated with a suunto inclinometer and horizontal measurement scaled from in-field photographic interpretation.

BP-18 begins on a 255 mm nail at 7.4 m, due east of a power pole. From here the line crosses ~14.3 m of mixed grasses and alder to the landward edge of the asphalt road surface at 6.8 m. The seaward edge of road is just below 6.8 m. From here, the line follows
