# COASTAL GEOMORPHOLOGY, PROCESSES AND EROSION AT THE TOURIST DESTINATION OF FERRYLAND, NEWFOUNDLAND AND LABRADOR

A thesis submitted to the

**Master of Science**

April 2016

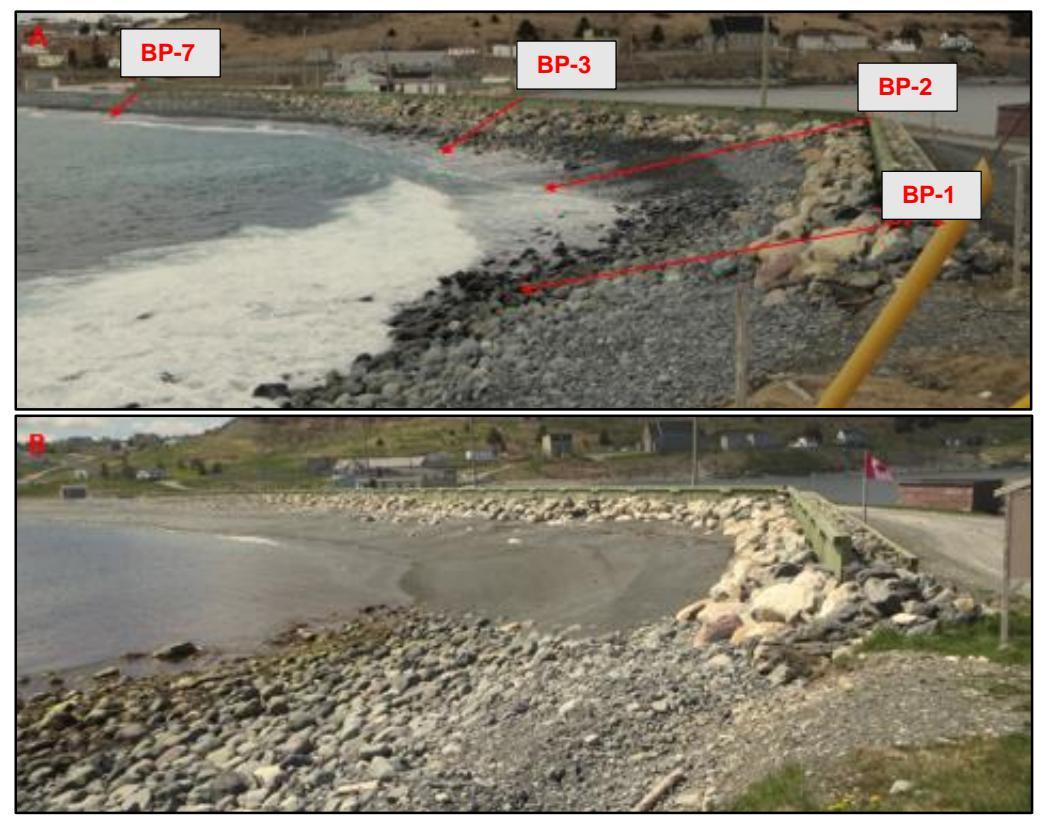
Figure 5.20. The structure of the breakwater on the south side of the tombolo. A: shows sediment type and elevation in April 2013 during falling tide from low high water, and B: shows sediment type and elevation in June of 2014 during low water. The upper section of pebbles and cobbles have been replaced with coarse sand. High high water level covers the lower armour stone in front of the breakwater at BP-2.

Residents commented that saltwater occasionally comes up to the road surface to the right of the reddish-brown stage in Figure 5.20.

Multiple observations and information from residents and the Town reveal that the breakwater is holding, although there have not been any storms of the magnitude and setup of the 2009 storm event. However, there is information to suggest that future damage or failure will occur. High high water (not surge conditions) was observed covering the lower armour stone in November 2013 (Figure 5.21). From this point, there is approximately 2 m of armour stone and breakwater above water during this calm condition. The water depth over nearshore shoals was observed at  $\geq 2$  m and the low tide berm was ~1.6 m below water. This suggests that large waves during this condition would likely displace the armour stone. Impact marks on the seaward side of the breakwater from armour stone moved by large waves were observed from previous events. Many of the originally placed armour stones have been displaced seaward and are now partially or fully buried in sediment in the intertidal zone. During erosion and accretion cycles, and larger wave events, sediment accumulates seaward of the armour stone creating a swash ramp (Figure 5.20A) that provides for swash flow up to and over the breakwater. This results in sediment deposition on the paved road surface and fill erosion on the north edge and gravel surface down to The Pool. The Town is considering future maintenance to reposition armour stone that has been moved due to wave events and to address excessive sediment accretion (e.g. swash ramp) (Mayor R. Paul, Pers. Comm., Numerous Dates).

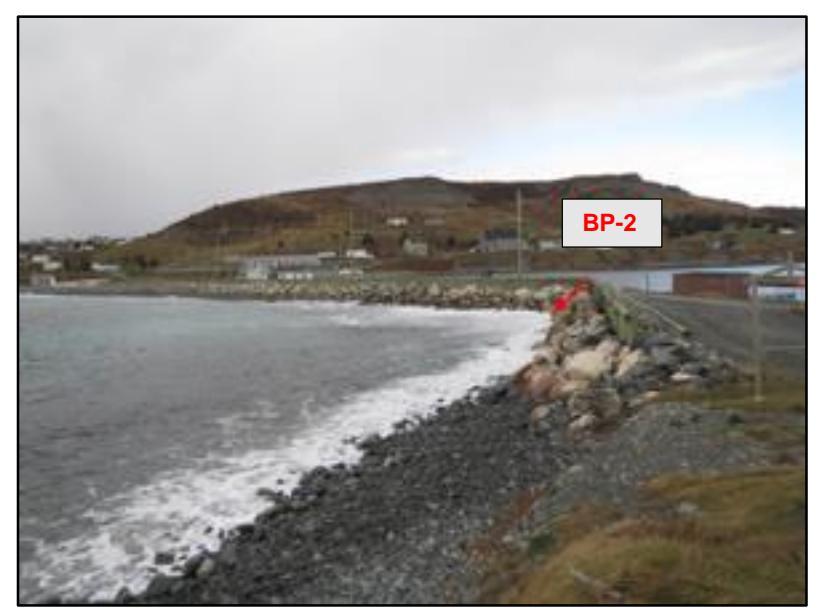
Figure 5.21. Water level at BP-2 breakwater. BP-2 (first turn in the breakwater) elevations reveal that the water level at this time is  $\sim$ 2.3 m above MTM datum; the inner paved road to the right is < 2 m above MTM datum. The water is higher on this side versus the upper right in Ferryland Harbour due to localized surge in the Backside.

A storm of similar magnitude to Hurricane Gabrielle in 2001 at surge conditions (< 1m below top of breakwater) would have very likely resulted in waves breaking very close, on, or over the breakwater. The resulting overtopping and overwashing would likely transport barrier material and armor stone over the breakwater and wash out the roadway

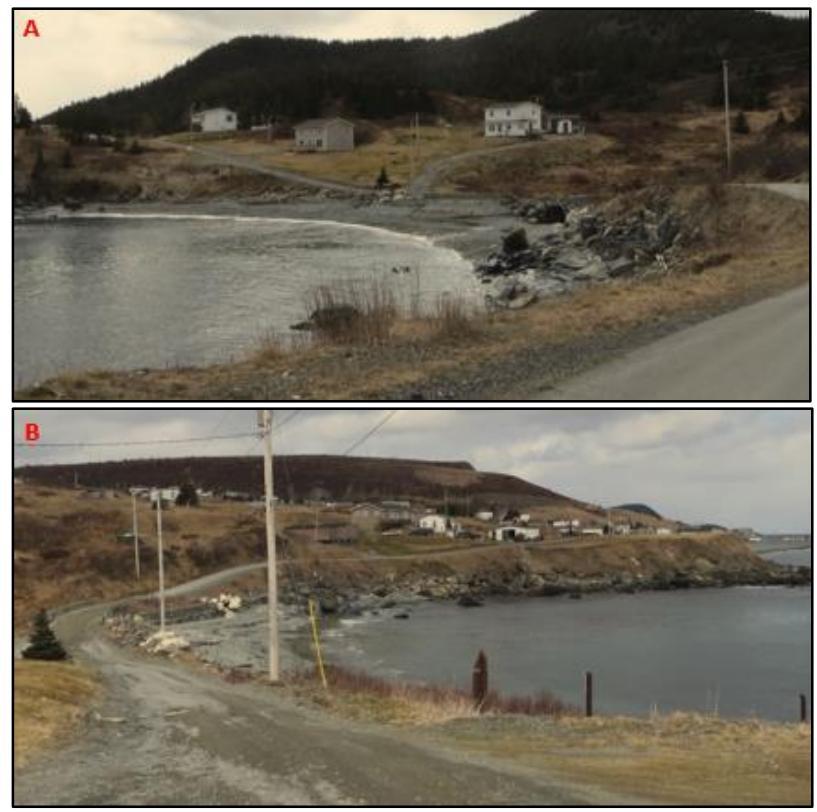
Figure 5. 24. Meade's Cove. A: is the view from the road looking southwest. B: is the view from the lower cove looking north.

The storm berm is backed by dilapidated cribbing and an old seawall on the south side of the culvert. The section of barrier on the north side of the culvert is backed by gabions, eroding fill and rocky shoreline. The barrier is <3 m in elevation and is known to be impacted by large waves (> 3 m) occasionally at high tide or surge conditions resulting in overtopping and overwashing. This results in the deposition of barrier material on the

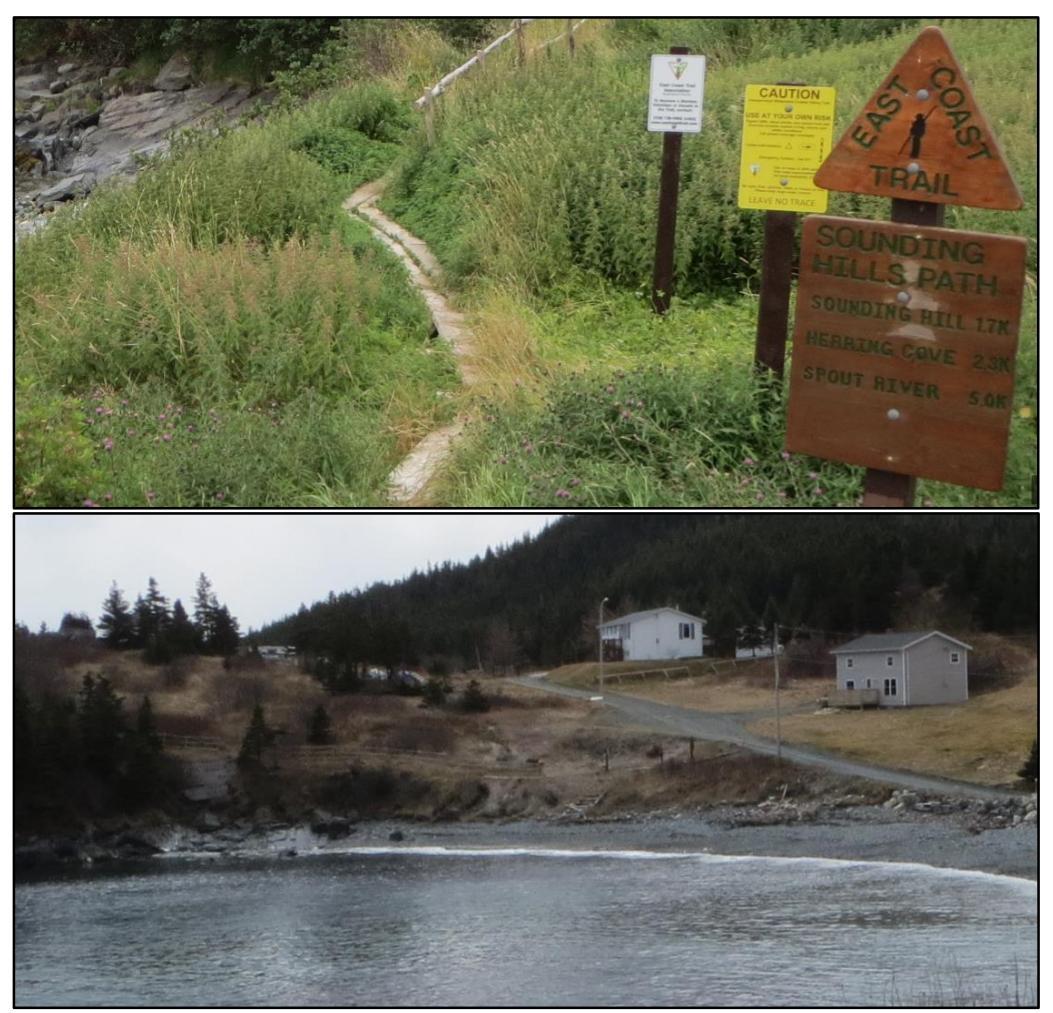
The Sounding Hills section of the East Coast Trail southward from Meade's Cove is located on the edge of an unstable till cliff undergoing erosion. Since 2013 material, including large boulders, have been observed eroded from the cliff falling to the barrier below. Freeze-thaw cycles heave and loosen the till while rainfall and wave undercutting transports the sediment onto the barrier where it is reworked or transported into deeper water. This is undermining the first 50m of the Sounding Hills Trail and is a hazard to trail users.

Figure 6.1. East Coast Trail - Sounding Hills Path. **Top**: First 50 m of trail with signs at the trailhead identifying Sounding Hills Path and warning of the risk of hiking along coastal areas. **Bottom**: bank erosion (middle of the photo). Note the large boulders which have toppled from the till cliff on the left of the barrier. Photos: The top was taken in August 2014 and the bottom was taken April 2013.
