FATIGUE CRACK GROWTH CHARACTERISTICS OF  
OFFSHORE STRUCTURAL STEEL IN MARINE ENVIRONMENT

**A Thesis submitted to the School of Graduate Studies in partial  
fulfillment of the requirements for the degree of Master of  
Engineering**

**Faculty of Engineering and Applied Science  
Memorial University of Newfoundland  
April, 1993**

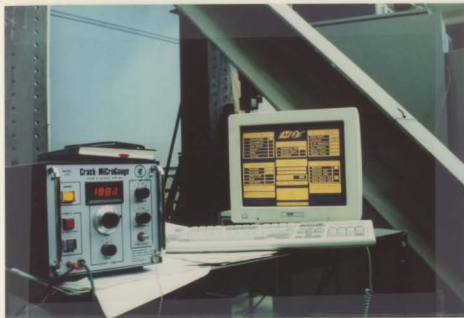
Figure 3.5: The Crack Micro Gauge and MDT testing software screen.

A PC based fatigue testing system MDT 1.1 was used to control the fatigue loading and for data acquisition (figure 3.5). Figure 3.6 schematically shows the load control system used. The signal from load cell goes to the MTS Controller where it is first amplified and demodulated by the Transducer Conditioner and then passed onto the Servo Controller by the Feedback Selector. The Servo Controller compares the feedback with a composite signal, the summation of the external program (MDT 1.1) and the set up of different parameters at the front control panel. If an error exists, an error signal is sent to the Servo Valve which opens in the direction and to
